Bearing Damage Characteristics of Fibre-reinforced Countersunk Composite Bolted Joints Subjected to Quasi-static Shear Loading

Hamed Yazdani Nezhad, Brian Egan, Fiachra Merwick, Conor T. McCarthy

To appear in: *Composite Structures*

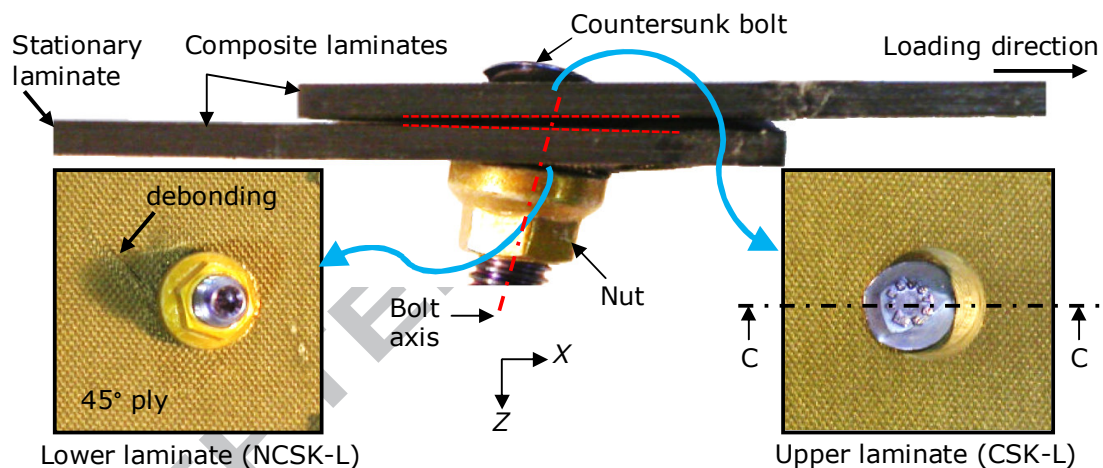
In the quasi-static tests of the CBJ specimens, fastener pull-through, fastener failure and bearing damage were observed as final failure modes. Figure 2 shows the single-bolt CBJ failed by a combination of the bearing failure and fastener pull-through. Extensive bearing damage was observed in all tests until very late in the loading history prior to fastener failure. Some fibre-matrix cracking/debonding can be observed in NCSK-L close to the composite-nut interaction (see inset to Figure 2). However, the main source of damage in the joints was extensive bearing damage at the countersunk hole, which occurred prior to final catastrophic failure. This was to be expected as the joints were designed to initially fail in bearing [15]. The dashed line C-C represents the section where cut through CSK for microscopic studies presented later.

Figure 2: Combination of bearing and bolt failure in single-bolt CBJ. Dashed line C-C represents cut-through section for microscopic studies

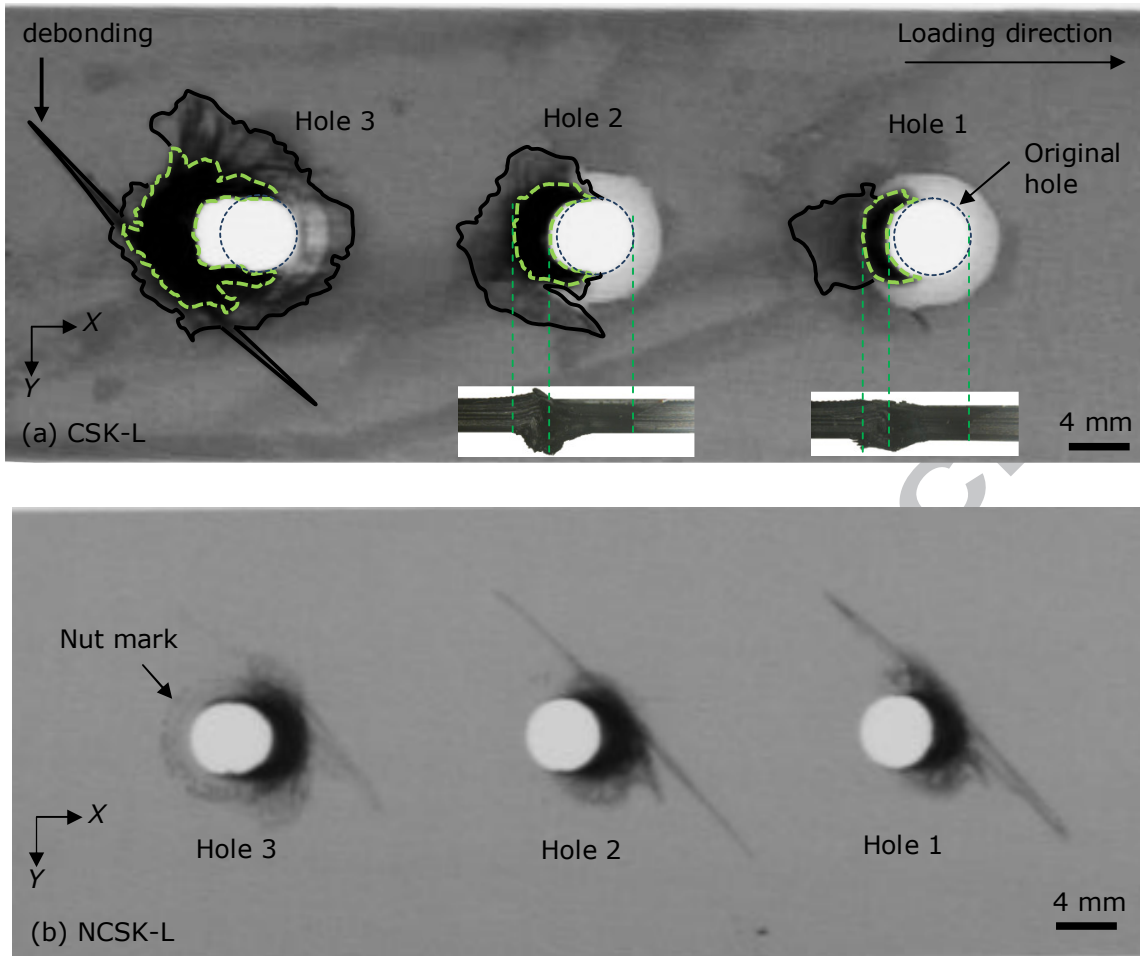
Figure 9: X-ray image of three-bolt CBJ using X-ray, (a) CSK-L, (b) NCSK-L

As seen in Figure 9(a), damage area in the CSK part is largest at Hole 3 and smallest at Hole 1, while damage at each bolt-hole in the NCSK laminate in Figure 9(b) is almost identical. This difference in damage area is attributed to the presence of countersunk head crushing into the top surface of the CSK laminate, as was clearly observed during testing. This observation is in stark contrast to what is observed in protruding head bolted joints, where damage is anti-symmetric, meaning that damage at Hole 1 in one joint member is normally equal to damage at Hole 3 in the opposite joint member [16, 17]. This loss of anti-symmetry means that countersunk bolted joints must be analysed fully at each bolt-hole, and that simplifying extrapolations derived from single-bolted joint tests must be used with caution. We thus now offer a new method to predict the damage growth in CSK joints based on the concept of damage areas.
