Citation: Maraveas, C. & Tsavdaridis, K. D. (2019). Assessment and retrofitting of an existing steel structure subjected to wind-induced failure analysis. *Journal of Building Engineering*, 23, pp. 53-67. doi: 10.1016/j.jobe.2019.01.005

Assessment and Retrofitting of an Existing Steel Structure subjected to Wind-Induced Failure Analysis

C. Maraveas^{1,2*} and K.D. Tsavdaridis³

¹C. MARAVEAS & ASSOCIATES P.C. - Consulting Engineers, Greece

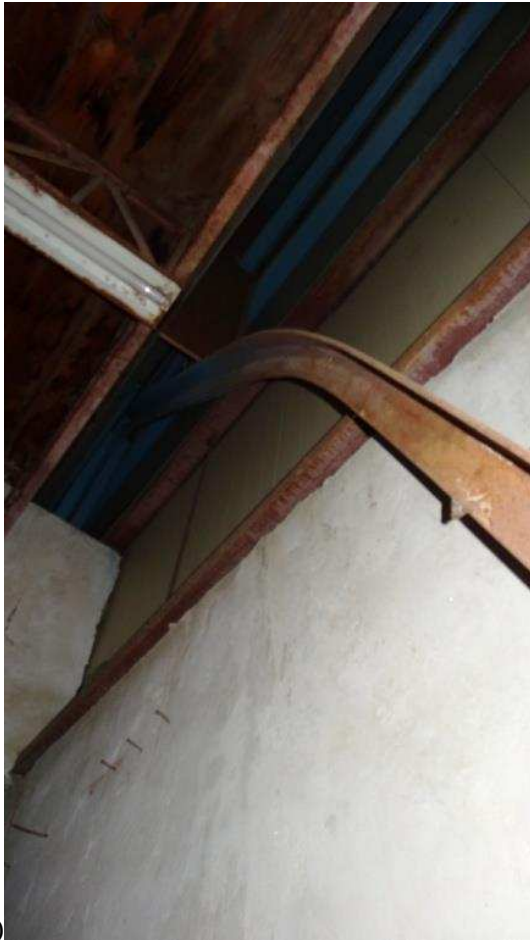
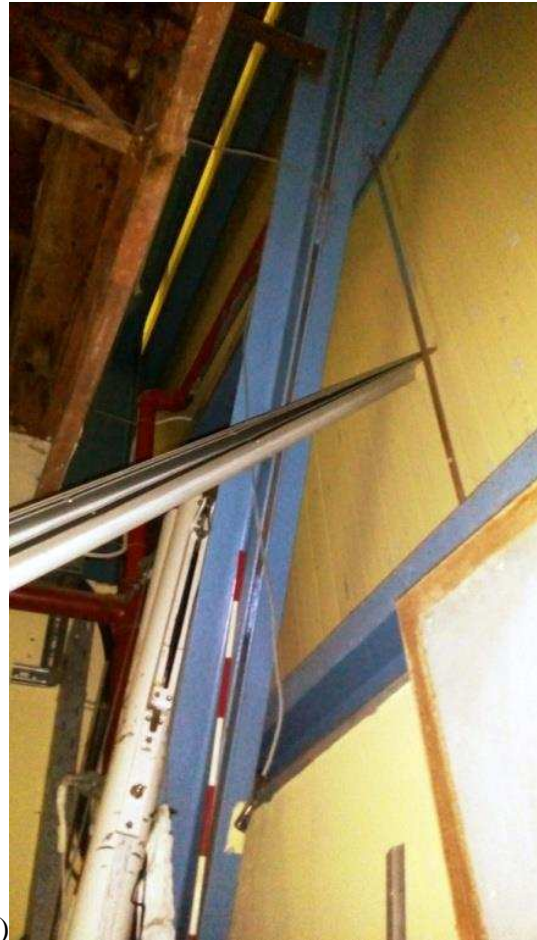
a) Extended buckling deformation of the corroded Λ -type vertical bracings to the south (Fig. 4a) as well as of the connecting beams between the IPE360 columns at +8.70 m (Fig. 5).

a) b)
Fig. 4. Vertical Λ -type bracing on the southern section of the building: a) the corroded portion with major second-order deformation and b) the undamaged portion.

In summary, this investigation indicated that corrosion (Fig. 4) and construction (Fig. 7 to 9) defects as well as accumulated damage (Fig. 4) from past events and further deterioration combined to produce the present structural condition. It is likely that failures of different structural elements (i.e., brick walls, bracings, etc.) resulted from different events that took place in an unknown sequence. Nevertheless, it is vitally important to examine the most likely sequences that could lead to failure before proposing strengthening measures. Since the most severe main steel structure failures are caused by the wind, more detailed numerical simulations are conducted in section 2.3.

- c) Replacement of insufficient vertical bracings using the same or different configurations (examples from the south and north sides of the building as well as Section 1-1 can be observed in Fig. 16, Fig. 17).

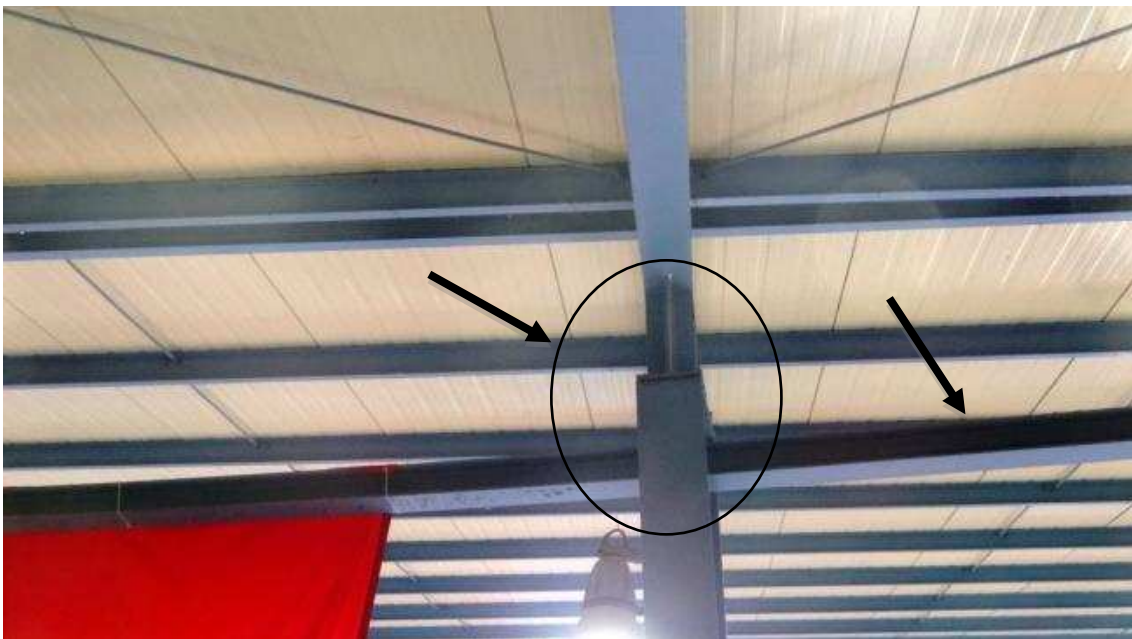
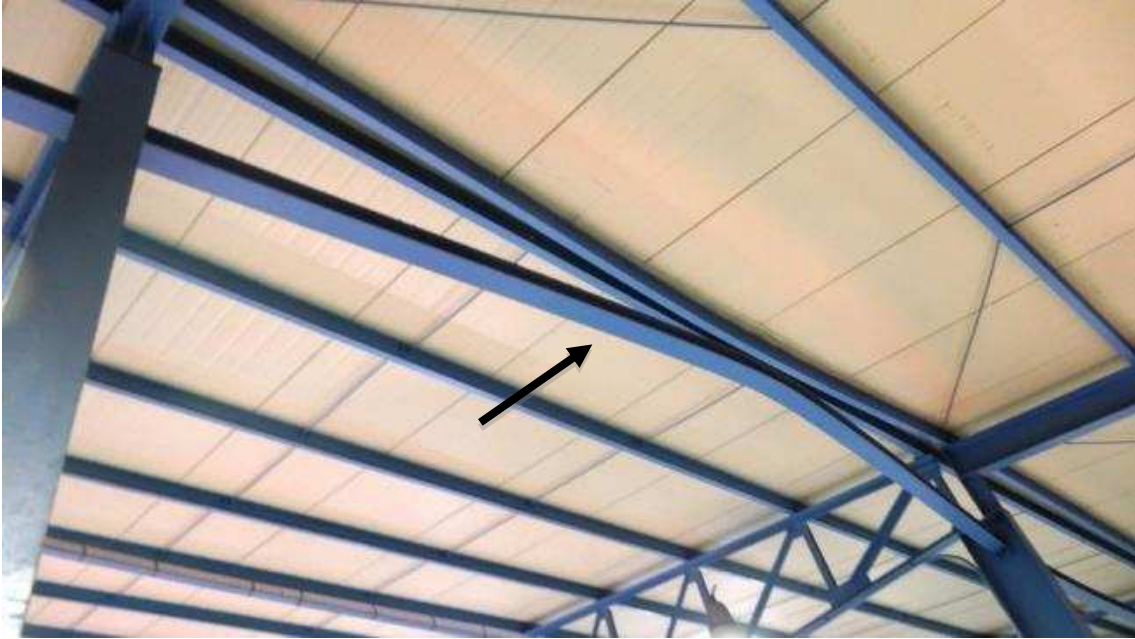
Fig. 5. Steel elements with major second-order deformations.

- d) Replacement of distorted members such as H-type connecting beams in Section 1-1 of Fig. 16, Fig. 17.
- e) Replacement of vertical elements at the end of the IPE360 column (Fig. 17), which is predicted to provide a stiffer beam-column connection.

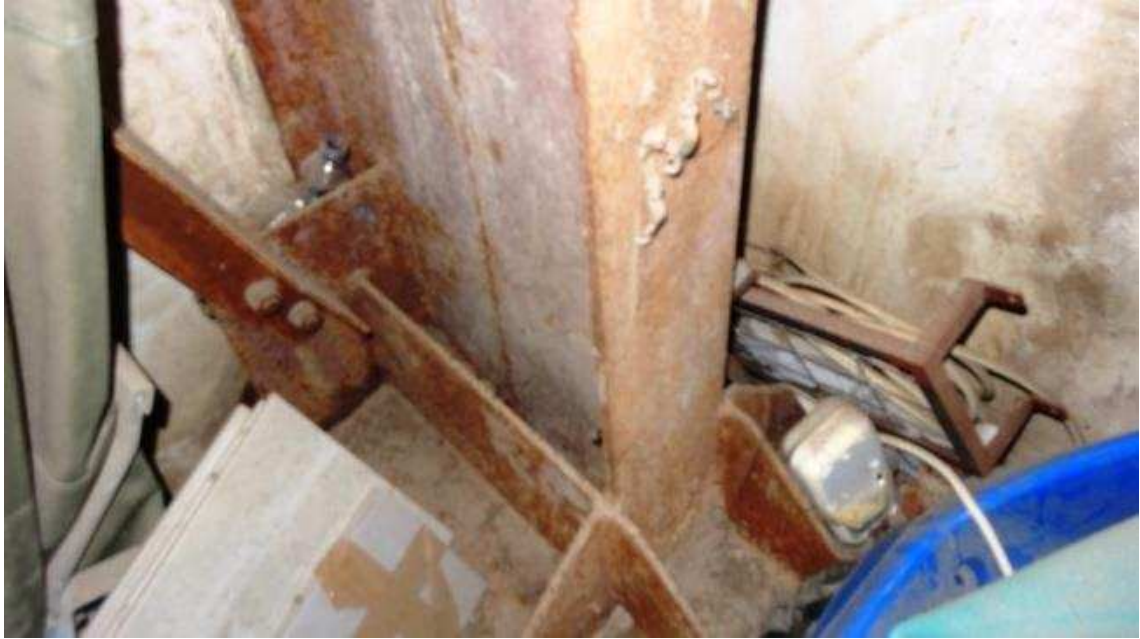
- b) Column-baseplate connections with major corrosion effects and insufficient stiffener thicknesses (Fig. 6a).
- c) Significant cracking effects at various locations along the perimeter of the brick wall. In particular, shear cracking expands to the concrete foundation wall on the north-east corner (Fig. 6b).
- d) Relaxed bolted connections at elements of major importance (i.e., vertical bracings) as well as relaxed anti-sag bars at the roof (Fig. 7).
- e) Major torsional deformation of vertical primary elements with insignificant torsional stiffness (Fig. 8).
- f) Almost non-existing column foundation under the first and last truss. They were connected to a slim (~20cm) layer of plain concrete without any reinforcement.

Fig. 6. Bad condition of the existing structure a) Column base with significant corrosion and b) brick wall with a large crack.

Minor but important restoration techniques should be implemented. They include tightening of bolts and anti-sag bars, surface treatment for corroded members that are not to be replaced (e.g., surfaces of columns near the base). Special treatment for foundation inadequacies is required as well. In particular, portions of the foundation beneath the gable columns (at both the east and west parts of the building) should be strengthened so that they can receive bending moments. The latter recommendation is illustrated in Fig. 18(a), where H-type steel beams are used as provisional column supports for an adequate length in both directions.

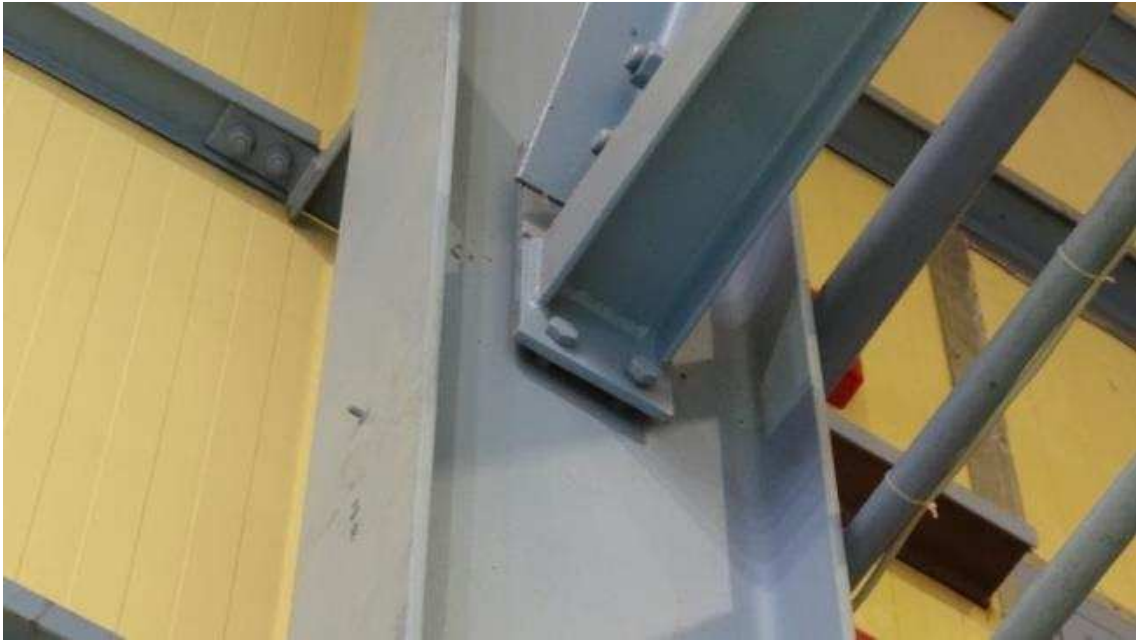
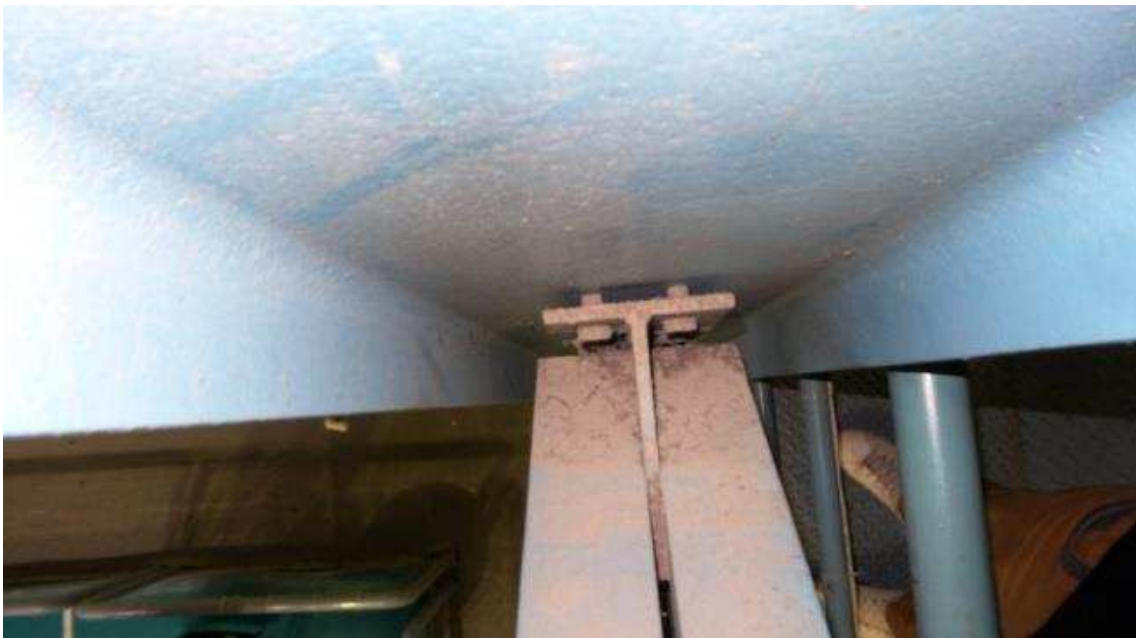
Fig. 7. Relaxed bolted connection.

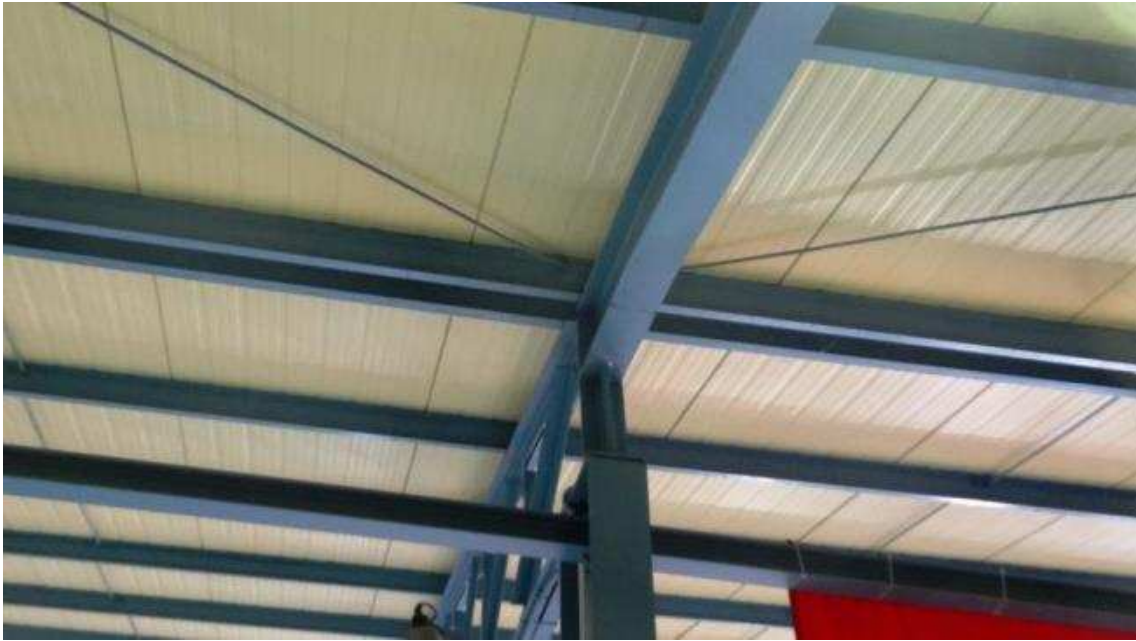
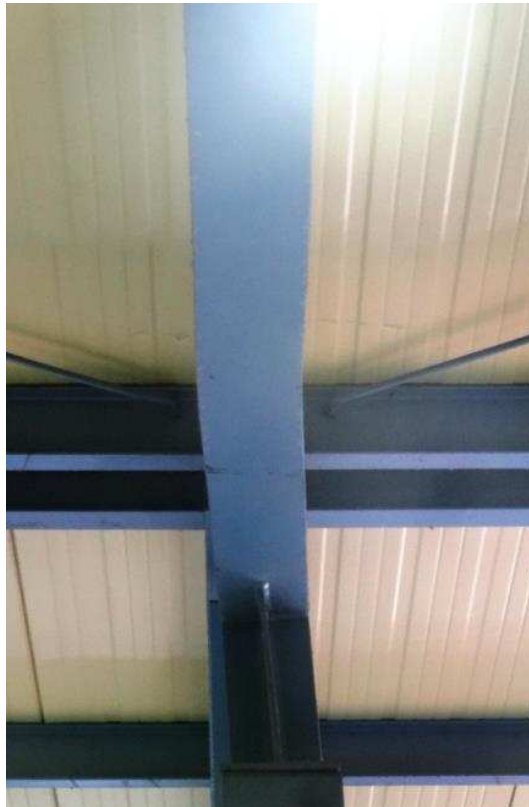
Fig. 8. Insufficient beam-column connection.

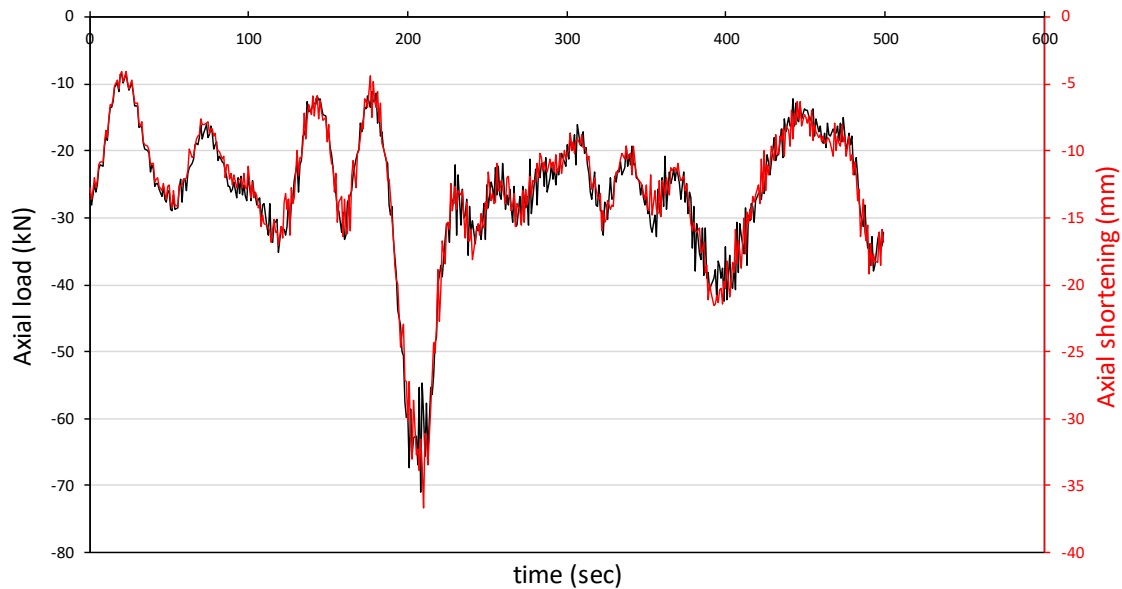
The axial force and dynamic histories as well as the axial displacement history determined via the dynamic analysis, are shown in Fig. 13. The maximum recorded load is 71.0 kN, which corresponds to axial shortening of 31.6 mm. The shortening itself ranges

from 4.0 to 36.7 mm. Considering only the axial load produces a surprising outcome since the maximum developed compressive force does not exceed the buckling capacity of the corroded bracing. However, a design engineer should cautiously consider the most critical qualities, which are the motives for a displacement-based analysis.

Fig. 13. Axial load and displacement response of element no. 10114.

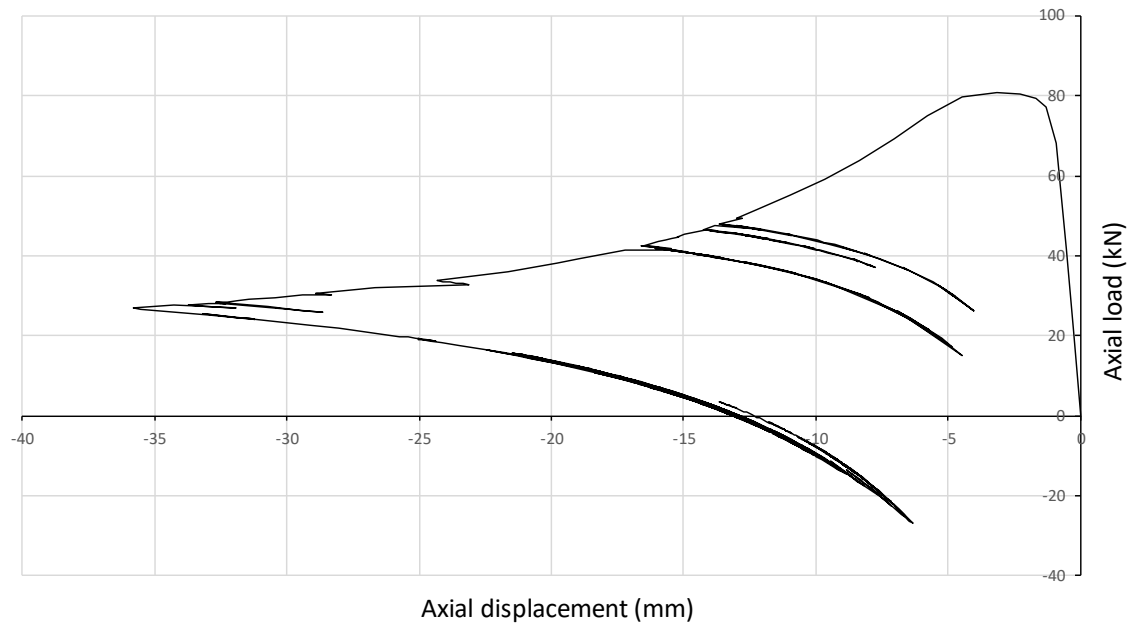
The buckling response, as shown in Fig. 14, was identified after importing the exact function of the axial displacement from the wind history analysis into Abaqus as a boundary condition amplitude. The maximum buckling capacity attained is greater than 81 kN (greater than 71 kN from Fig. 13). Nevertheless, buckling phenomena have occurred due to a significant shortening of the beam. In addition, the axial stiffness of the buckled beam is confirmed using the post-buckling curves. In particular, the stiffness (which is detected at the onset of a new compression region) is nearly equal for all subsequent loading paths after the first buckling occurrence (axial displacement of 3 mm).

Fig. 14. The response of the corroded buckled bracing, as determined using Abaqus.
