Cavitation in the Cylinder-liner and Piston-ring Interaction in Internal Combustion Engines

Doctor of Philosophy Thesis

Ioannis Vasilakos

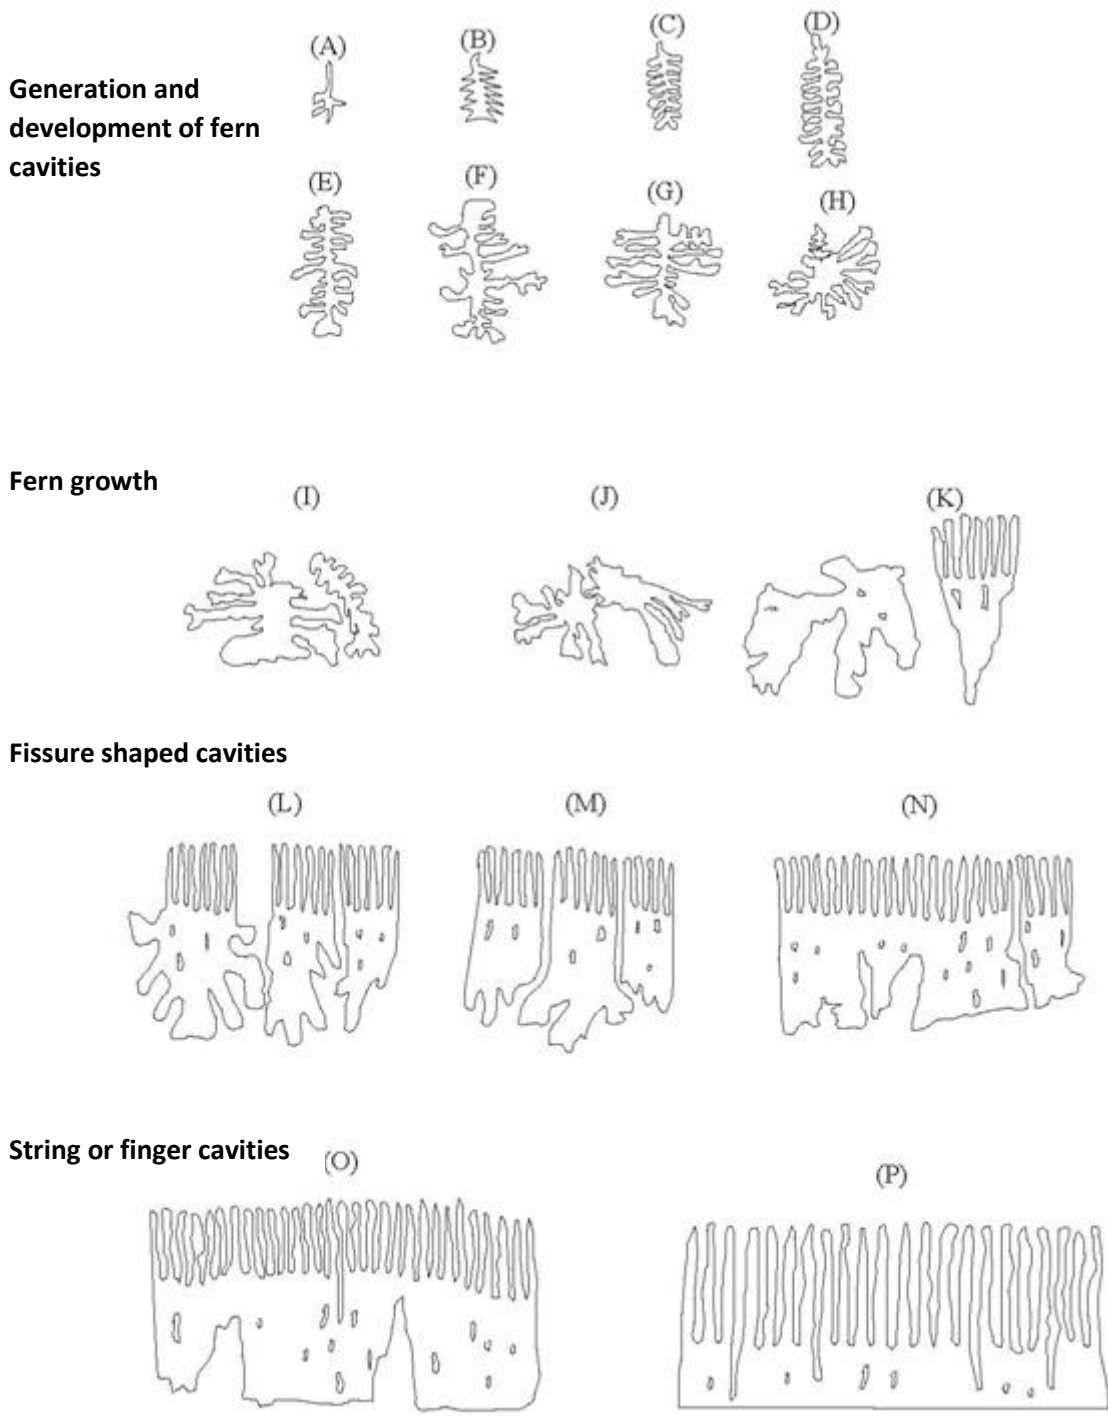
Figure 32 - Development of cavities as they appear on the surface on the ring (Dhunput, 2009)

The cavities as shown in figure 32 will pass through 4 main stages in their life cycle. These stages are the following; generation and development of fern cavities, fern growth, fissure cavities and string or finger cavities. There is one more stage that is related to the point in time where the cavities have formed bubbles and are at the end of their lifecycle before they collapse, and which comes after the string cavities stage. In the first stage at generation the cavities are initiated and start to appear on the piston-ring surface. These cavities are related to sub-figures 'A' to 'H' in figure 32. After the cavities, have initiated they next pass in the fern growth stage. These are sub-figures 'I' to 'K' in figure 32. During that stage, the cavities grow in size up to the point where they will enter the next stage and develop fissure cavities. Sub-figures 'L' to 'N' in figure 32 show the schematic of fissure cavities as these appear in the piston-ring and cylinder liner interaction. Finally, the fissure cavities pass into the next stage and develop string or finger cavities which are the last stage before the cavities start reducing in size, form bubbles and finally collapse. The string cavities can be seen in figure 32 as the sub-figures 'O and 'P'.

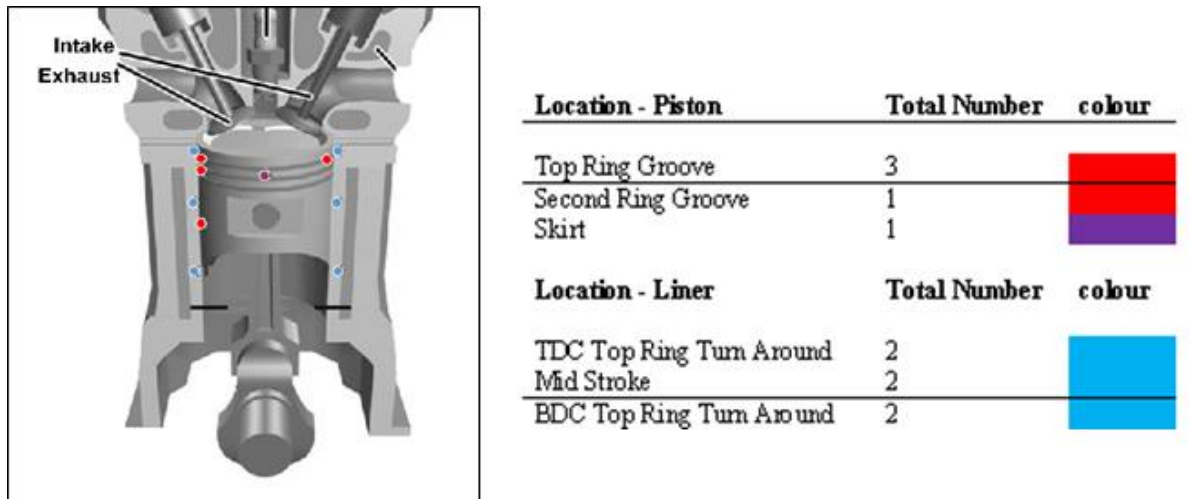
Figure 40 - Model of Thermocouples in Solid Cylinder Block (Ricardo, 2011)

type of engine can operate with gasoline, diesel or even bio-fuels while this particular model can be used as a port-injected or direct-injected engine. The engine used for the tests was a gasoline, spark ignition, port injected engine and the cylinder had a capacity of 450cc. The specific engine comes in two versions out of the factory, the low-pressure version and the high-pressure version. The current model is the high-pressure version that can withstand pressures of up to 160bar. This can be achieved with the use of a forged piston, a forged connection rod, a forged crankshaft and a forged set of inlet and outlet valves. The engine was also equipped with the optional thermocouple modified cylinder block which can perform a full thermal analysis with the use of thermocouples installed on the liner and the piston as shown in figure 40.

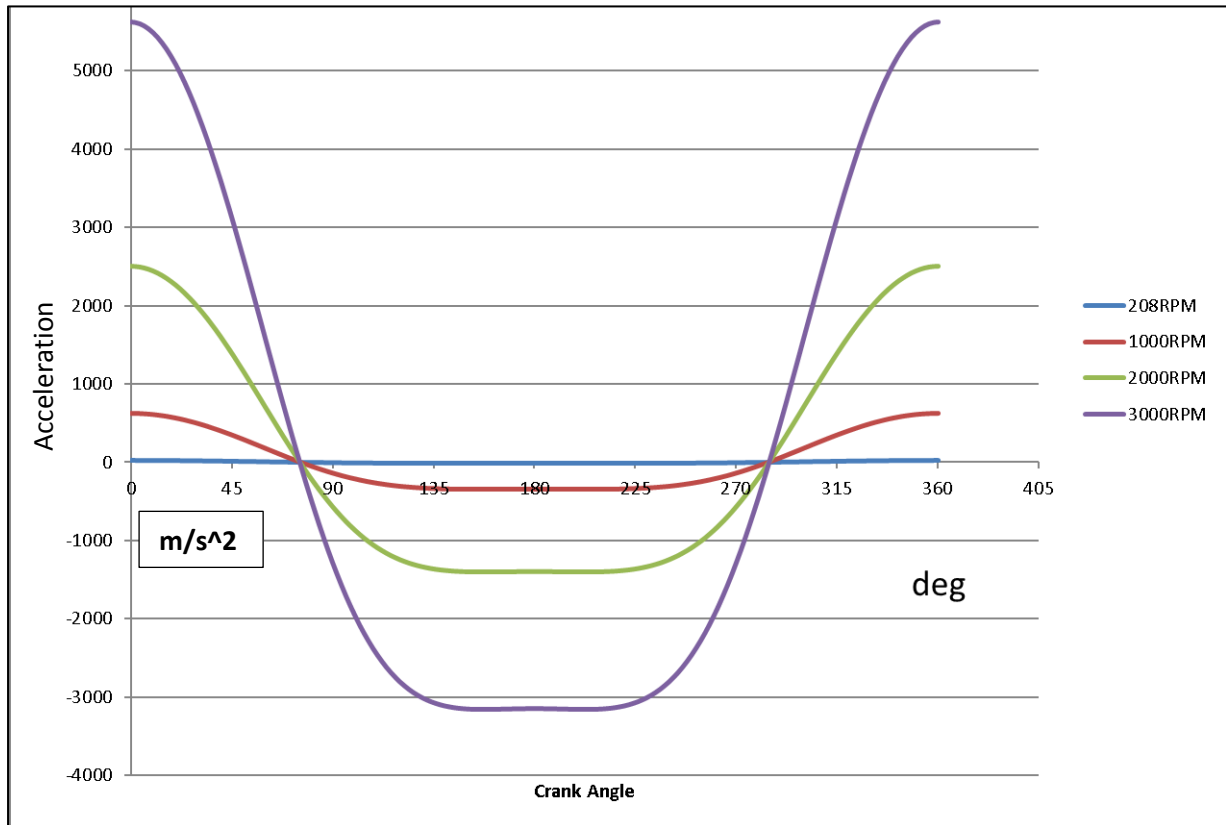
Figure 134 - Optical Engine Piston Acceleration Profile
