# **Cavitation in the Cylinder-liner and Piston-ring Interaction in Internal Combustion Engines**

Doctor of Philosophy Thesis

**Ioannis Vasilakos**

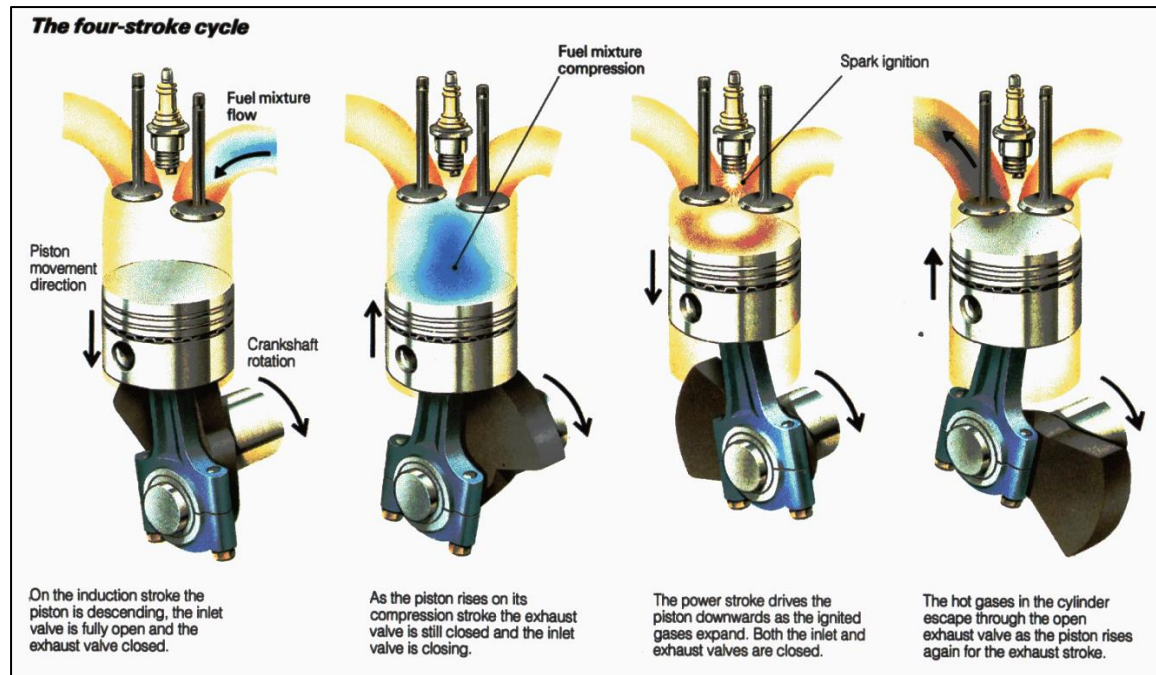
Figure 7 – Four Stroke Cycle (Moin, 2015)

Most internal combustion engines operate on either a four-stroke cycle or a two-stroke cycle. These basic cycles are company standard for all engines with slight variations found in individual designs. This chapter will analyse the operation of four stroke engines as the project focuses mainly on engines operating on that principle. Four-stroke engines perform four piston movements for every two revolutions to complete one cycle, figure 7.

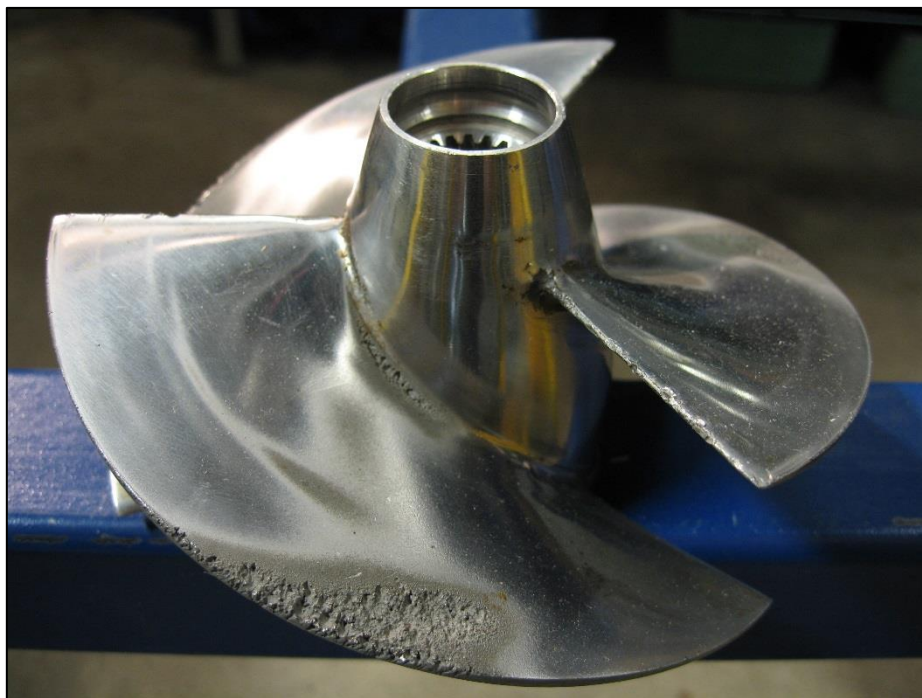
**Figure 10 - Cavitation Damage on Propeller of Personal Watercraft (SonicCavitation, 2015)**

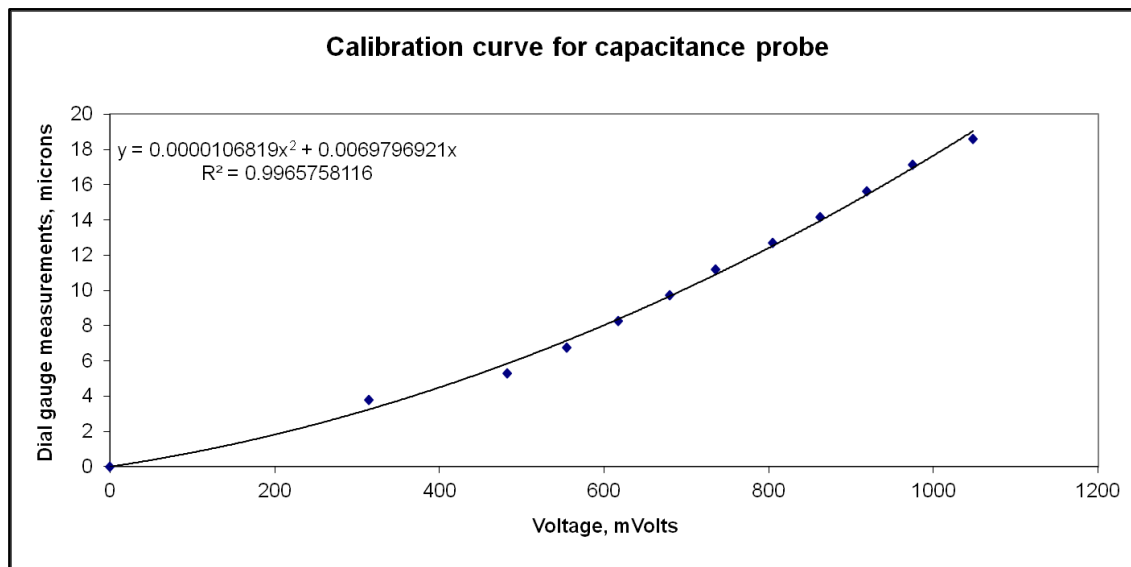
Figure 31 - Capacitance calibration sample chart and calibration equation

by monitoring the lift with the dial. The user must note the output voltage of the capacitance for every 2µm increments. This process is repeated eleven times to complete a set of calibration readings. Then each set is repeated five more times to successfully perform the calibration. After all the calibration data are collected the rest of the process according to Pyke (2000) is to derive a chart that will provide the equation from which the voltage can be converted into length. A sample calibration chart can be found in figure 31.

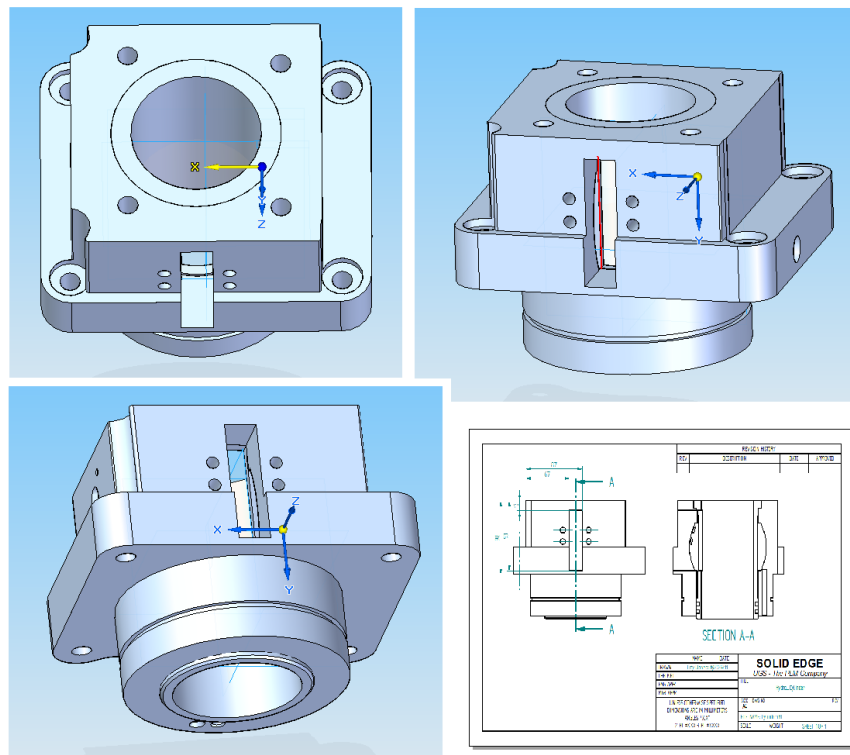
**Figure 45 - First design iteration of the cylinder block assembly**

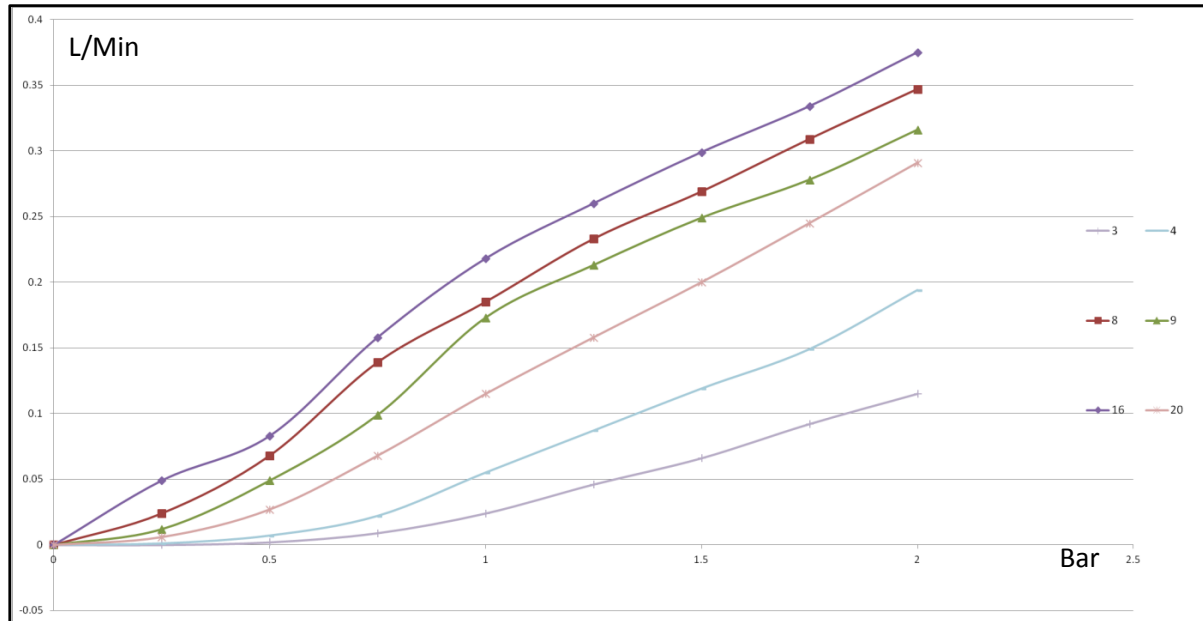
**Figure 60 - Optical test-rig measurements of flow rate vs. supply pressure at 40C**

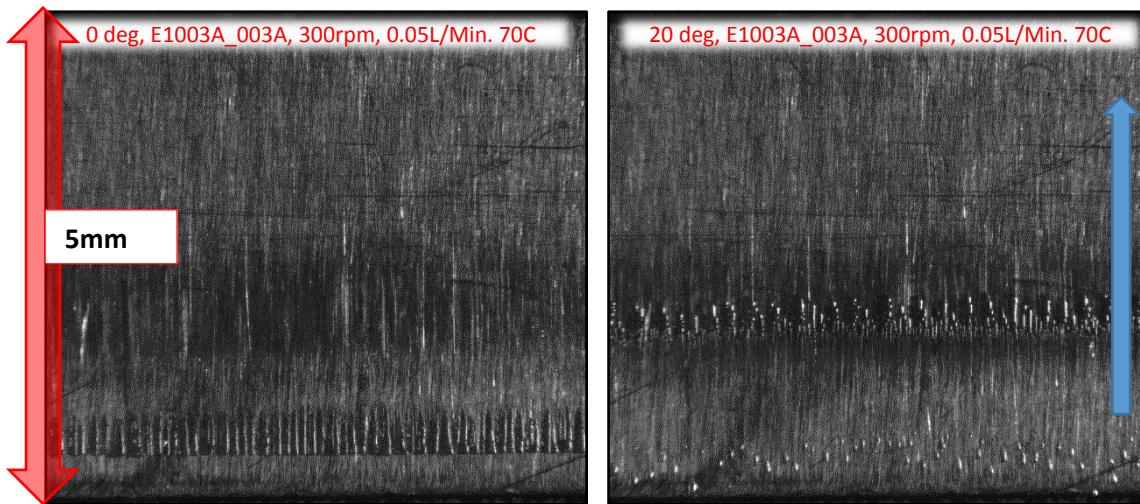
The first sample to be analysed is lubricant E1003A\_003A. The data are in a set of consecutive images where the speed is at 300rpm, the temperature at 70C, the frame rate at 36000fps and the lubricant supply flow rate at 0.05L/Min. The following set of unprocessed data offers a better understanding to why the figures plotted through the Matlab algorithms follow the trends they do. More information on the comparison between the raw and the processed data are given in earlier parts of this report where the output of the Matlab algorithm is compared next to the raw inputs. The following images illustrate the formation, development and collapse of cavities while testing lubricant samples on the test-rig. It is identified that the cavities which are generated on the top and the bottom of the ring are of different lengths. This is mainly due to the design of the ring, as the contact point with the liner is at an offset from the centreline, this is also discussed in the “Ring Profile” section of this report. The cavities shown in figure 65 to 74 pass through all the main stages of cavitation. The first stage is identified as the cavity generation, the cavities generated at this stage are also known as fern cavities.

Figure 65 - E1003A, 300rpm, 0.05L/Min, 70C, 0-20deg

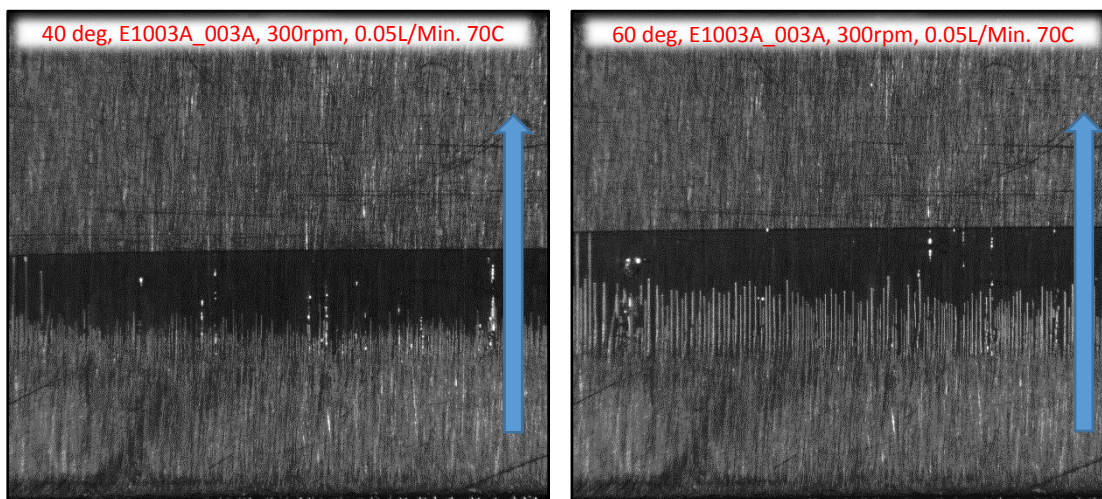
The next stage after the fern cavities is the development of the finger cavities. The finger cavities remain developed for the majority of the stroke until they are forced to collapse in the form of bubbles. The last stage before collapse is the formation of a cavitating sheet, this sheet is observed in certain frames as in figure 66 in the form of a large unified dark area. The captured data indicate that though the cavity behaviour is directly linked with the relative piston-ring and liner movement there is a small delay to the cavity reaction which is directly linked to each lubricant's individual viscosity.

Figure 66 - E1003A, 300rpm, 0.05L/Min, 70C, 40-60deg

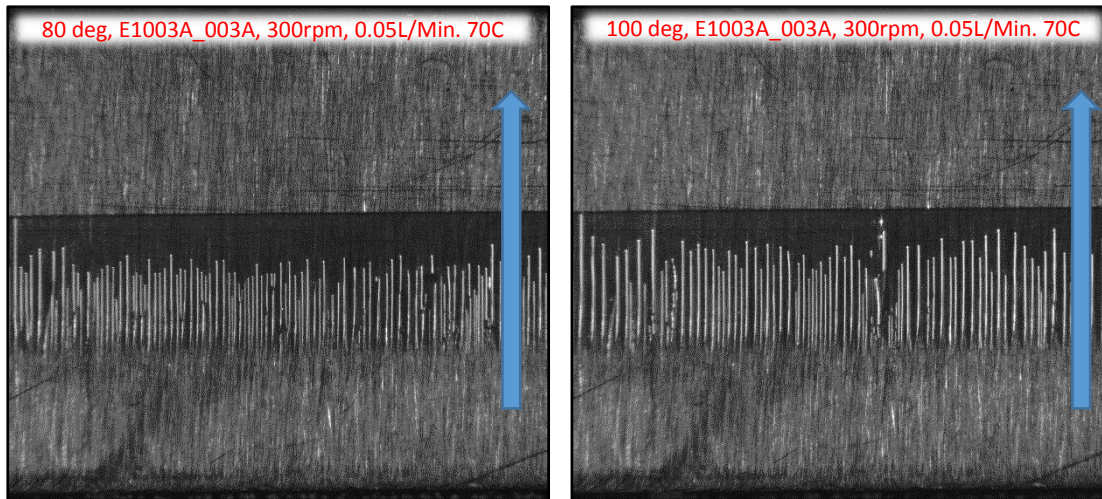
The following images have been enhanced with markers. The blue arrow indicates the liner movement direction in an attempt to give a better understanding of the link between the cavity behaviour and the relative liner movement, where a blue arrow is not present the liner is either at the TBC or BDC and its velocity is equal to zero.

**Figure 67 - E1003A, 300rpm, 0.05L/Min, 70C, 80-100deg**

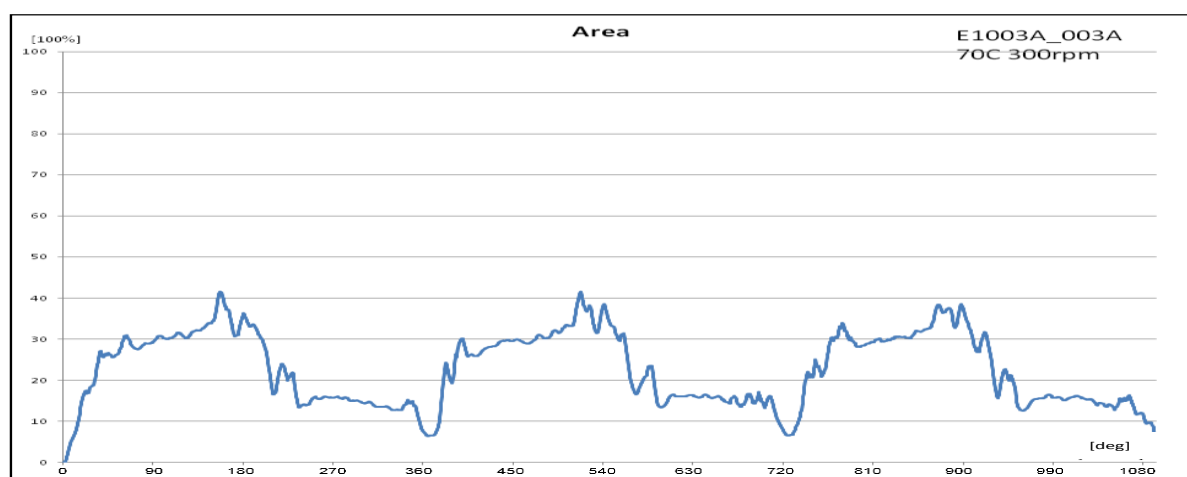
The following figures present information related to the area of the ring where cavitation occurs on its surface. They cover all the six lubricants tested at a temperature of 70C and a flowrate of 0.005L/Min at a speed of 300rpm. All the data are presented as a percentage of the total ring area against the rotational crank angle. For the first lubricant E1003A\_003A in figure 75, the test conditions as mentioned earlier are; flow rate of 0.005l/min, temperature at 70C and a speed of 300RPM. This specific lubricant belongs to base oil Group 1 with the addition of add-pack 1. This specific lubricant has no additional Viscous Modifiers. Figure 75 shows the area of cavitation for that specific lubricant as a sequence of three consecutive cycles. The cavitating area behaviour is repeatable on every cycle. Lubricant E1003A\_003A shows a peak of maximum area of cavitation at 180, 540 and 900 degrees, for all the three cycles. These are the middle-points of every cycle and where the liner changes direction. In the same figure, it is supported that the area of cavitation is directly linked to the crank angle.

**Figure 75 – Area Covered, E1003A\_003A, 0.005L/Min, 70C, 300RPM**

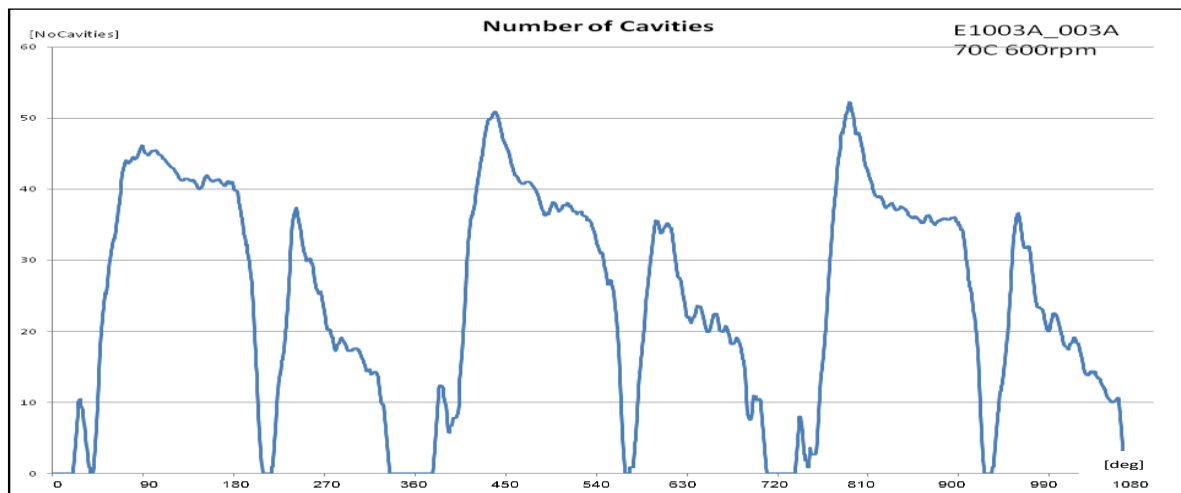
**Figure 93 – Number of Cavities, E1003A\_003A, 0.005L/Min, 70C, 600RPM**

Figure 93 shows the number of cavities that are generated for lubricant E1003A\_003A and what is immediately observed is the difference in the number of cavities between the up-stroke and the down-stroke. This observation is the same for all the lubricants in the batch and when it is compared with the lower speed the comparison shows that despite lubricants like as 004A showed cavities of similar numbers the higher speed constantly offers greater number of cavities on the upstroke that the down stroke for every sample of every cycle. This phenomenon is mainly based of the way the test-rig has been designed. The cylinder liner is free from restrictions on its upper part while it pivots on the lower one. The higher the speed the greater the hydrodynamic effect which increased the oil film thickness as this is supported by A. Dhunput and the work he did on oil film thickness on the test rig. One more observation that A. Dhunput made was that despite the fact that the ring has a curved profile that it is not the only factor that contributes to the gap created between the piston ring and the cylinder liner. Since the cylinder is pivoting on the bottom dead centre and while it is known that the higher the speed and the higher the lift of the cylinder liner, this will create a triangle which will always introduce a gap on the top side of the ring greater than the lower side of the ring. Furthermore, the higher the speed the more noticeable the effect. This is the main reason behind the noticeable difference between the down stroke and up stroke while the speed increases.

Despite the number of the cavities generated the profile for all the runs shows great similarities. Figure 93 presents the number of cavities generated for 3 consecutive cycles for the sample E1003A\_004A. Lubricant 004A is part of base group 4 which contains also lubricant 020A. When comparing these two lubricants it is obvious that at this speed the number of cavities and the profile of the curve shows a lot of similarities. This is something that has not been observed at the lower speed. At the lower speed, the number of cavities between the two lubricants showed a few differences and this came down to the additional viscous modifier and the individual KV70 since the remaining were very close. At this higher speed, the differences seem to be ironed out and the lubricants come very close to each other. It will be a useful addition the repetition of the measurements at a higher speed to confirm that this observation is linear, and it increased along with the rotational speed.

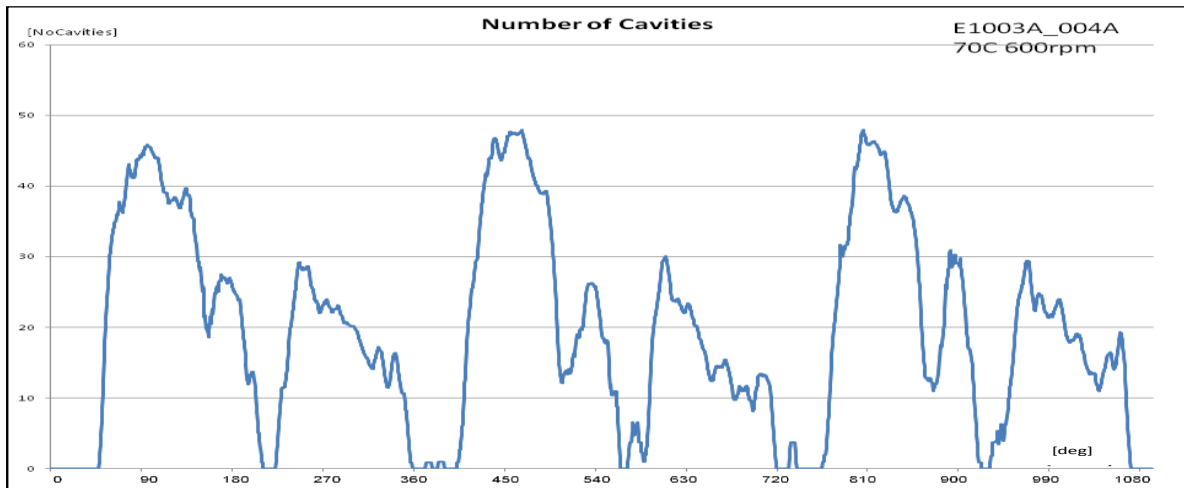
**Figure 94 – Number of Cavities, E1003A\_004A, 0.005L/Min, 70C, 600RPM**

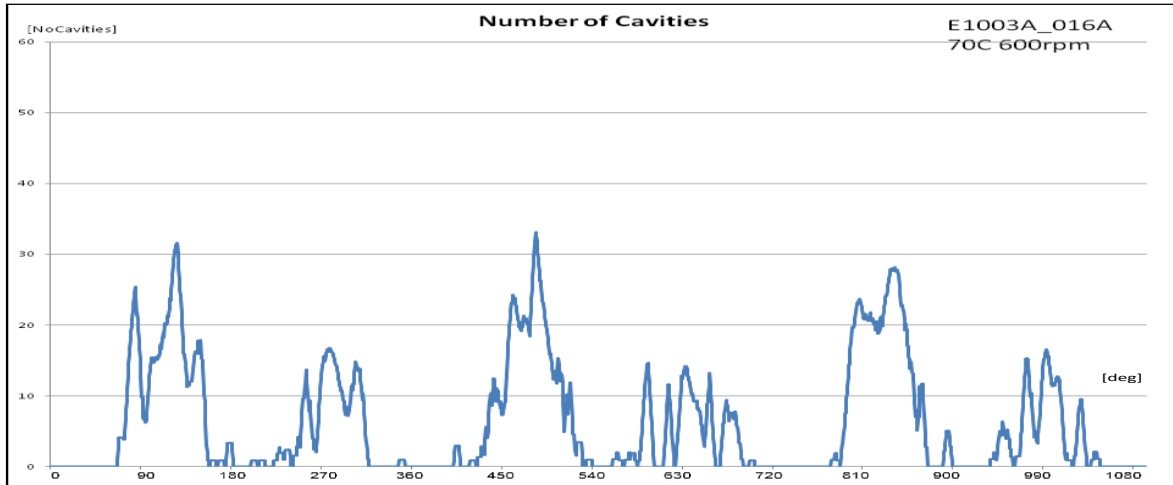
In general, there is a significant difference in the number of cavities between the up-stroke and the down-stroke where the number of cavities is significantly smaller in the down-stroke than the up-stroke. In figure 96 lubricant E1003A\_009A shows a significant increase to the number of cavities compared to the previous lubricant in figure 95. The cavities are increasing in number very early in the cycle and maintain their number for a longer period than in the previous sample. Figure 96 shows a less disrupted profile than the previous lubricant.

**Figure 97 – Number of Cavities, E1003A\_016A, 0.005L/Min, 70C, 600RPM**

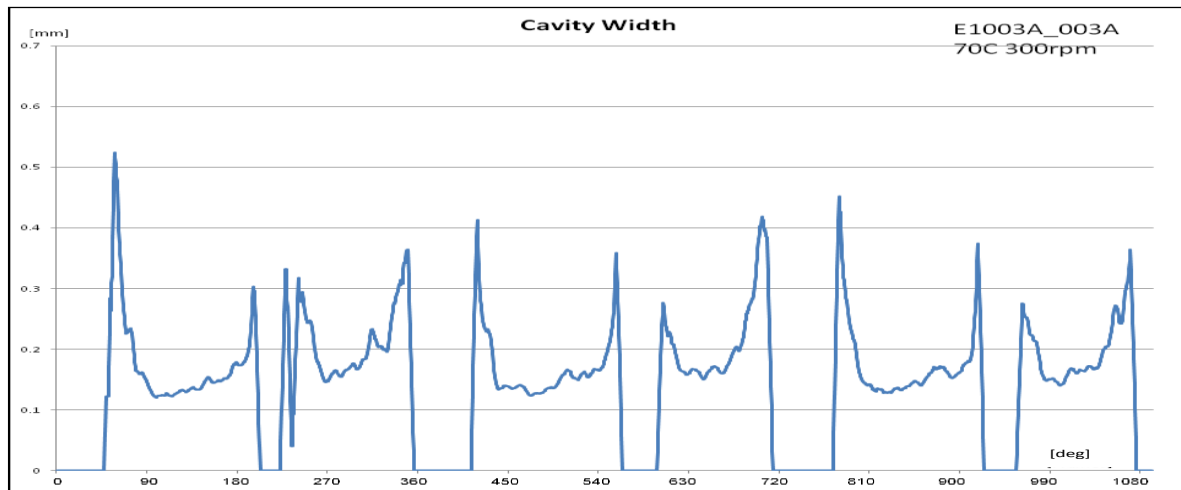
E1003A\_003A present the distinct profile just described of the graphs related to the width of the cavities. It has been noted that the cavities start at a greater width than the one they maintain for the majority of each stroke.

**Figure 99 – Cavity Width, E1003A\_003A, 0.005L/Min, 70C, 300RPM**

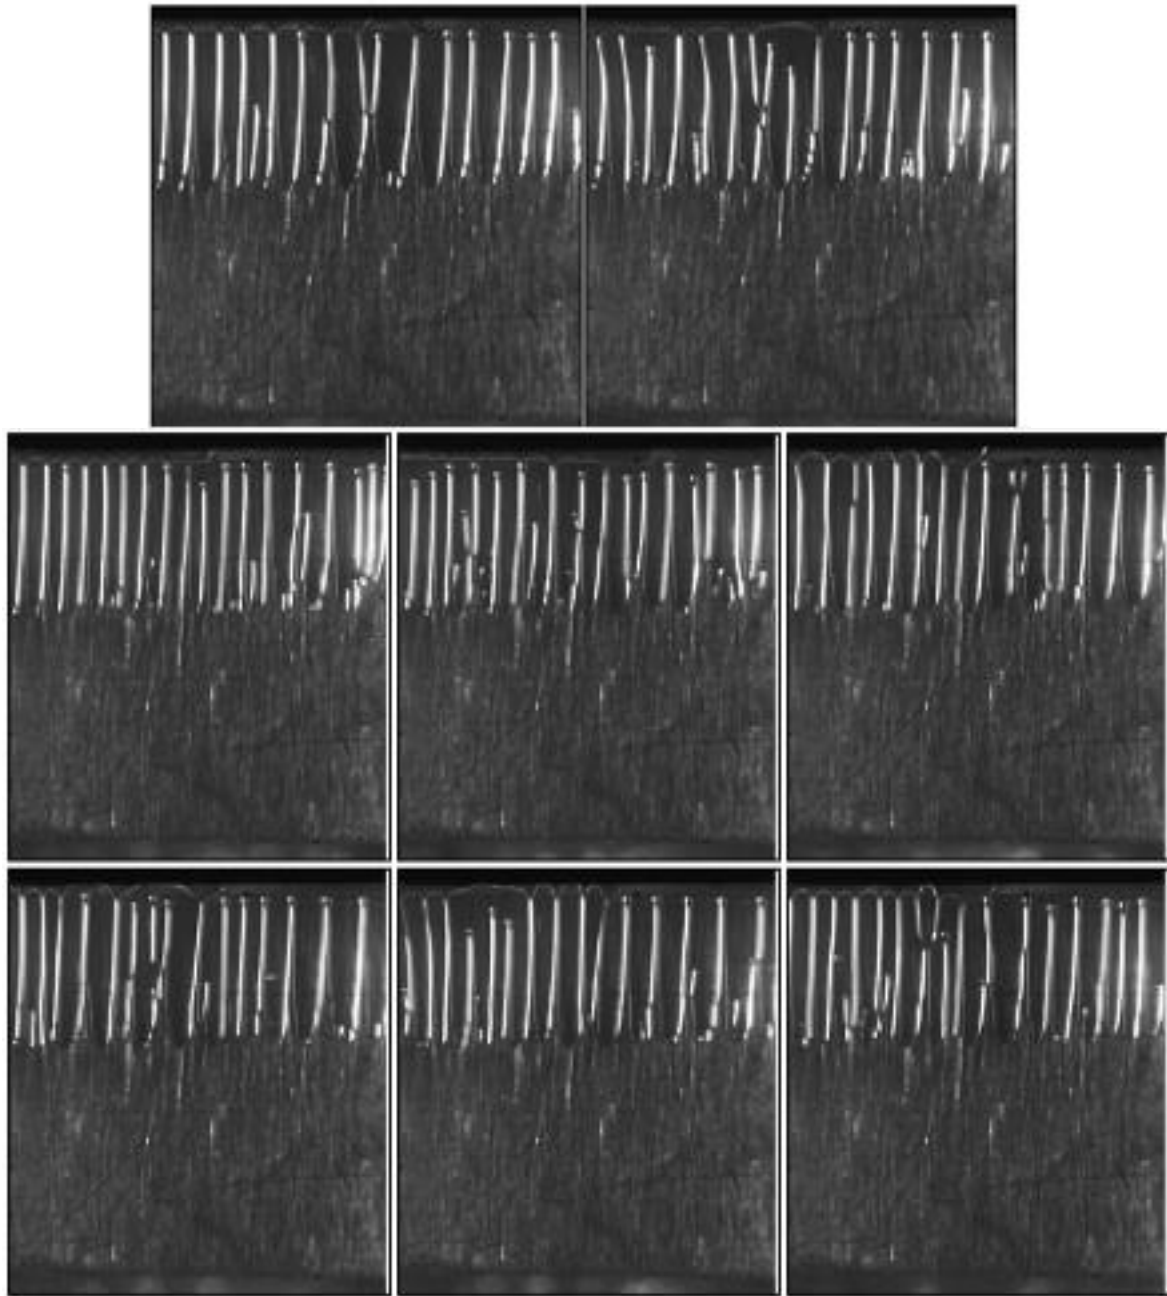
**Figure 123 – Repeatability between different test runs, E1003\_021A, 600RPM, 70C, 0.05L/Min**

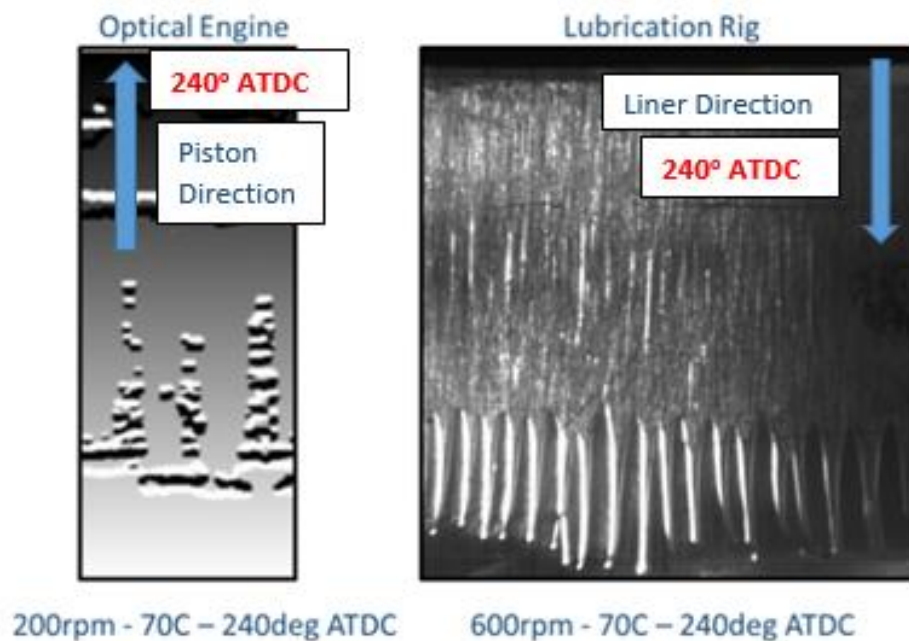
Figure 125 - Side by Side optical-engine and lubrication test-rig Cavity Comparison

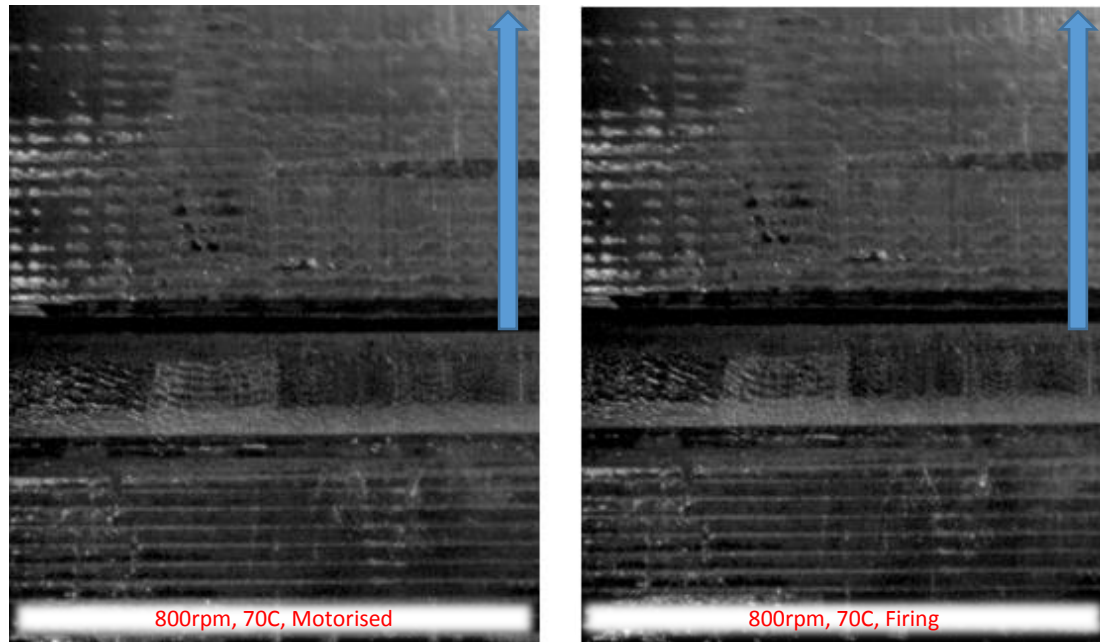
**Figure 130 - Firing vs Motorised operation, 800RPM, 70C**

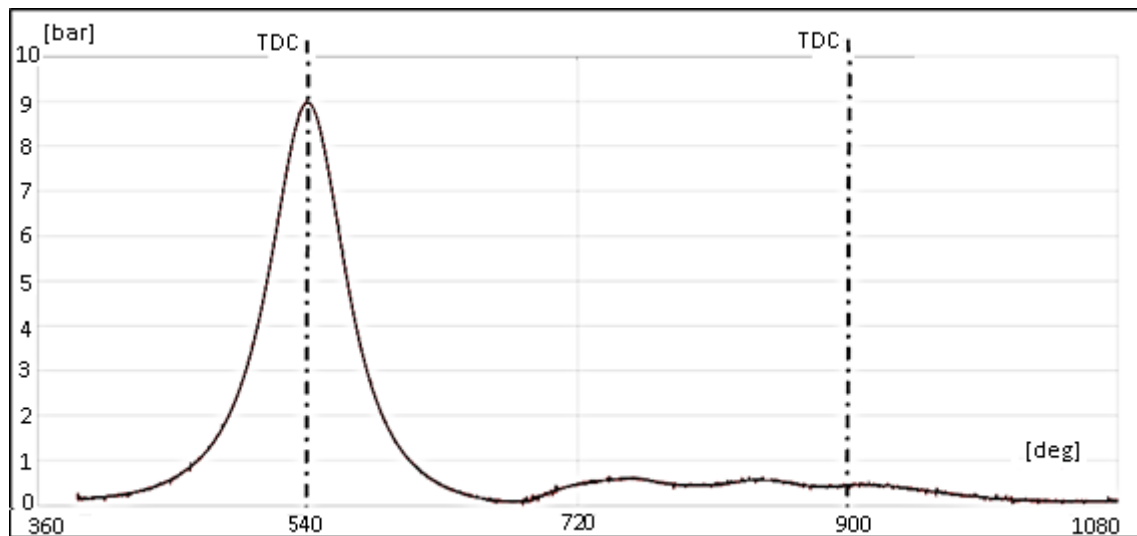
**Figure 131 - The optical-engine pressure trace, Motorised, 1000RPM, 70C, 720deg**

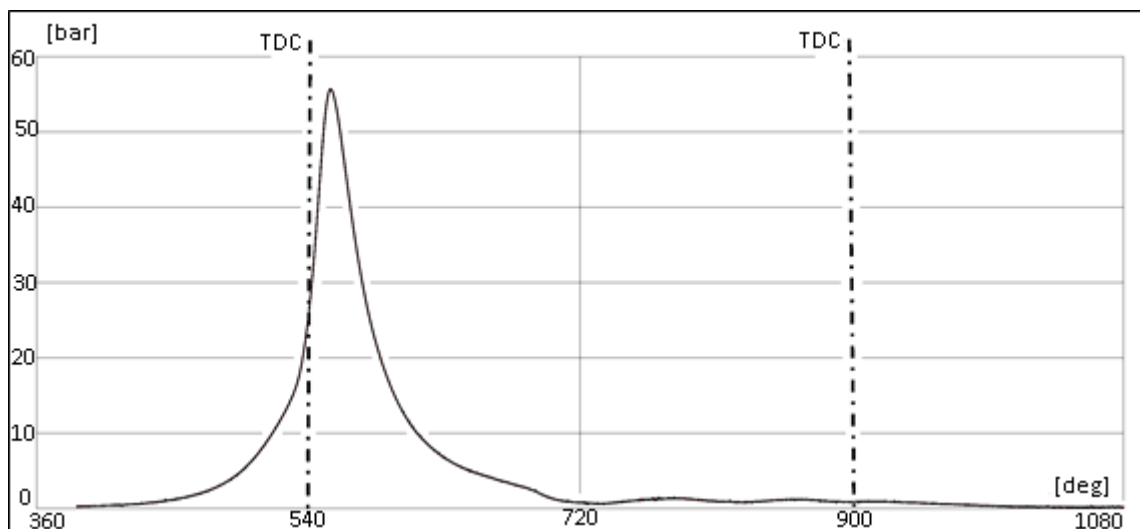
**Figure 132 - The optical-engine pressure, Firing, 1000RPM, 70C, 720deg**

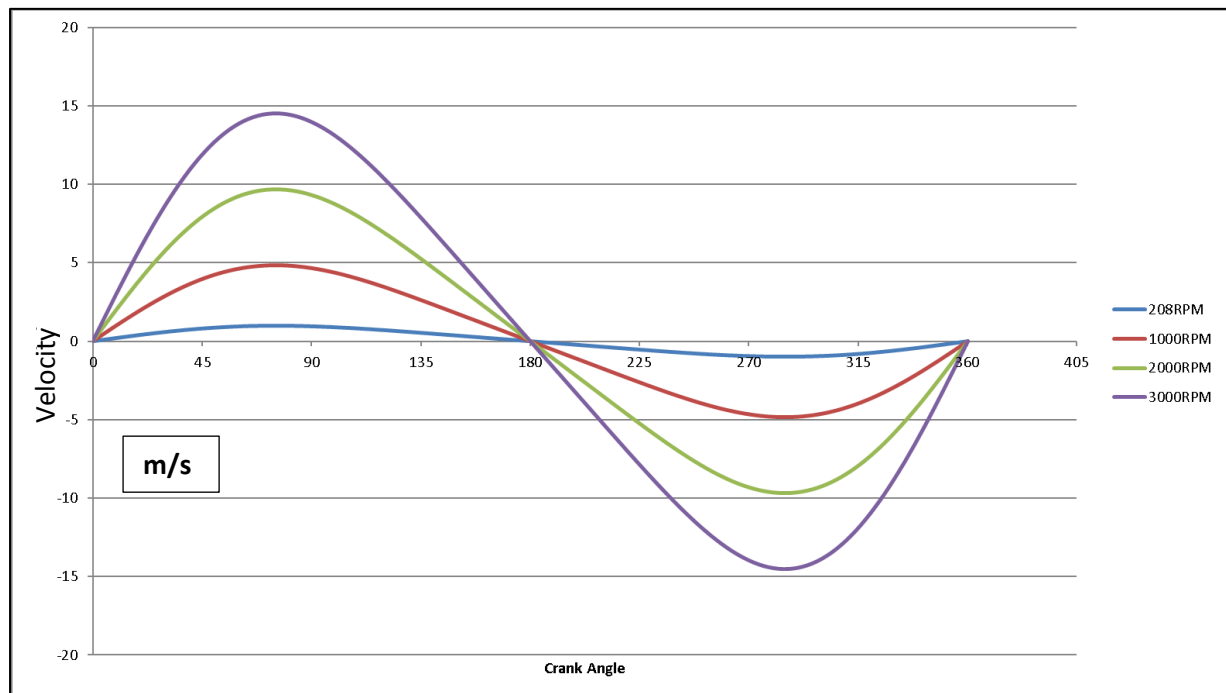
Figure 133 - Optical Engine Piston Velocity Profile

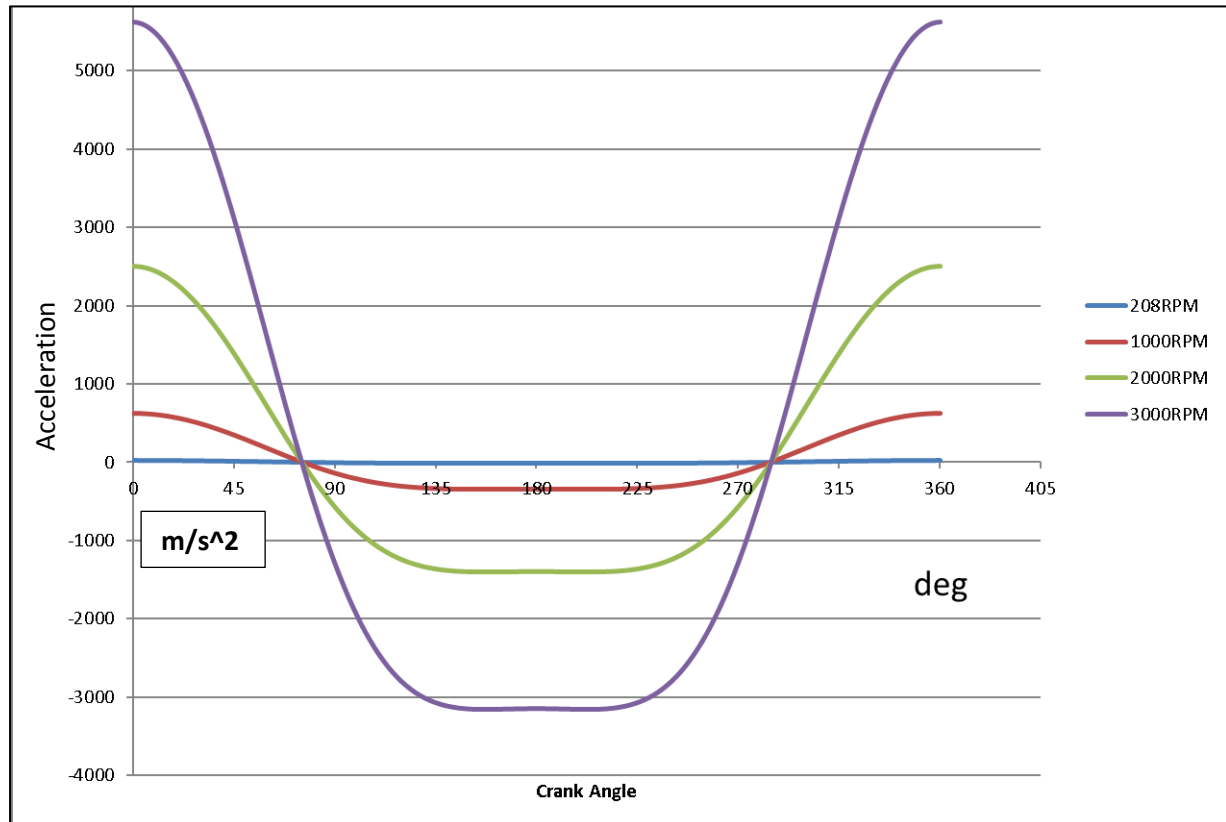
Figure 134 - Optical Engine Piston Acceleration Profile

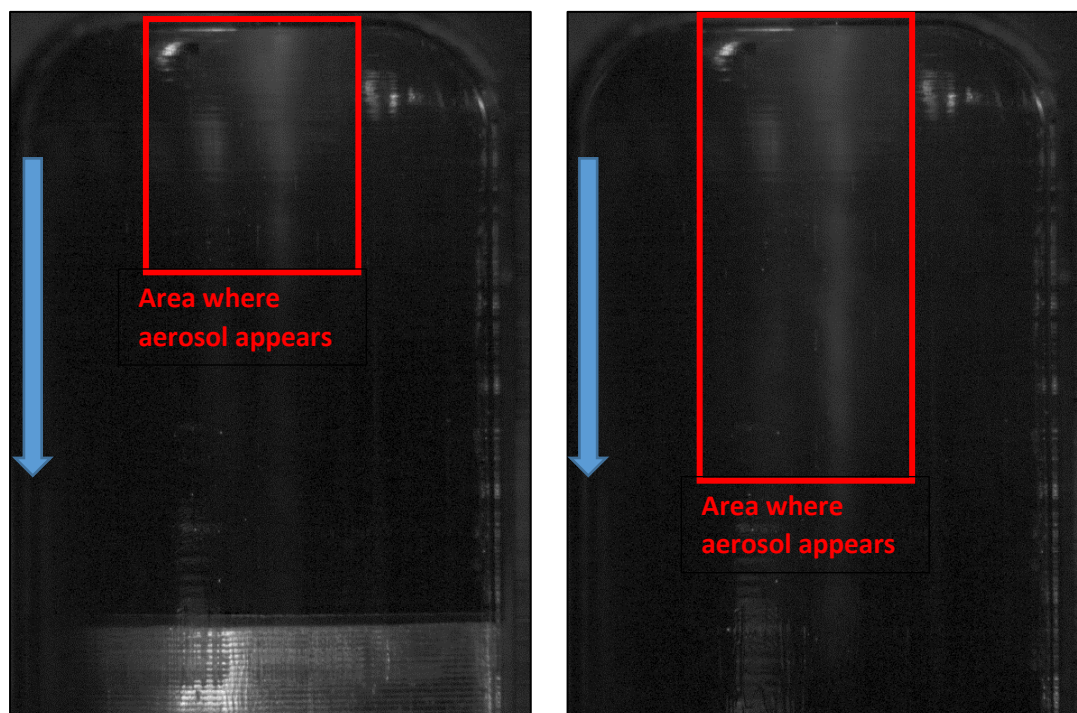
Figure 135 - Aerosol effect, 208rpm, 70C, Motorised

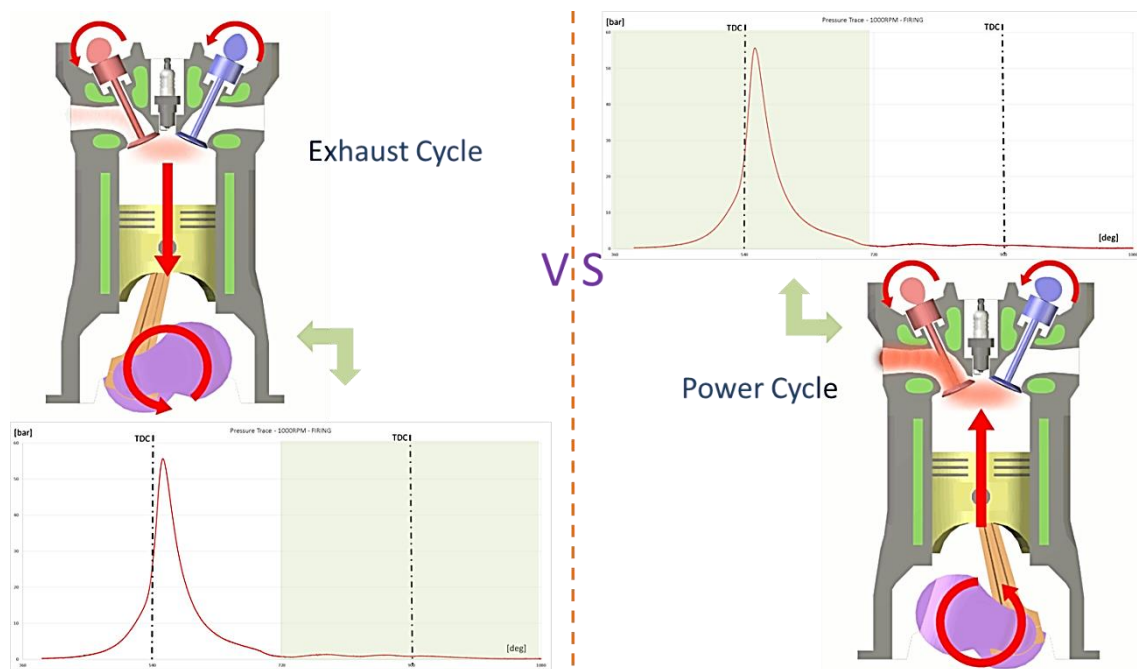
Figure 139 - Exhaust/Intake Cycle VS Power Cycle
