Citation: Armakolas, I. (2018). Cavitation erosion fracture mechanisms and their detection in ship rudders. (Unpublished Doctoral thesis, City, University of London)

Cavitation Erosion Fracture Mechanisms and their Detection in Ship Rudders

This thesis is submitted for the fulfilment of the requirements for the degree of
Doctor of Philosophy

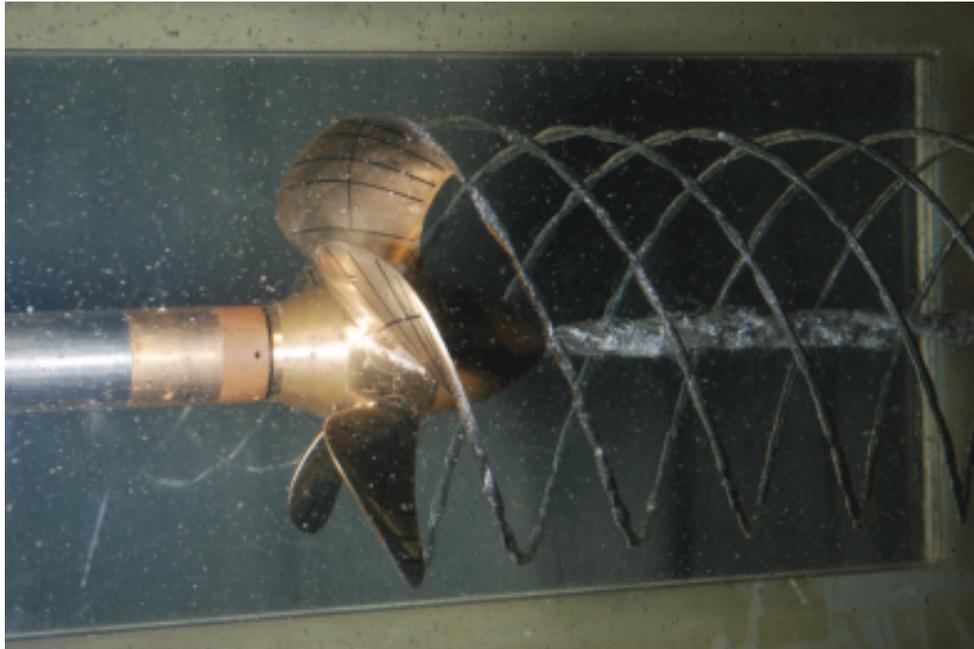
Figure 2.2: Tip and hub vortex cavitation (Source: SVA Potsdam GmbH, n.d)

Conversely, the hub vortex is created by a combination of vortices originating from the root of each blade and it is very likely to cavitate in the presence of a converging propeller cone. Hub vortex cavitation has the appearance of a rope of which the strands correspond to the number of blades of the propellers. A combination of tip and hub vortex cavitation can be seen in Figure 2.2:

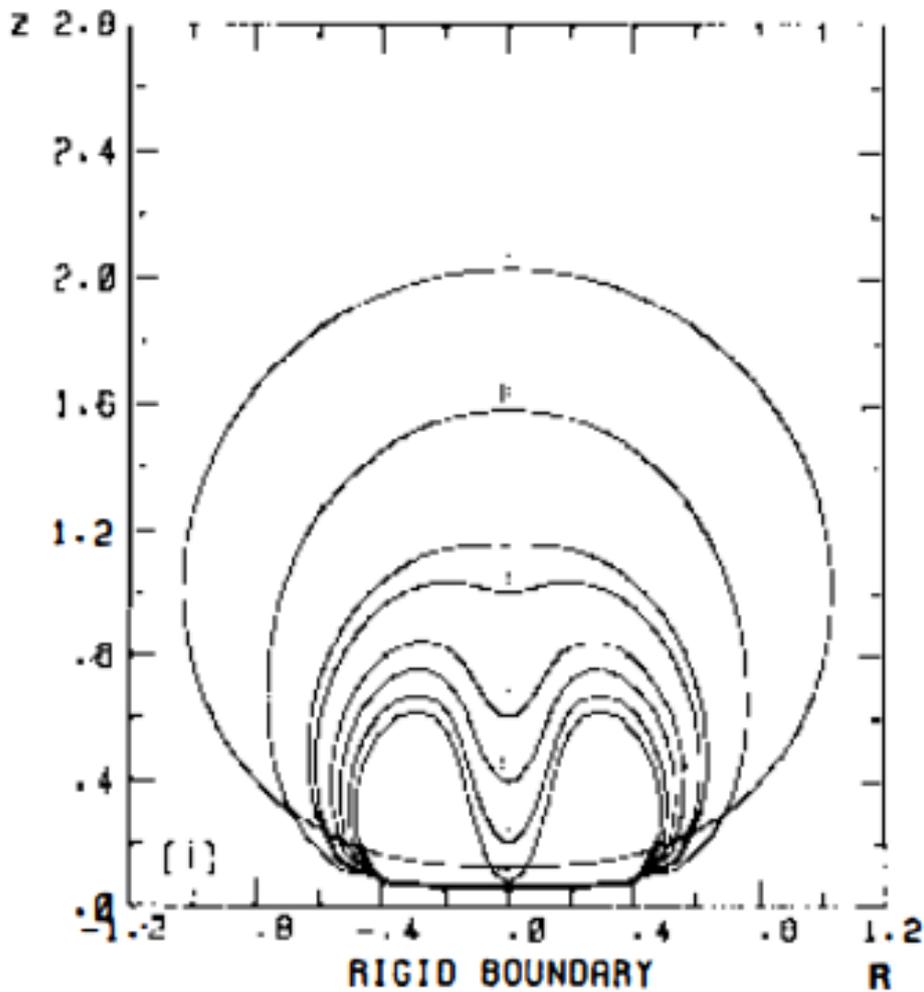
Figure 2.13: Successive bubble shapes during collapse, near a solid wall – rigid boundary (Source: Blake and Gibson, 1987).

Some theoretical calculations from Blake and Gibson (1987), in the case of a bubble collapse near a solid wall, can be seen in Figure 2.13, in the form of successive bubble shapes.

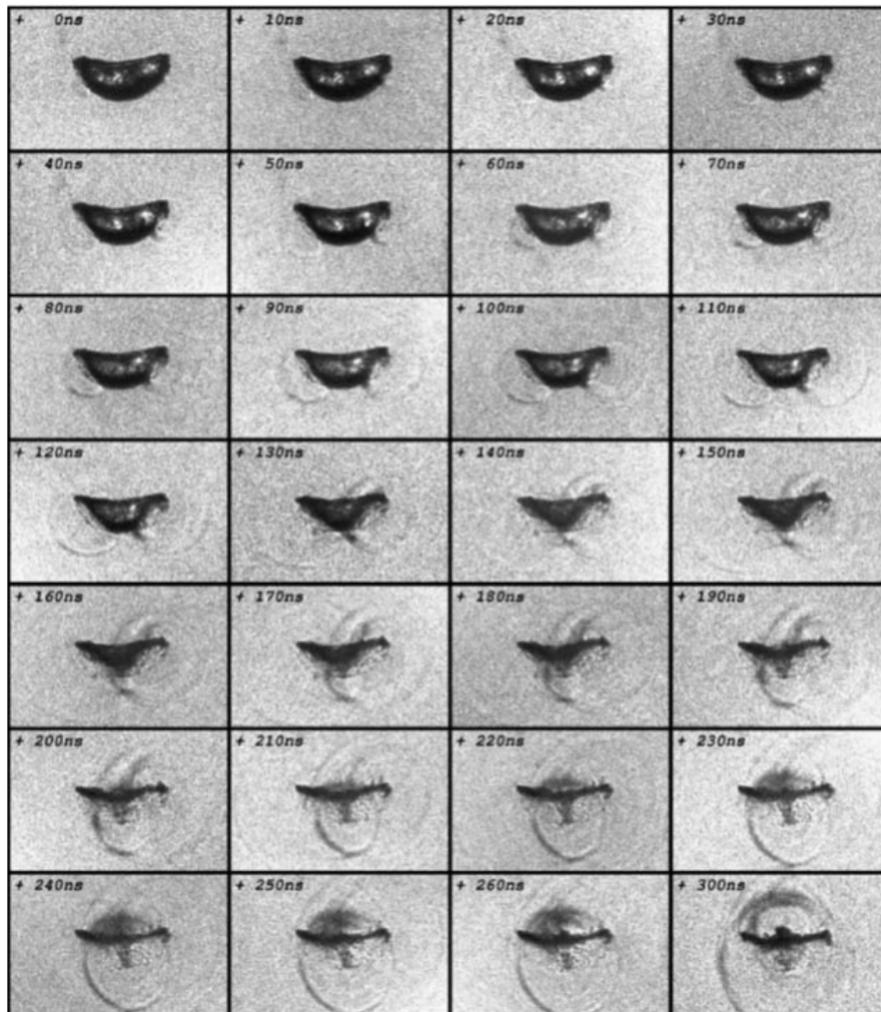
Figure 2.14: Shock wave generation during bubble collapse filmed at 100 million frames per second. Time is noted on the upper left corner of each shot (Source: Lindau and Lauterborn, 2003)

Photographic evidence of the generation of a high – pressure shock wave is presented in Figure 2.14:

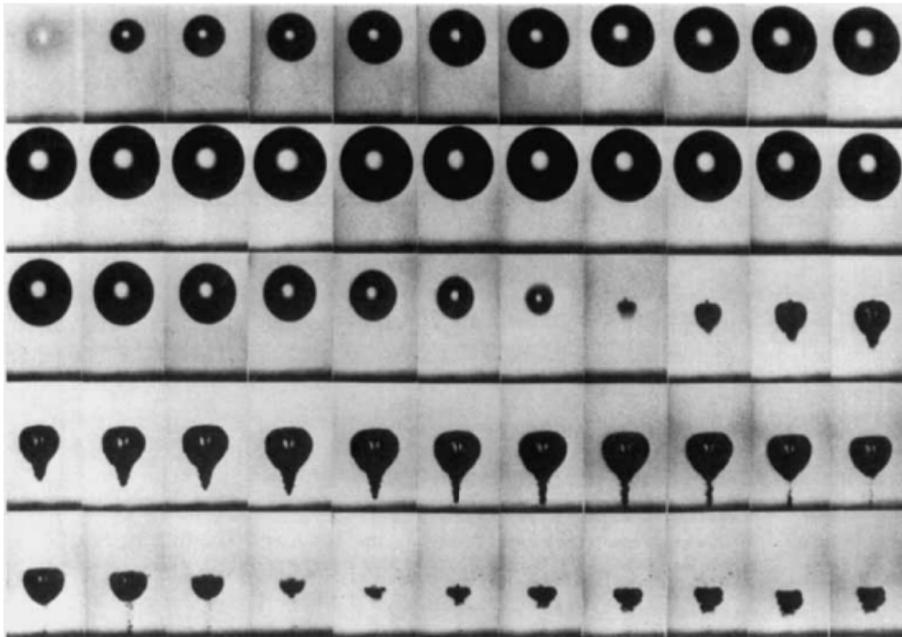
Figure 2.15: Liquid jet formation during bubble collapse filmed at 75000 frames per second (Source: Lauterborn and Bolle, 1975)

Photographic evidence relating to the formation of a liquid jet during bubble collapse is presented in Figure 2.15. In particular, the liquid jet is evident in the form of thin black line, connecting the bubble and the flat surface.

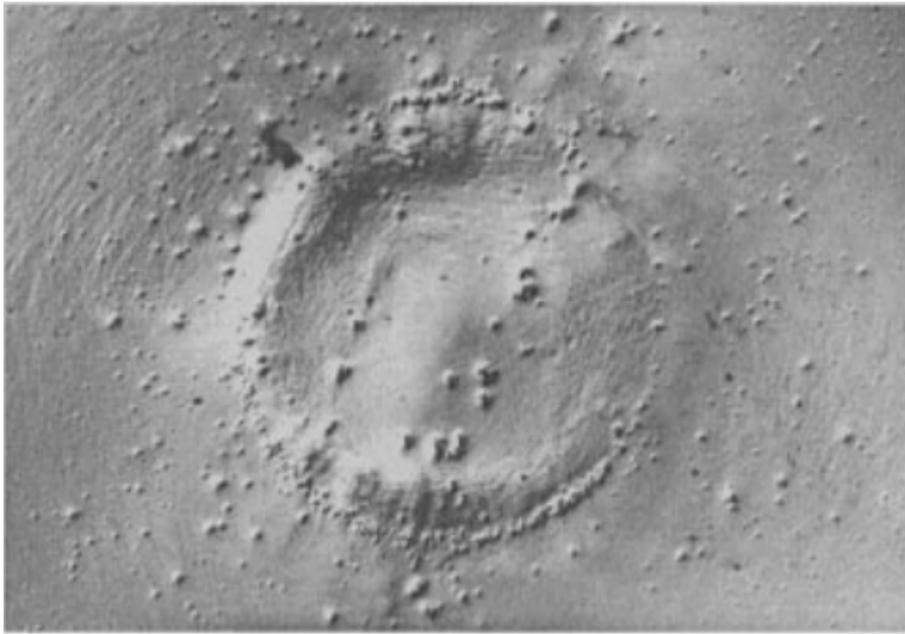
Figure 2.16: Erosion pattern of an aluminium specimen for a distance $\gamma = 0.69$ (Source: Philipp and Lauterborn, 1998)

The erosion pattern, of one of the aluminium specimens that were utilized in this study, is presented in Figure 2.16, at a distance $\gamma_r = 0.69$, for which high water hammer pressures are expected.

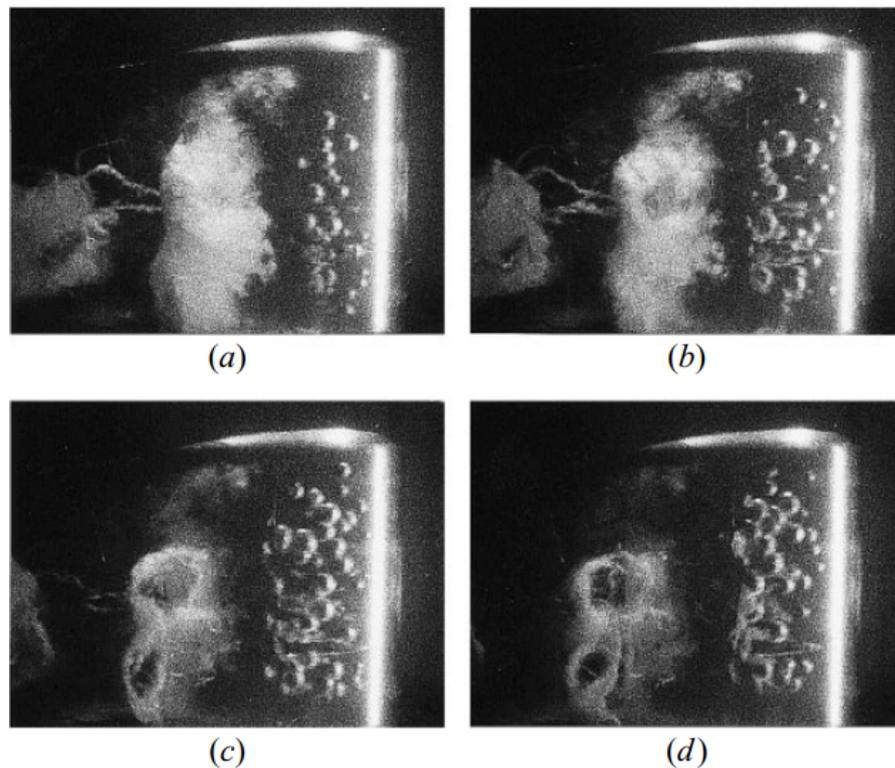
Figure 2.17: Consecutive frames showing the collapse of cloud cavitation in the vicinity of a hydrofoil (Source: Reisman et al., 1998)

amplify the collapse velocities of the surrounding bubbles and as a result the amplitude of the pressure waves related to those collapses increases too. Reisman et al. (1998) showed that the shock wave, which propagates inward, may strengthen considerably near the cloud centre due to geometric focusing, therefore, the erosive potential of the total collapse could also increase. Photographic evidence of cloud cavitation collapsing, from this study is presented in Figure 2.17:

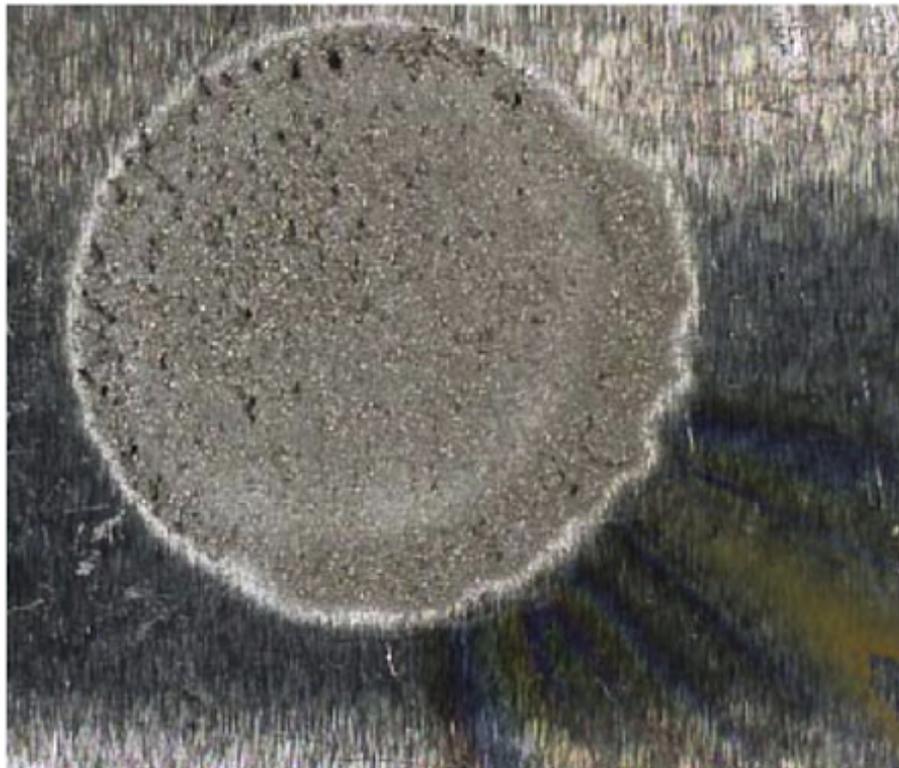
Figure 2.20: Oxide induced colour – tinting marks on grade DH36 steel (Source: Carlton, 2012)

With regards to the physical properties there is a general tendency for the erosion rate to increase when the parameters of temperature, velocity and pressure rise, up to a point above which the erosion rate decreases again. It is also noteworthy that, in grade DH36 steel that was subjected to cavitation erosion, oxide induced colour-tinting marks were observed (Carlton, 2012). These can be seen in Figure 2.20:

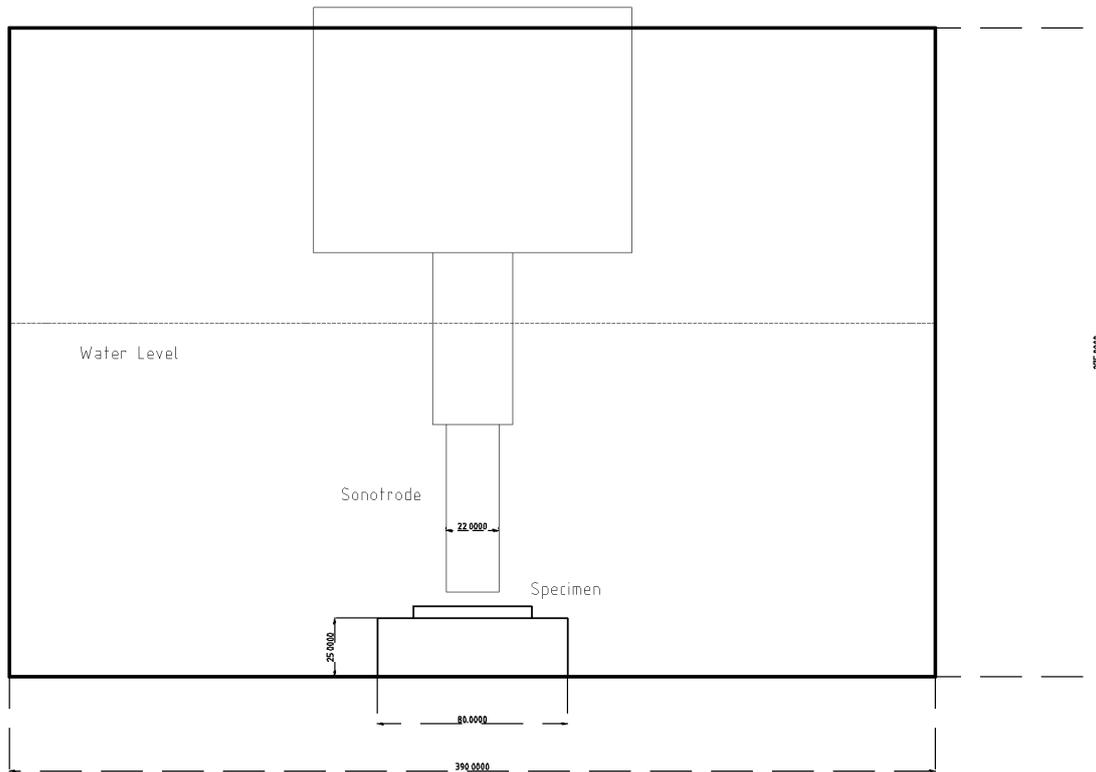
Figure 3.1: Test rig – Perspex water tank

The water tank and the probe of the ultrasonic transducer (sonotrode) which is positioned just above the submerged specimen, can be seen in Figure 3.1:

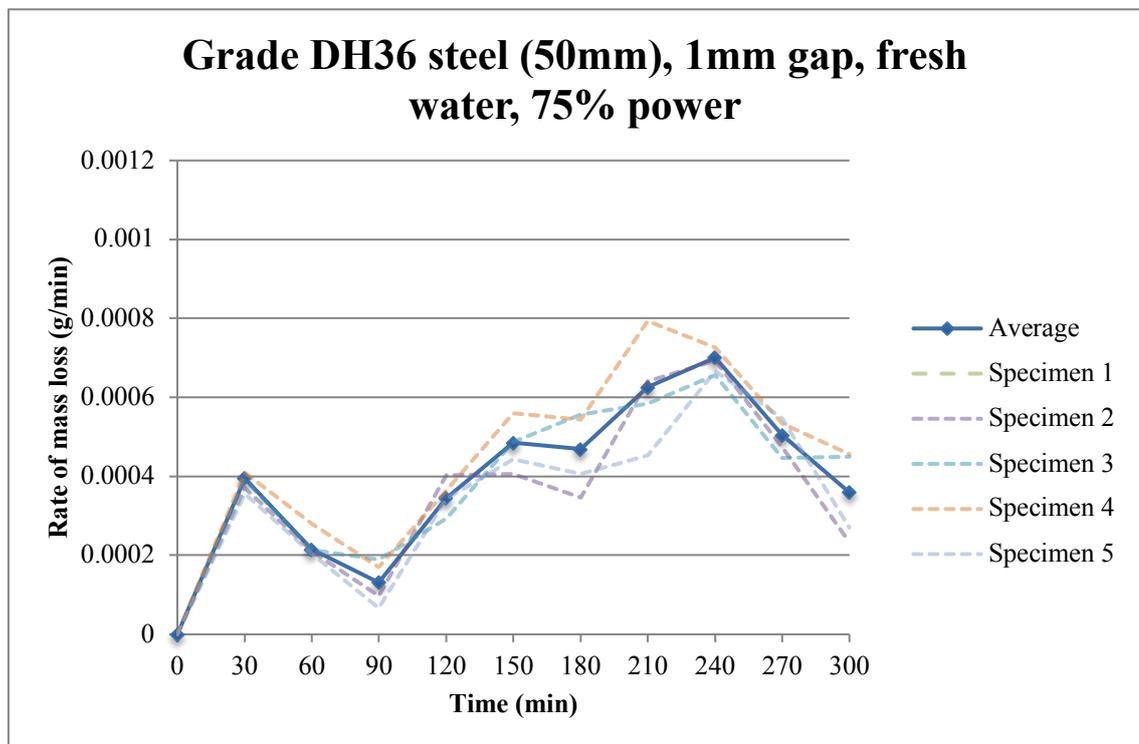
Figure 4.6: Rate of mass loss of grade DH36 steel (50 mm) for a 75% (750W) power output.

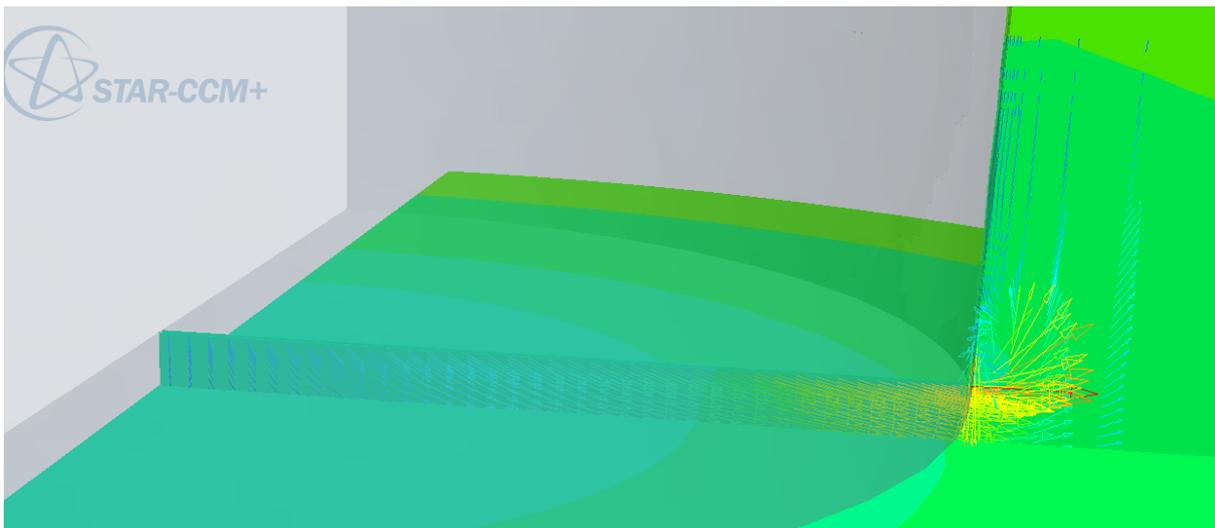
Figure 4.7: CFD simulation of sonotrode operation (Source: Carlton, n.d.)

The measured difference between the two specimen sizes, although small, can be attributed to dissimilar cavitation flow characteristics relating to their different side length and relevant exposed surface area. In particular, the side length of the smallest specimens (25 mm) is comparable to the diameter of the sonotrode tip (22 mm) whereas with regards to the large ones, their side length (50 mm) is more than two times the diameter of the sonotrode tip. It can be seen in Figure 4.7, where a CFD simulation of the sonotrode operation is presented, that a flow turbulence occurs at its edge, thus the smaller specimens are prone to experience edge effects. As such, an increased amount of erosion would be expected in that instance, which is indeed the case.

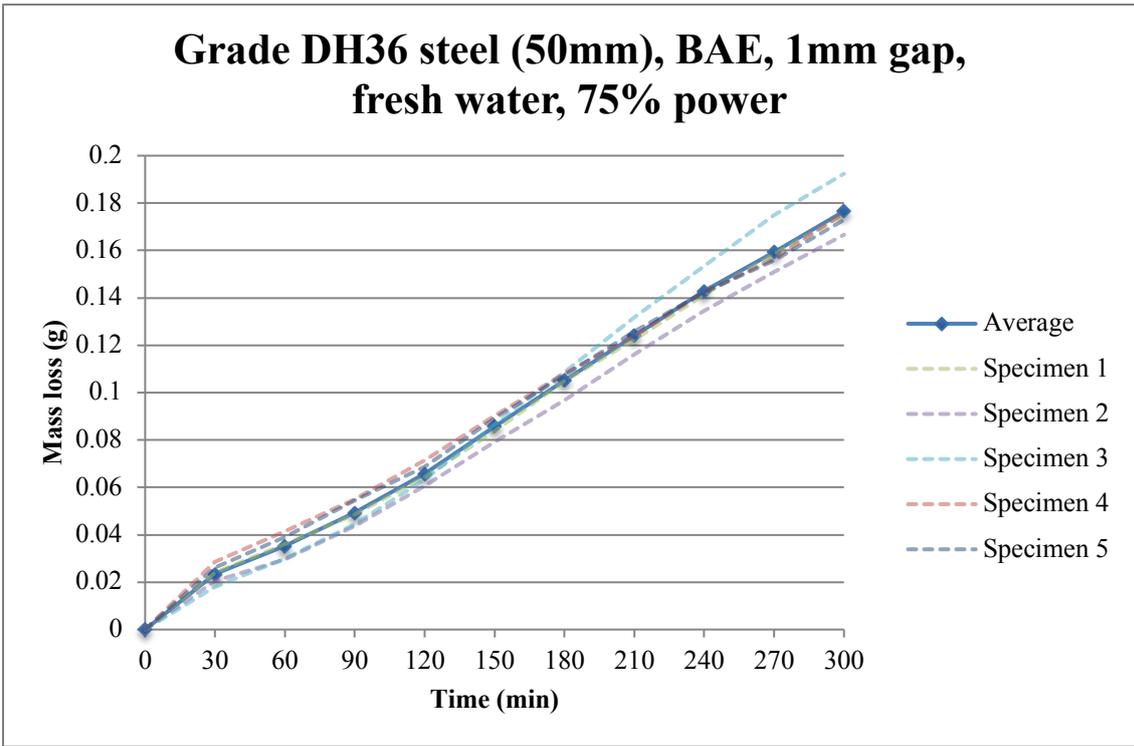
Figure 4.8: Mass loss of grade DH36 steel (50 mm) from BAE Systems for a 75% (750W) power output.

Figures 4.8 and 4.9 show the mass loss and rate of mass loss of 50mm side length grade DH36 steel specimens, supplied by BAE Systems for a 75% (750W) power output:

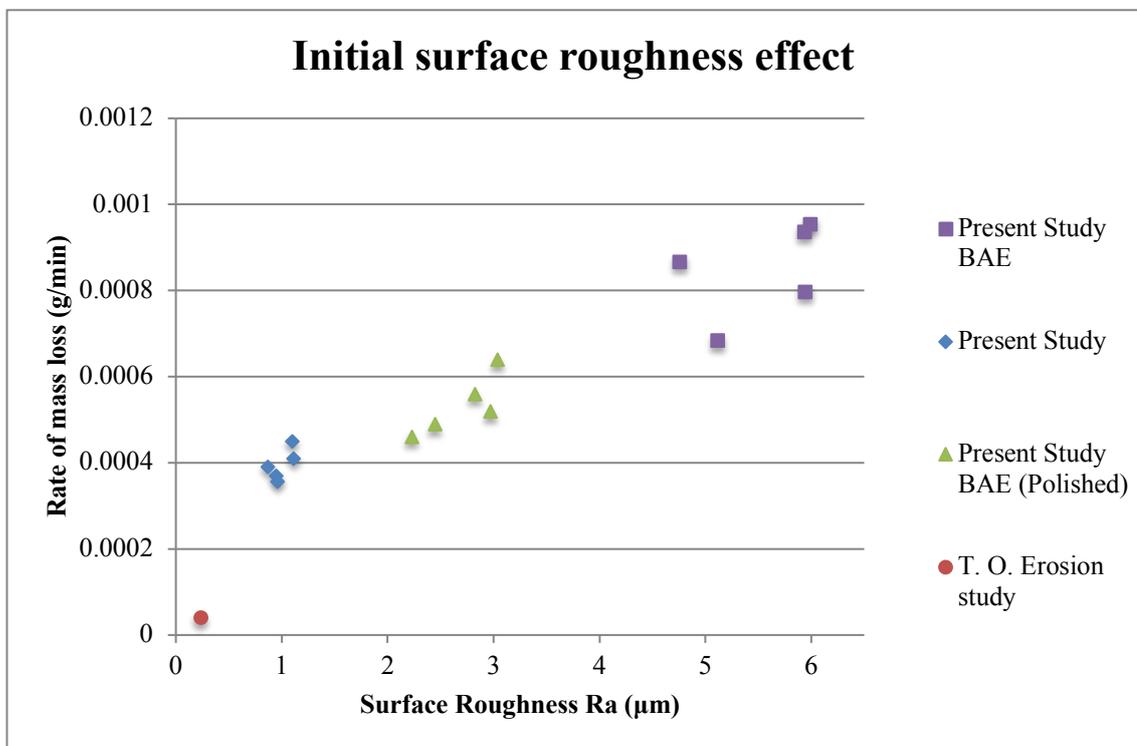
Figure 4.10: Initial surface roughness.

Although the ‘steadier’ behaviour that was observed, with regard to the rate of mass loss, can be attributed to the internal condition of the alloys (flaws and cracks) or a slightly dissimilar chemical composition, within the material standard, a hypothesis relating to the initial surface roughness was formed with regard to the initial peak of mass loss and the observed differences between suppliers. As such, an exploration was conducted, for specimens provided by both the first supplier and BAE Systems (as received and polished). An average initial surface roughness value for the specimens of the ‘T. O. Erosion study’ is also provided. Results, as measured by use of a Mitutoyo SJ-310 roughness tester are presented in Figure 4.10:

A connection between the initial surface roughness and the rate of mass loss may be observed. This is due to the presence of notches on the rougher surfaces, that act as stress concentrators and result into an increased amount of damage – mass loss. This hypothesis may also explain why the average rate of mass loss of specimens with dissimilar initial surface roughness becomes almost identical further into the procedure, despite the initial differences, whereas an analogous degree of erosion can be observed for all specimens towards the end of the exposure. The progression of the macroscopic appearance of erosion in the case of grade DH36 steel is presented in Figure 4.11:

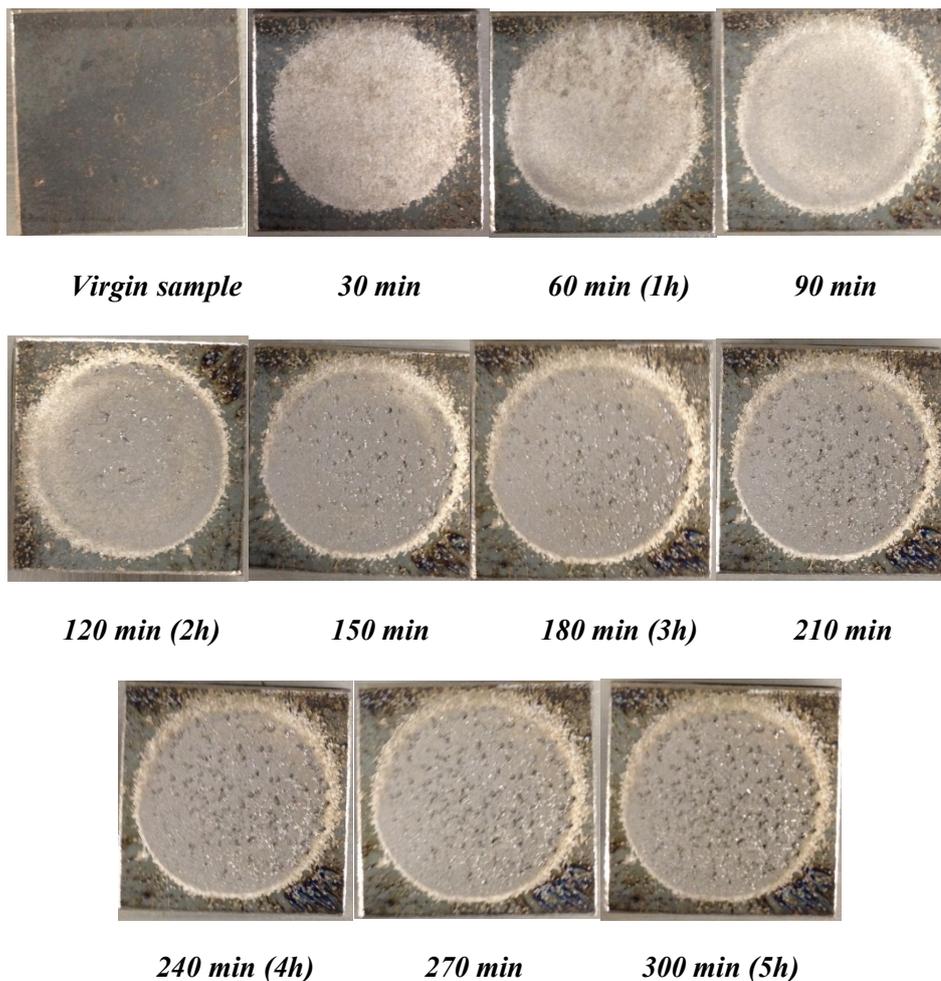
Figure 4.11: Progression of erosion for Grade DH36 steel.

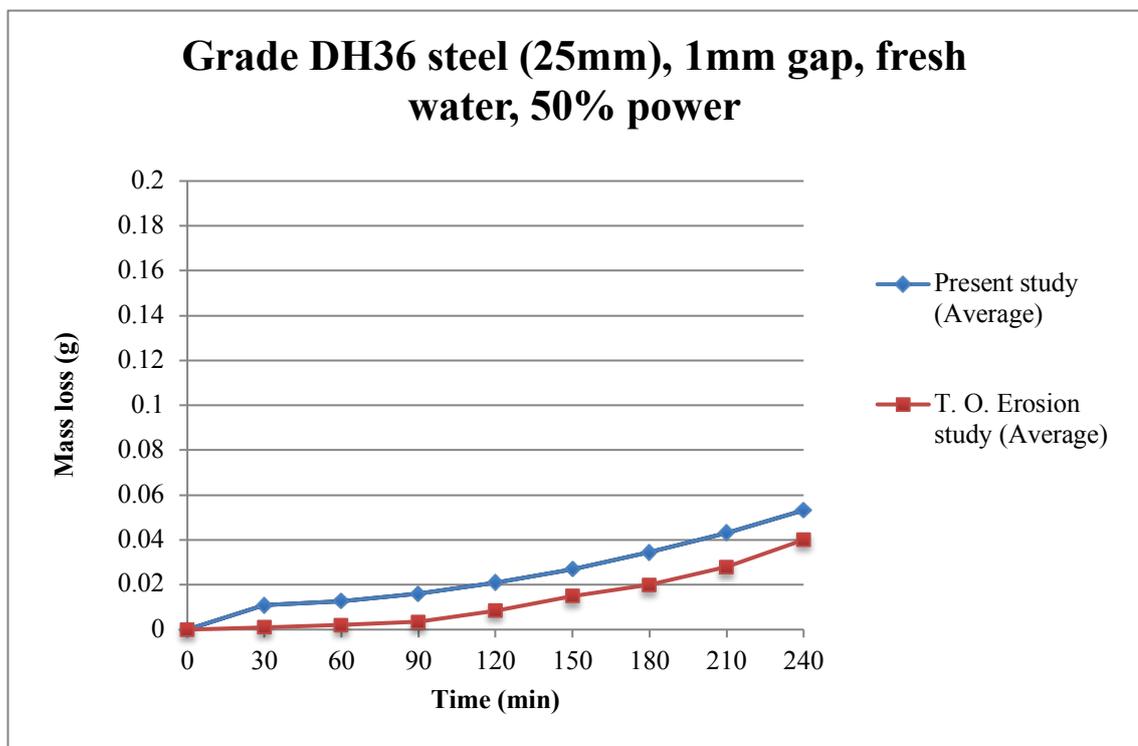
Figure 4.12: Mass loss comparison between the ‘T. O. Erosion study’ and the present study.

A graphic comparison between grade DH36 steel specimens with a side length of 25 mm, from the ‘T. O. Erosion study’ and the present study, in terms of cavitation induced mass loss, is presented in Figures 4.12 and 4.13:

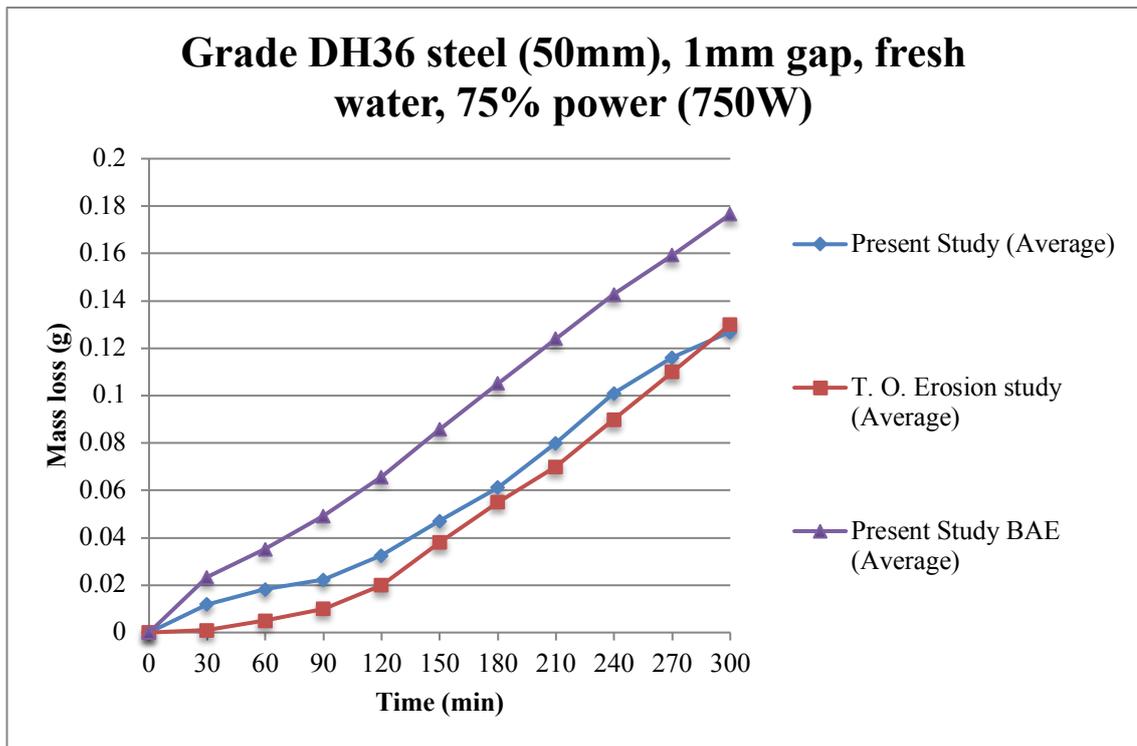
Figure 4.14: Mass loss comparison between the ‘T. O. Erosion study’ and the present study - Two suppliers are considered for the present study.

Results from specimens, with a side length of 50 mm, from two different suppliers were also compared to the ‘T. O. Erosion study’ and are presented in Figures 4.14 and 4.15:

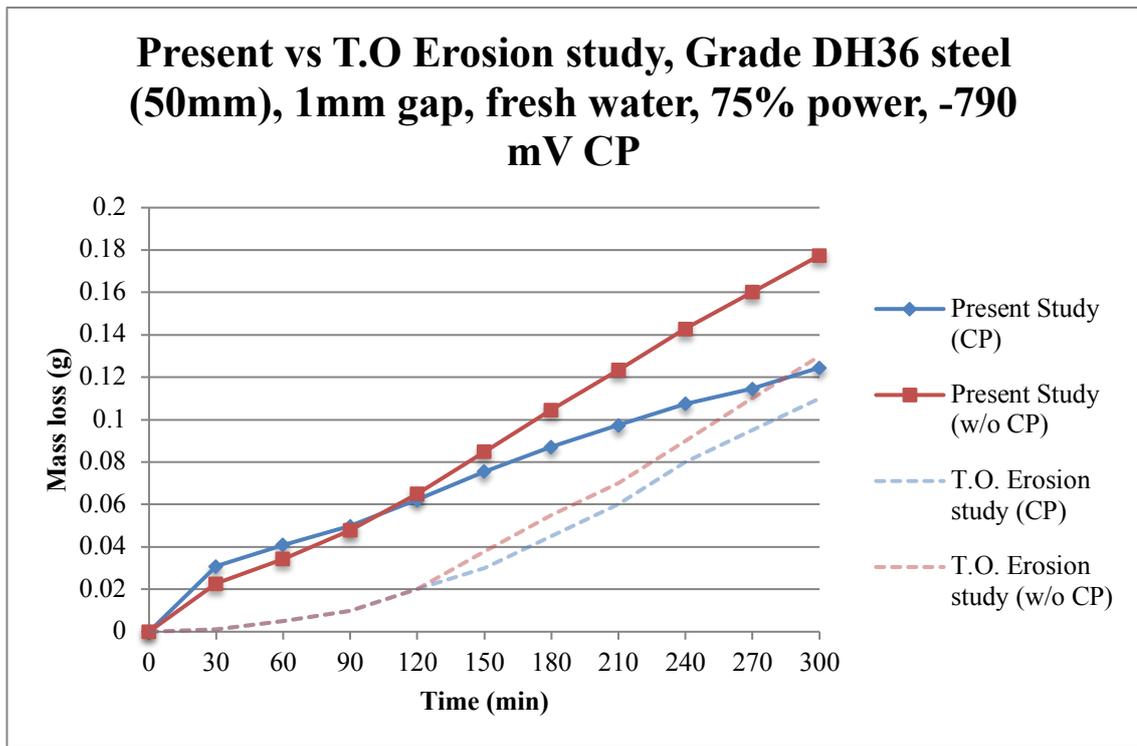
Figure 4.18: Mass loss of grade DH36 steel (50 mm) at a 75% (750W) power setting and under a -790 mV CP. Present vs ‘T.O. Erosion study’.

A similar behaviour was observed in the ‘T. O. Erosion study’, of which the experimental conditions were utilized. Mass loss and mass loss rate results from both studies, with and without cathodic protection are presented in Figures 4.18 and 4.19:

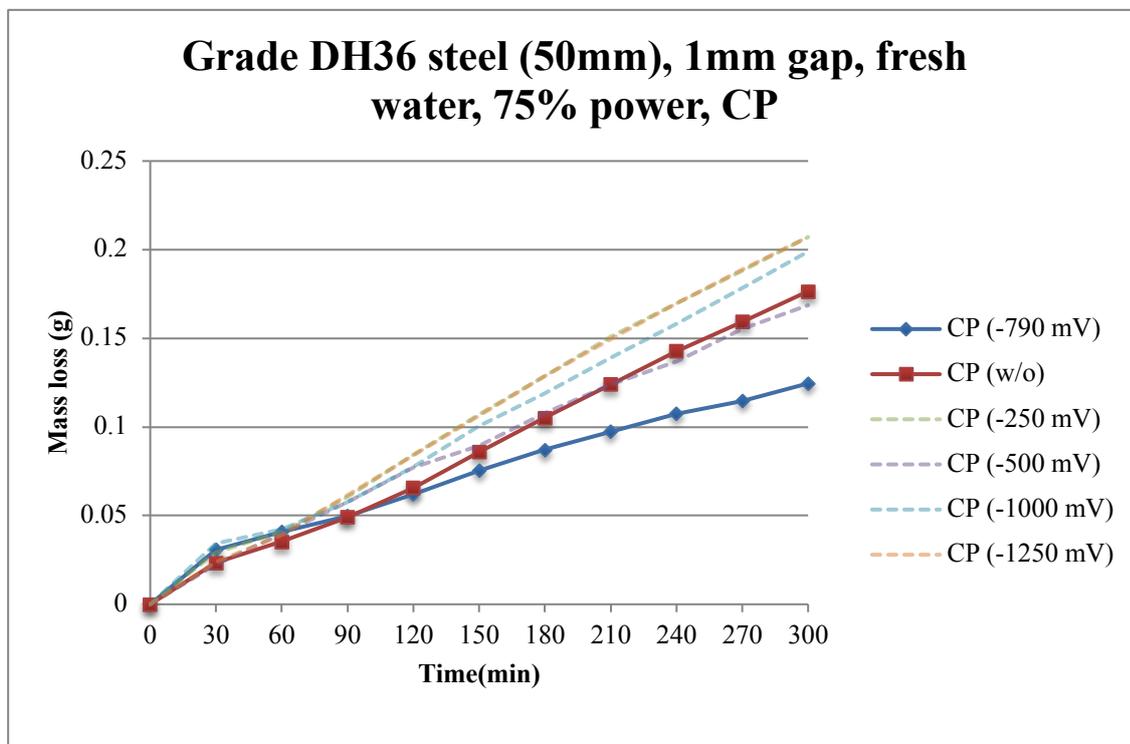
Figure 4.20: Mass loss of grade DH36 steel (50 mm) at a 75% (750W) power setting and under different CP potentials.

Mass loss and rate of mass loss results for different potentials are presented in Figures 4.20, 4.21 and 4.22:

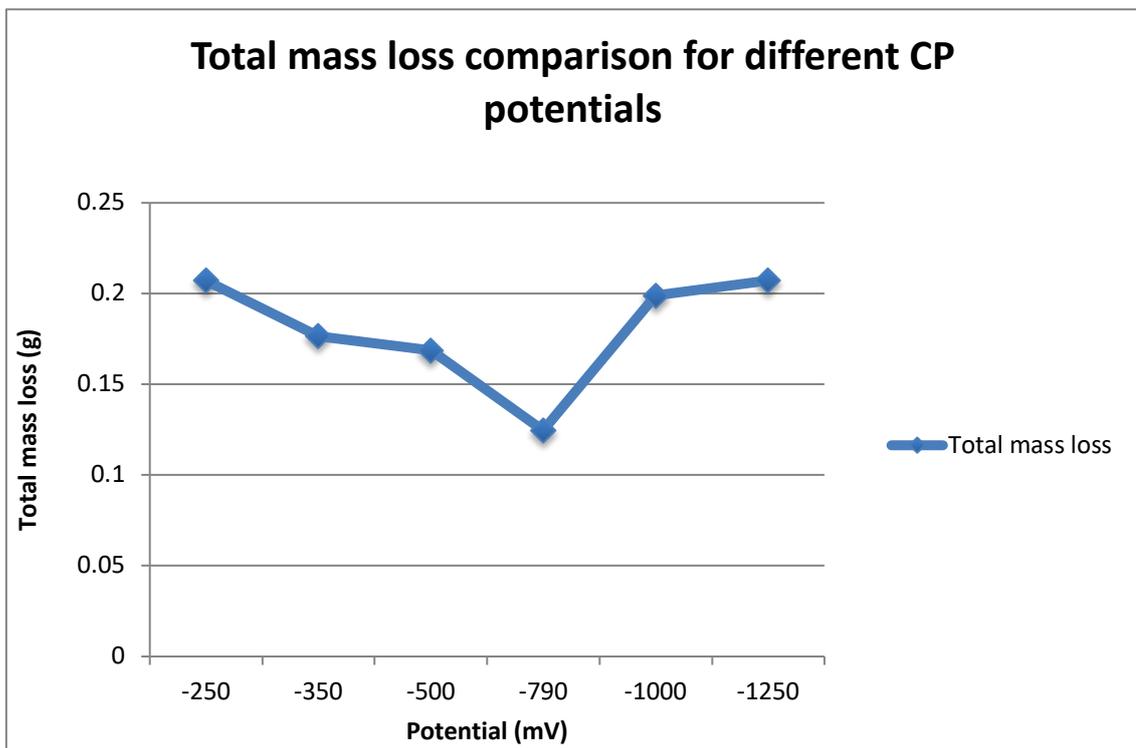
Figure 4.22: Total mass loss versus different working potentials for grade DH36 steel.

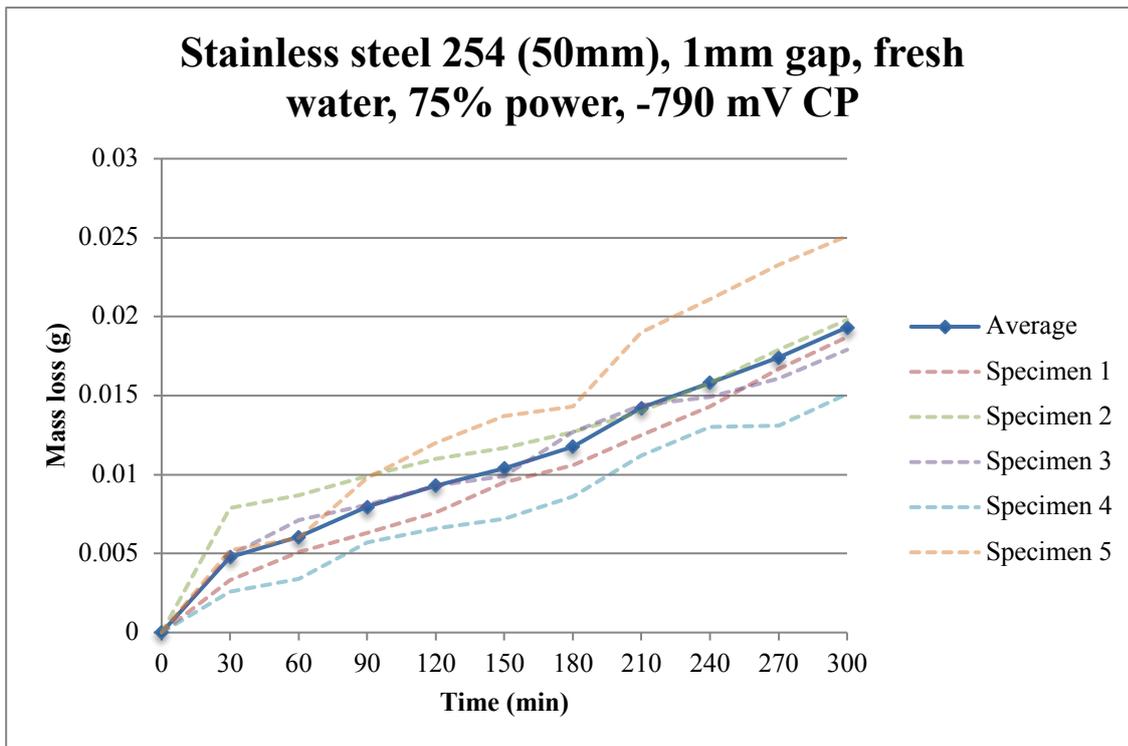
Figure 4.23: Mass loss of stainless steel 254 at a 75% (750W) power setting and under a -790 mV CP.

Mass loss and rate of mass loss results for stainless steel 254 are presented in Figures 4.23 and 4.24. It should be noted that the average surface roughness of the stainless steel 254 specimens was 5.12 μm .

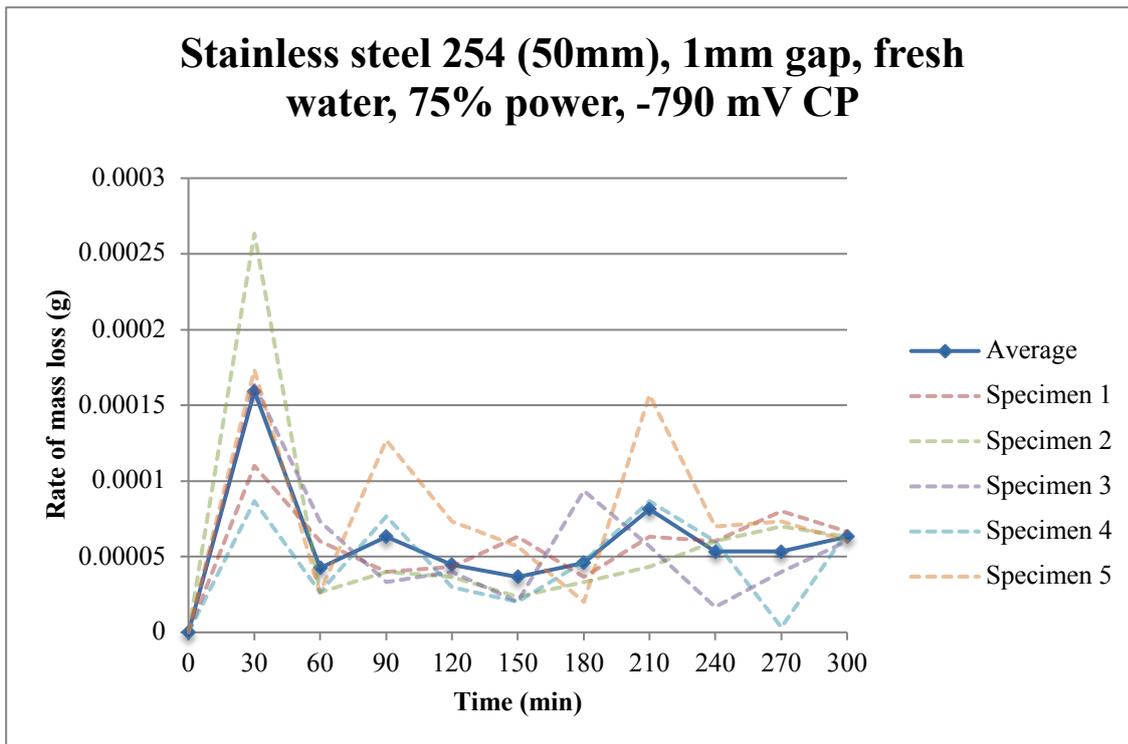
Figure 4.24: Rate of mass loss of stainless steel 254 (50 mm) at a 75% (750W) power setting and under a -790 mV CP.

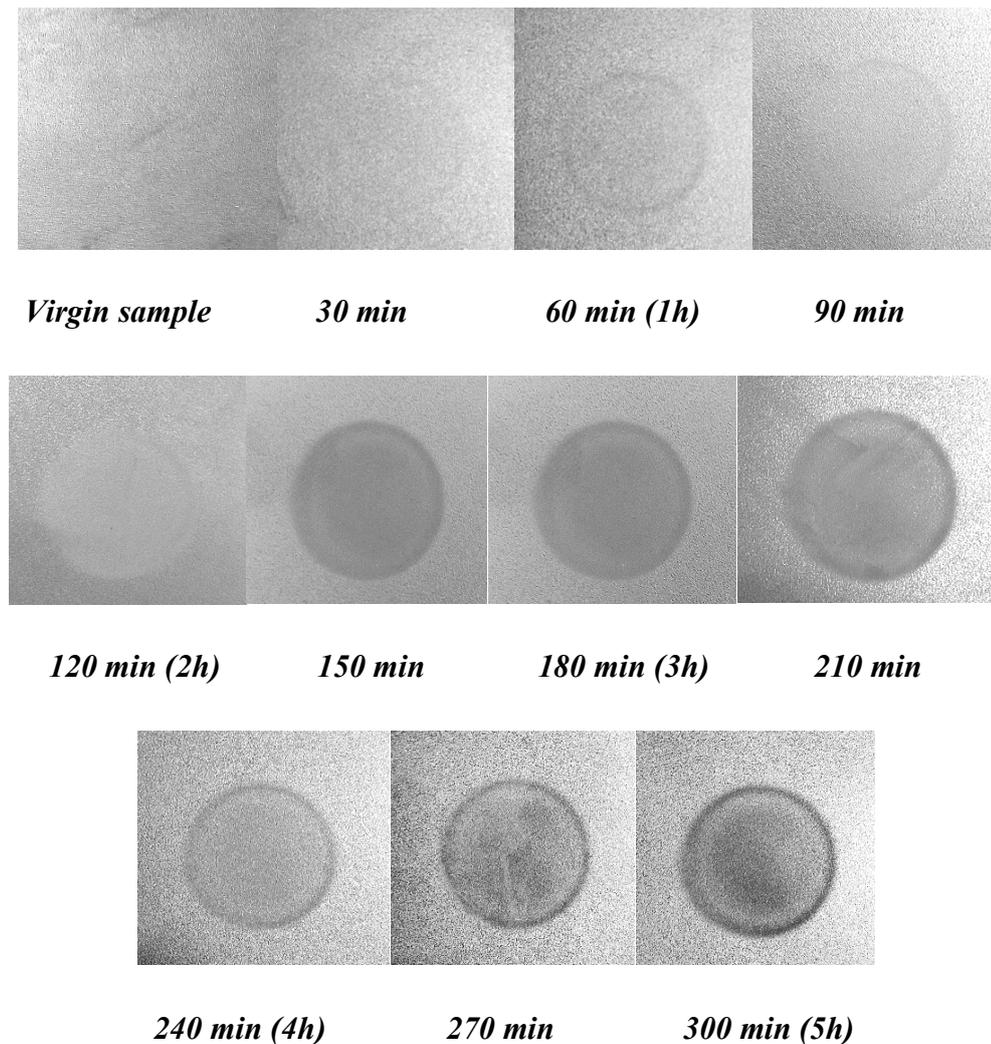
Figure 4.25: Progression of erosion for stainless steel 254.

The progression of the macroscopic appearance of erosion for stainless steel 254 is presented in Figure 4.25:

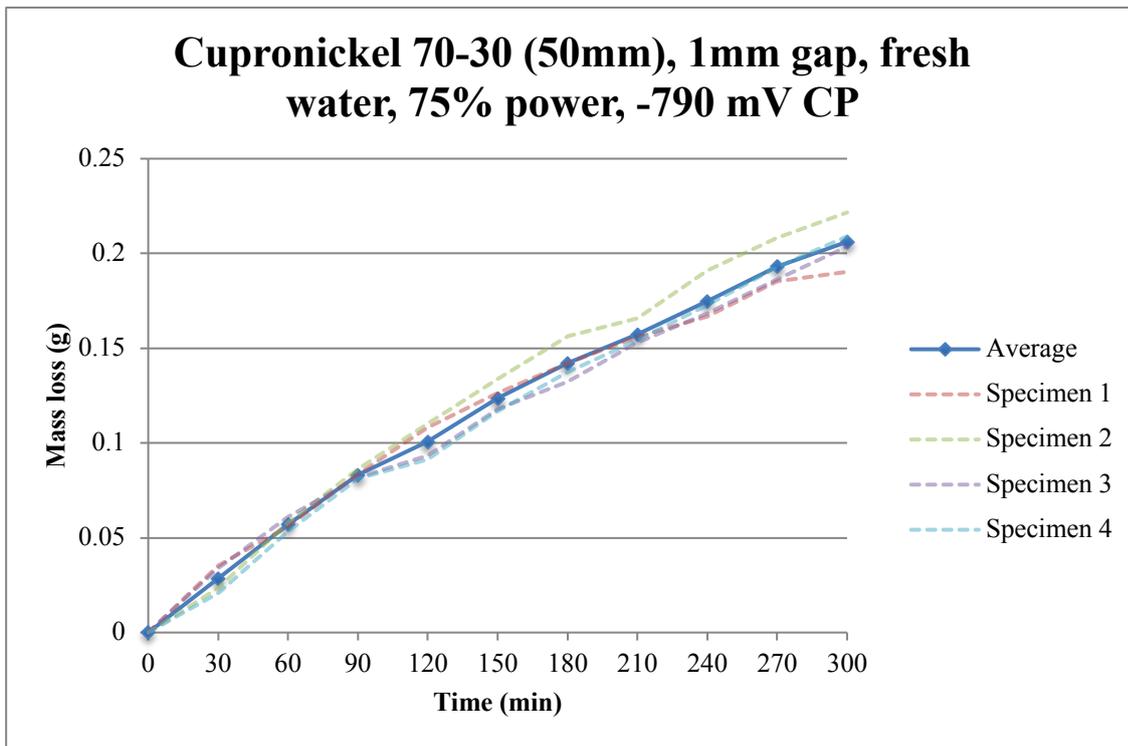
Figure 4.26: Mass loss of cupronickel 70-30 at a 75% (750W) power setting and under a -790 mV CP.

Mass loss and rate of mass loss results for cupronickel 70-30 are presented in Figures 4.26 and 4.27. In that instance the average surface roughness was of the order of 10.22 μm .

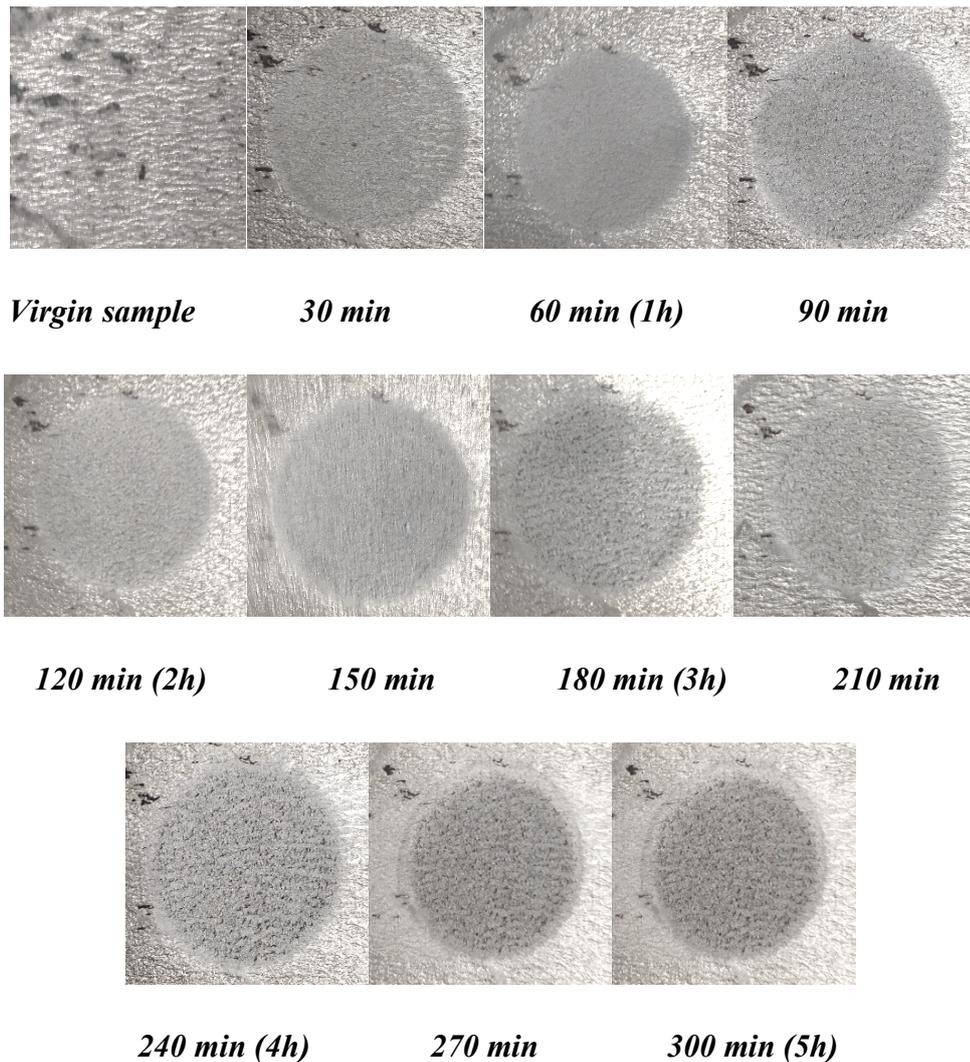
Figure 4.28: Progression of erosion for cupronickel 70-30.

The progression of the macroscopic appearance of erosion for cupronickel 70-30 is presented in Figure 4.28:

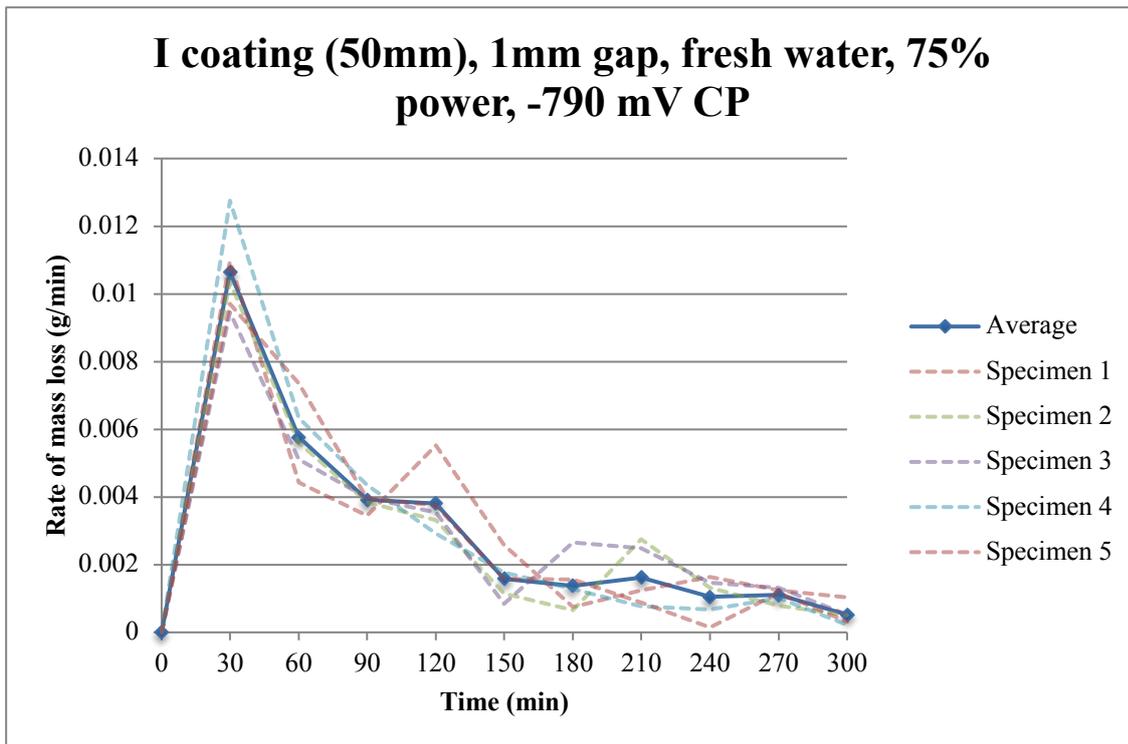
Figure 4.30: Rate of mass loss of I coating at a 75% (750W) power setting and under a -790 mV CP.

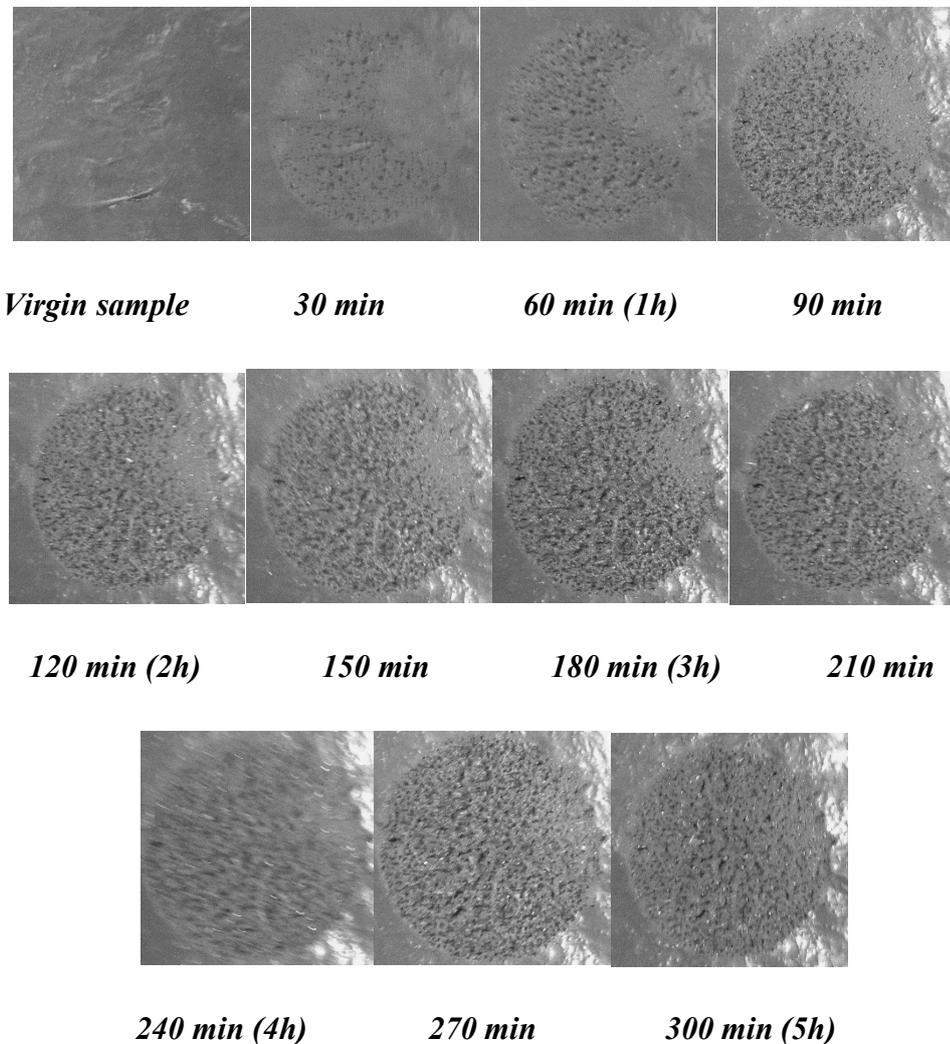
Figure 4.34: Progression of erosion for P coating.

The progression of the macroscopic appearance of erosion for P coating is presented in Figure 4.34:
