Citation: Armakolas, I. (2018). Cavitation erosion fracture mechanisms and their detection in ship rudders. (Unpublished Doctoral thesis, City, University of London)

Cavitation Erosion Fracture Mechanisms and their Detection in Ship Rudders

This thesis is submitted for the fulfilment of the requirements for the degree of
Doctor of Philosophy

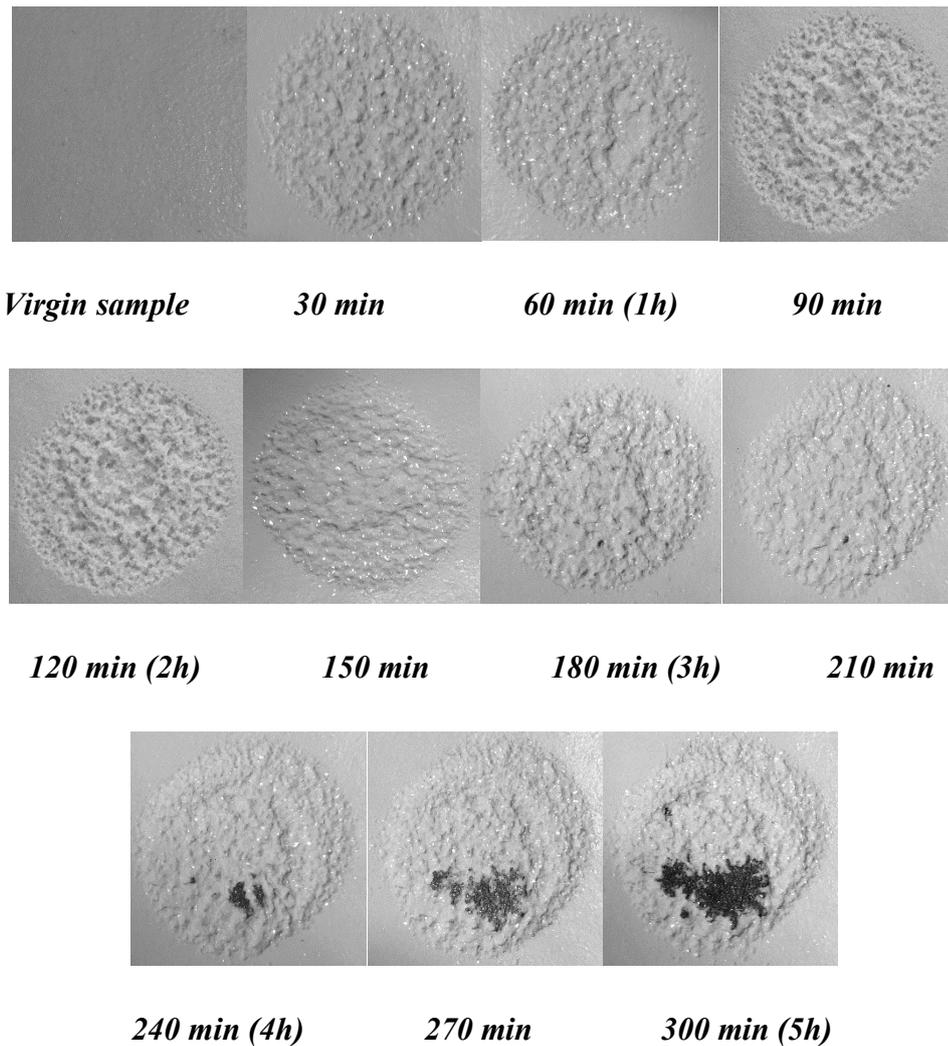
Figure 4.40: Progression of erosion for Double coating.

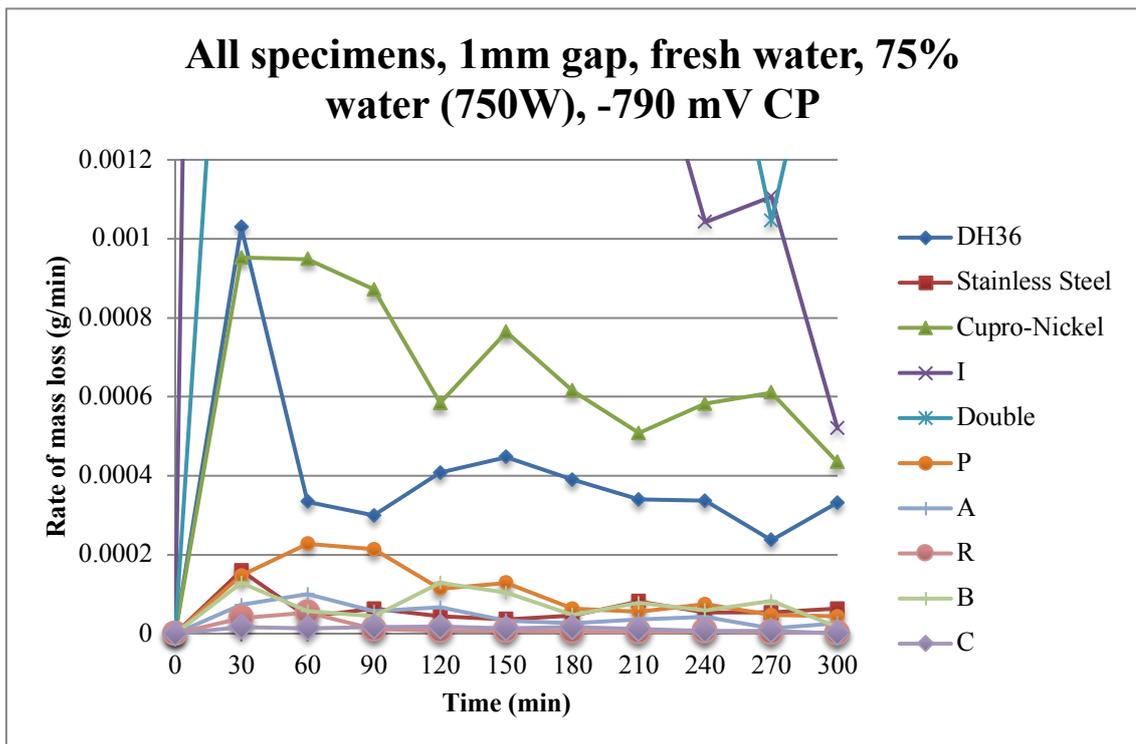
Figure 4.57: Rate of mass loss comparison – All specimens (except I, Double).

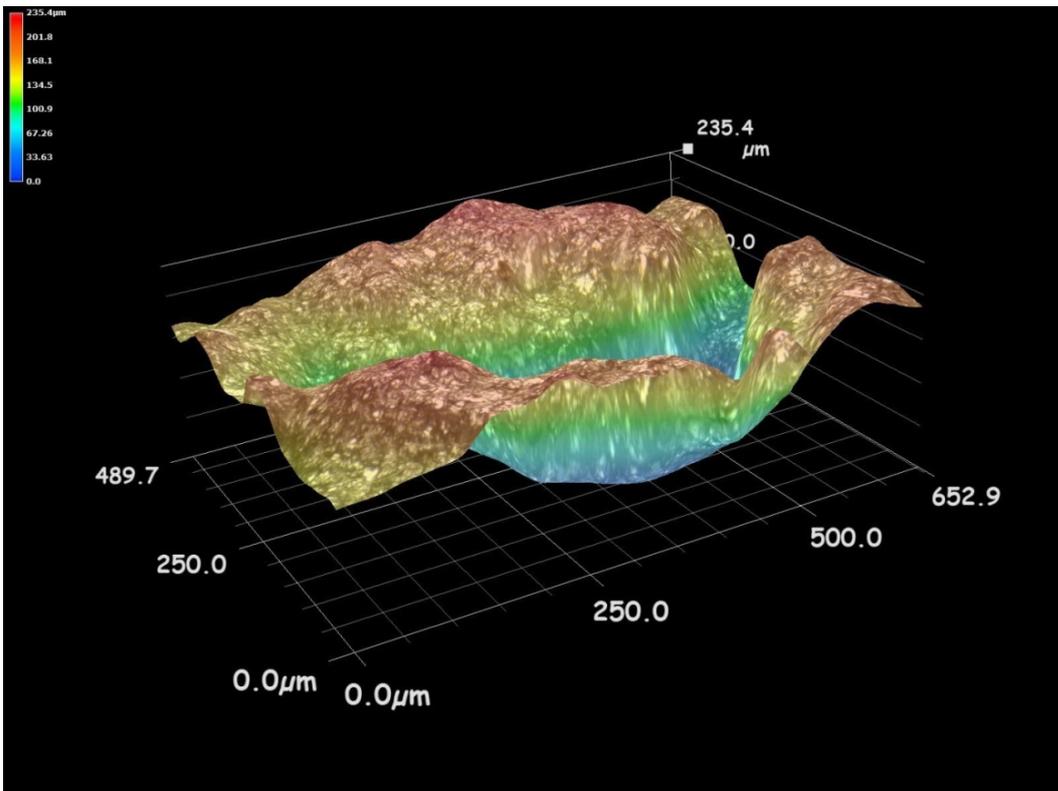
Figure 5.4: 3D illustration of erosion pit (1). Grade DH36 steel – Colour contour.

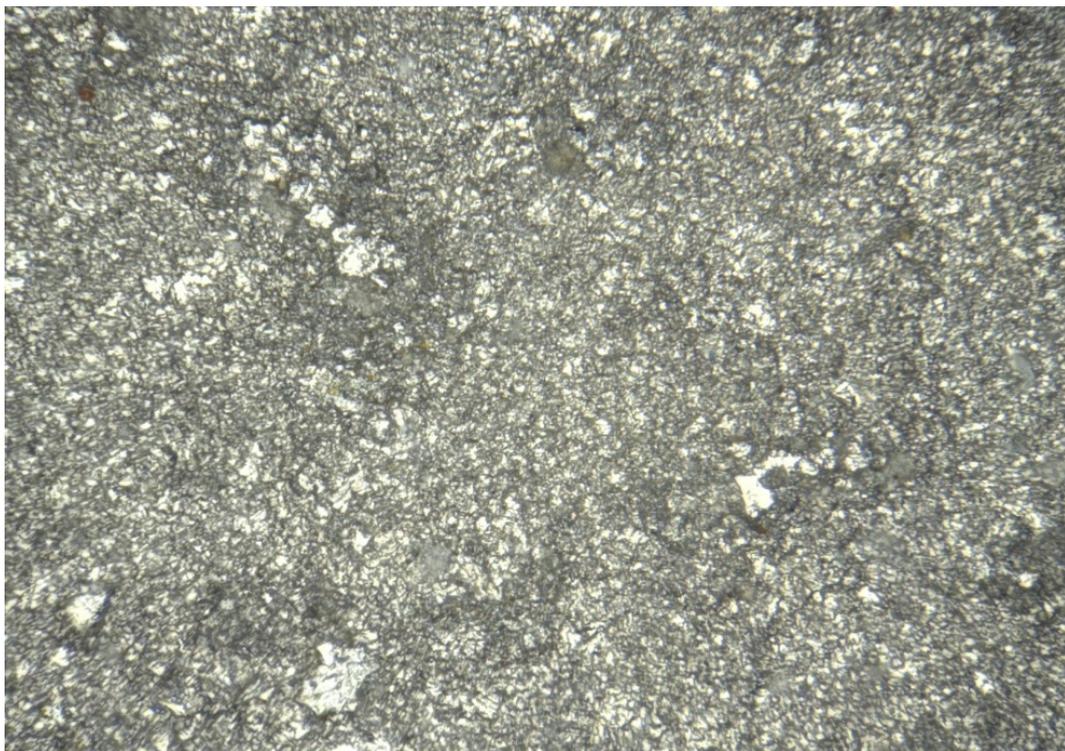
Figure 5.5: Microscopic appearance of cavitation - induced erosion for stainless steel 254 (x500).

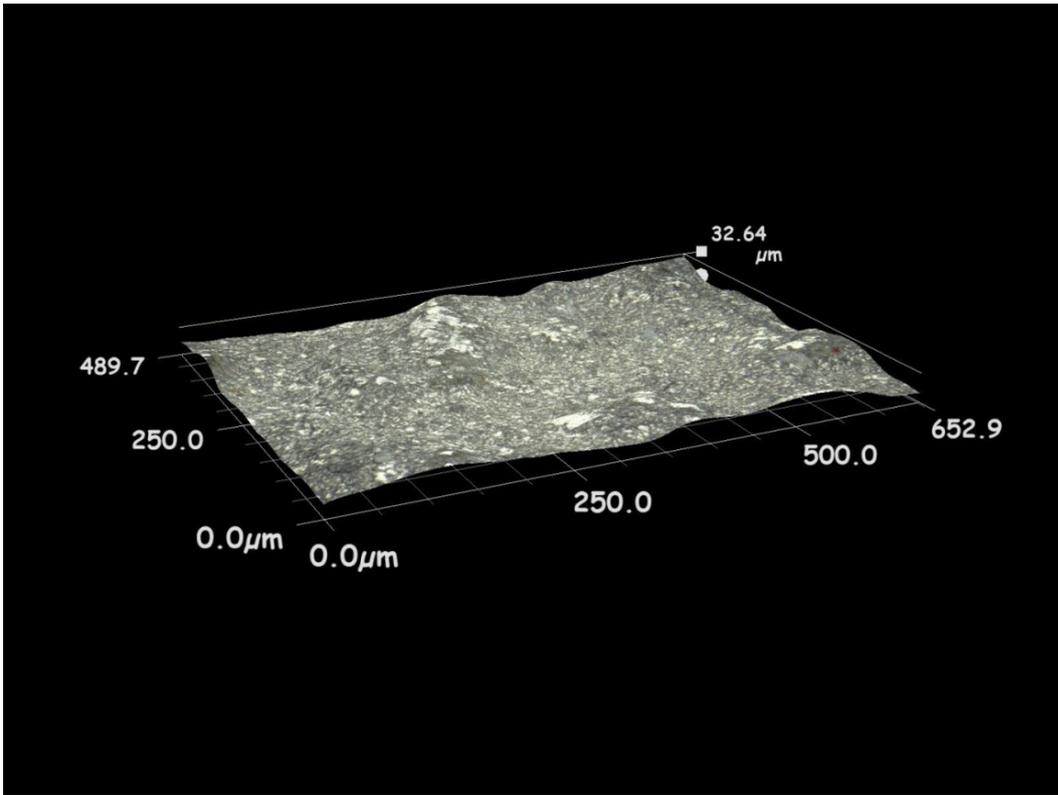
Figure 5.6: 3D illustration of erosion pit (1). Stainless steel 254.

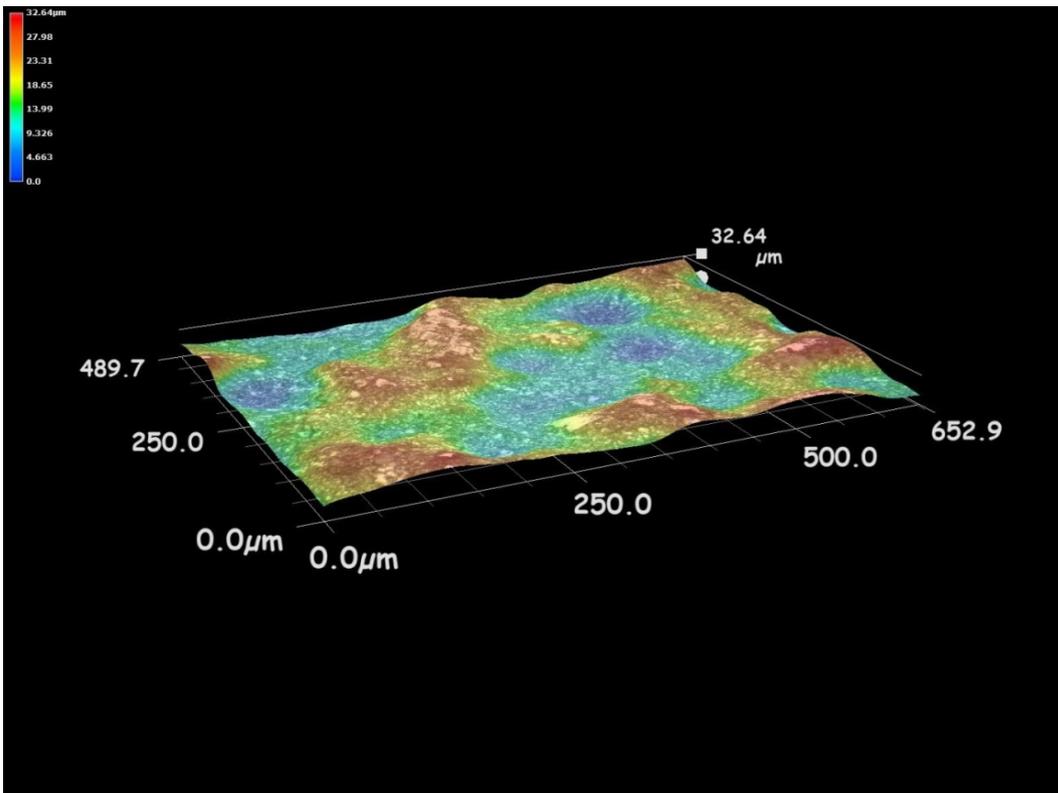
Figure 5.7: 3D illustration of erosion pit (1). Stainless steel 254 – Colour contour.

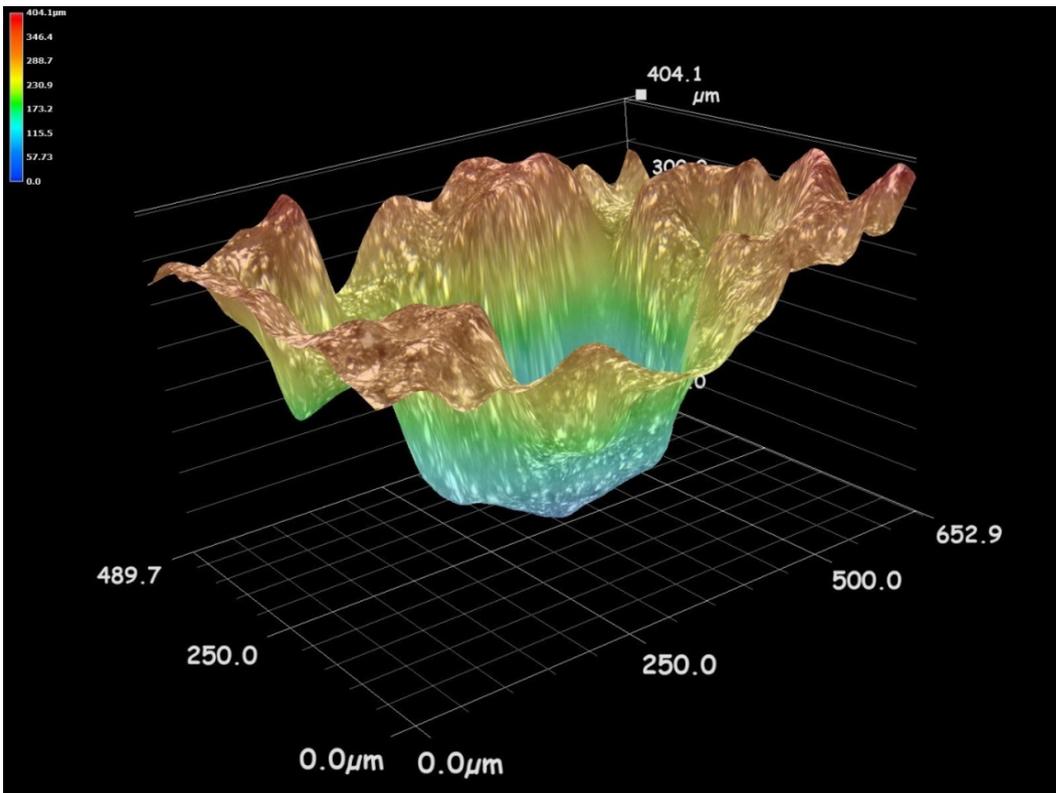
Figure 5.10: 3D illustration of erosion pit (1). Cupronickel 70-30 – Colour contour.

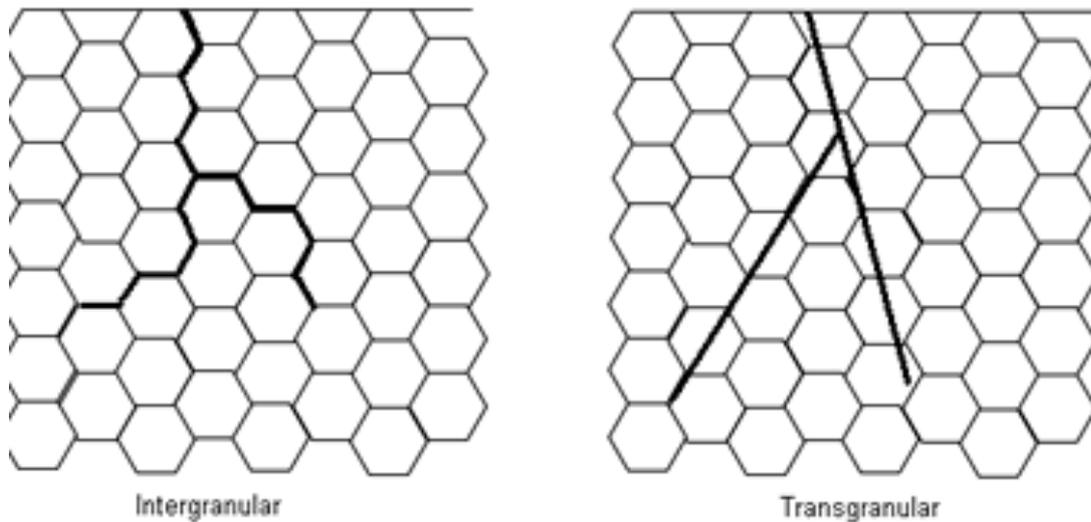
Figure 5.35: Intergranular and Transgranular fracture. (Source, GO-TECH, n.d.).

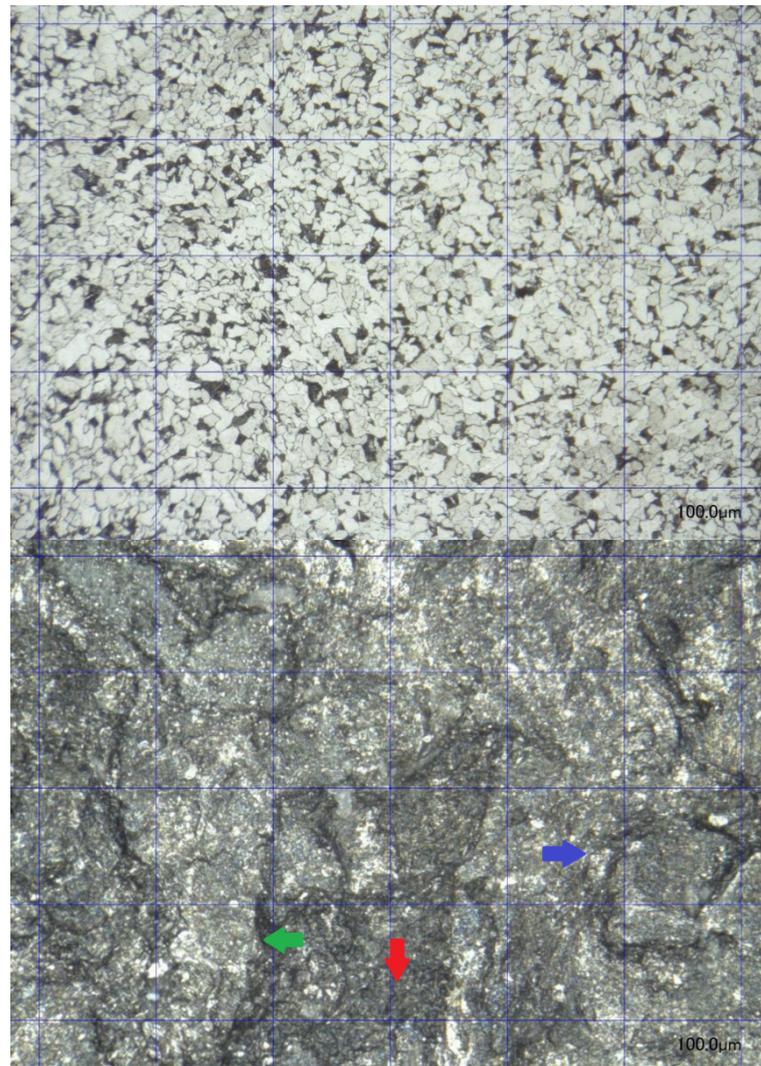
Figure 5.40: Microscopic images of non-eroded (Top) and eroded (Bottom) grade DH36 steel. Arrows: Green – Intergranular, Blue – Transgranular, Red – Ductile.

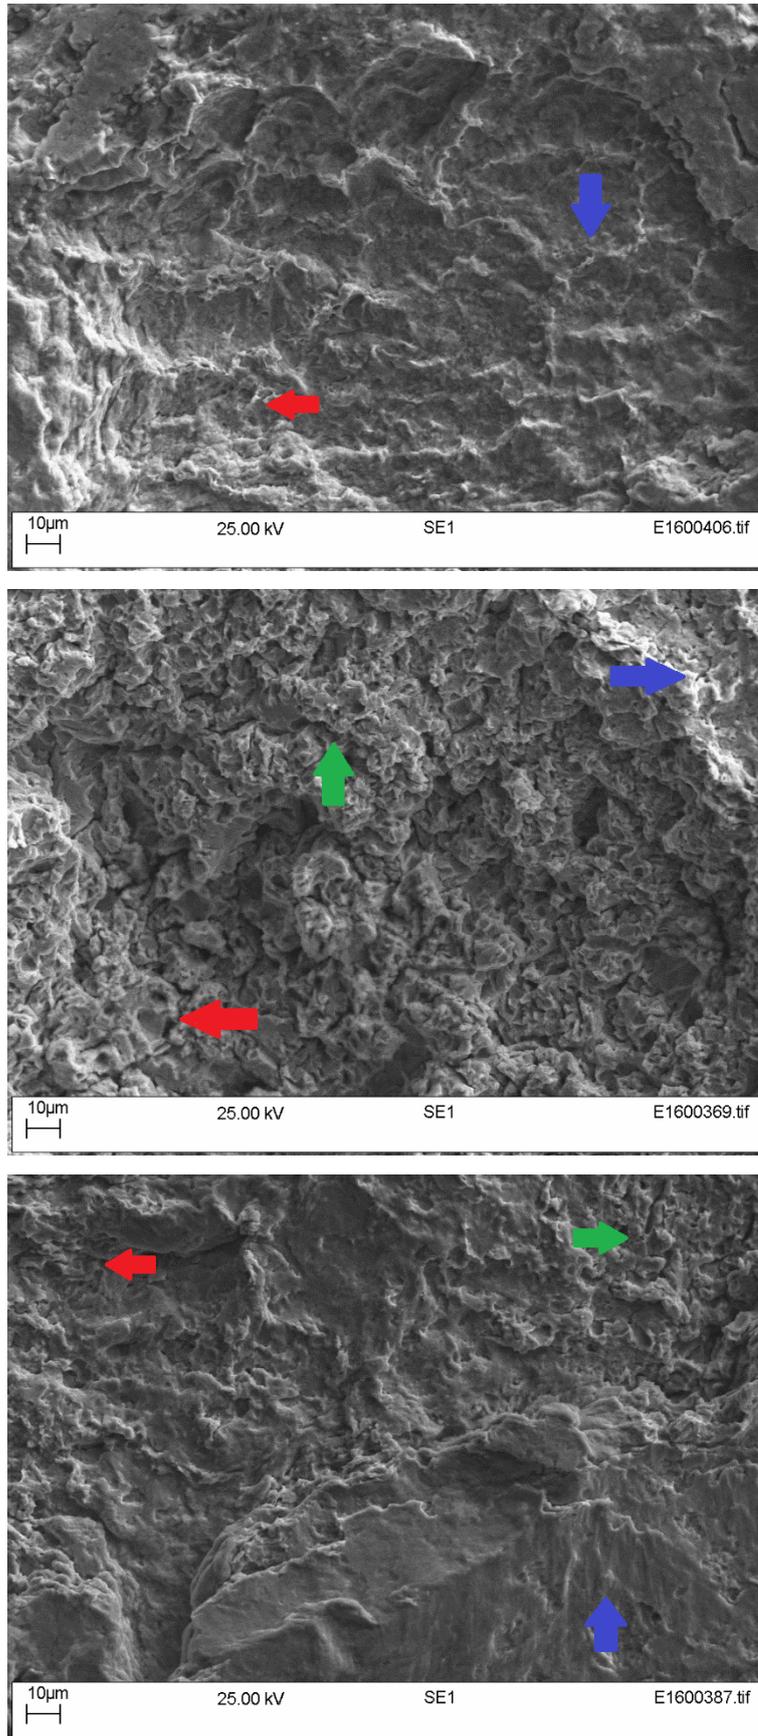
Figure 5.42: Erosion progression for grade DH36 steel. SEM images. Top-0.5h, Middle 2.5h, Bottom-5h. Arrows: Green – Intergranular, Blue – Transgranular, Red – Ductile.

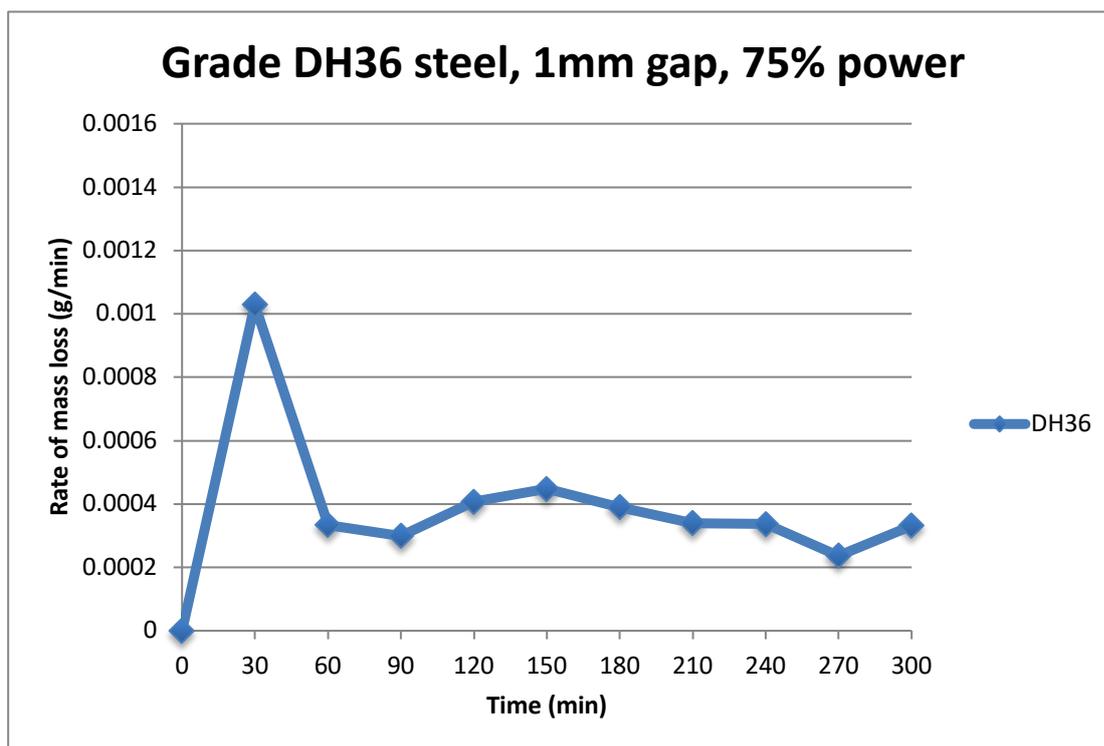
Figure 5.43: Rate of mass loss of Grade DH36 steel.

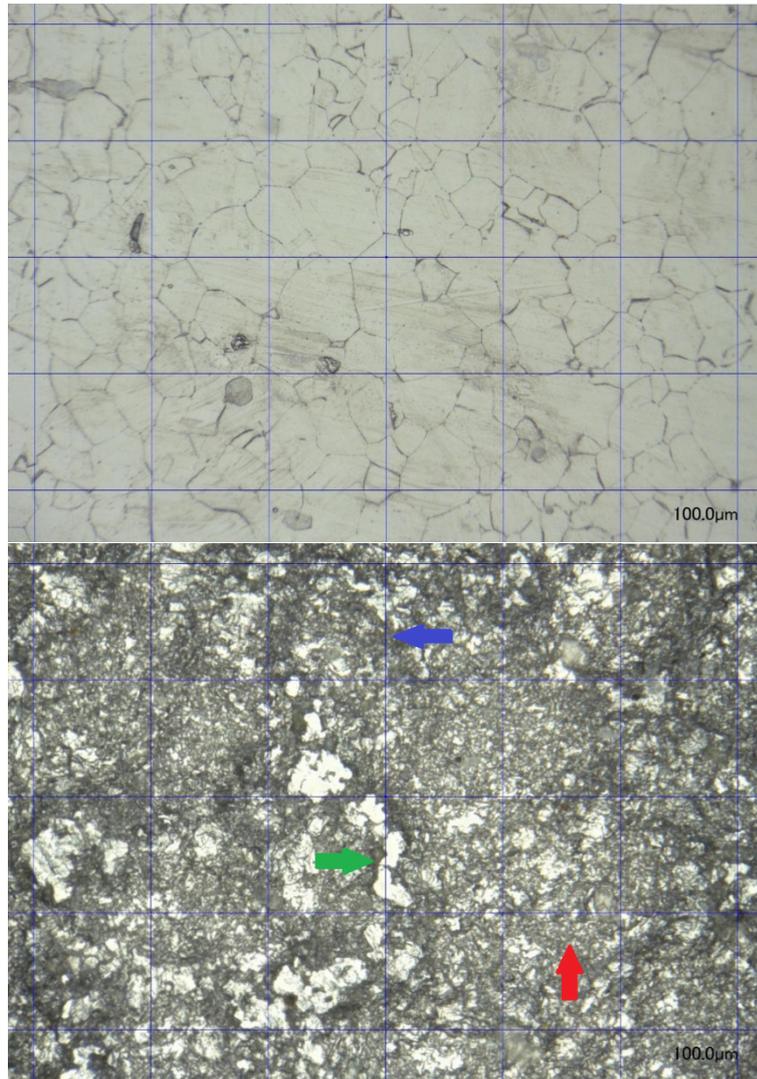
Figure 5.45: Microscopic images of non-eroded (Top) and eroded (Bottom) stainless steel 254. Arrows: Green – Intergranular, Blue – Transgranular, Red – Ductile.

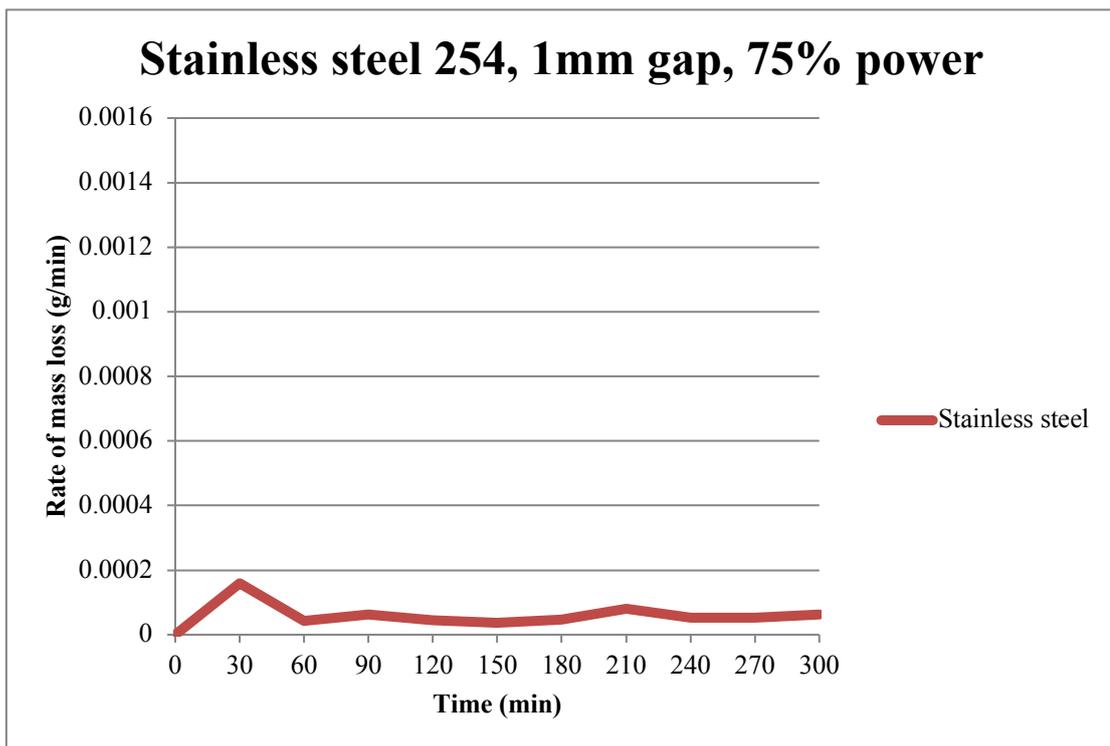
Figure 5.48: Rate of mass loss of stainless steel 254.

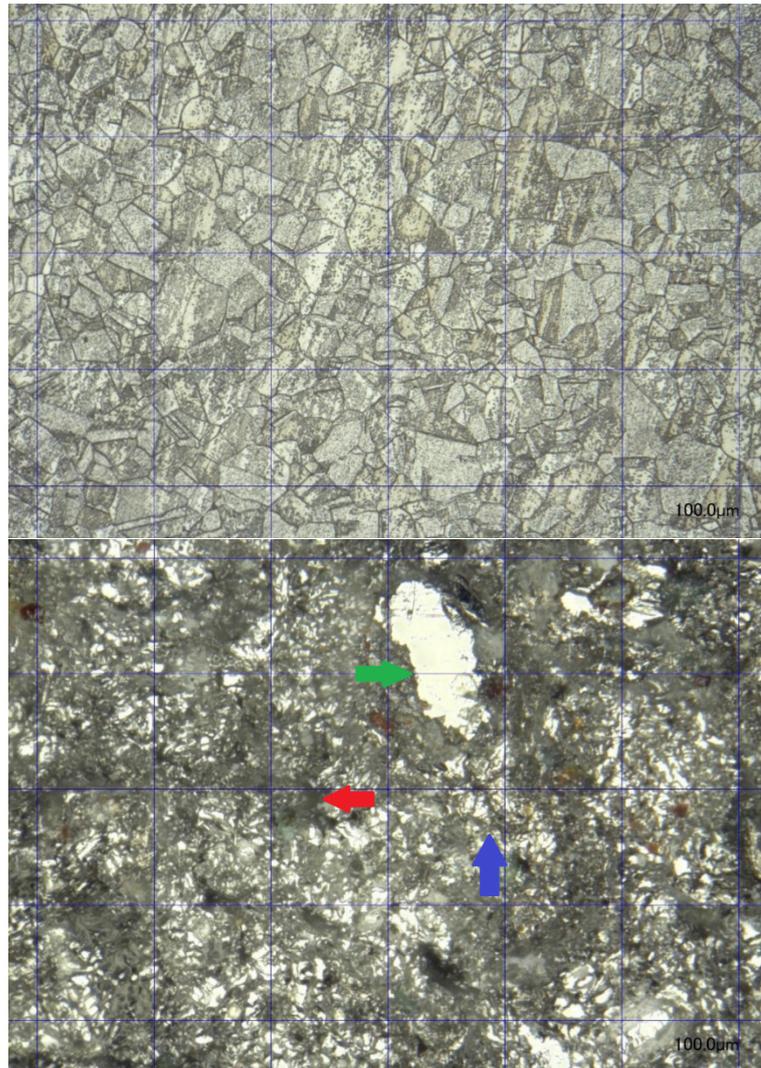
Figure 5.50: Microscopic images of non-eroded (Top) and eroded (Bottom) cupronickel 70-30. Arrows: Green – Intergranular, Blue – Transgranular, Red – Ductile.

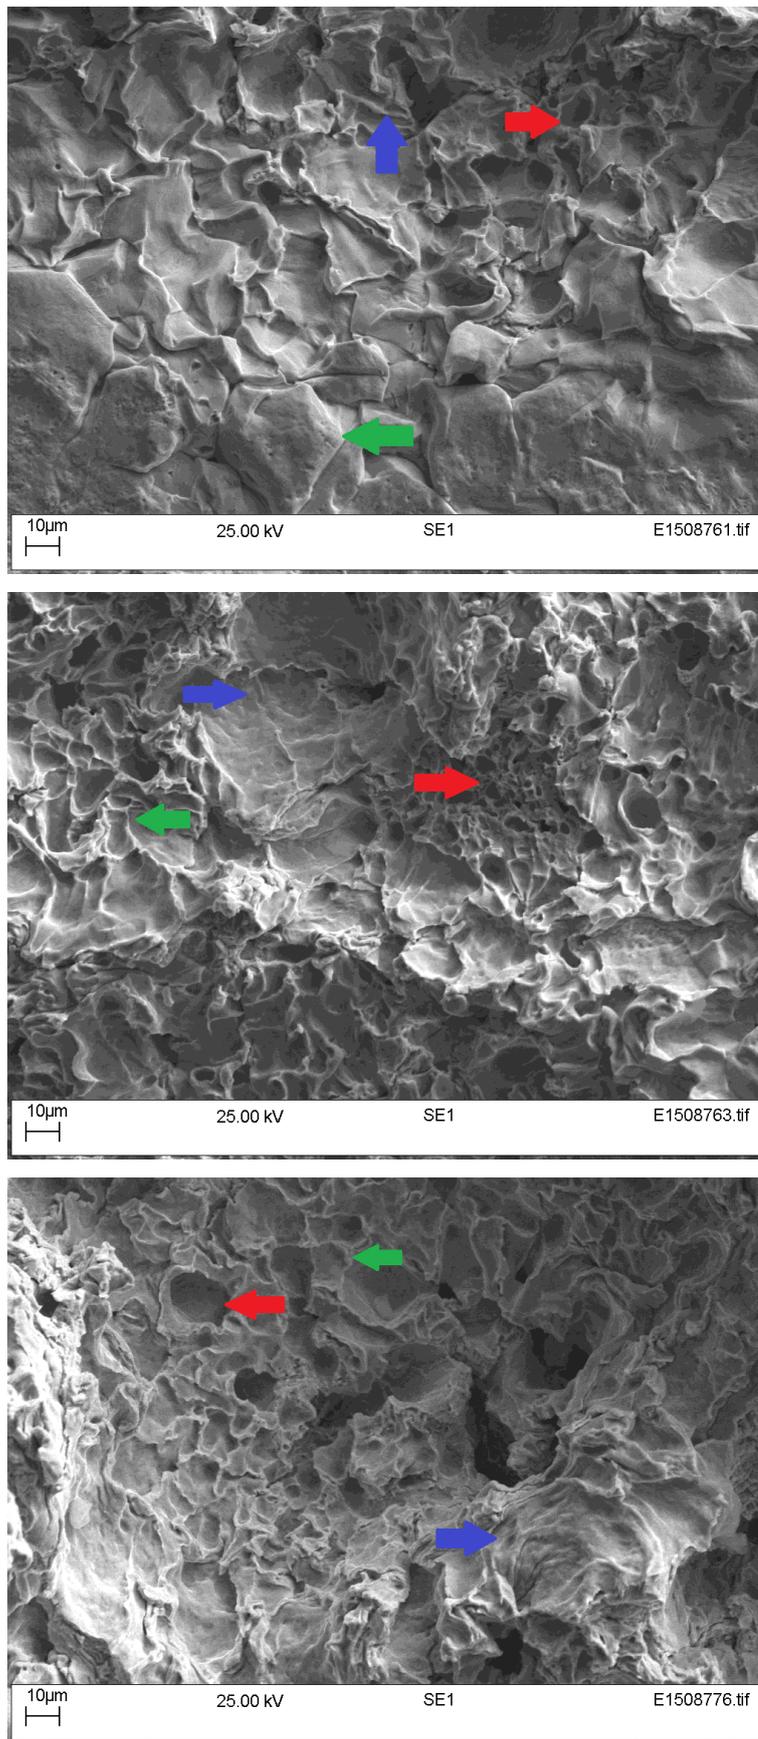
Figure 5.52: Erosion progression for cupronickel 70-30. SEM images. Top-0.5h, Middle 2.5h, Bottom-5h. Arrows: Green – Intergranular, Blue – Transgranular, Red – Ductile.

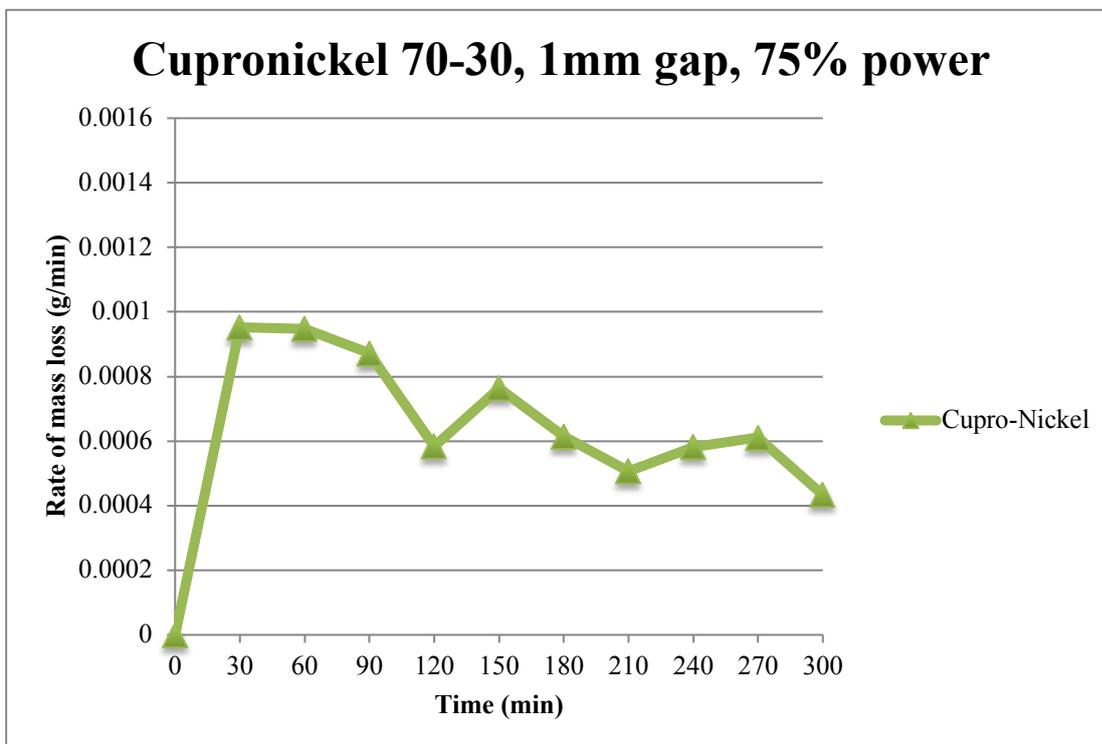
Figure 5.53: Rate of mass loss of cupronickel 70-30.

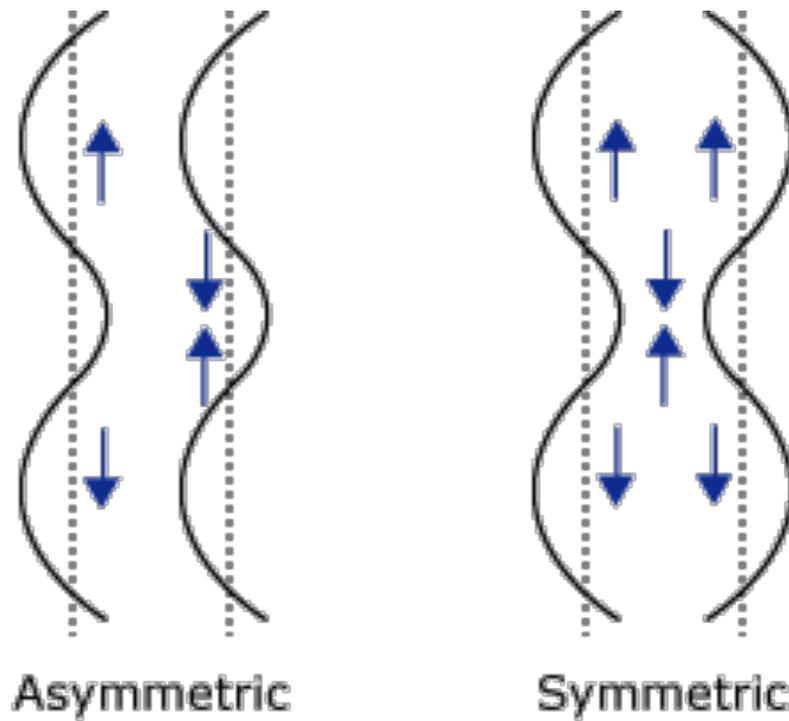
Figure 6.4: Asymmetric and symmetric Lamb waves (Source: NDT Resource centre, n.d.)

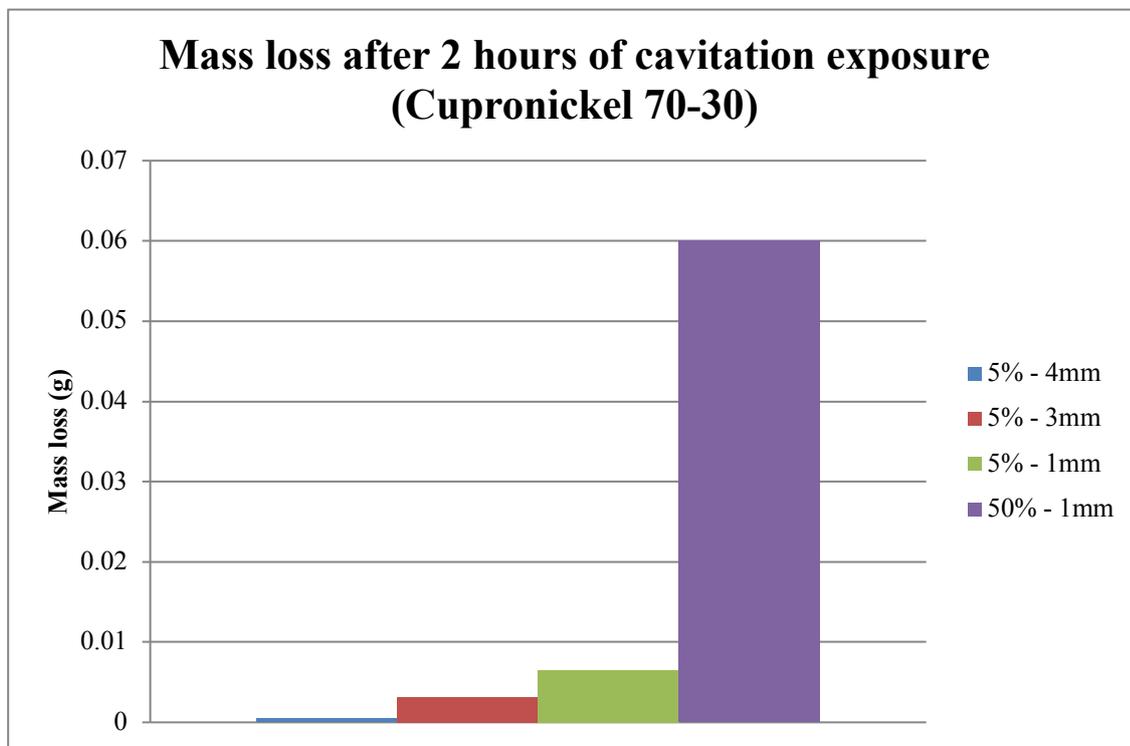
Figure 6.52: Mass loss of cupronickel 70 -30 for various test rig configurations

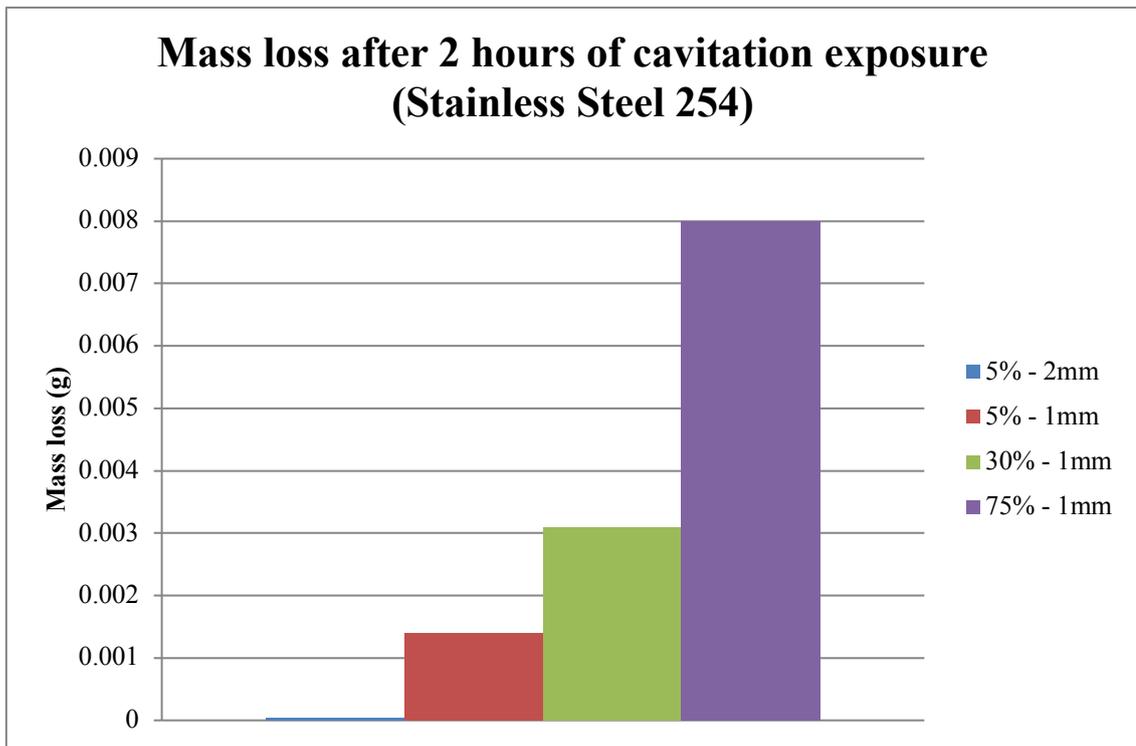
Figure 6.53: Mass loss of stainless steel 254 for various test rig configurations

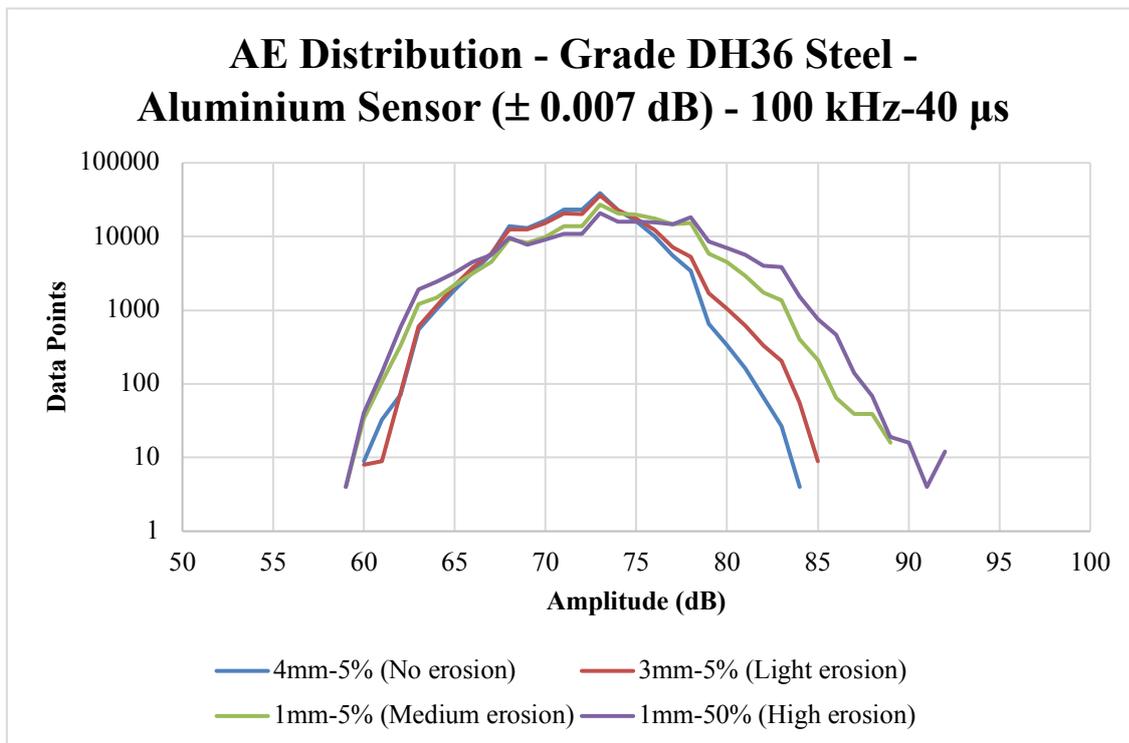
Figure 6.54: AE Distribution - Grade DH36 steel

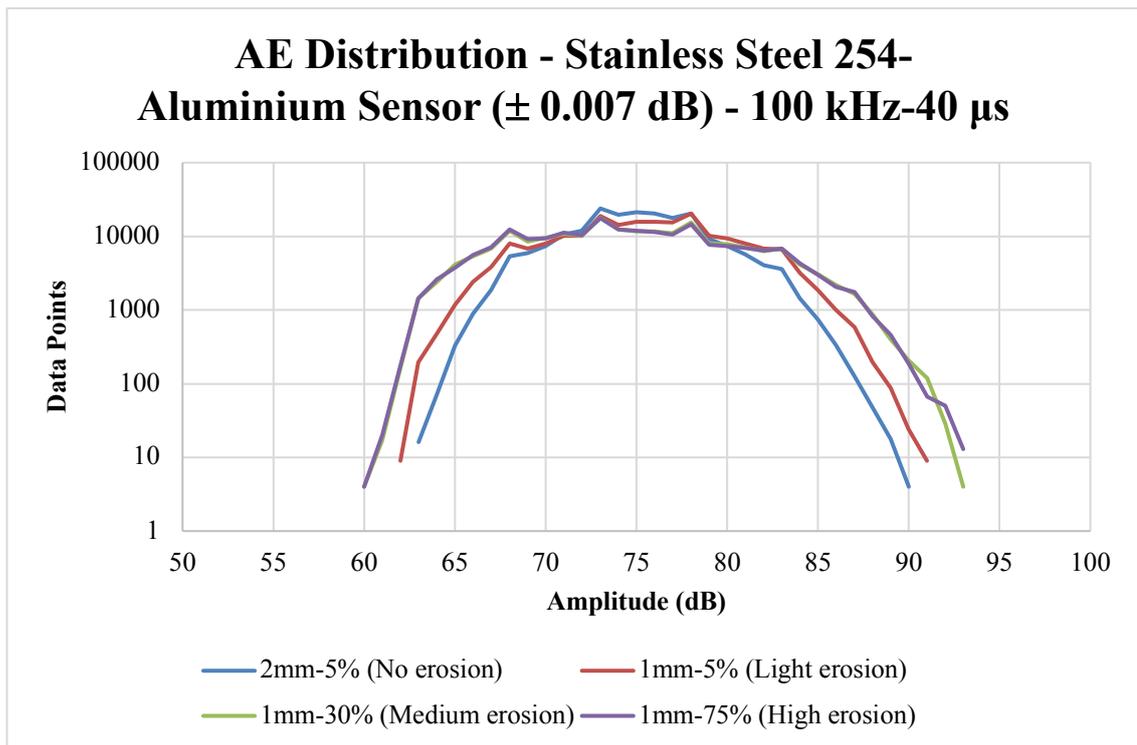
Figure 6.56: AE Distribution – Stainless steel 254

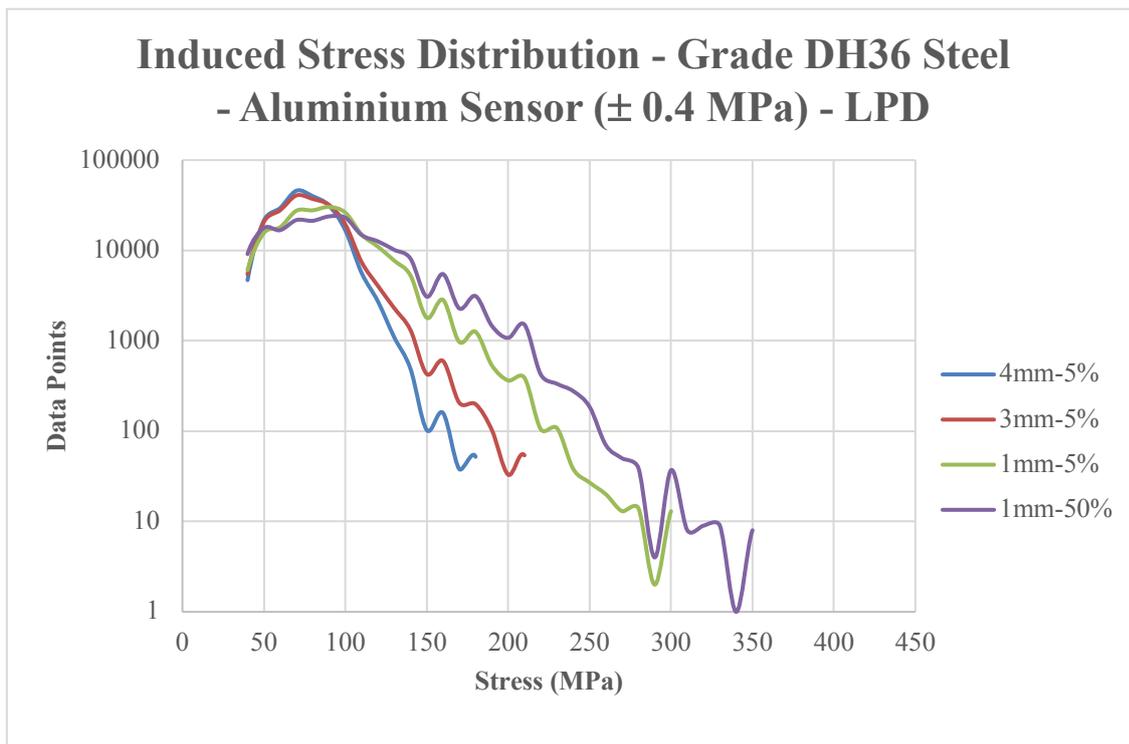
Figure 6.57: Stress distribution for grade DH36 steel. Aluminium sensor (LPD)

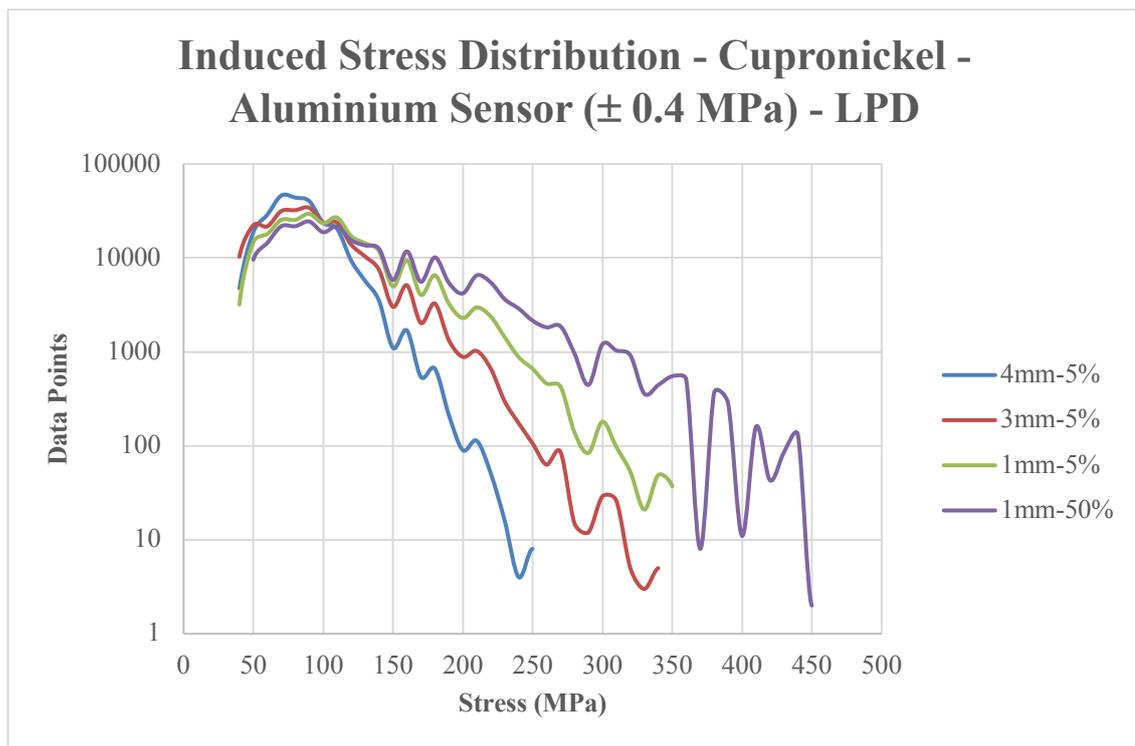
Figure 6.63: Induced stress distribution for cupronickel 70-30. Aluminium sensor (LPD)

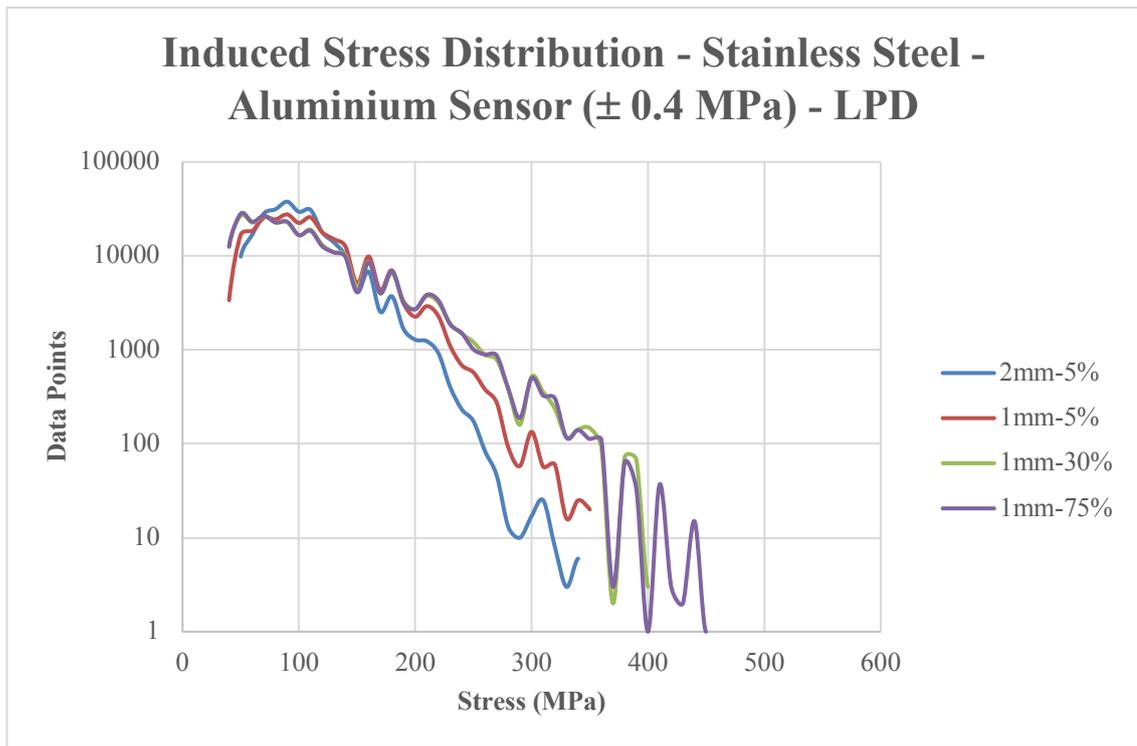
Figure 6.64: Induced stress distribution for stainless steel 254. Aluminium sensor (LPD)

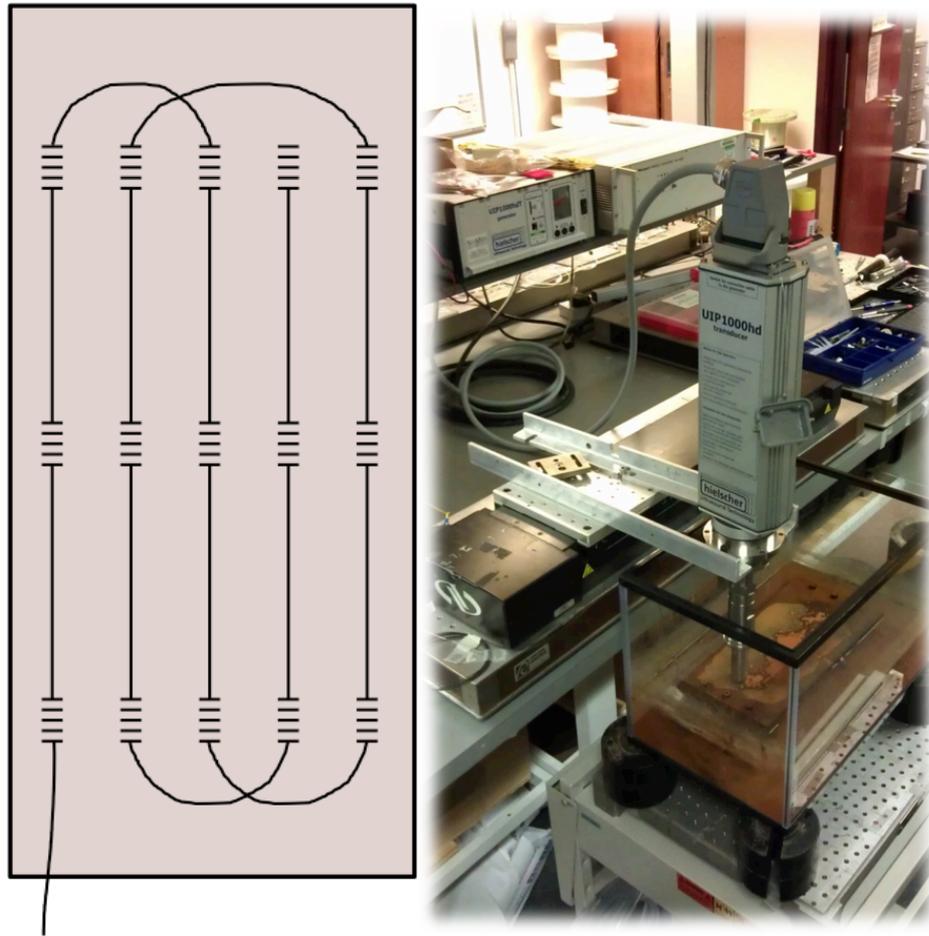
Figure 6.66: Left – Attached FBG sensors layout, Right – Test rig.

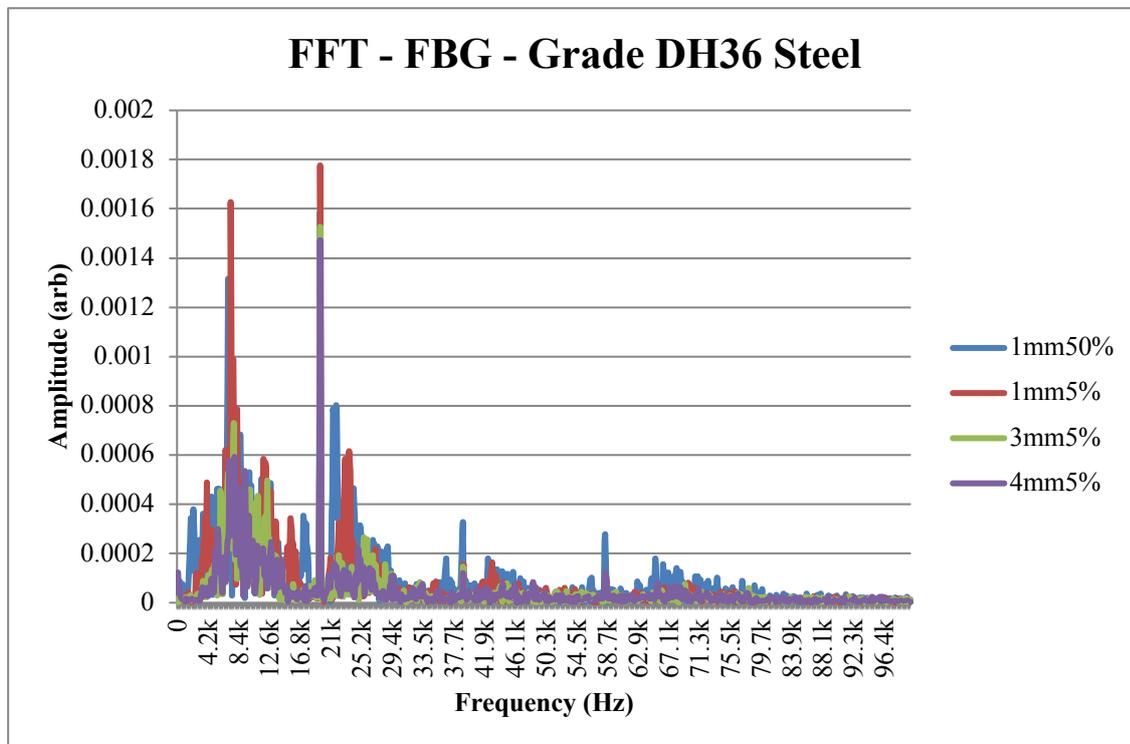
Figure 6.70: FFT – FBG sensor – DH36 steel (4mm-5%, 3mm-5%, 1mm-5%, 1mm-50%)
