Citation: Armakolas, I. (2018). Cavitation erosion fracture mechanisms and their detection in ship rudders. (Unpublished Doctoral thesis, City, University of London)

Cavitation Erosion Fracture Mechanisms and their Detection in Ship Rudders

This thesis is submitted for the fulfilment of the requirements for the degree of
Doctor of Philosophy

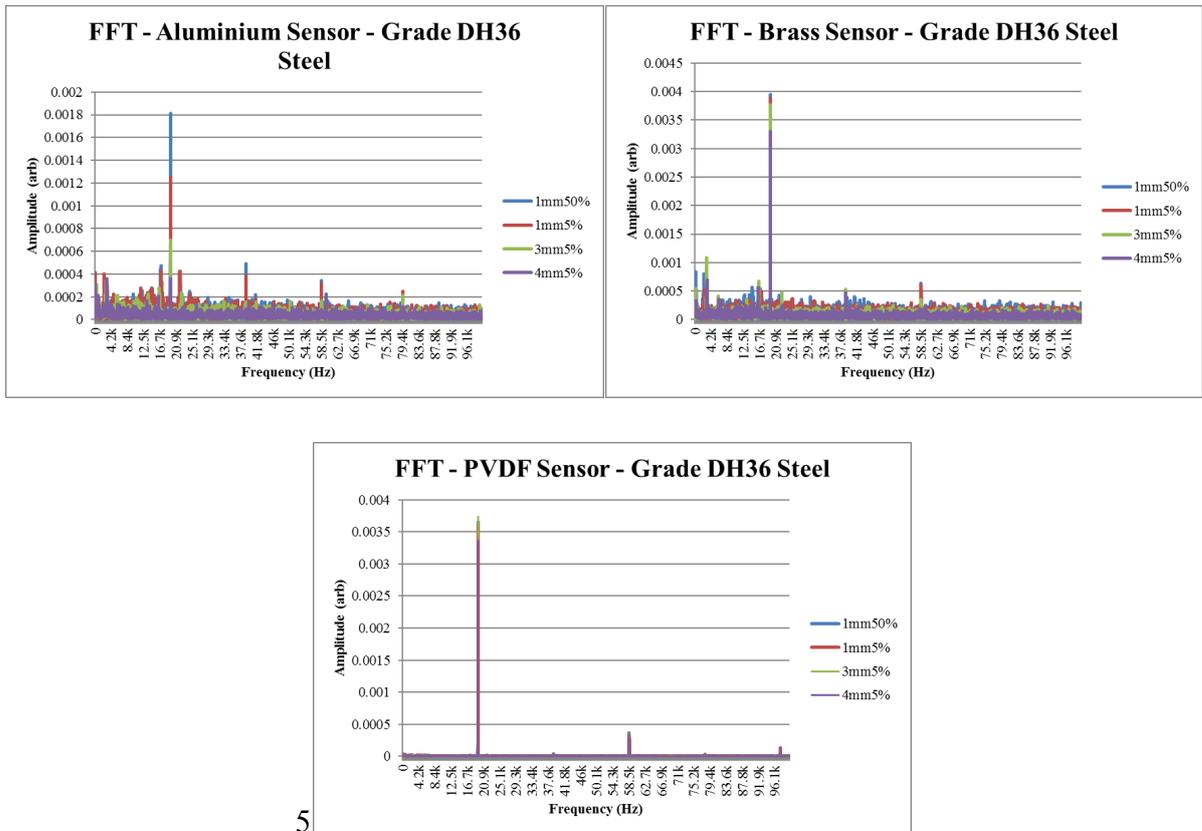
Figure 6.71: FFT comparison of different piezoelectric sensors.

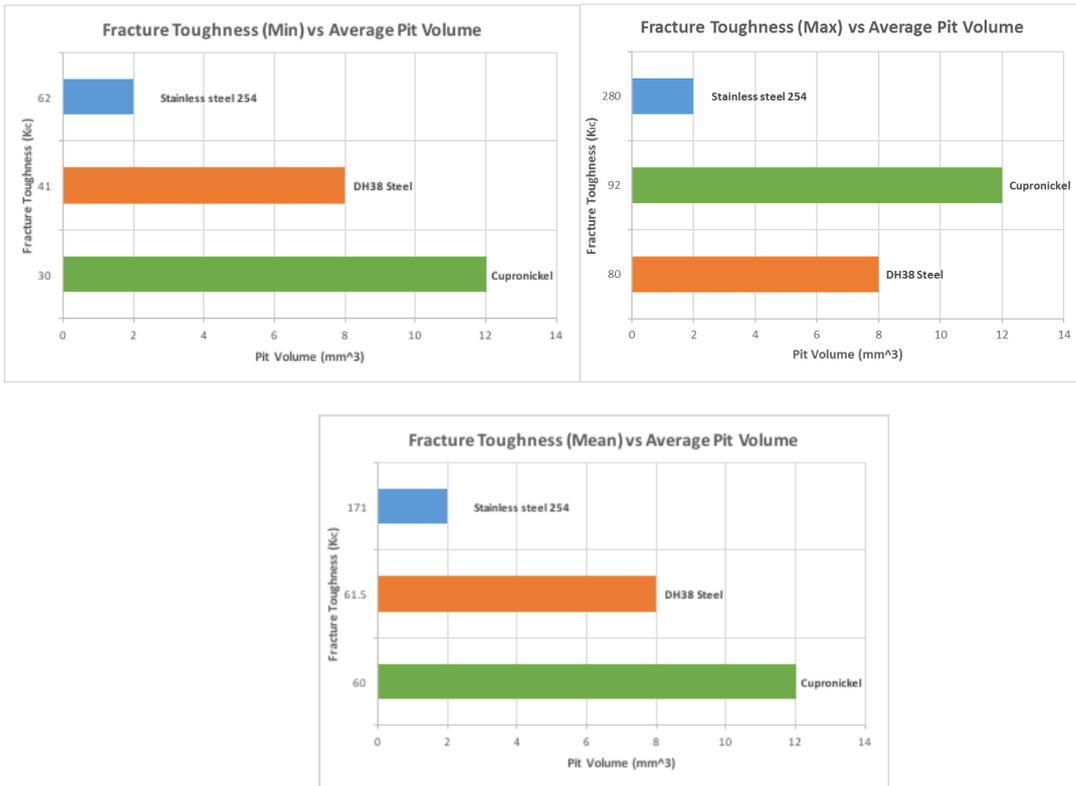
Figure 6.74: Fracture toughness vs Average pit volume

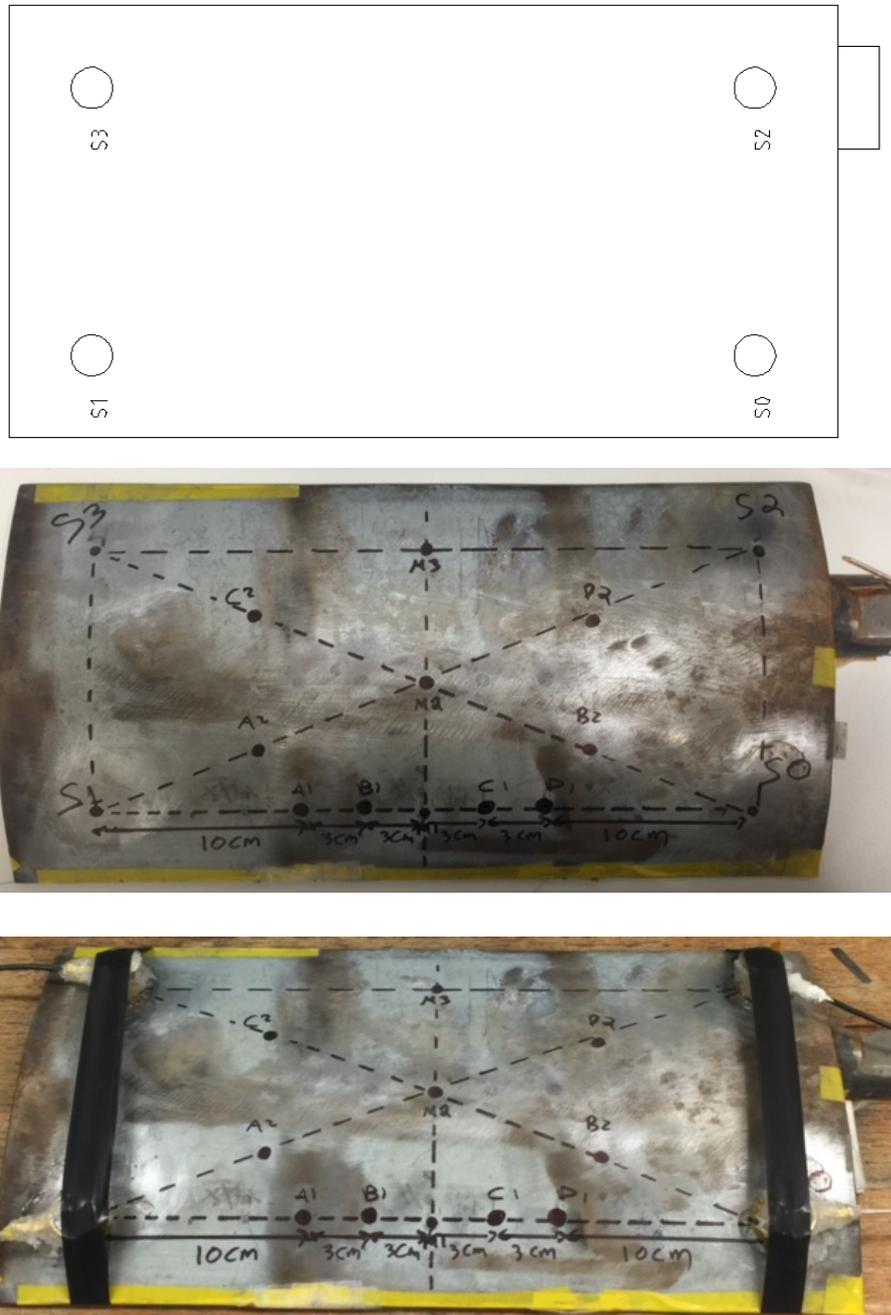
Figure 7.7: Top – Location of the four acoustic sensors (drawing). Middle – Location of the four acoustic sensors (image). Bottom – Mounted acoustic sensors (image).

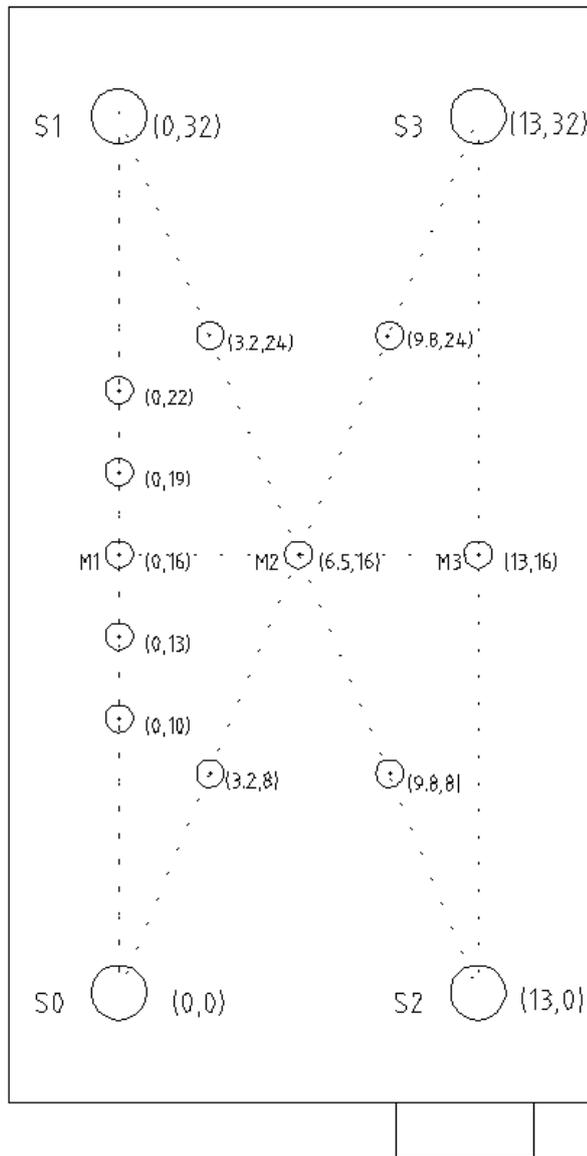
Figure 7.8: Coordinates of different sensors and sonotrode placements on the half rudder model.

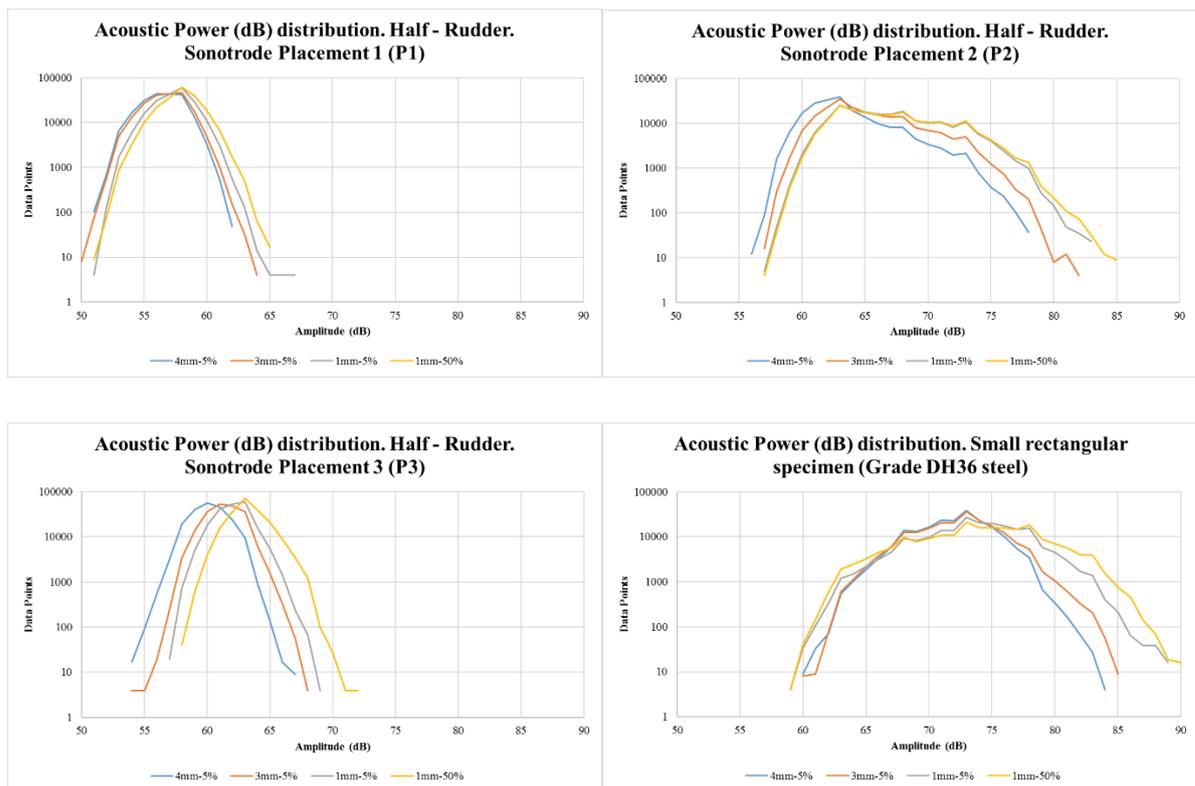
Figure 7.10: Acoustic Power (dB) distribution curves for different sonotrode placements and various test rig configurations with regards to the rudder as well as the small rectangular specimen (Grade DH36 steel).

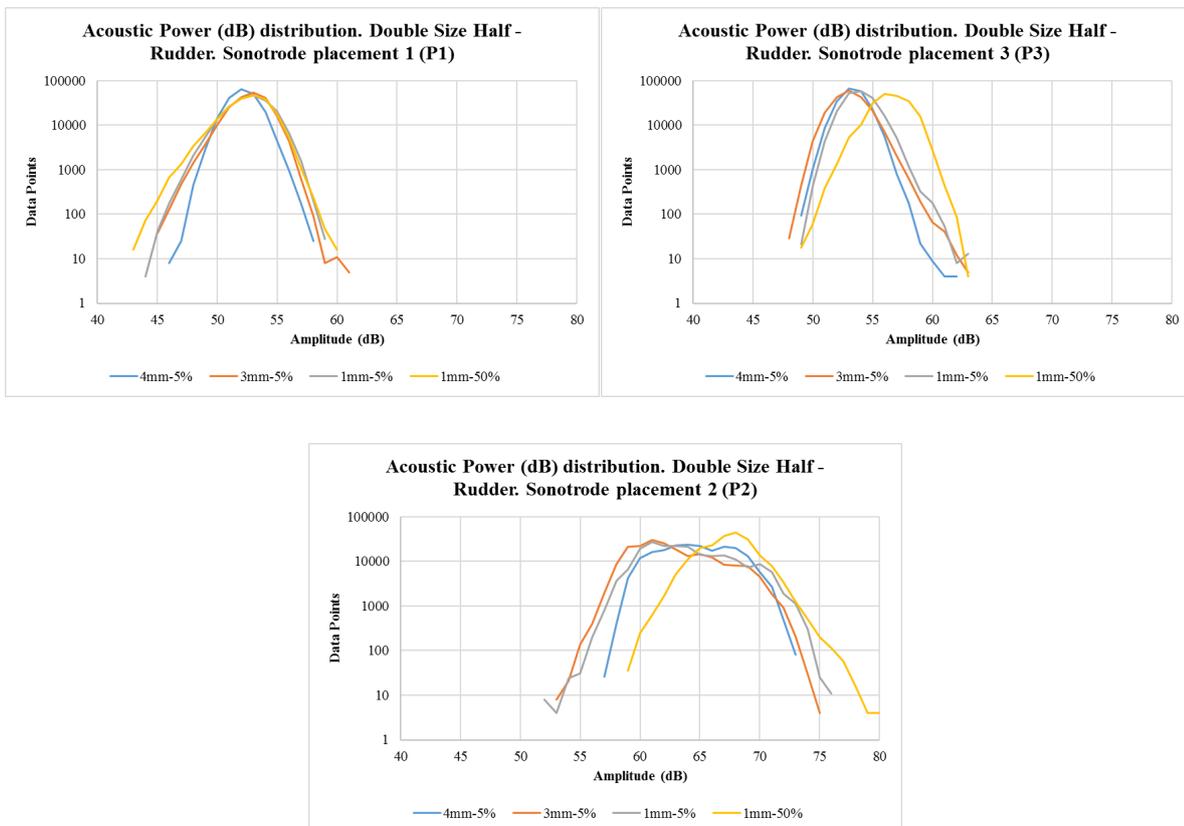
Figure 7.15: Double size rudder. Acoustic power (dB) distribution results for various sonotrode placements (P1, P2, P3) and test rig configurations.

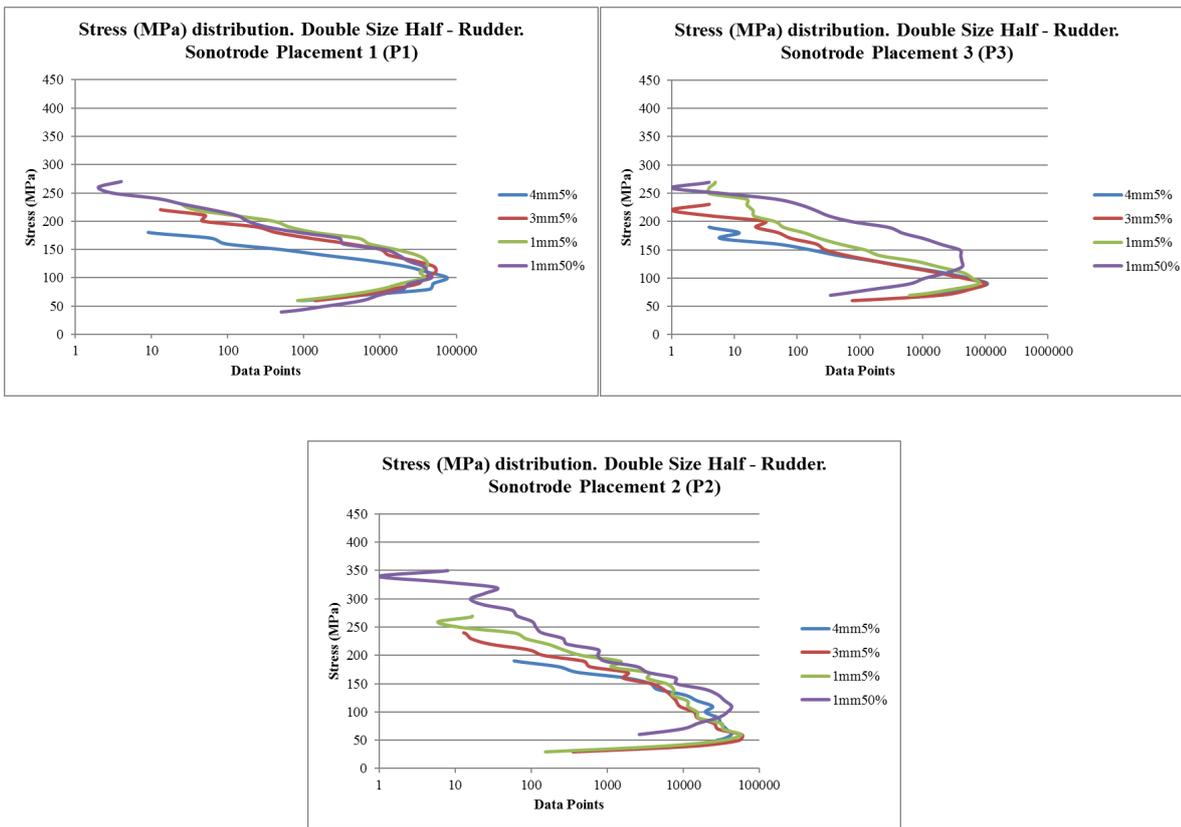
Figure 7.16: Double size rudder. Stress distribution for sonotrode placements P1, P2, P3.

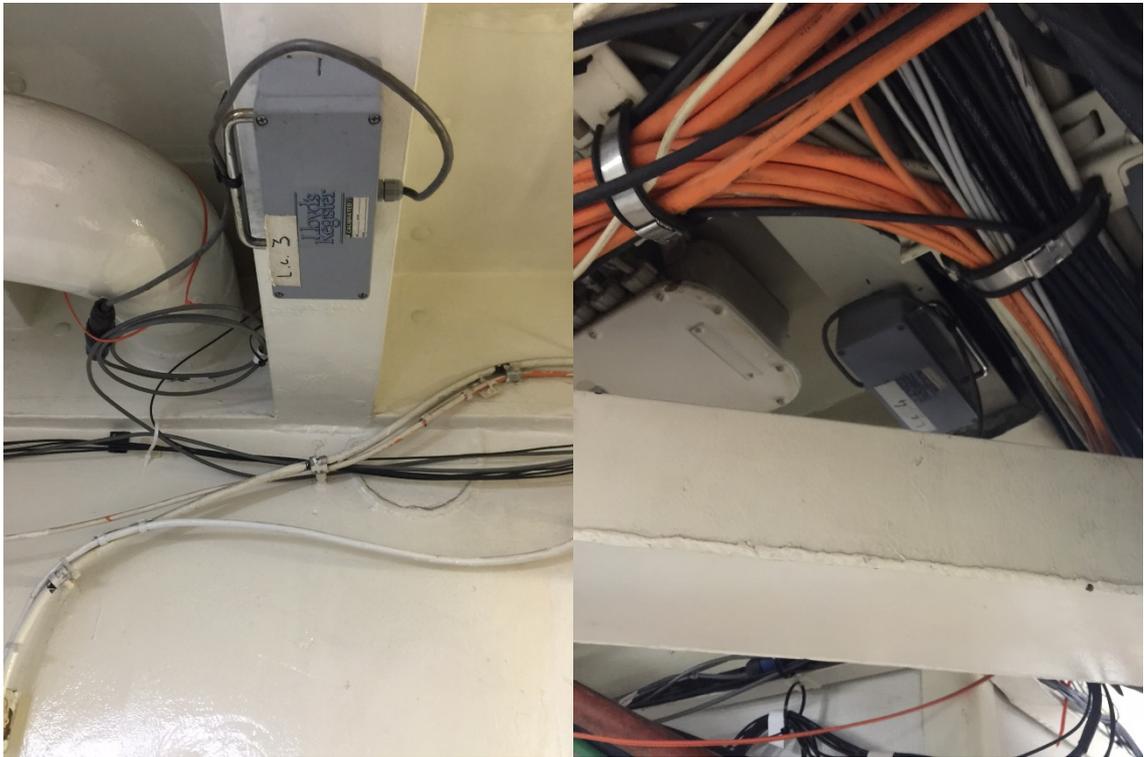
Figure A2: Gauge length strain extensometers installed at crucial points of the ship structure.

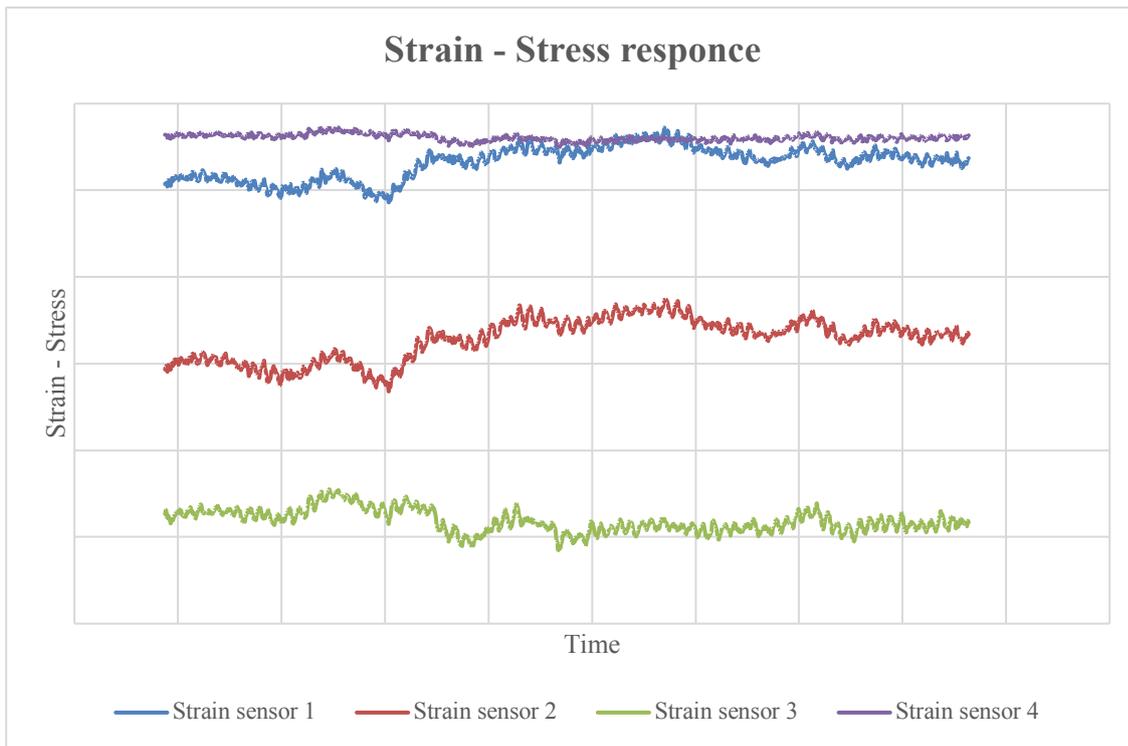
Figure A3: Strain – Stress response of four gauge length strain extensometers during sea trials.

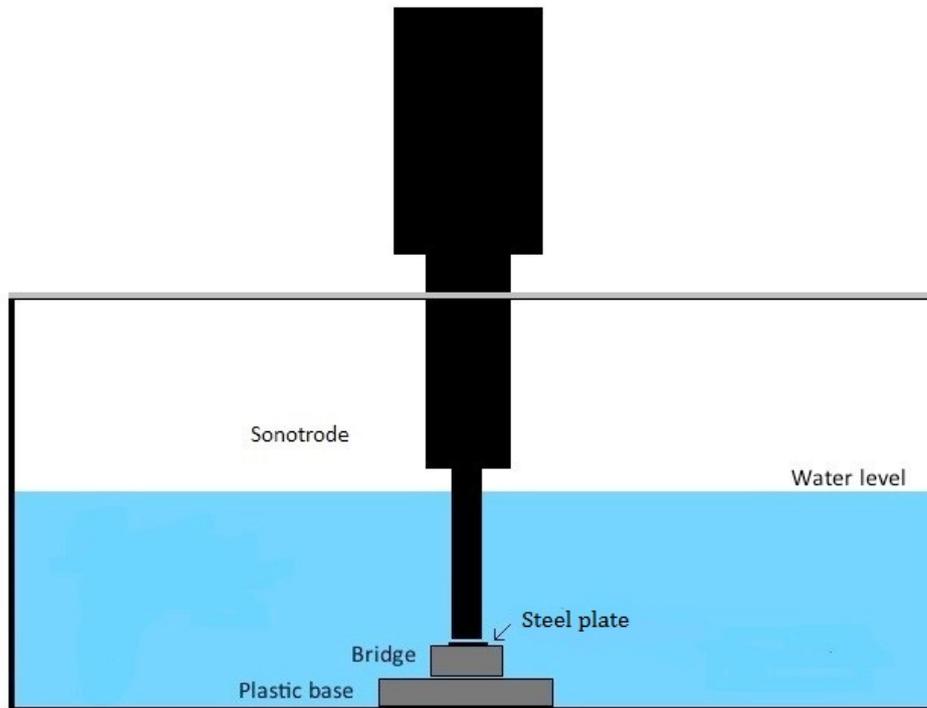
Figure E1: Test rig and water recirculation system

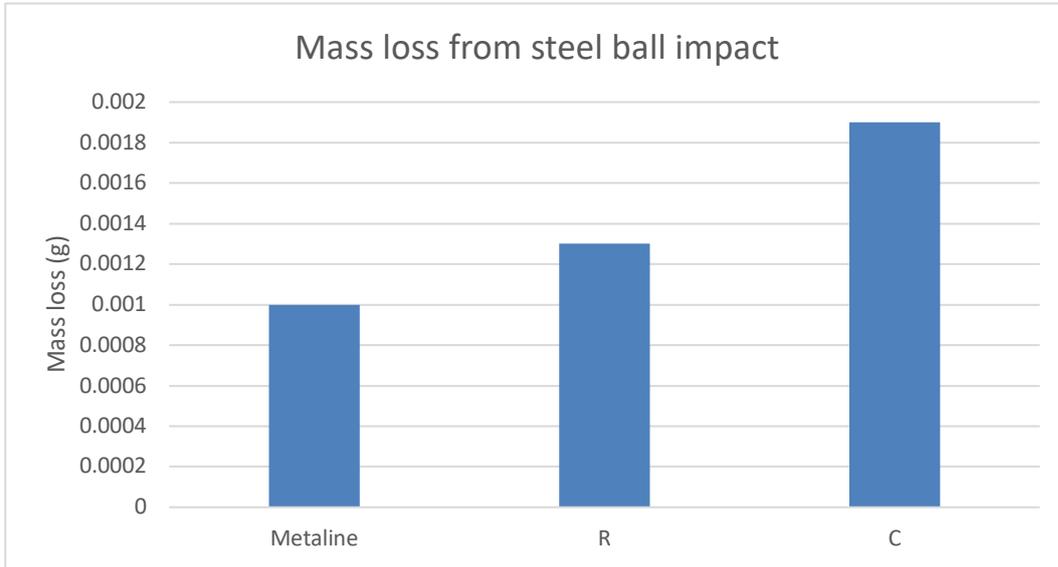
Figure E14: Mass loss due to steel ball impact

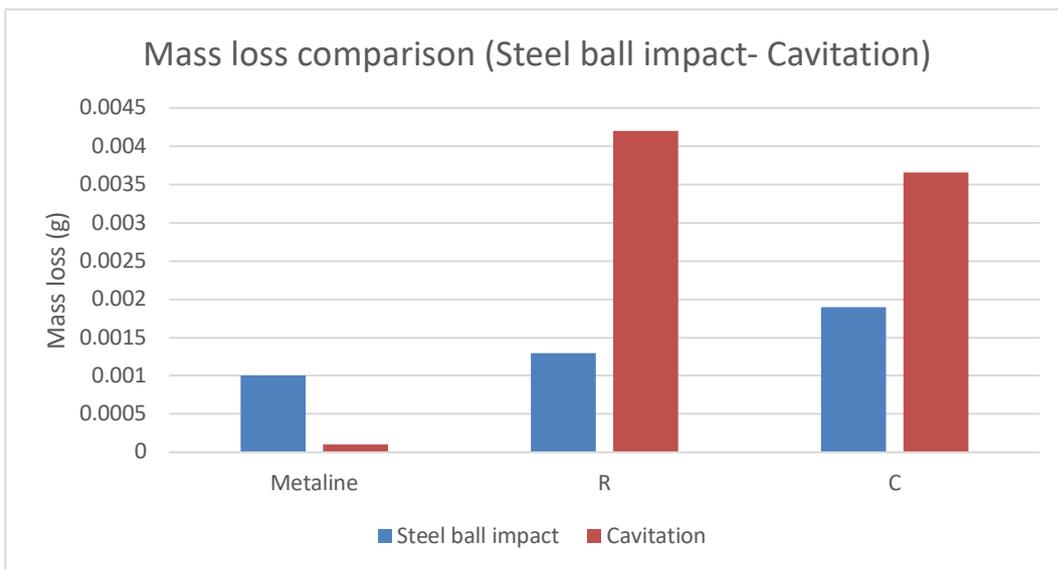
Figure E15: Mass loss comparison. Steel ball impact – Cavitation

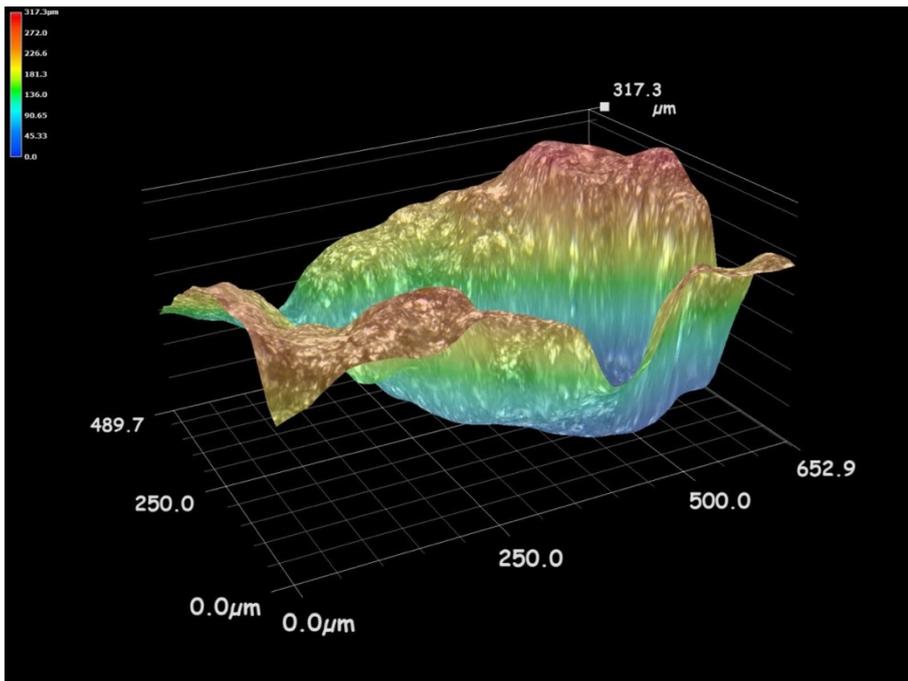
Figure F4: 3D illustration of erosion pit (3). Grade DH36 steel – Colour contour.

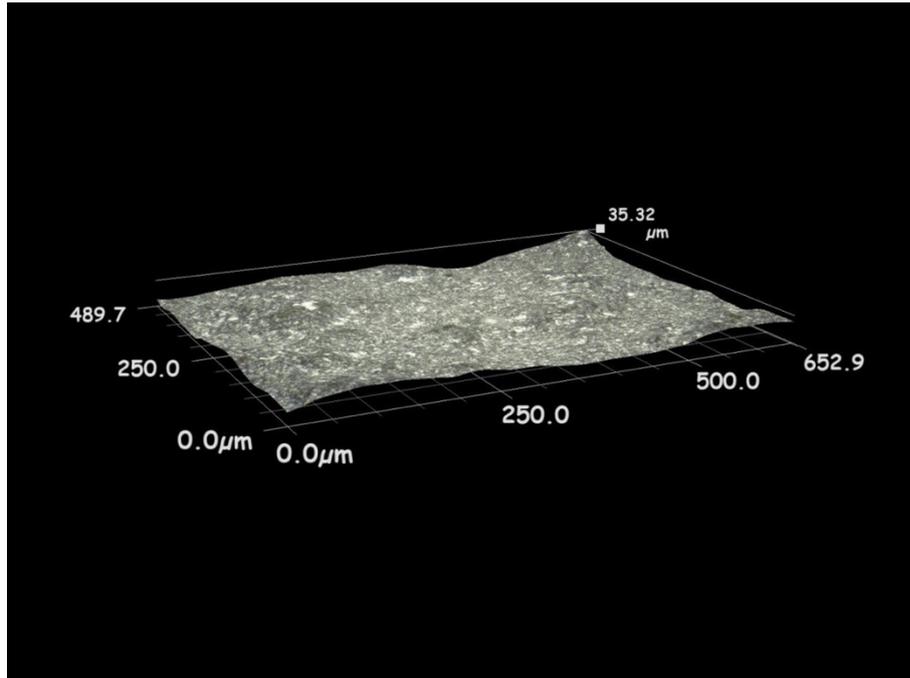
Figure F5: 3D illustration of erosion pit (2). Stainless steel 254.

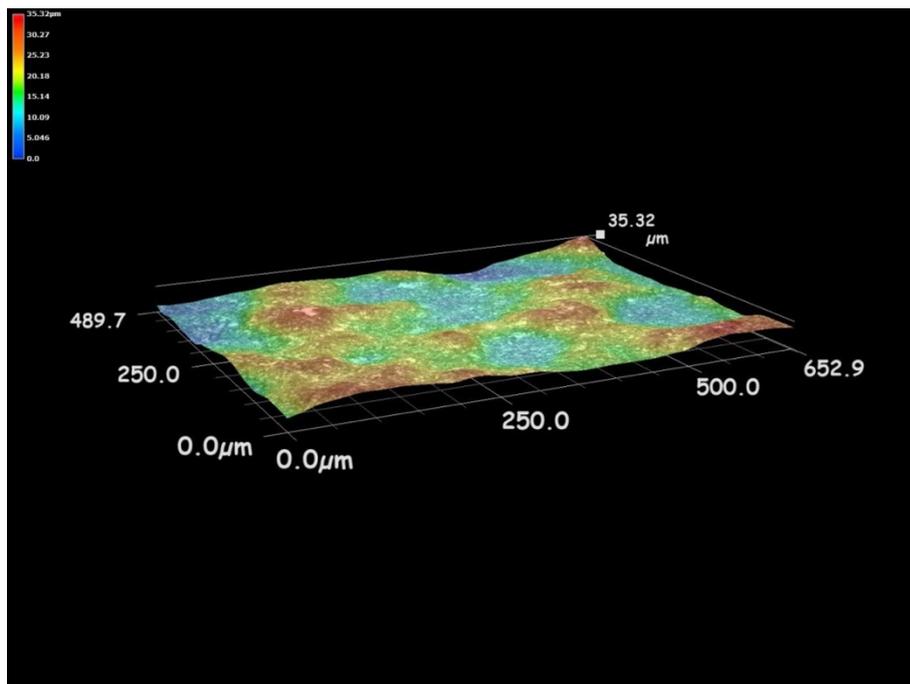
Figure F6: 3D illustration of erosion pit (2). Stainless steel 254 – Colour contour.

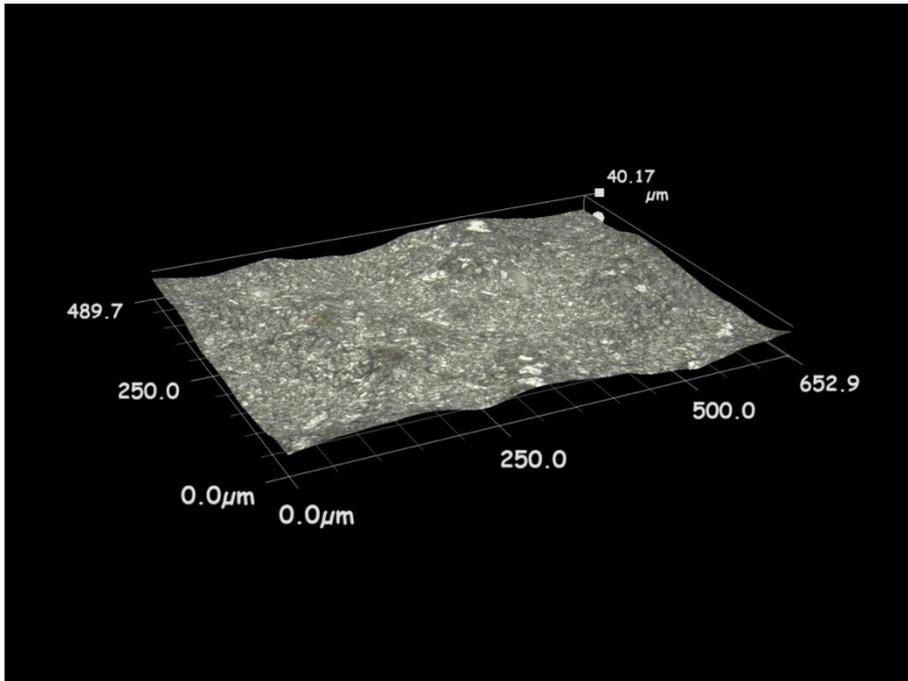
Figure F7: 3D illustration of erosion pit (3). Stainless steel 254.

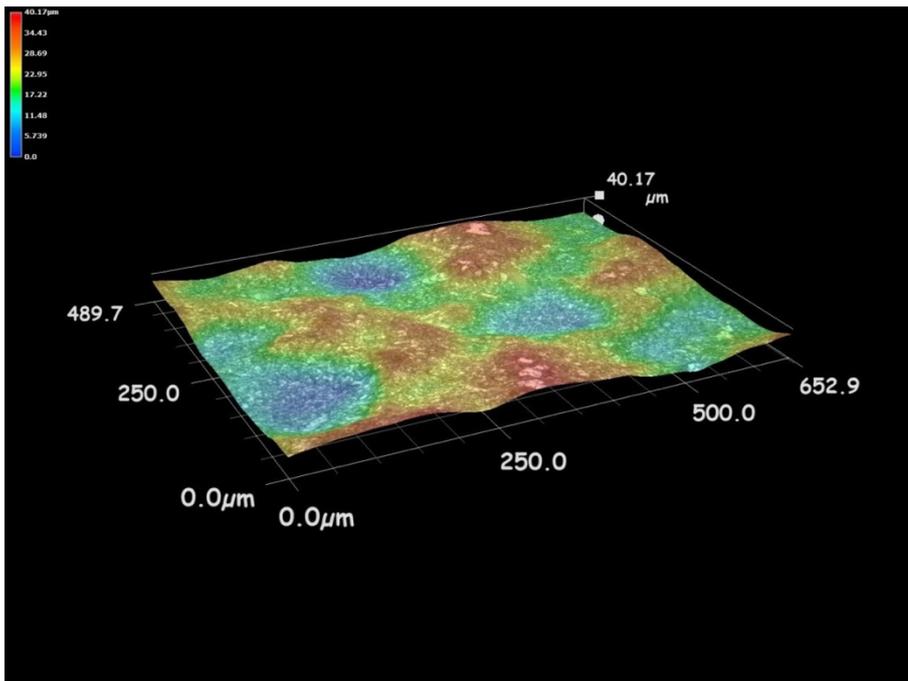
Figure F8: 3D illustration of erosion pit (3). Stainless steel 254 – Colour contour.

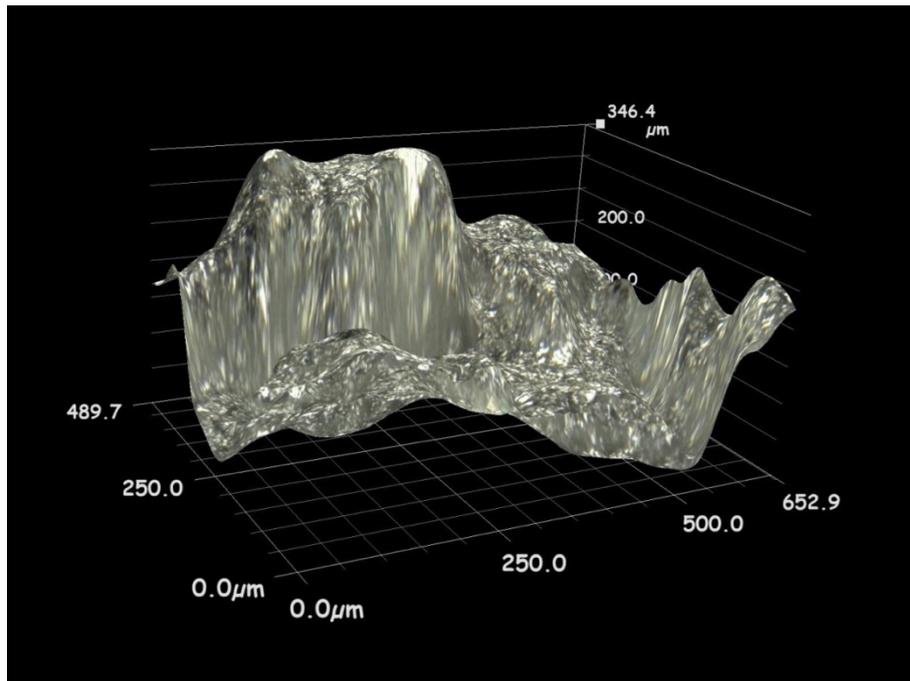
Figure F9: 3D illustration of erosion pit (2). Cupronickel 70-30.
