**Citation:** Zhao, Y., Tinsley, L., Addepalli, S., Mehnen, J. & Roy, R. (2016). A coefficient clustering analysis for damage assessment of composites based on pulsed thermographic inspection. *NDT & E International*, 83, pp. 59-67. doi: 10.1016/j.ndteint.2016.06.003

# A Coefficient Clustering Analysis for Damage Assessment of Composites based on Pulsed Thermographic Inspection

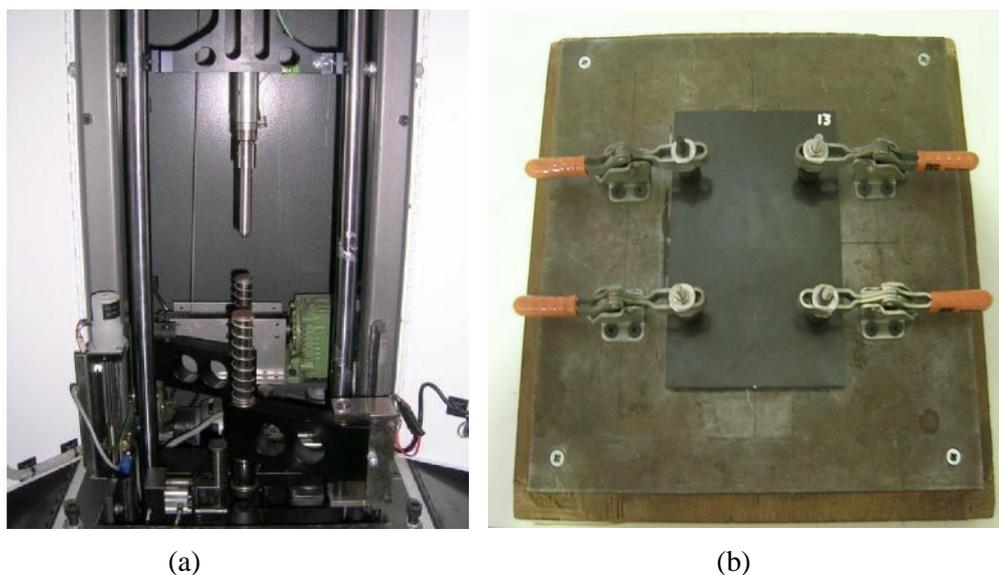
**Fig. 1:** (a) The weight-drop machine used for impact generation and (b) specimen support fixture.

spherical 16mm diameter weight drop machine which employed a drop weight of 2.281kg, as illustrated in Fig. 1(a). The support used to hold the sample in place was designed by following the instructions given by the standard BS ISO 18352, shown in Fig. 1(b).

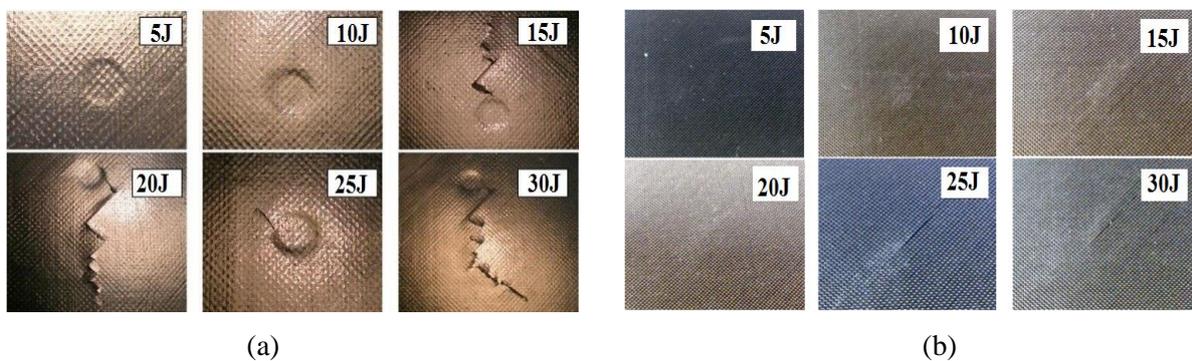
**Fig. 2:** Snapshot of 6 studied specimens. (a) Impact damage is visible from the impacted side of the specimens; (b) the rear surface of the samples present invisible or subtle evidence of damage.

The weight impact energy is equivalent to  $m \times g \times h$ , where  $m$  refers to impact mass, here 2.281kg was used,  $g = 9.8m/s^2$  is gravitational acceleration, and  $h$  is the drop height. Impact energy is adjusted by changing the height of the drop-weight, details of which are shown in Table 1. The specimens were subjected to represent impact energies of 5, 10, 15, 20, 25 and 30J respectively. As shown in Fig.2 (a), in all samples, each of the damages are clearly visible from the impacted side, but they are hidden or less obvious from the rear surface, as shown in Fig. 2 (b).

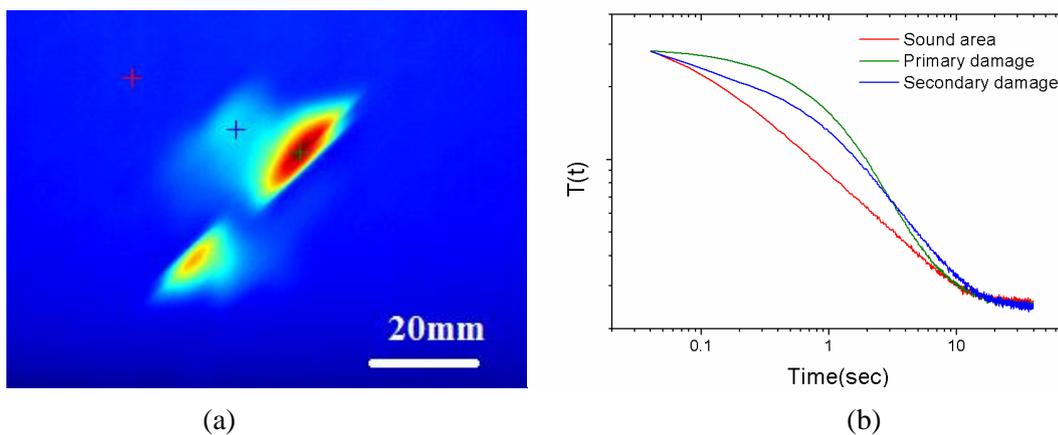
**Fig. 3:** (a) Infrared image of the laminate as shown in Fig.2 for 30J impact, inspected from the non-impact side of the laminate. This snapshot was sampled at 1 second after the flash, where the 'jet' colour map was used. (b) The logarithmic time-temperature curve plotted for three selected pixels in (a) with the marker colours indicating the respective curves.

Fig. 3(a) shows an infrared image of the laminate that was subjected to an impact of 30J, where 'jet' colour map was used. Three pixels from different areas were considered and corresponding temperature decay curves in the logarithmic scale are shown in Fig. 3(b). It is shown that when the heat diffuses through the sound area (represented by red curve and marked by red cross in Fig. 3 (a)) the temperature decay characteristics are uniform for a slope of -0.5 as established in [30]. However, it can be inferred from the thermogram that there is the area represented by the green marker that shows a different temperature decay profile in comparison with the area where the material is not supposed to have any damage.

This profile when plotted over time is represented by the green curve in Fig. 3(b), which confirms this deviation from the time-temperature profile of a sound area, confirming the presence of near and sub-surface damage as established in the literature [11, 12, 14, 31]. From Fig. 3(a), it can also be inferred that there is a secondary damage that has also been caused by the impact, but have a much lower contrast. It can be inferred that the deviation of the curve, now represented by the blue curve, from the base material (the red curve) confirms the presence of additional damage, which in this case may be referred to as secondary damage. The results obtained thus provide validation ensuring that the trend obtained is in line with what has been established in other researches.

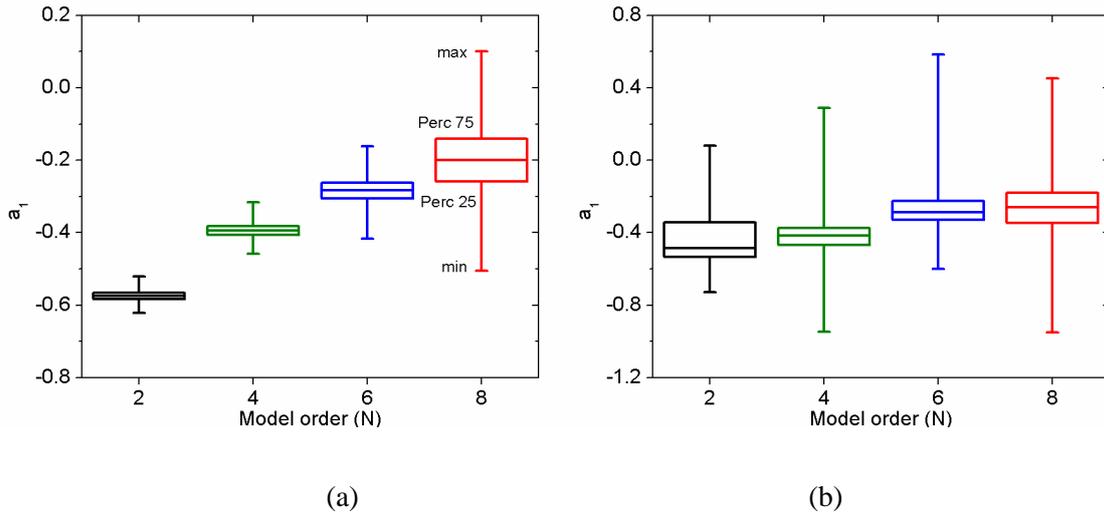
**Fig. 4:** Box chart for  $a_1$  with different model orders estimated from a damage-free specimen (left) and a damaged specimen of 30J (right).

Although the model fitting is not as close as a high order model, the coefficients are much less sensitive to noise and more consistent for pixels from sound area. This fact is clearly evidenced by Fig. 4, where Fig. 4(a) shows the box chart for the polynomial coefficients  $a_1$  with different model orders estimated from a damage-free specimen, and Fig. 4(b) shows the

box chart for  $a_1$  with different model orders estimated from a damaged specimen (30J). It can be observed from Fig. 4(a) that the variance of  $a_1$  indicates the sensitivity to variation of pixels from the damage-free specimen, and its significant increase following the increment of the model order. As before, Fig. 4(b) represents the variation  $a_1$  for a damaged area, indicating the sensitivity to variation of pixels. No significant difference has been observed between different model orders.

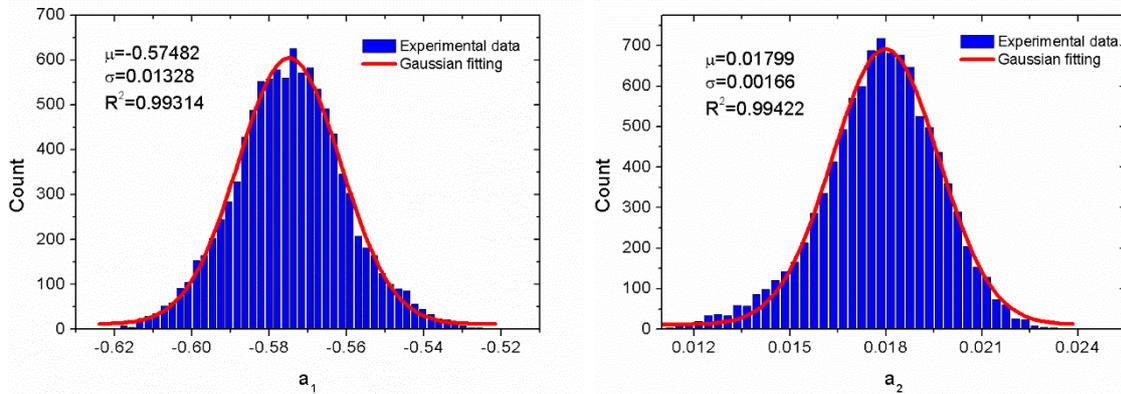
**Fig. 5:** The distribution of the coefficients for the damage-free specimen with corresponding Gaussian fitting.

100 pixels was sampled and the model (4) was fitted for each pixel. Fig. 5 shows the distribution of the first order coefficient  $a_1$  and the second order coefficient  $a_2$  with corresponding Gaussian fitting respectively. It is clearly shown that both coefficients are located within a narrow range with an approximate Gaussian distribution. The standard deviation of the fitting,  $\sigma$ , is 0.01328 and 0.00166 respectively, which is relatively very small comparing with the mean of distribution,  $\mu$ , which is -0.57482 and 0.01799 respectively. The value of R-Square, as the indicator of approximation level, is 0.99314 and 0.99422, respectively.

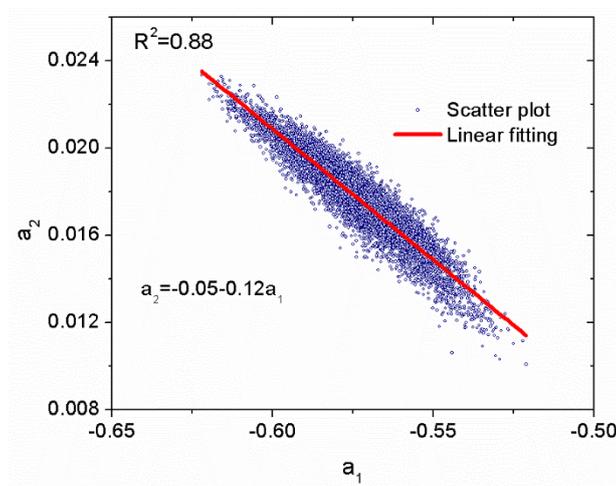
**Fig. 6:** The plot of the second order coefficient  $a_2$  as a function of the first order coefficient  $a_1$  for one damage-free specimen.

Fig. 6 shows the scatter plot, illustrated by blue dots, for pixels sampled from the damage-free specimen. The plot exhibits a spindle shaped profile which indicates a strong linear relationship between these two coefficients. The linear relationship can be described as

As shown in Fig. 6, the red plot illustrates the model (6) with  $R^2 = 0.88$ . The boundary condition of  $a_1$  is determined by 99% quantile of distribution, which is  $[-0.62, -0.53]$ . The distance tolerance  $\tau_d$  is chosen as 0.033 based on Eq. (5).

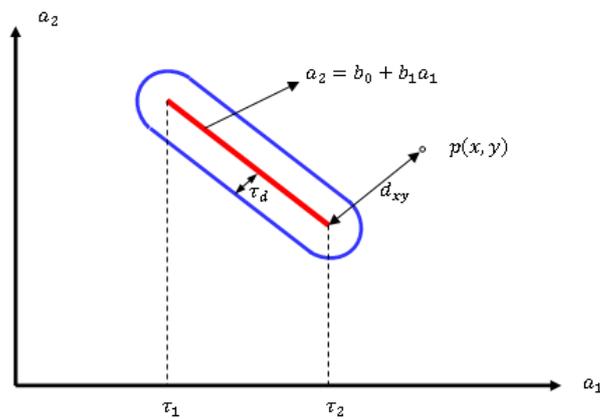
**Fig. 7:** Illustration of the classification process, where the red line segment denotes the baseline. Any pixel whose scatter of  $a_1$  vs  $a_2$  locates inside the region surrounded by the blue curve is determined as a pixel from sound area, or it is determined as a pixel from damaged area.

sound areas. The classification process is illustrated in Fig. 7, where the red line segment denotes the model (4). Considering a pixel  $p(x, y)$ , the first step is to estimate the first and second order coefficient of the model (3), and then calculate the shortest distance from the coefficient coordinate  $(a_1^{x,y}, a_2^{x,y})$  to the line segment, denoted by  $d_{xy}$ . If  $d_{xy}$  is smaller than a preset tolerance  $\tau_d$ , this pixel is determined as a pixel coming from a sound area of the component, or the pixel is determined as a damaged pixel. The value of  $d_{xy}$  indicates the level of difference of thermal behavior with damage free area. The larger the value of  $d_{xy}$ , the more complex the thermal behavior is, which could directly relate to the level of structure change. The value of  $\tau_d$  is chosen based on the standard derivation of the coefficients calculated from the damage-free specimen. Through a large amount of testing and performance comparison, the paper proposes to select  $\tau_d$  by

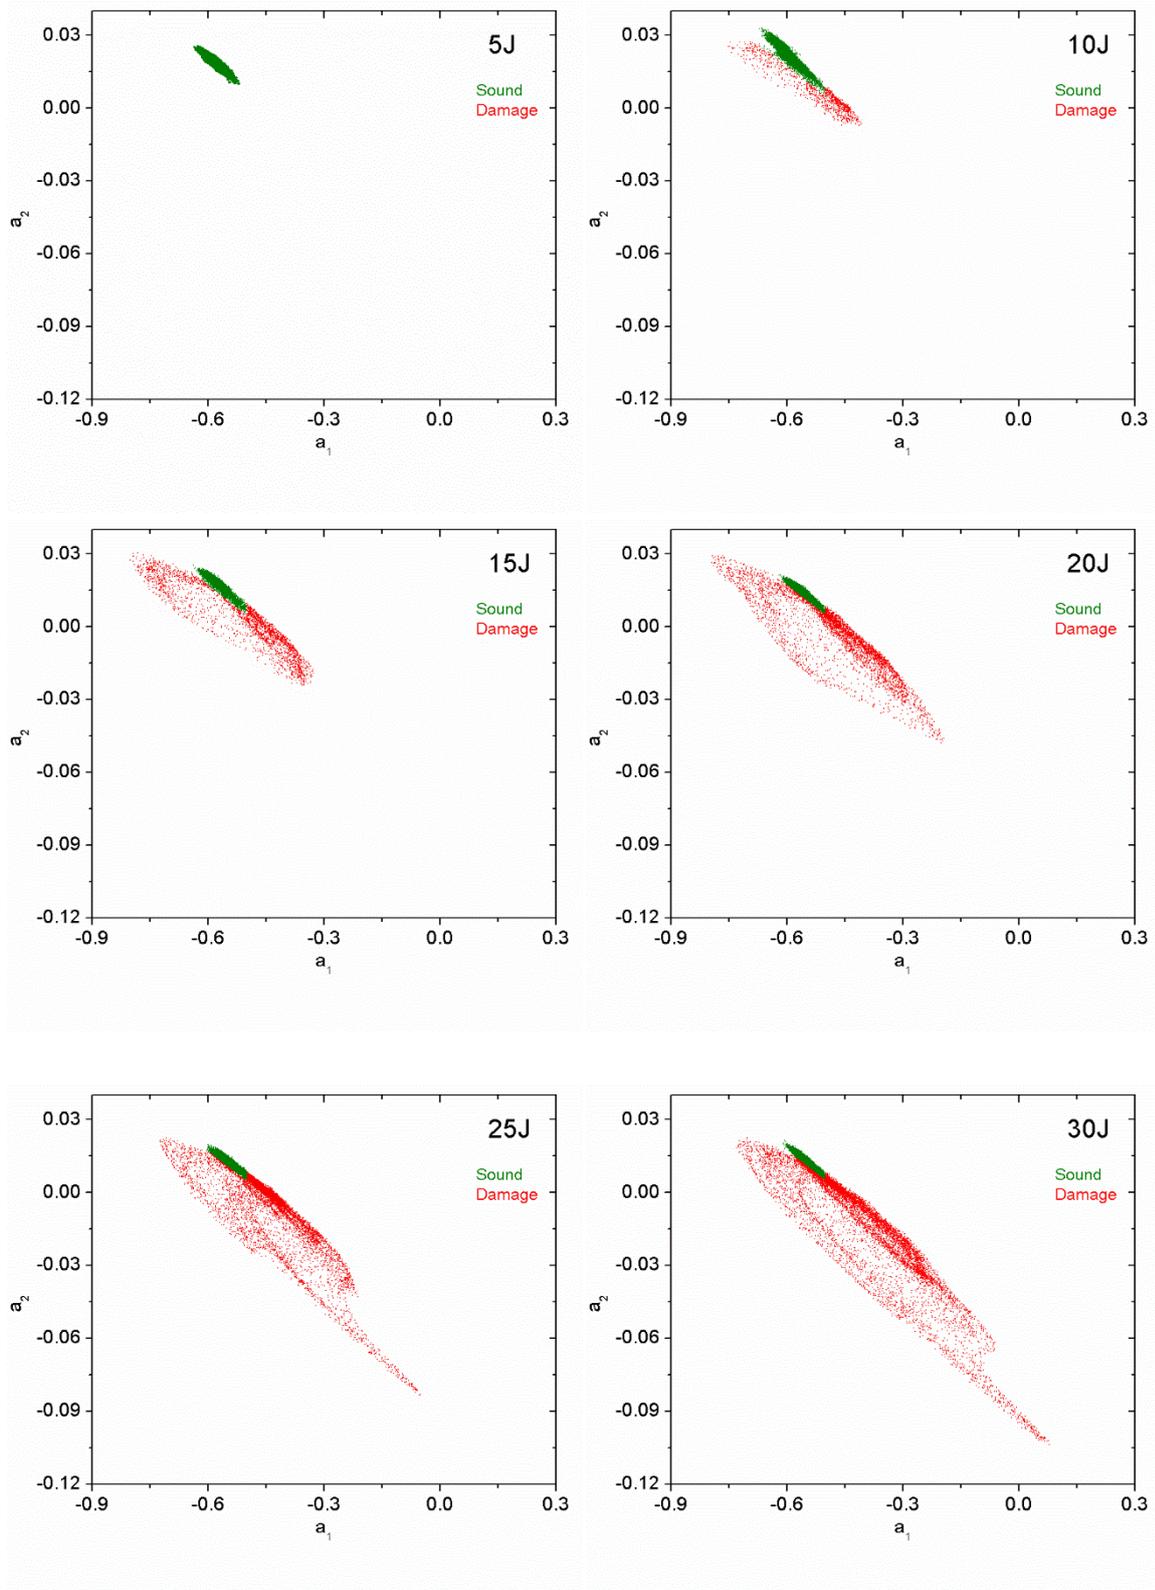
**Fig. 8:** The classification results based on the scatter of the first order coefficient and the second order coefficient for all specimens, where the green colour denotes the detected sound pixels and the red colour denotes the detected damaged pixel.

By applying the developed CCA method with the estimated parameters into the thermal decay data, the scatter plots of  $a_1$  vs  $a_2$  are shown in Fig. 8. The green scatters were classified as the pixels from sound areas, and the red scatters were classified as the pixels from damaged areas based on the process shown in Fig. 7.

There are almost no damaged pixels detected for the specimen at 5J. As expected, the number of damaged pixels detected increases following the increment of impact energy, which indicates a growing area of damage. The change in the contour of clustering indicates that a

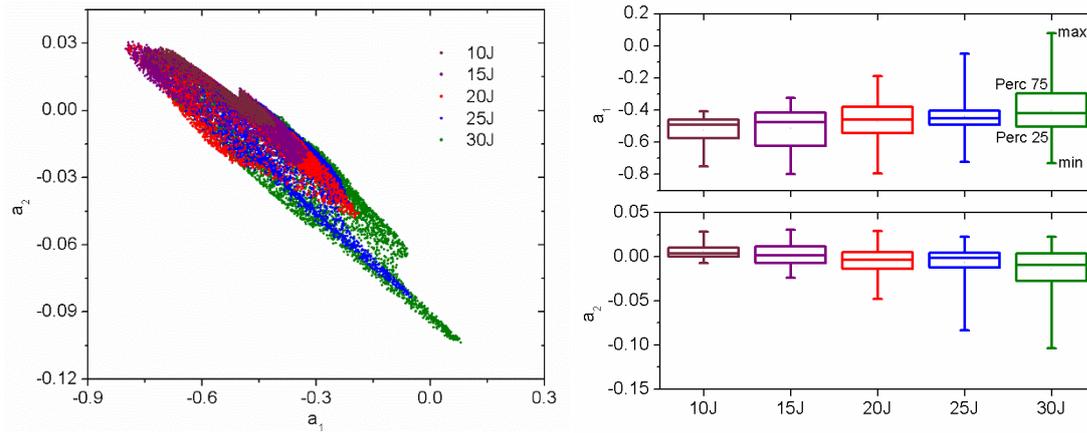
**Fig. 9:** Properties for pixels from defective areas for the specimen 10J-30J. Left: coefficient clustering overlay; top-right: box chart of the first order coefficient; bottom-right: box chart of the second order coefficient, which shows the minimum, maximum, 25% percentile and 75% percentile of all of the data.

higher energy impact causes more complex thermal behavior indicating potentially a more complex structural damage, which adds to deviation in the thermal behavior exhibited on the surface in comparison to sound areas. To explore more information, the left figure of Fig. 9 illustrates the overlap of coefficient clustering for pixels from defective areas for the specimen 10J-30J (5J is not included due to no damage detected). It has been observed that the scatters grow towards to the bottom-right corner following the increase of impact energy. This indicates that the linearity of temperature decay curve reduces because  $a_1$  is closer to zero, and more complicated thermal behaviors have been observed because  $a_2$  is further away from zero. The set of figures on the right in Fig. 9 show the box charts of both coefficients for pixels from damaged areas. It has been observed that following the increase of impact energy, the range between the maximum and the minimum for both coefficients increases which indicates that a higher energy impact potentially causes more complex structural damage. The minimums of  $a_1$  are similar for all tests, but the maximum is closer to zero; the maximums of  $a_2$  are similar for all tests, but the minimum is further away from zero. The variation of the box size for all tests is relatively small, which indicates that most damaged pixels have similar thermal behavior.

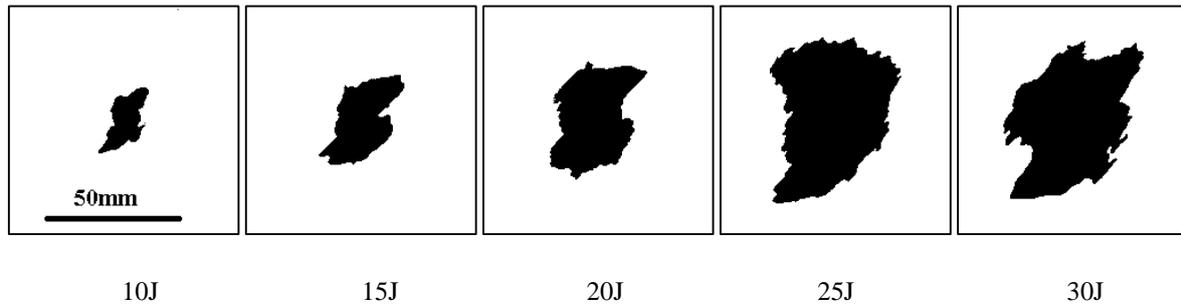
**Fig. 10:** Visualisation of the detected defect area for all specimens in the binary form.

Fig. 10 shows the visualisation of the detected damage area (black colour) in the binary form by converting the classification results into the spatial domain. To quantify the measurement, Table 3 presents the calculated properties of the detected damage area for each specimen, where the compactness measures the shape. Compactness was calculated by

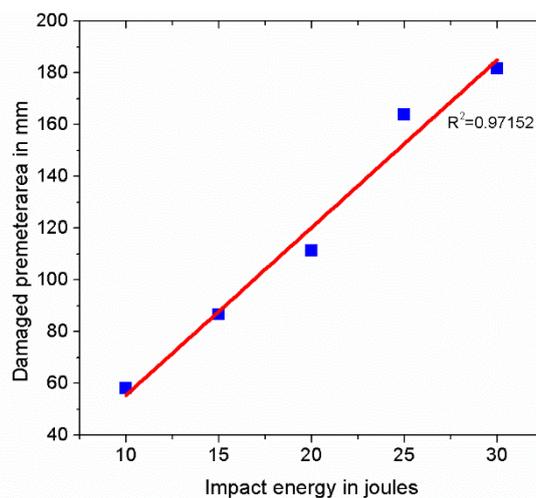
**Fig. 11:** Perimeter of the detected damaged area as a function of impact energy.

standard derivation: 0.043). The compactness of 30J is significantly smaller with the value of 0.489, which indicates a more irregular shape. A plot of perimeter as a function of impact energy, shown in Fig. 11, indicates a highly linear relationship. A line is fitted to the plot by the least square method with  $R^2$  (coefficient of determination) = 0.97. For the specimen 30J, the high impact energy causes a potentially more complex damage structure, rather than an increased damage area in comparison with that of the 15J specimen.

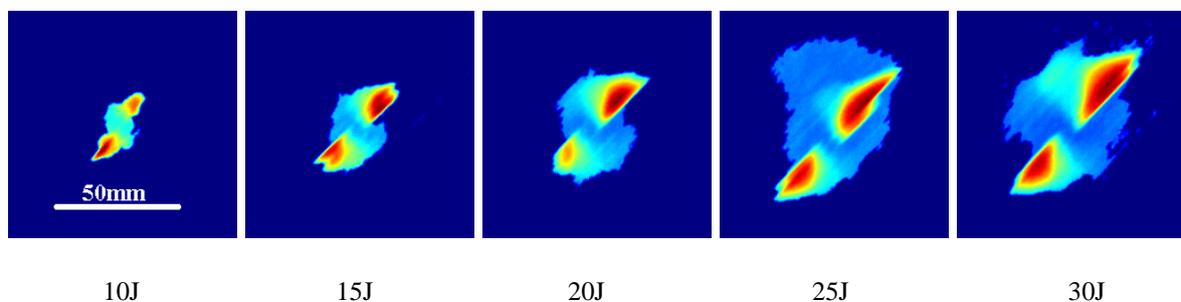
**Fig. 12:** Reconstructed data visualisation of damage across a range of samples: based on the  $d_{xy}$  values from the CCA method.

Once the raw data sequence is converted into polynomial coefficients, and has undergone the coefficient clustering step transforming them into  $d_{xy}$ , these values can then be plotted back in the spatial domain, providing a new and alternative visualisation of the detected damage areas, as can be seen in Fig. 12. It has been observed that there are consistently two areas (top right

and bottom left) that have high values of  $d_{xy}$  for all specimens with impact damage. This phenomenon may be caused by the mechanism of the weight-drop machine itself.
