EXPERIMENTAL STUDY ON BEHAVIOUR OF SHEAR CONNECTORS IN MOMENT RESISTANCE OF STEEL COMPOSITE JOINTS

Feng Fu

Abstract. This paper presents an experimental investigation on the behavior of steel stud connectors in steel composite joints with precast hollowcore slabs in resisting the static bending moment. An experimental program including 5 flexural tests was carried out, and the failure modes of the studs, as well as the shear capacity of stud connectors are investigated. Their contribution to the overall joint moment capacity were studied in depth. The pertinent design recommendation in shear stud design for enhance the moment capacity of the composite joints are also proposed. The testing results and design recommendations presented in this paper can provide basic for future design of composite joints using shear stud connectors with precast slabs

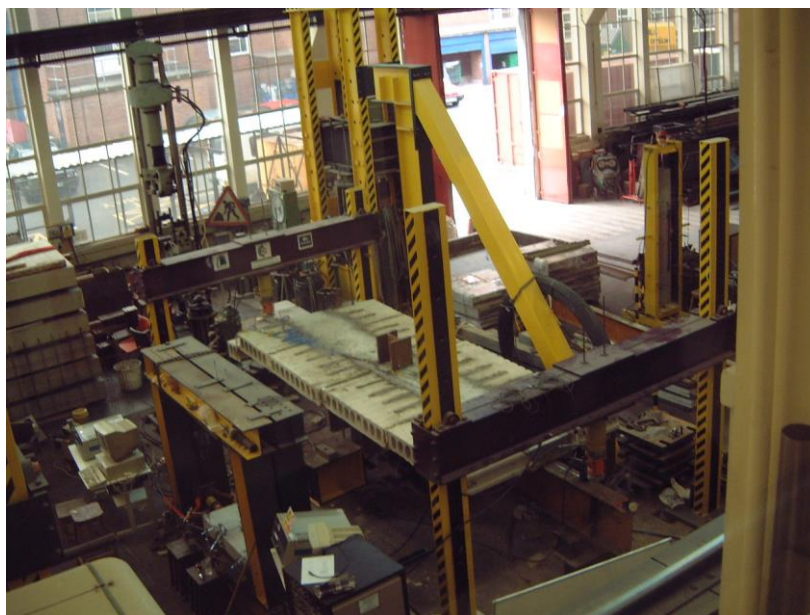
ciform arrangement as shown in Fig. 1 to simulate the internal beam–column joints in a semi-rigid composite frame. The specimen was assembled from two 3300 mm long; $457 \times 191 \times 89$ kg/m; grade S275 universal beams and one $254 \times 254 \times 167$ kg/m; grade S275 universal column to form the cruciform arrangement. The beams are connected to the column flanges using 10 mm thick flush endplates with two rows of M20 Grade 8.8 bolts. The steel connection is a typical connection currently used in UK practice for simple joints, this is to ensure that the enhanced performance of the composite joint is not provided by the bare steel connection. A single row of 19 mm diameter headed shear studs is pre-welded to the top flange of the steel beams.

Figure 1 Test arrangements

Load is applied by hydraulic jacks simultaneously to each ends of the steel beams as shown in Fig. 1 to produce the bending moment of the joints. The load was applied at 10 kN intervals and continued until failure occurred of the joints.

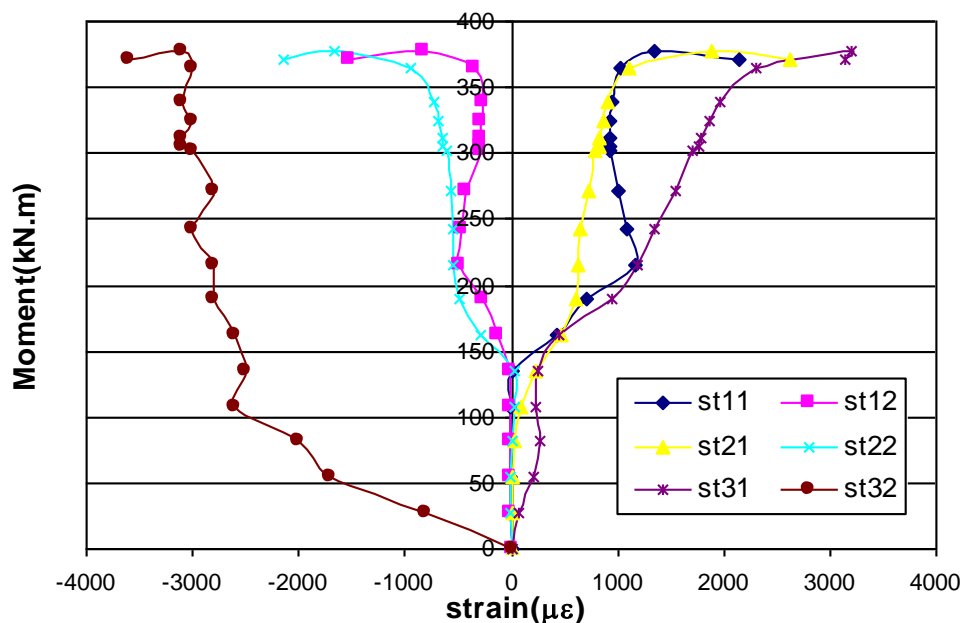
Fig. 3 gives the moment-strain curves of the shear studs in Test CJ4 at east side of the joints where ST11 and ST12 represents the reading of the two strain at front and back face of the stud along the bending axis of the joints, as it is explained in Figure 2. It is can be seen that, the strain at one face of the stud is in compression and in tension at another face, it shows that the stud shank is under the bending, this is due to curvature difference and the slip between the slab and the steel beam, so the studs are also in bending apart from longitudinal shear force.

Fig 3 Moment vs. stud strain curves of Test CJ4 at east side of the joints

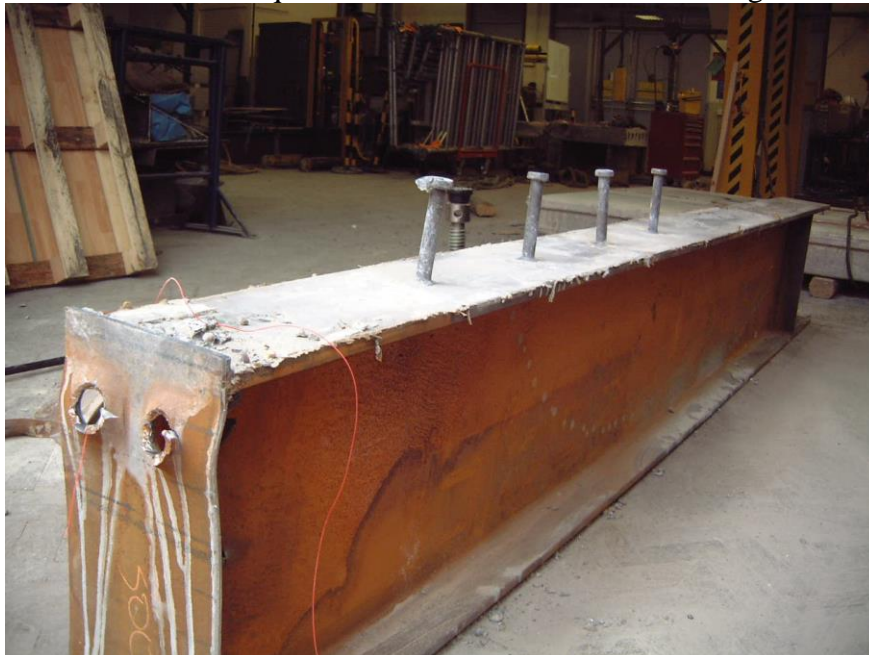
Test CJ6 is full shear interaction case. Figure 5 shows the status of the shear studs after dismantling. It can be seen that, all the studs are remaining intact, but deformation can be observed for all the studs. More severe deformation can be observed in the first stud, and its stud head was squashed. No obvious squash were observed for the remaining 3 studs.

Fig 5 Steel beam after dismantling for CJ6

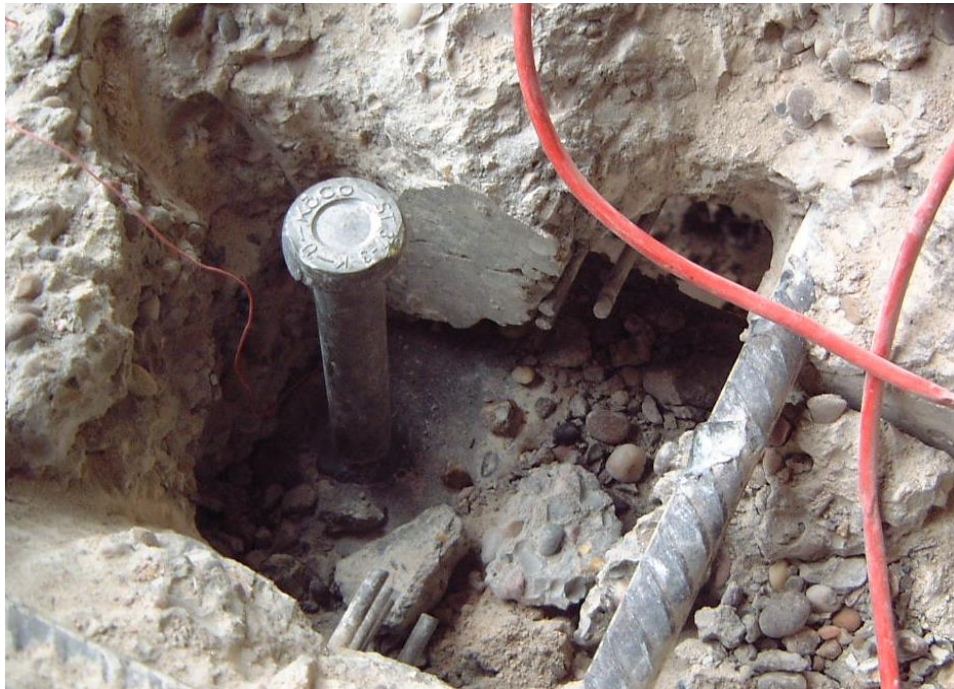
Test CJ7 is also full shear interaction case. Figure 6 shows the status of the shear studs after dismantling. It can be seen that, the studs are remaining intact.

Fig 6 Condition of headed stud after dismantling CJ7
