Citation: Zhou, H., Zhang, Y., Fu, F. & Wu, J. (2020). Collapse Mechanism of Single-Layer Cylindrical Latticed Shell under Severe Earthquake. *Materials*, 13(11), 2519. doi: 10.3390/ma13112519

Collapse Mechanism of Single-Layer Cylindrical Latticed Shell under Severe Earthquake

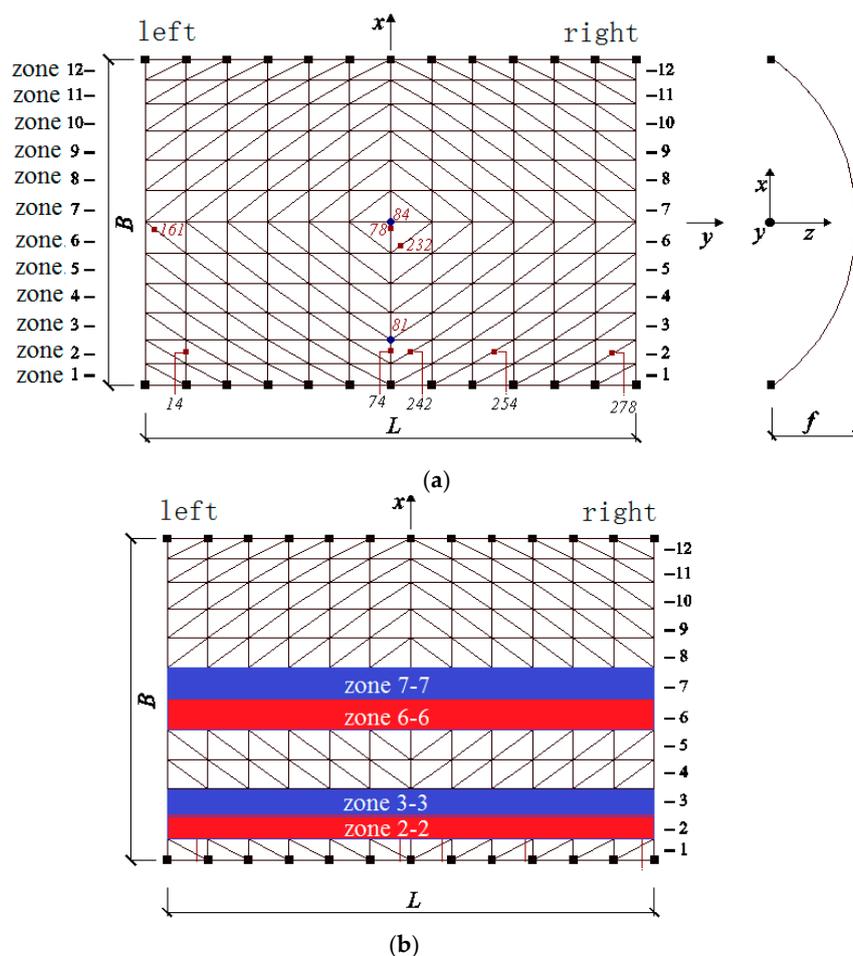
Figure 1. Single-layer cylindrical latticed shell with structural zone denoted: (a) Structural zone in the model; (b) Structural zone in the dome.

The collapse analysis is performed by the general-purpose program ABAQUS 6.12 by Dassault SIMULIA, through the further development of the subroutine VUMAT program in Abaqus. The numerical method introduced in Zhou et al. [36] is used in this research. All the structural members of the reticulated shell are simulated using the beam elements. Each beam element is further discretized into eight longitudinal fibers across their cross-section, with an appropriate constitutive model defined for each fiber, as shown in Figure 1.

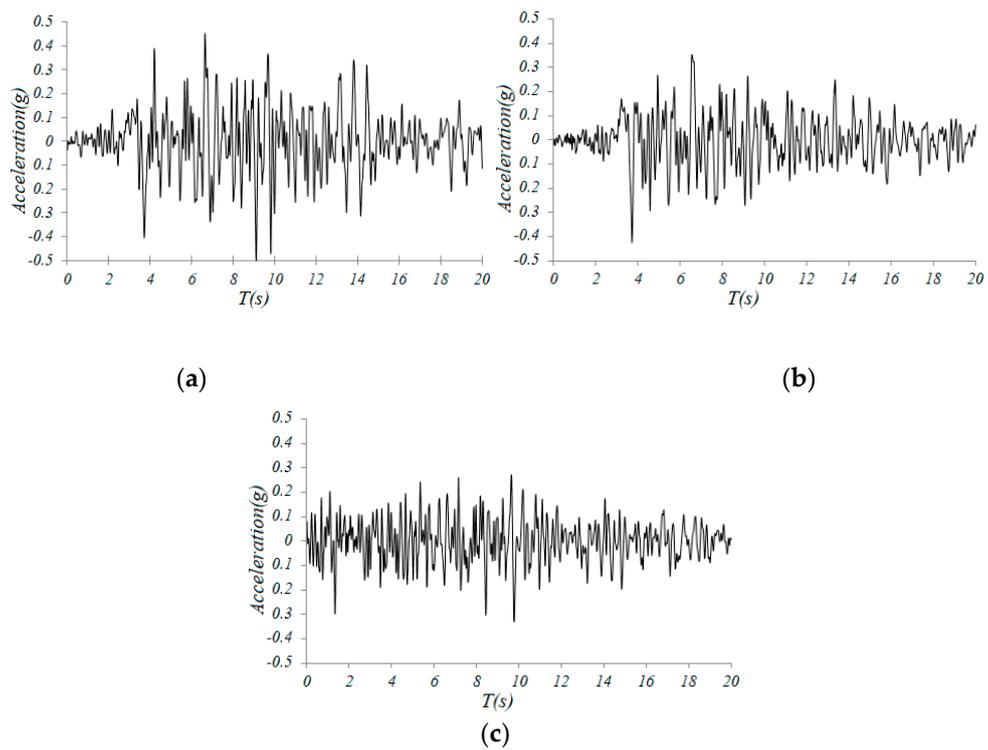
Figure 3. Amplified Taft earthquake wave: (a) X direction, (b) Y direction, (c) Z direction.

The analysis was divided into two steps. The first step was static analysis, where the gravity load was applied to the dome. The second step was dynamic analysis, where the time history of the Taft earthquake (Figure 3) was applied at the support, in X, Y, and Z directions, with the peak ground acceleration (PGA) of 0.5 g in the X direction, $0.85 \times 0.5 \text{ g}$ in the Y direction, and $0.65 \times 0.5 \text{ g}$ in the Z direction, respectively. According to the Chinese earthquake design code [37], the scale factors of 3.211304, 2.370329 and 3.161574 were applied to the original time history in three directions, respectively. The time duration was 20 s, which is greater than 10 times the natural period of the dome. The time step was 0.02 s. The constitutive model of the material uses the hybrid hardening model and the modulus considered the cumulative effect of damage to simulate the performance deterioration of the material, which occurred during plastic tension in the hysteresis process under seismic loading.

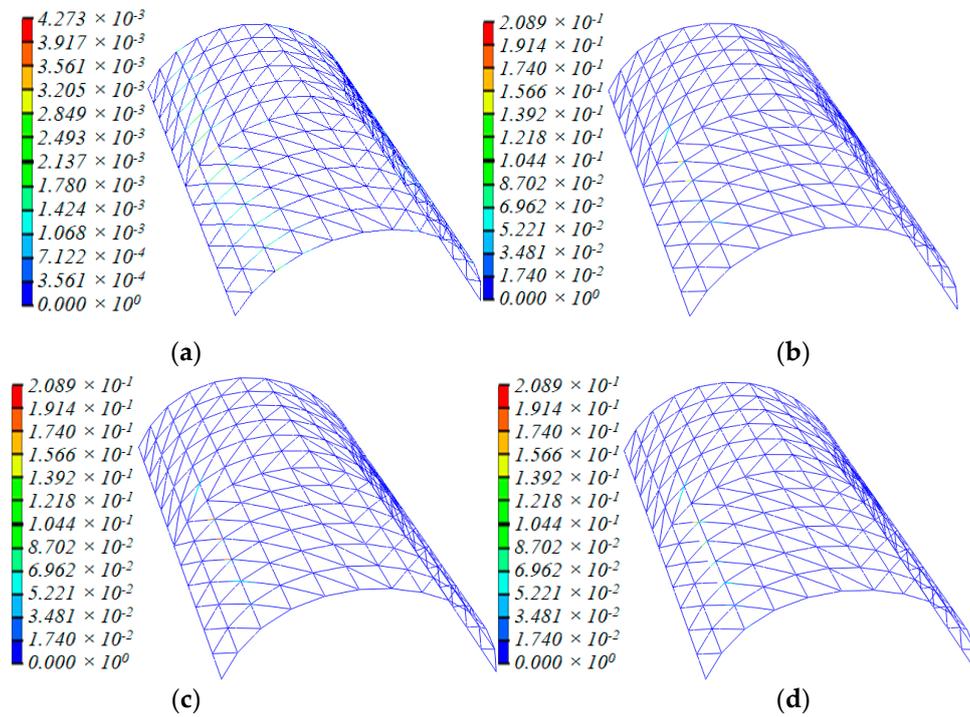
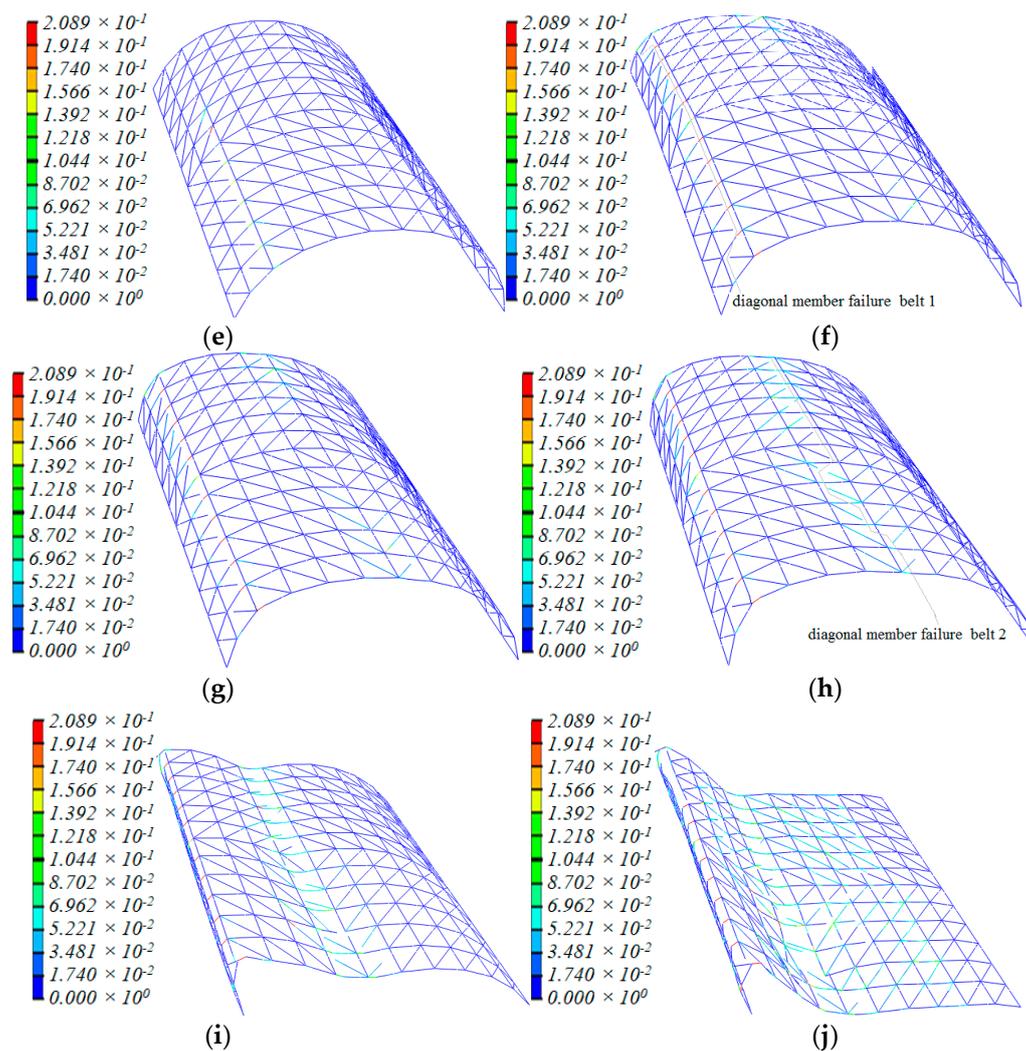
Figure 4. Deformation and D value distribution of structural members during the collapse process: (a) $t = 4.56$ s, (b) $t = 6.16$ s, (c) $t = 11.78$ s, (d) $t = 11.80$ s, (e) $t = 12.03$ s, (f) $t = 14.38$ s, (g) $t = 15.40$ s, (h) $t = 15.83$ s, (i) $t = 16.38$ s, (j) $t = 16.78$ s.

Figure 4 depicts the deformation and damage distribution during the collapse process, where the distribution of the D value can be checked. It demonstrates the process where the D value was zero, which indicates that no damage occurred until the rupture of the member when $D > D_{\text{limt}}$.

According to the analysis results, the dome entered the plastic stage at 1.88 s for the first time. Damage distribution spread to zones 2-2 and 3-3 and the symmetric zone of 6-6/7-7, but the D value was extremely small in this stage. With the ground motion continued, at 6.16 s, the D value of many diagonal and lateral members in zones 2-2 and 3-3, at adjacent ends, had obviously exceeded that of members in other zones (Figure 4b). By 11.78 s, the damage state of the whole dome had furtherly deteriorated. The D value of damaged structural members kept rising and more diagonal and lateral members were damaged. At 11.80 s, three diagonal bars in zone 2-2 failed at the ends of the joints with a threshold value of 0.209.

At 12.03 s, all the diagonal members in zone 2-2 failed, while the damage range spread to the left of the zone, with the damage area increased dramatically, although no member failure was observed. At 14.38 s, all the diagonal members in zone 2-2 failed because of continuous damage accumulation, and the failed zone was like a continuous and regular “diagonal member failure belt”. Lateral bars were left unbroken and the damage area continue to propagate. The deflection of the dome had been significant. Furthermore, some lateral members and diagonal members in zone 6-6/7-7 were damaged.

Afterwards, the damage area was found between zones 6-6 and 7-7. At 15.40 s, most diagonal members in the zone were damaged and a few at two longitudinal ends failed. By 15.83 s, most diagonal members in zone 6-6 and two diagonal members at the right of zone 7-7 had failed. The position of structural members failed in a similar manner to the “diagonal member failure belt” with its width becoming slightly wider than when it first came into being (Figure 4h). No lateral members failed, though they were obviously damaged. Furthermore, the overall downward deflection of the dome became significant during this process. With the continuous action of the earthquake, the dome began to collapse downward rapidly. Horizontally, the dome collapsed towards the position of the first “diagonal member failure belt”, the whole dome now looked like an italic letter “M”. Finally, 1.13 s later, with the formation of the second “diagonal member failure belt”, the dome collapsed totally. The D value of longitudinal bars of the dome had not increased much throughout.

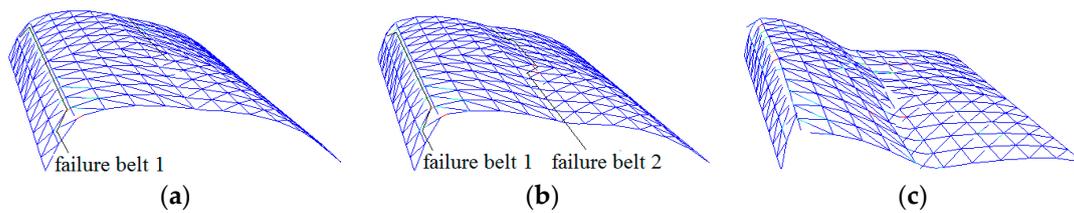
Figure 5. Collapse process of cylindrical reticulated domes of different span/depth ratios at typical times (span/depth = 4:1): (a) belt 1 formed, (b) belt 2 formed, (c) dome collapses.

Figures 5 and 6 depict the deformation and distribution of the damage of the structural member during the collapse process for the other two domes, with span:depth ratios of 4:1 and 2:1, respectively. Their spans are kept at 20 m. Figures 7 and 8, respectively, depict the other two 20-m-span domes, one with a length:width ratio of 1:1, another with a ratio of 2:1. With the increase in the length:width ratio, the position of the “diagonal member failure belt” moved from zones 2-2/6-6 to 3-3/7-7. The decrease in the length:width ratio caused a contrasting trend. With the exception of the above, the basic process of collapse and final collapse forms are similar.

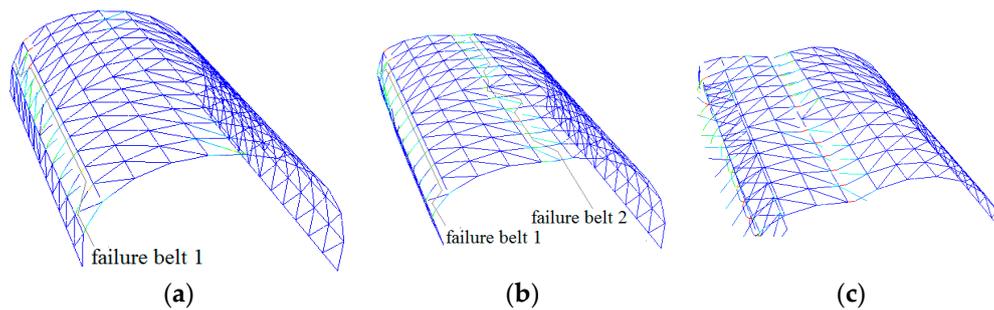
Figure 6. Collapse process of cylindrical reticulated domes of different span/depth ratios at typical times (span/depth = 2:1): (a) belt 1 formed, (b) belt 2 formed, (c) dome collapses.

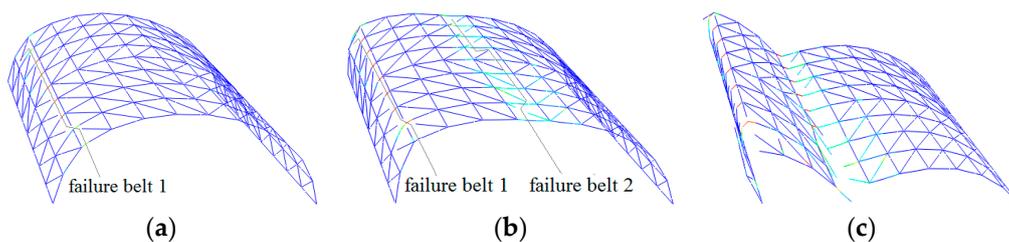
Figure 7. Collapse process of cylindrical reticulated domes of different length/width ratios at typical times (length/width = 1:1): (a) belt 1 formed, (b) belt 2 formed, (c) dome collapses.

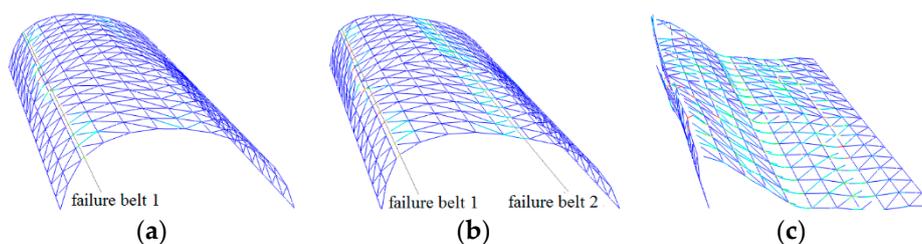
Figure 8. Collapse process of cylindrical reticulated domes of different length/width ratios at typical times (length/width = 2:1): (a) belt 1 formed, (b) belt 2 formed, (c) dome collapses.

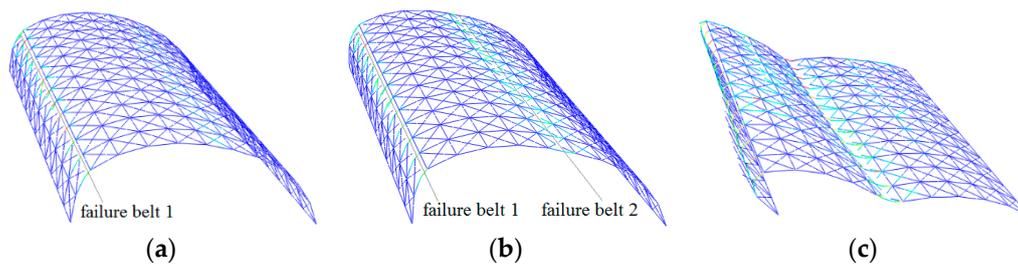
Figure 9. Double diagonal member failure belt: (a) belt 1 formed, (b) belt 2 formed, (c) dome collapses.

Figure 9 depicts the failure mode of double-diagonal member cylindrical reticulated domes, which are similar to single-diagonal member cylindrical reticulated domes.

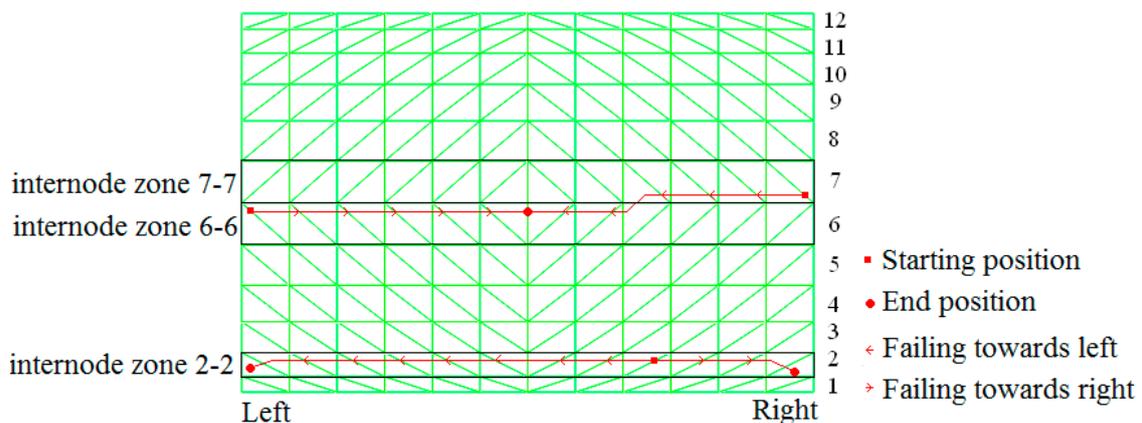
Figure 10. The demonstration of the collapse mechanism of the shell.

Therefore, a consistent failure pattern for the collapse process of single-layer cylindrical reticulated domes can be concluded. Under severe earthquakes, serious damaged first occurs at 1/4 height of the dome. Diagonal members failed continuously from the center to the boundary lengthwise and the first “diagonal member failure belt” came into being (Figure 10). The stiffness of the dome also greatly weakened. Then, another damaged zone appeared at the middle of the dome and, in this zone, diagonal members failed continuously lengthwise from the ends to the center. A second “diagonal member failure belt” was formed. The stiffness of the dome was reduced further. The whole deflection became significant. The position of the “belt” varied slightly with the change in geometry. In the final stage, the dome deflected rapidly at the second “belt”, dropping towards the first “belt”. The dome collapsed. We call this collapse process and phenomenon the “double-diagonal -members-failure-belt” pattern.

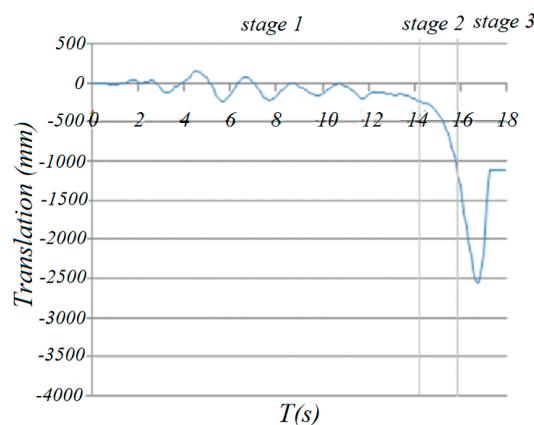
Figure 11. The horizontal translation of gravity center in X direction.

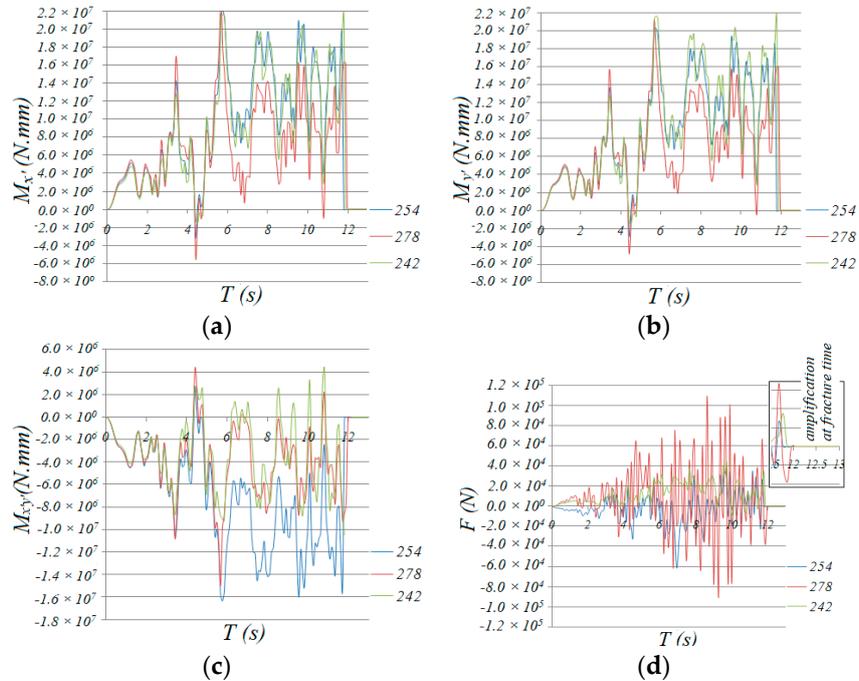
Figure 12. Time history of the internal force of the diagonal members: (a) $M_{x'}$, (b) $M_{y'}$, (c) $M_{x'y'}$, (d) F .

As shown in Figure 12, through a comparison of the time history curves of bending moments $M_{x'}$ and $M_{y'}$, torsion $M_{x'y'}$ and axial force F of members 242/254/278 in zone 2-2, it can be found that, although the axial force F of 254 was less than that of 242, the bending moments $M_{x'}$ and $M_{y'}$ and torsion $M_{x'y'}$ of 254 are obviously larger than those of 242. The axial force and bending moments of 278 are approximate to those of 254, but the torsion of 278 is less than that of 242. So, the D values of the slant bar of 254 and neighboring bars in zone 2-2 are obviously larger than those of other bars (Figure 4b,c).

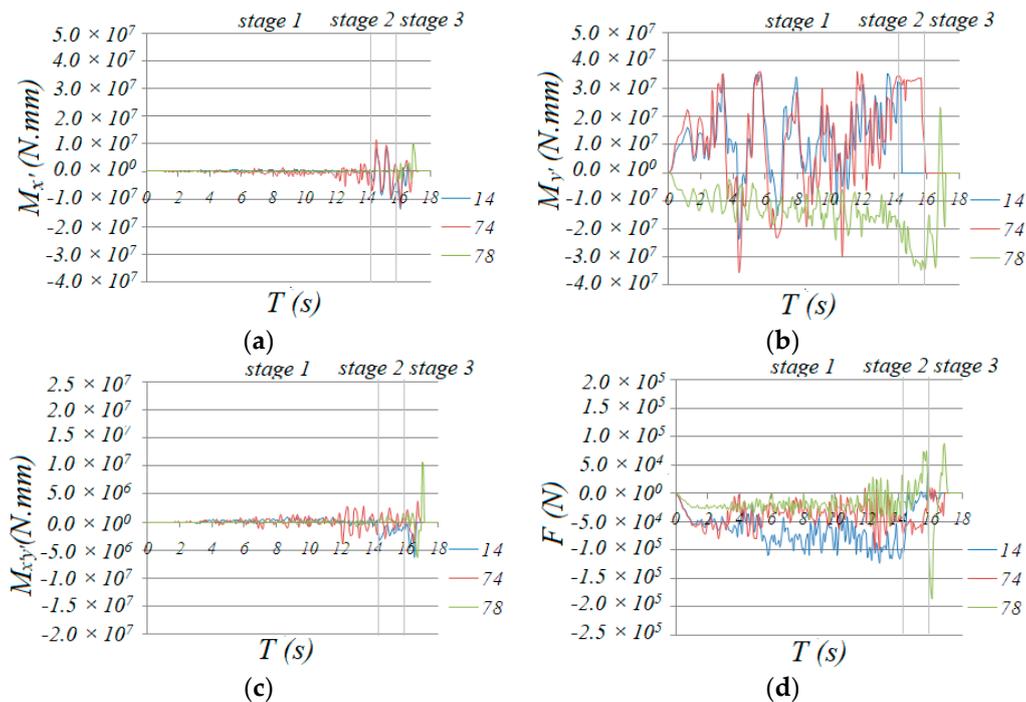
Figure 13. Time history of internal forces of traverse bar 14, 78 and 74: (a) $M_{x'}$, (b) $M_{y'}$, (c) $M_{x'y'}$, (d) F .

According to Figure 13, which shows the variety of internal forces of traverse bars 14, 78 and 74 at the center of zone 2-2, the traverse bars are mainly subjected to bending moment $M_{y'}$, while axial force F , bending moment $M_{x'}$ and torsion $M_{x'y'}$ at this stage are minimal, so $M_{y'}$ contributed mainly to the damage increment. This is why, in Figure 14, the normal stresses of upper section fiber 3 and lower section fiber 7 were much larger than those of middle section fibers 1 and 5, which hardly exceeded the yield point and caused corresponding material damage. Thus, damage development concentrated in fiber 3 and 7 and traverse bars hardly failed. This is the common response observed in all the traverse bars of the monoclinic and double-skew cylindrical reticulated domes under the same ground motion.

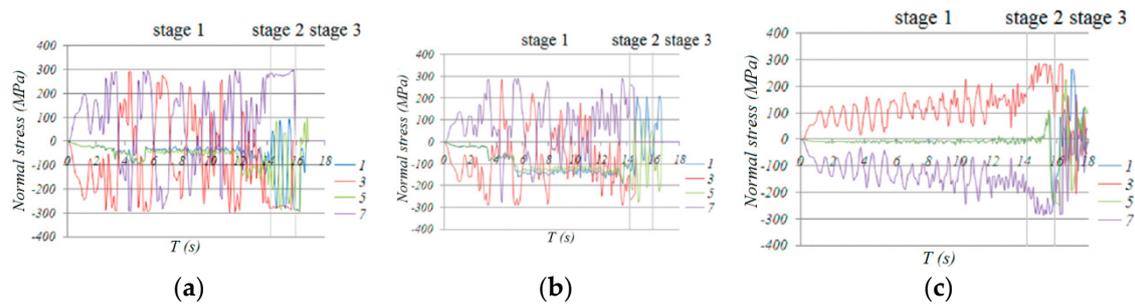
Figure 14. Time history of normal stress in fiber 1,3,5,7 of traverse bar 14, 78 and 74: (a) bar 74, (b) bar 14, (c) bar 78.

In Figure 14a, we can see that the normal stress at upper fiber 3 and lower fiber 7 at the end section of traverse bar 74 was maintained at a value of 280 MPa, which was much greater than the initial yield stress of 235 MPa, while the normal stress of fibers 5 and 1 also increased dramatically, acting as a plastic hinge. Fiber 3 and 7 of traverse bar 14 failed at a short time after entering this stage, but the stress of fibers 1 and 5, whose stress was relatively small, increased rapidly to around 200 MPa. We can conclude that the normal stresses of the remaining fibers of bar 14 were larger than the yield point. This means that the end of bar 14 acted as a plastic hinge as well. Finally, we can conclude that all the traverse bars in zone 2-2 that had not yet failed acted as plastic hinges. The formation of plastic hinges induced significant internal force redistribution effect. As shown in Figure 17, the bending moment M_y' , axial force F , bending moment M_x' and torsion $M_{x'y}'$ of diagonal bars 161 and 232 (Figure 1), one at the end and the other at the mid of zone 6-6, were less than those of bars 242, 254 or 278 (Figure 12) in stage 1. Thus, almost no damage was done to these bars. However, the value of M_y' , M_x' , torsion $M_{x'y}'$, began rapid increasing since the formation of the first “belt”.

The successive failure of diagonal members and damage to traverse bars in zone 6-6 greatly weakened the vertical stiffness of the dome. Thus, under the earthquake loading, the dome deflected downwards significantly. At the same time, angular displacement was observed in the traverse bars in zone 2-2, which made damage in fibers 3 and 7 develop rapidly (Figure 14).

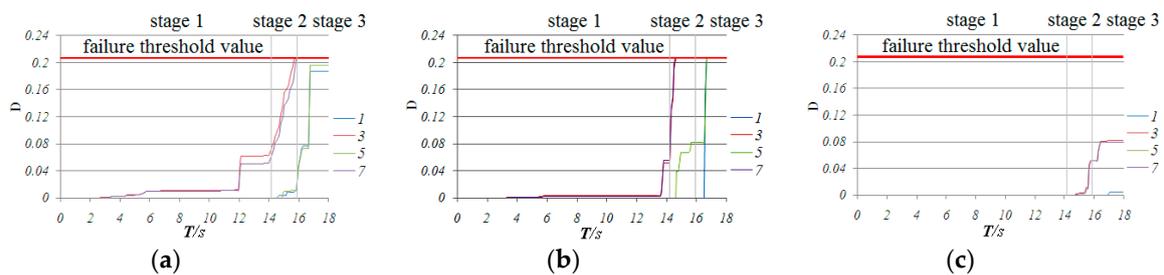
Figure 15. Time history of D value in fiber 1,3,5,7 of bar 14, 78 and 74: (a) bar 74, (b) bar 14, (c) bar 78.

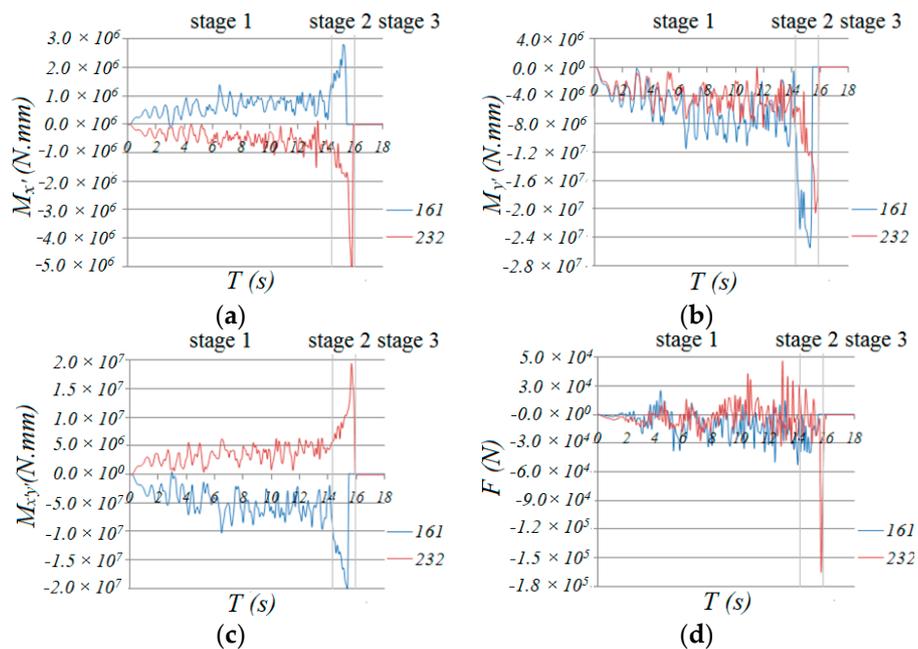
Figure 17. Time history of internal forces of diagonal bar 161 and 232: (a) $M_{x'}$, (b) $M_{y'}$, (c) $M_{x'y'}$, (d) F .

Therefore, continuously increasing the internal force induced by ground motion resulted in severe damage to the diagonal bars 0.8 s later when entering the second stage, because the internal forces of the bars at two ends were larger than that of the bars in the middle; the bars at the ends of the nodes of zone 6-6 failed first (Figure 4g). Then, the other bars failed successively from both ends to the middle in a short time. Finally, at 15.83 s, the second belt was formed.

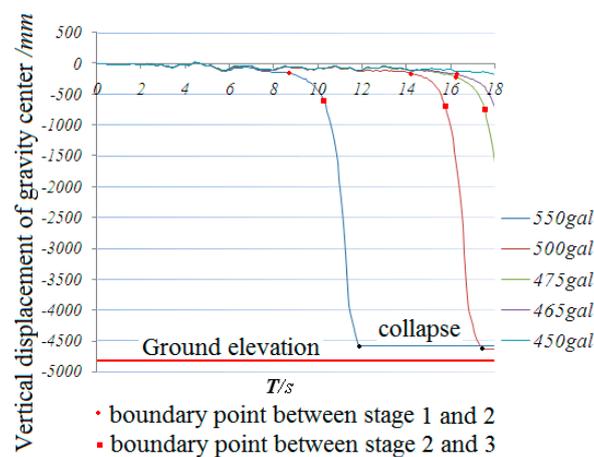
Figure 20. Time history of vertical translation of gravity center.

The deformation of the dome changed throughout the whole collapse process; therefore, the center of the structure changed as well. Figure 20 shows the change in the locations of the center of gravity of the structure during the whole collapse process. Different peak ground acceleration values were selected with the same duration of 18 s. It can be seen that the center of gravity decreased with the different PGA values.

When PGA was 0.45 g, the damage was observed at 1.9 s and the rupture of the first diagonal bar occurred at 16.44 s. However, the failure belt was not formed until 18 s. At 1.9 s, the location of the center of the gravity fluctuated and no significant acceleration in the center of gravity was observed.

When PGA was 0.465 g, the first diagonal member failure belt formed at 16.55 s. The second belt started to form at 17.63 s. However, the failure belt was not formed until 18 s. It can also be observed that the slope of the curve in Figure 17 increased dramatically.

When PGA was 0.475 g, the rupture of the first diagonal member failure belt formed at 16.38 s. The second belt started to form at 17.48 s. However, it can also be observed that the slope of the curve increased at stage 2 compared to stage 3. When PGA was 0.5 g, the rupture of the first diagonal member failure belt occurred at 14.38 s. The second belt started to form at 15.83 s.

It can also be seen that when PGA was 0.475 g, the acceleration distance of the center reached 1286mm; however, for a larger PGA of 0.5 g, when the time was shorter than 16 s, the acceleration distance of the center was smaller than 1286 mm, which indicates the effect of the duration on the time history.

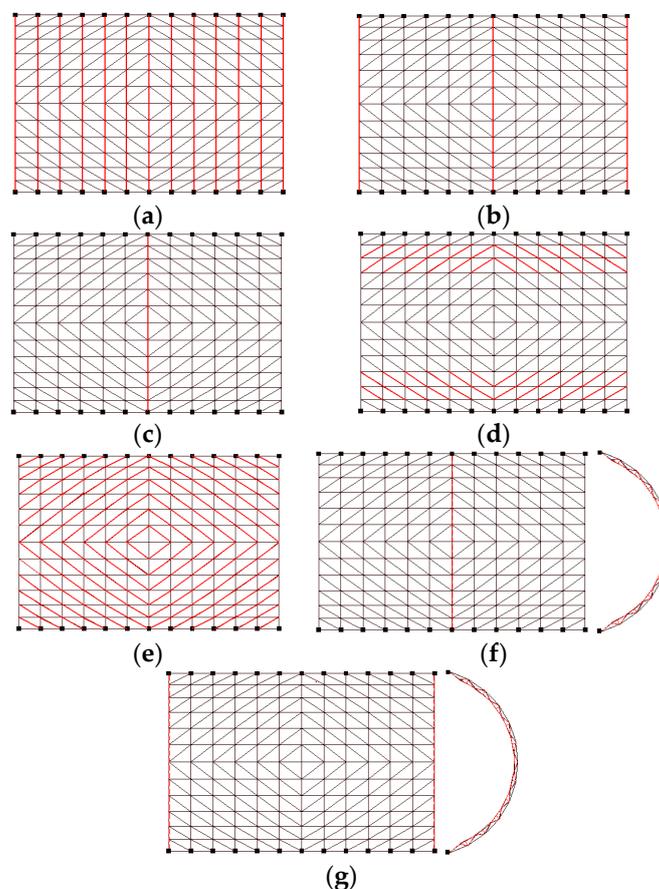
Figure 21. Seven different schemes to enhance the dome: (a) scheme 1, (b)scheme 2, (c) scheme 4, (d) scheme 4, (e) scheme 5, (f) scheme 6, (g) scheme 7.

Note: Red solid line represents the enhanced bars; the red dotted line indicates the plane arch truss. The height of the truss section is 450mm, and the diameter of the truss web members is $\Phi 30 \times 3.5$

Based on the numerical simulation results, seven mitigation schemes were developed to prevent the collapse of the dome: in Figure 21a, the cross section of all top chords in the transverse direction increased. In Figure 21b, the cross section of three top chords in the transverse direction increased. In Figure 21c, the cross section of the top chords at center was increased. In Figure 21d, the cross section of the diagonal members as shown in the Figure increased. In Figure 21e, the cross section of all the diagonal members increased. In Figure 21f, extra diagonal and bottom chords were added to the arch at the center of the shell. In Figure 21g, extra diagonal and bottom chords were added to the two arches at the end of the shell. All the increased section sizes used the ones specified in GBT17395-1998 [38], with a wall thickness of 6 mm.

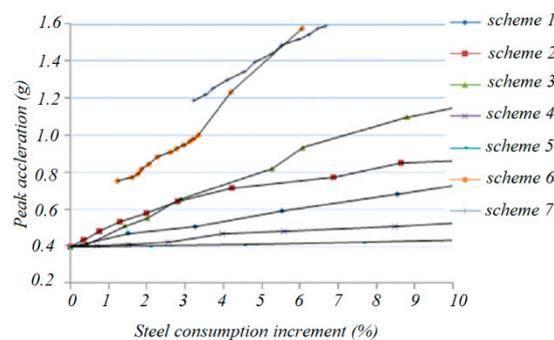
Figure 22. Relation between collapse peak acceleration vs. steel consumption increment.

A time history analysis was performed for all seven enhanced schemes. The results are shown in Figures 22 and 23. Figure 22 shows the relationship between the various earthquake inputs with the increase in the use of the steel material.

It can be seen that, with the increase in the steel consumption, the collapse peak acceleration, which can be taken as the seismic capacity index of schemes 6 and 7, increases most rapidly. On the other hand, for schemes 2 and 3, the capacity index increases less than in schemes 6 and 7, while in schemes 4 and 5, the capacity index increases the least.

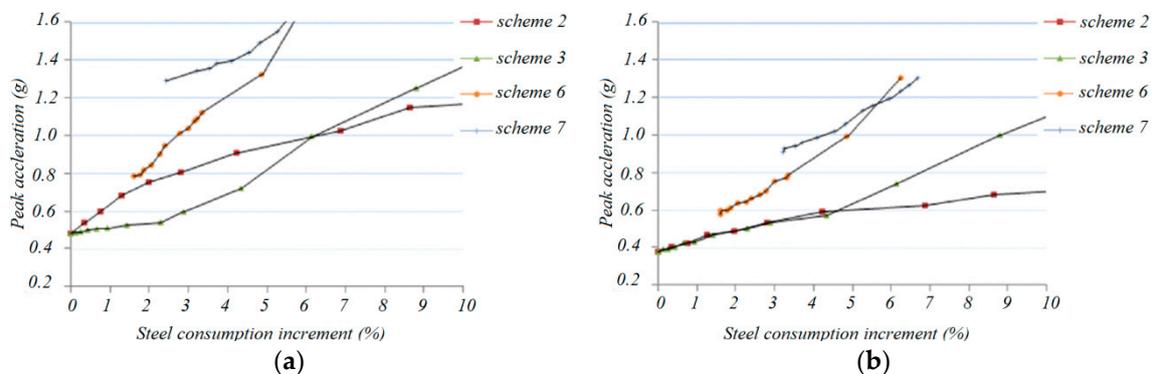
Figure 23. Curve of acceleration vs. steel consumption increment under various live loads: (a) proof live load 1.3 KN/m^2 , (b) proof live load 1.7 KN/m^2 .

Figure 23 shows the relationship between the various live loads (1.3 KN/m^2 and 1.7 KN/m^2) on the roof with the use of the steel material after the analysis. It can be seen that scheme 7 shows a reasonably high earthquake resistance with a small increase in steel usage.
