Citation: Cai, B., Wu, A. & Fu, F. (2020). Bond behavior of PP fiber-reinforced cinder concrete after fire exposure. *Computers and Concrete, An International Journal*, 26(2), pp. 115-125. doi: 10.12989/cac.2020.26.2.115

Bond behavior of PP fiber-reinforced cinder concrete after fire exposure

Bin Cai ^{ab}, Ansheng Wu^a, Feng Fu ^b

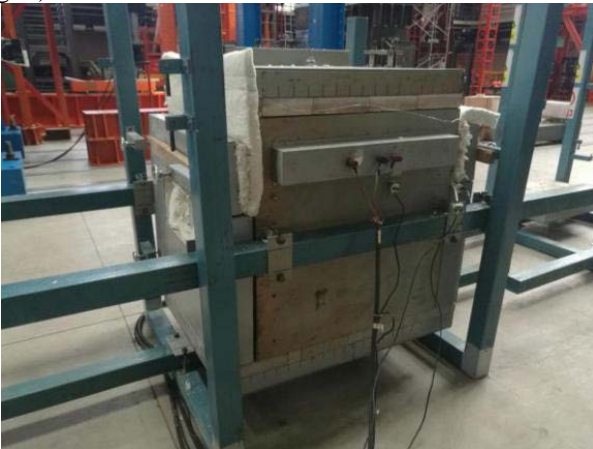
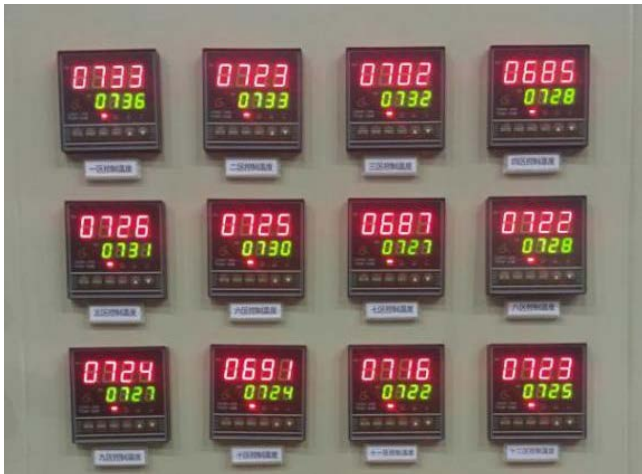
Fig. 3 Electric oven for heating

divided into 5 groups (each 10 specimens) according to heating temperature, including room temperature (RT), 200, 400, 600 and $800 \text{ }^\circ\text{C}$. Firstly, the specimens were dried in oven at $100 \text{ }^\circ\text{C}$ for 24 h, and then heated in a computer-controlled electric oven at the rate of $10 \text{ }^\circ\text{C}/\text{min}$ until reaching the target temperature (Fig. 3).

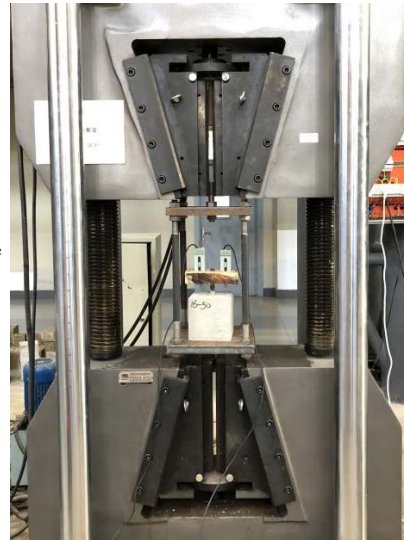
Fig. 7 Pull-out experimental installation

The similar instrumentation of the tests (Fu,2010, Gao,2017, Qian 2020 and Wen 2020,Deng,2020,Guo,2019) was adopted. The pull-out tester was illustrated in Fig. 7. Each specimen was restrained by a steel frame, which consisted of two 30-mm-thick rebar plates and five 25-mm-diameter rebar bars. The frame was clamped by an MTS (Maximum test force: 2000KN, indication accuracy: <1%, motor power: 0.75kW, operating voltage: 380V/220V) loading frame. The rebars of a specimen passed through the reserved hole on the lower plate and was clamped by the lower clamping device. Lubricating oil was

painted in between each specimen and the bottom plate, so as to reduce the specimen-rebar friction during the pull-out tests. Two displacement meters were installed on the top of each specimen to measure the relative slip of the rebar to the specimen, and the pull force was recorded by the force meter of the loading frame. The bond strength of PP fiber-reinforced cinder concrete was calculated as follows:
