CONTROLLING FLASHOVER BETWEEN ELECTRODE SEGMENTS IN DC POWER CAPACITORS

M.A. Grafton, J.C. Fothergill, L.A. Dissado and J.R.R. Shirley-Elgood

Electrical and Electronic Power Engineering Research Group,
Department of Engineering, University of Leicester

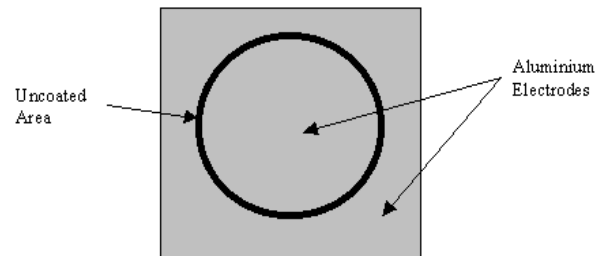
All the results in this paper were derived from specimens comprising a thin film of capacitor grade PP 9 μ m thick with a evaporated coating of aluminium on one side. This was 200 \pm 1 nm thick according to the evaporator’s quartz crystal thickness monitor (Edwards FTM 7). However SEM and AFM measurements of cross sections of the specimens set in epoxy showed the coating was very uneven and varied in thickness from 0.5 to 2.0 μ m. Flashover took place across an annulus formed in the evaporated aluminium using a circular metal mask. This left a central circular electrode of diameter 47 mm surrounded by a gap, which could be varied from 100 to 1500 μ m. This is shown in Figure 1.

Fig 1. Specimen for measuring flashover

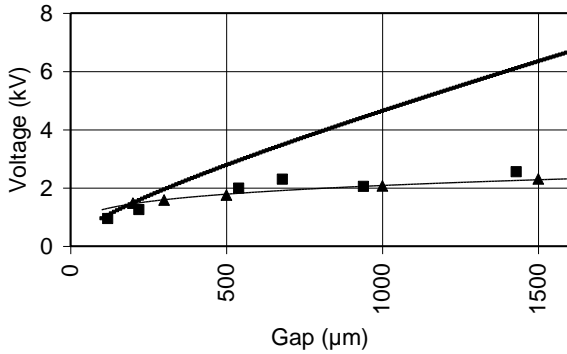
Variation of flashover voltage with annulus gap Fig. 2 shows the flashover voltage for different annuli using a single coated PP layer with the annulus exposed to air as indicated by the square plots. Also shown is the flashover voltage calculated from the Paschen curve, Dissado and Fothergill [2], calculated for a uniform field in the gap as indicated by the top curve.

Figure 2: Flashover voltage as a function of annulus width shown with corresponding Paschen curve

For small gaps the flashover voltage appears to be limited by the breakdown strength of the air. At larger gaps (>~300 μm) the flashover voltage is limited by other factor(s) for example, the field intensification at the electrode edge. This intensification was calculated using finite elements and the “Paschen values” were scaled down accordingly; these are shown as triangular points with an associated trendline. This suggests that for larger gaps the flashover is likely to be controlled by the stress enhancement.

The voltage can deviate from these trendlines by as much as 500V. The flashover voltage tends to increase for the larger gaps since topographic imperfections and asperities cause reduced flashover voltages. These flashover first. These increasing trends tend to be more prominent at larger gaps. From figure 2 this is likely because the narrower gaps’ flashover voltages are determined by the air (or material in the annulus) whereas the specimen geometry is more influential at larger gaps. At present there is some inconsistency in the results, possibly due to variation in humidity or PP surface preparation, which is reflected in the two different sets of results for the 680 μm gap.

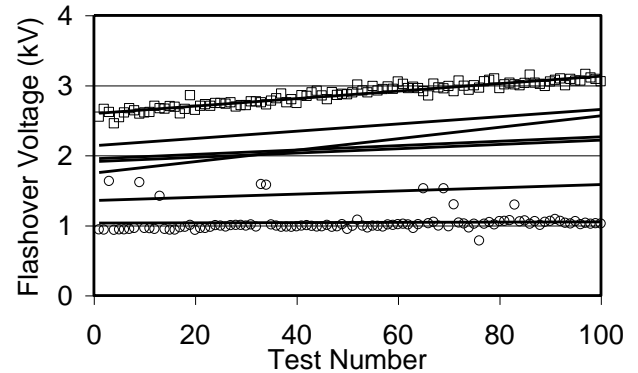
Statistical distribution of flashover voltages The flashover test was repeated 100 times for each sample. This is possible as the aluminum electrode evaporates at the flashover site thereby widening the gap and extinguishing the discharge. Subsequent discharges take place at either other parts of the annulus or adjacent to the previous flashover where the remaining aluminum leaves a distorted shape that gives a local field enhancement. Figure 3 shows results for 6 annuli gaps (with 680 μm repeated). The data is shown for the smallest and largest gaps but only best fitting straight lines are shown for the other cases (for the sake of clarity).

Figure 3: Increase in flashover voltage with successive flashovers. The gap sizes in increasing order of flashover voltage for test 1 were: 120, 220, 540, 680, 940, 680 (repeated) and 1430 μm

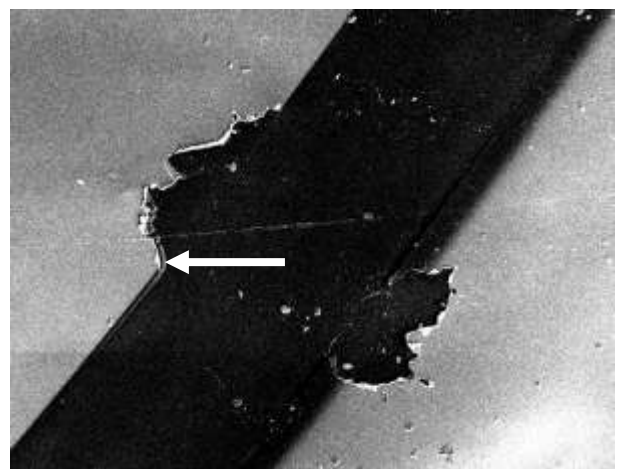
Physical Characterisation Following a flashover the electrode is found to be eroded in a characteristic “butterfly” shape, figure 4.

Fig. 4: Erosion of electrodes due to a flashover across a 830 μm width annulus.

This effect has been observed on a repeatable basis and is not well understood at present. However one would expect that the highest field points are the corners indicated by an arrow in Fig. 4. This would cause preferential erosion at these points and leave a characteristic central protrusion. The surface of the PP is eroded in tracks but these appear to be very clean and not prone to subsequent tracking, Fig. 5.

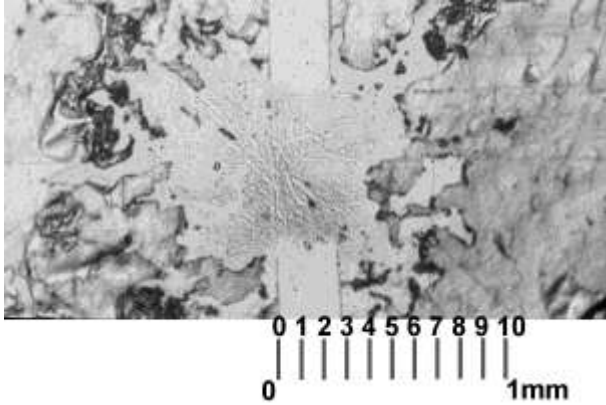
Fig. 5: Surface tracks that appear on polypropylene following a flashover event.

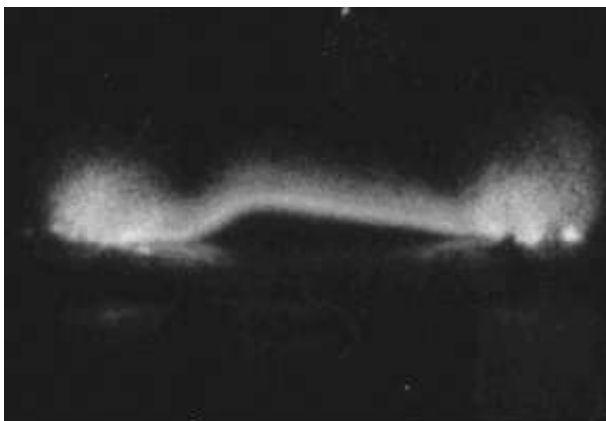
Observation of Arc Fig.6 is a photograph of a typical arc observed during data acquisition. It is evident from the photograph that the arc does not traverse the PP surface but actually 'leapfrogs' across from electrode to electrode. This may be due to convection from the heat of the arcing plasma but may be due to repulsion of the negative head of the discharge from negative charges trapped on the PP surface.

Fig. 6: Photograph of typical flashover in air

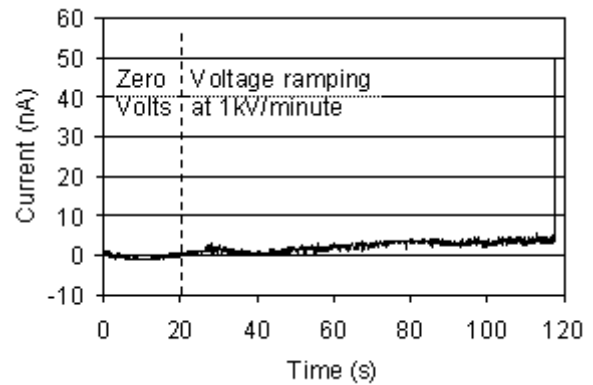
Measurement of Current The current was monitored using a Keithley 617 electrometer and plotted as a function of time. Fig. 7 shows this for a sample with an annulus of 280 μm . A conduction (Ohmic) process would give a current that ramped up with voltage whereas a displacement (capacitive) process would result in a constant current since $i = C \cdot dV/dt$. Any other dominant characteristics one may find would be due to charge injection and accumulation. In spite of

noise generated by the measurement system, one can observe the Ohmic and capacitive characteristics although it was rather difficult to see evidence of charge injection and accumulation on the PP surface.

Fig. 7: Current measured for first flashover

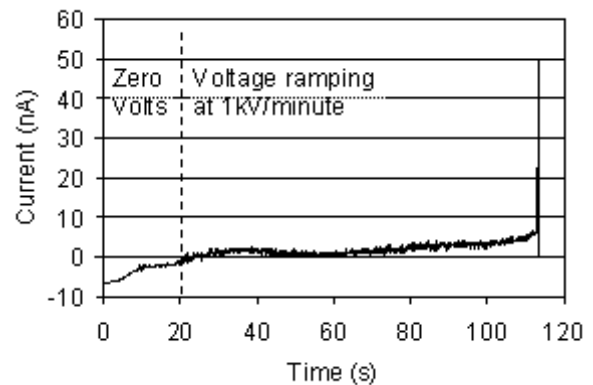
For subsequent flashovers on the same sample, the current plot does not start at zero amps. This is shown in Fig.8 for the fifth flashover subsequent to that in Fig. 7.

Fig. 8: Current measured for 5th flashover

In fact the current starts at approximately -6nA due to residual charges left in the system from the previous flashover. Using a dielectric spectroscopy it was found that a typical sample of 300 μm annulus had a capacitance between the inner and outer electrodes of $C=6 \text{ pF} \pm 5\%$. Since the first 20 seconds of each test had zero volts applied, the area under this part of the curve represents the remnant charge from the previous test. Using integration it was found that the total charge was approximately 74nC. This cannot be "capacitive" charge for two reasons. Firstly the previous discharge voltage was $V=1.55\text{kV}$ at the time of flashover. The maximum charge stored was therefore $V \cdot C = 9.3 \text{ nC}$. Secondly the charge is only slowly removing – taking about 20s. It seems likely that this charge is trapped on the surface of the PP in the annulus gap.

Another observation seen in some current measurements is the increase in current just prior to flashover. This is also shown in Fig. 8. This effect could be due to corona current of insufficient energy to cause flashover,
