Citation: Grafton, M. A., Fothergill, J., Dissado, L. A., Elgood, S., Stevens, G. C. & Thomas, J. L. (2001). Controlling flashover between electrode segments in DC power capacitors. Paper presented at the IEEE 7th International Conference on Solid Dielectrics, 25-29 June 2001.

CONTROLLING FLASHOVER BETWEEN ELECTRODE SEGMENTS IN DC POWER CAPACITORS

M.A. Grafton, J.C. Fothergill, L.A. Dissado and J.R.R. Shirley-Elgood

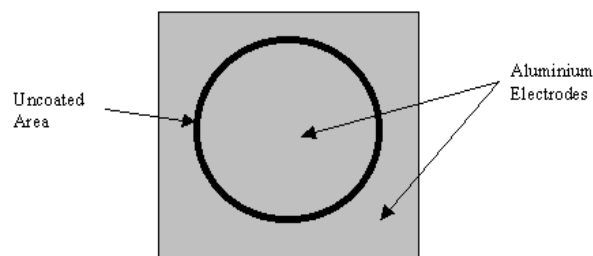
All the results in this paper were derived from specimens comprising a thin film of capacitor grade PP 9 μ m thick with a evaporated coating of aluminium on one side. This was 200 \pm 1 nm thick according to the evaporator’s quartz crystal thickness monitor (Edwards FTM 7). However SEM and AFM measurements of cross sections of the specimens set in epoxy showed the coating was very uneven and varied in thickness from 0.5 to 2.0 μ m. Flashover took place across an annulus formed in the evaporated aluminium using a circular metal mask. This left a central circular electrode of diameter 47 mm surrounded by a gap, which could be varied from 100 to 1500 μ m. This is shown in Figure 1.

Fig 1. Specimen for measuring flashover
