# Dielectric Spectroscopy of Epoxy/Glass Composite Materials

M. N.Ajour<sup>1</sup>, L.A.Dissado<sup>1</sup>, J.C.Fothergill<sup>1</sup>, P.N.Norman<sup>2</sup>

**Abstract:** *Glass fibre reinforced epoxy (GFRE) material is used in pressboard transformers for optical telecommunication systems, typically at voltages between 1 to 2kV. A programme has been set up to follow the electrical ageing of the GFRE through dielectric and space charge (PEA) measurements. Here we report on the characterisation of the GFRE prior to ageing made by means of linear dielectric spectroscopy. Preliminary results for the aged samples show differences in dielectric response that could be related to de-bonding at the epoxy-fibre interfaces observed in some failed samples.*

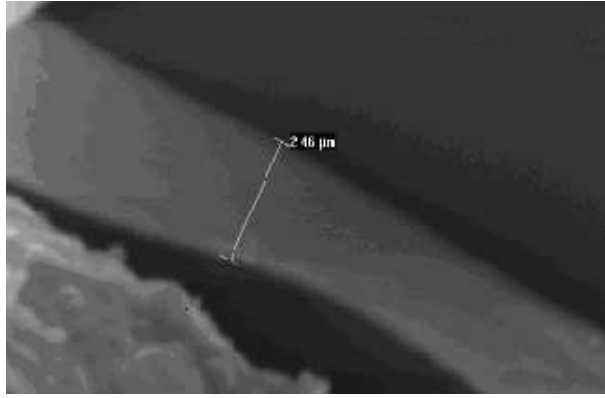
Figure 5 shows the voids (black lines) between the fibres and epoxy. The white line is 2.46 µm long

The generation of the interface voids is likely to be the cause of dielectric breakdown [6] as long as they are aligned with their long axis in the direction of the electric field [7]. Because of the weave of the mat most such voids will be aligned perpendicular to the field direction with a width of around 2-3 $\mu$ m, which is insufficient to support discharges at the fields applied [7]. At some stage, however, such voids can be expected to join together to provide a gap in the field direction long enough to support discharges. Once discharges can occur failure will follow rapidly. We believe that this is what happened in the sample that broke down.
