**Citation:** Zimos, D.K., Papanikolaou, V.K., Kappos, A. J. & Mergos, P.E. (2020). Shear critical R/C columns under increasing axial load. *ACI Structural Journal*, 117(5), pp. 29-40. doi: 10.14359/51725886

# SHEAR-CRITICAL R/C COLUMNS

## UNDER INCREASING AXIAL LOAD

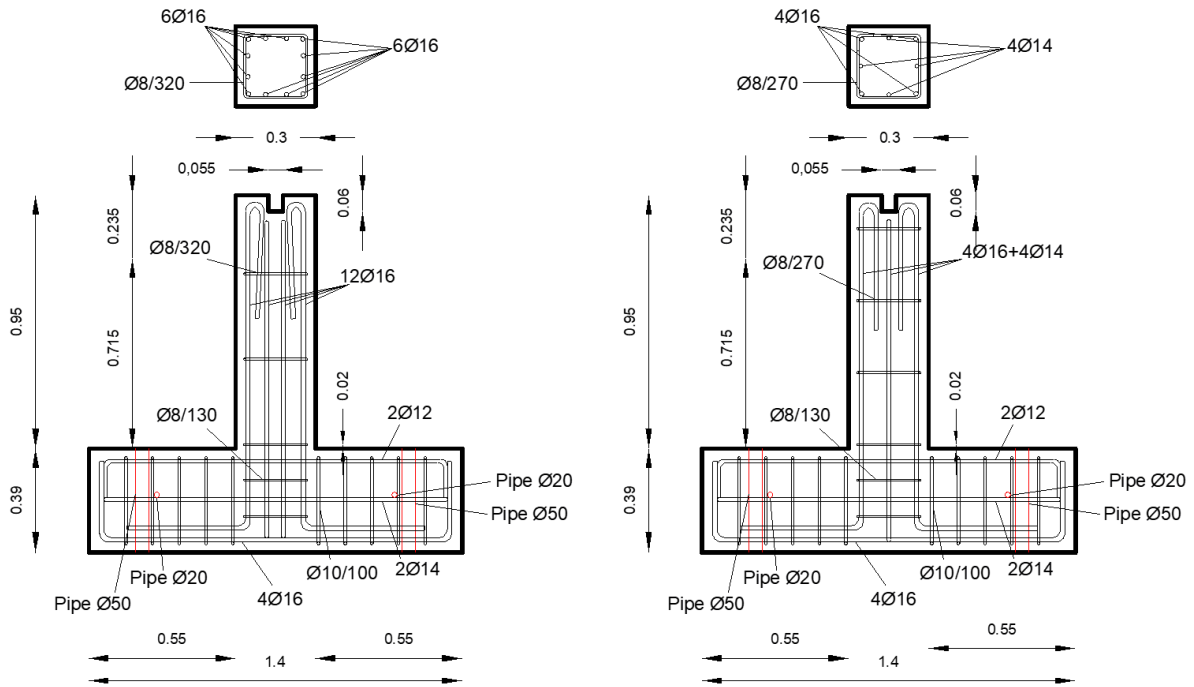
1  
2 *Fig. 1: Design of (a) shear critical (SC) and (b) flexure-shear critical (FSC) specimens (lengths*  
3 *in m; rebar and pipe diameters in mm).*

5 Two sets of three columns with same geometry and materials but different reinforcement were  
6 designed and fabricated (Fig. 1); they were formed as cantilevers, representing the length  
7 between the base and the contraflexure point of short columns. The column cross-section is  
8 square,  $300 \times 300$  (mm), and their length (at lateral loading level) is 715 mm (aspect ratio of  
9 2.4). Consistent with old practice, the transverse reinforcement is sparse,  $\text{Ø}8/320$  (mm) and  
10  $\text{Ø}8/270$  for the shear critical (SC) and flexure-shear critical (FSC) specimens, respectively, and  
11 has  $90^\circ$  hooks (Fig. 1). The longitudinal reinforcement was designed to achieve the desired  
12 response and failure types; it is  $12\text{Ø}16$  (16 mm diam. bars) for the SC critical columns and  
13  $4\text{Ø}16+4\text{Ø}14$  for the FSC columns resulting in a total reinforcement ratio of 2.68% and 1.58%,

15 The specimen design is shown in detail in Fig. 1, including the column mounting bases which  
16 were heavily reinforced to avoid any unwanted failure and make them sufficiently stiff, thus  
17 minimizing the displacement of the column top due to deformations of the base.

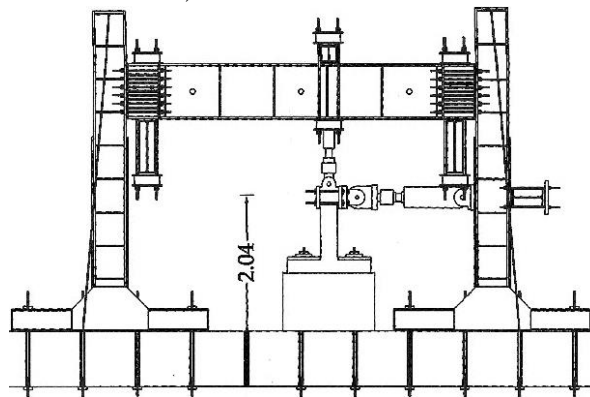
*Fig. 2: Experimental set-up shown schematically.*

2 Specimens are subjected to uniaxial bending and axial loading, as seen from the experimental  
3 set-up (Fig. 2). The double-acting double-hinged horizontal actuator applies a quasi-static  
4 cyclic load, operating in displacement-control mode, externally controlled by a dedicated  
5 displacement draw-wire sensor, since the standard actuator-based (internal) displacement-  
6 control may introduce significant ‘lash’ into the results, mainly due to the mounting setup and  
7 the non-negligible elastic deformations of the reaction frame, thus overestimating the actual  
8 lateral displacement of the tested specimens<sup>20</sup>.

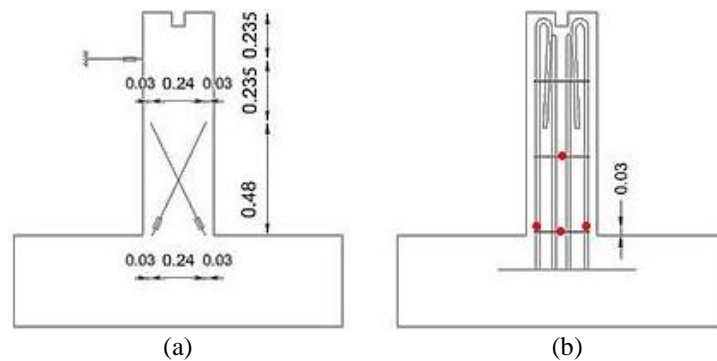
4 *Fig. 3: Instrumentation of specimens: (a) draw-wire sensors and (b) strain gages.*

21 The instrumentation of the experiment comprises load cells, LVDTs, draw-wire sensors and  
22 strain gages. The load cells are mounted on the two actuators, measuring the resisting force  
23 from the specimens. Draw-wire sensors are used to measure the top lateral displacement,  
24 displacements along the diagonal needed to calculate shear deformations, and the potential base

1 uplift, in order to ensure that no significant base deformations develop. In the vertical direction,  
2 the axial deformation is directly measured from the axial displacement sensor of the vertical  
3 actuator. Strain gages were installed on longitudinal and transverse bars near the base of a  
4 shear-critical column (see detailed instrumentation arrangement in Fig. 3).  
5 In addition to instrumental measurements, digital image correlation (DIC) was used to  
6 measure column deformations. Using a high-resolution camera from a fixed position, column  
7 images already painted with a speckle pattern were collected at each cycle. The distance  
8 between the initial and the shifted positions of each individual speckle point on the front face  
9 of the column can be measured at each cycle, providing the entire displacement contour along  
10 the front surface of each column throughout the duration of the test.

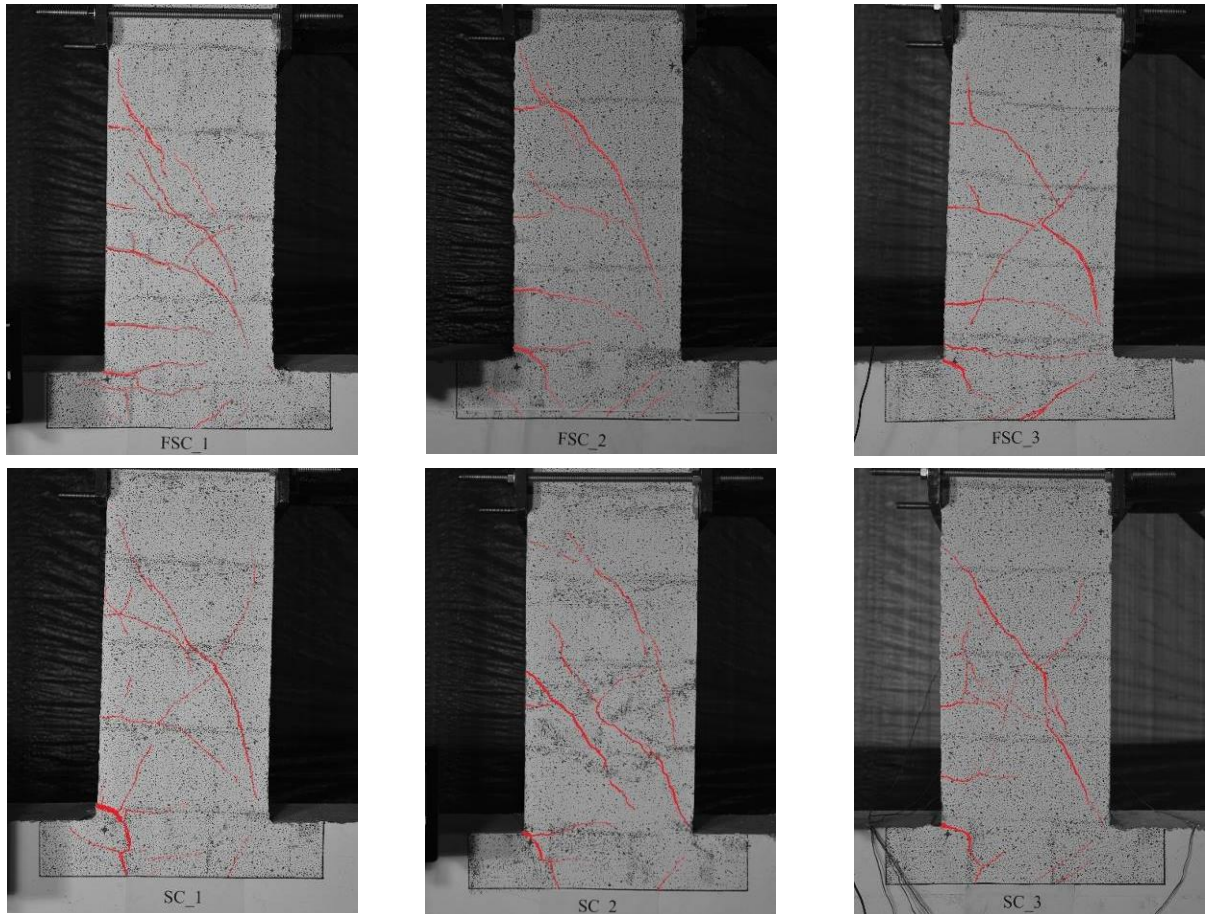
1 Fig. 4: Damage state (surface crack patterns) of specimens at displacement level of 12 mm.

9 Cross-inclined shear cracks appeared at a displacement level of approximately 6 mm (0.84%  
10 drift) or 9 mm (1.26% drift) and started opening considerably from about 12 mm (Fig. 4),  
11 reaching large widths of approximately 4 to 10 mm near the final cycles (Fig. 5). Their  
12 bottom end was always at the column/base interface and their inclinations were usually  
13 around 28°-33° on average. The SC specimens seem to have larger average shear crack angles  
14 than the FSC ones, which all exhibit 28° angles on average. Spalling of concrete cover was  
15 observed close to the bottom ends of the inclined cracks, due to local decrease of the  
16 compression zone depths at those sections resulting from the shear cracks. Despite substantial  
17 opening of these diagonal cracks, no fracture of transverse bars occurred, as the 90°-  
18 anchorage of the ties led to their slippage at high displacement levels. The strain gages

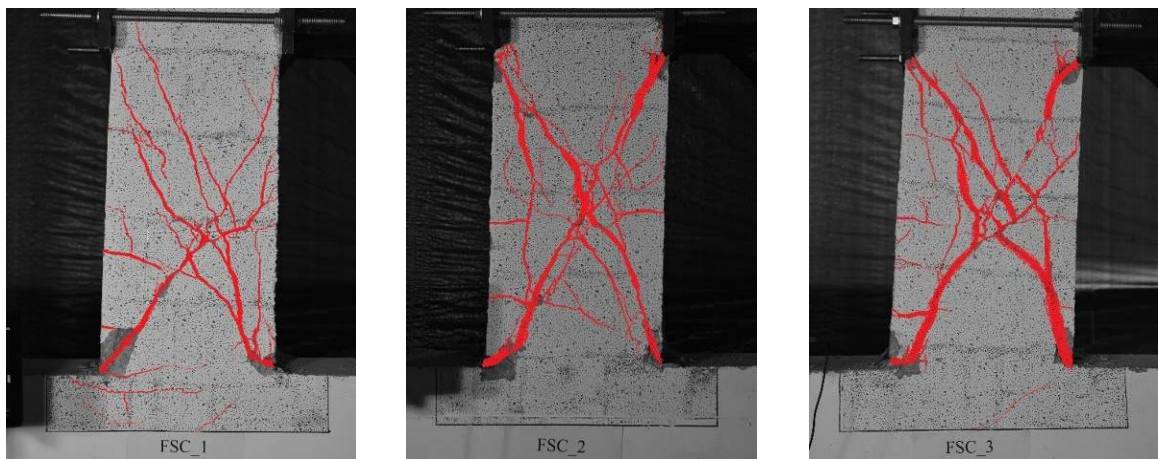
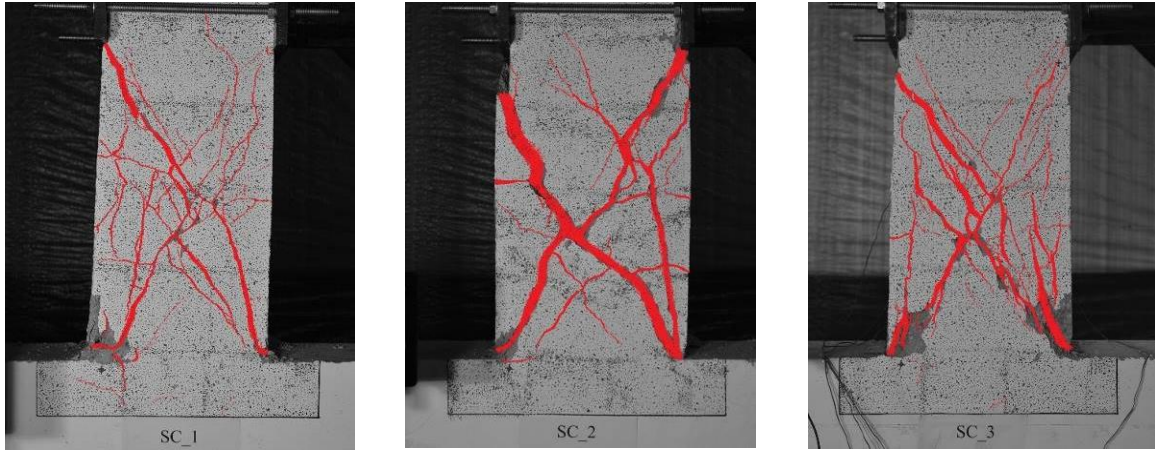
1 Fig. 5: Damage state (surface crack patterns) of specimens at displacement level of 18 mm (15 mm for FSC\_3).

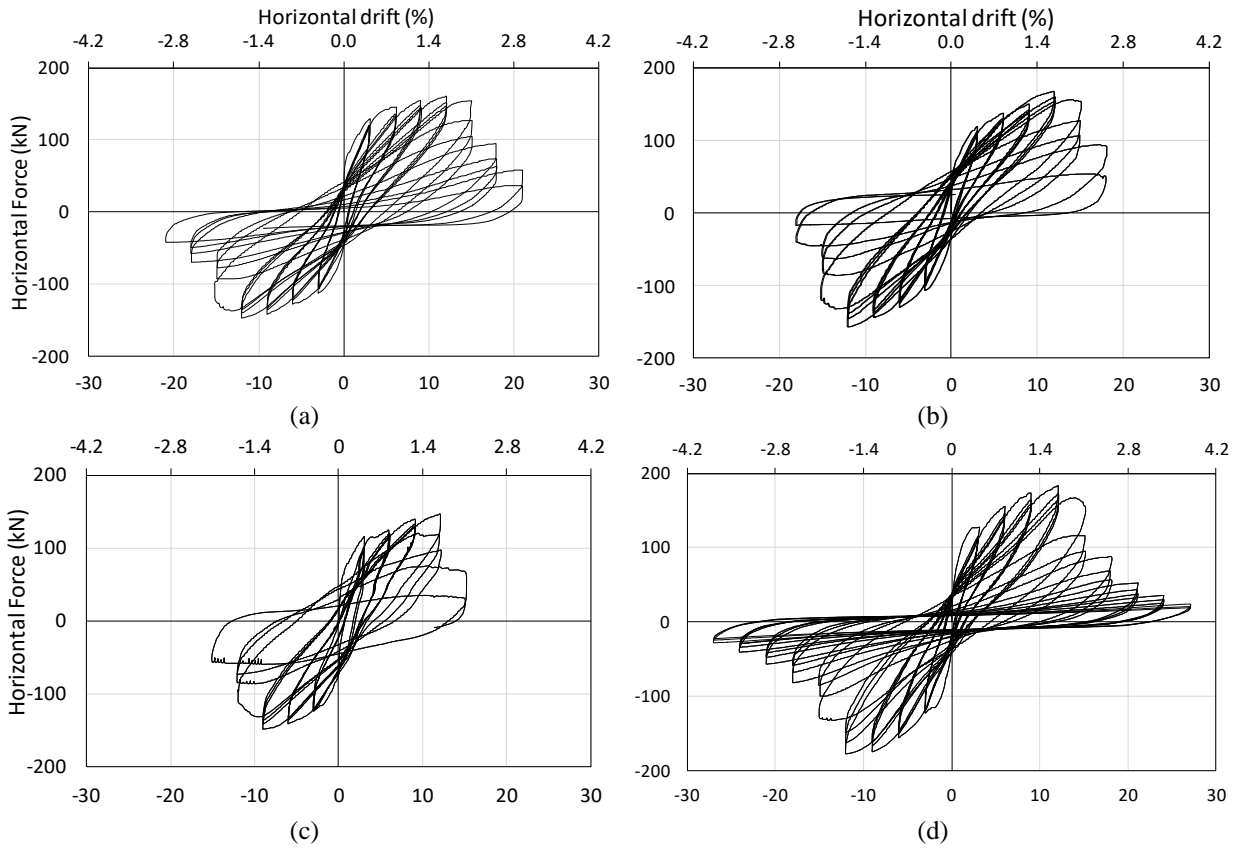
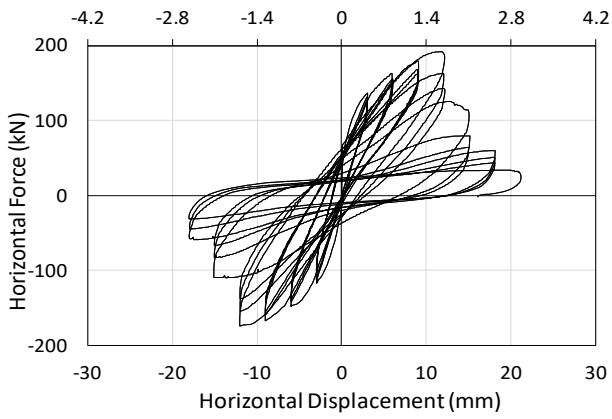
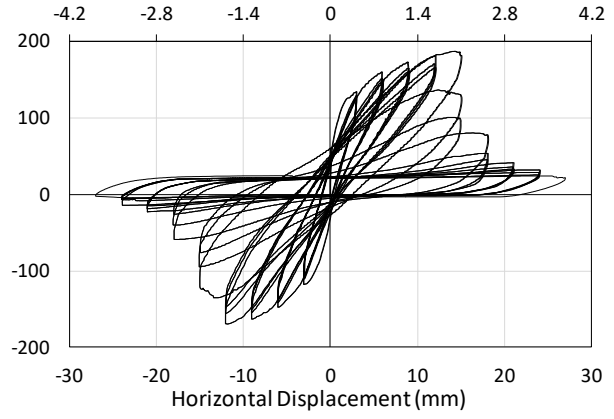
1 Fig. 6: Hysteretic response of specimens (a) FSC\_1, (b) FSC\_2, (c) FSC\_3, (d) SC\_1, (e) SC\_2  
2 and (f) SC\_3.

6 The specimens' hysteretic responses in terms of horizontal force (kN) vs lateral displacement  
7 (mm) or lateral drift (%) are shown in Fig. 6. Due to high sampling rate, smoothing has been  
8 applied to all hysteretic responses; original responses and smoothing method are given in <sup>22</sup>.

9 The responses of the FSC (flexure-shear critical) specimens are quite similar, with peak  
10 strengths of around 150-160 kN developing at 12 mm (1.68% drift). Limited cyclic strength  
11 degradation and reloading stiffness degradation are exhibited in the pre-peak domain, which  
12 however increase significantly after peak.

13 The SC specimens remained almost 'elastic' up to a strength of around 130 kN (peak of the  
14 first displacement level), followed by a rather stiff strain-hardening branch up to about 200  
15 kN at 12 mm displacement. One specimen (SC\_3) did not reach its peak strength at a  
16 displacement of 12 mm (4<sup>th</sup> cycle), but in the next cycle. This led to the increase in axial load  
17 occurring before the onset of shear failure, instead of just after it, as initially planned. The SC  
18 specimens also exhibit much higher cyclic strength degradation in the post-peak domain.

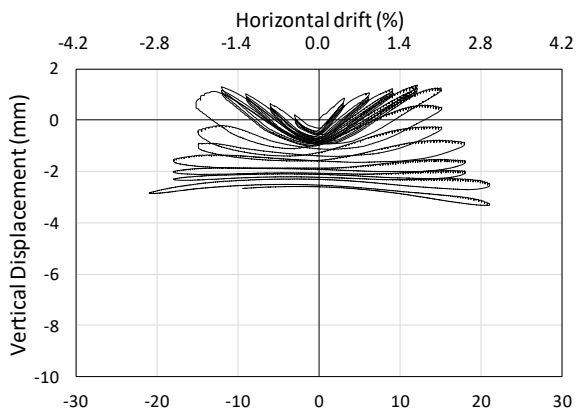
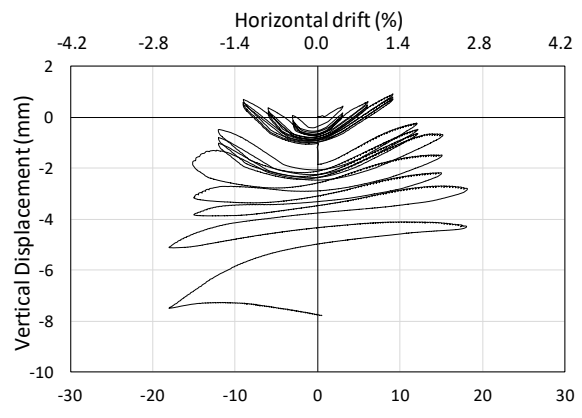
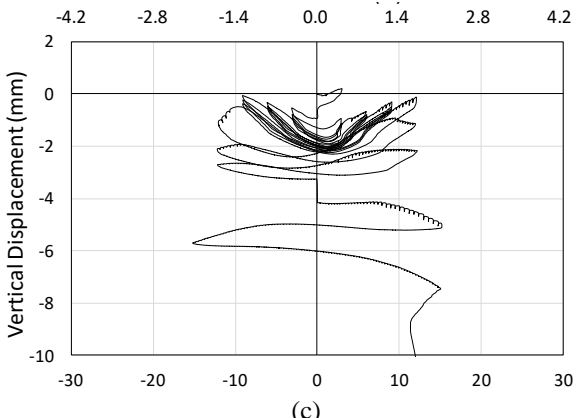
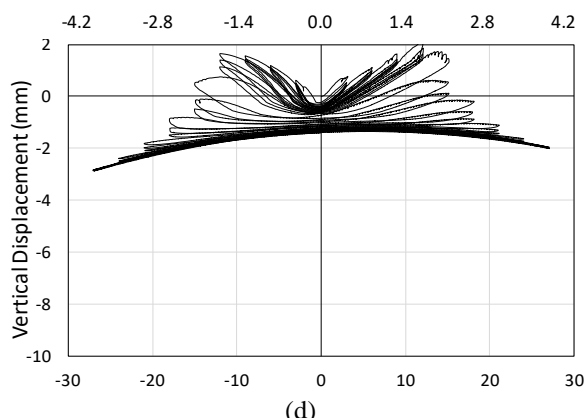
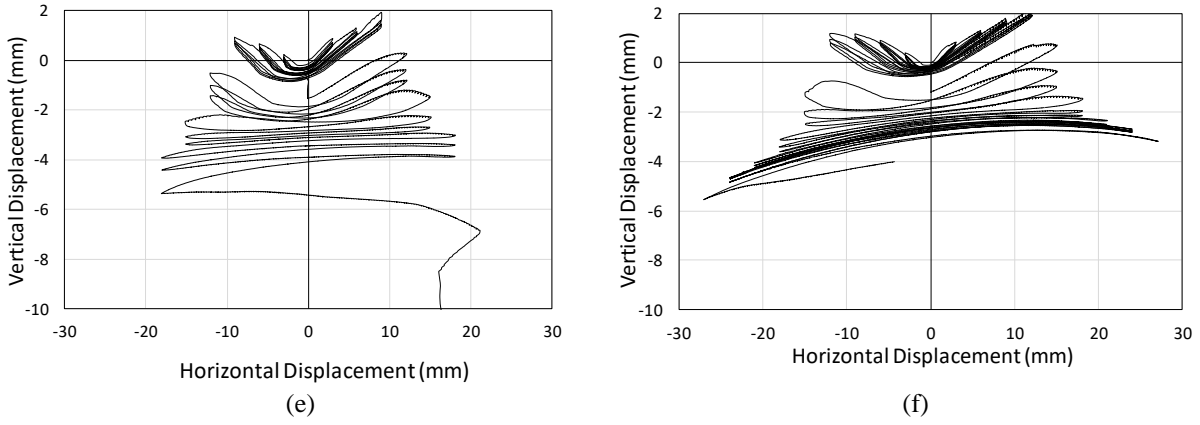
1 Fig. 7: Axial hysteretic response of specimens (a) FSC\_1, (b) FSC\_2, (c) FSC\_3, (d) SC\_1, (e)  
 2 SC\_2 and (f) SC\_3.

2 Vertical displacements of all specimens follow the typical U-shaped pattern up to the onset of  
3 shear failure, i.e. having a specific negative displacement (compressive strain) at the  
4 'vertical' position (zero lateral displacement) with increasing displacements towards the  
5 peaks of each cycle. The increased vertical displacements at the extremes of each cycle come  
6 from the well-known phenomenon of member elongation in the nonlinear range of the  
7 response; curvatures lead to high tensile strains of the tension reinforcement, also  
8 accompanied by opening of cracks; with consecutive cycles at increasing lateral  
9 displacements, plastic strains accumulate leading to further elongation.

10 However, the shape of the observed pattern changes from the onset of shear failure onwards;  
11 from a U-shape, it turns flat and eventually into an inverted-U-shape, while vertical  
12 displacements generally decrease further with each cycle. This corresponds to a change in the  
13 physical behavior of a member; as the peak of each cycle is reached after the full depth  
14 diagonal crack has formed, the upper discrete parts of the column are pushed downwards  
15 under the influence of the constant axial load. Of course, as the displacement reverses, the  
16 cracks partly close and a part of this downward displacement is recovered (hence the  
17 inverted-U-shape); after a given point, the accumulation of downward displacements  
18 becomes very significant with vertical displacements decreasing to even less than -5 mm (i.e.  
19 an average normal strain of -0.7%). The sudden increase of axial deformations accompanying

20 the onset of axial failure is shown to start at around -7 mm for this test series. Specimens  
21 FSC\_2, FSC\_3 and SC\_2 exhibited this behavior, while FSC\_1, SC\_1 and SC\_3 were  
22 stopped before the onset of axial failure either for the safety of the equipment or because the  
23 specimen was observed to have been damaged extensively and its resistance had fallen to a  
24 small fraction of the previously attained maximum strength.

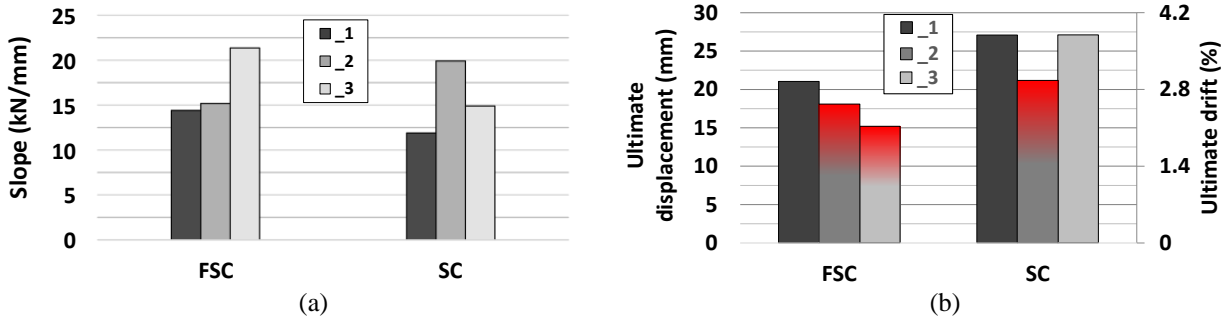
3 Fig. 8: (a) Experimentally obtained descending branch slopes, and (b) maximum horizontal  
 4 displacements of FSC and SC specimens.

12 The maximum horizontal displacement attained by each specimen is presented in Fig. 8b with  
13 specimens that failed axially having a gradient filling; note that this is a lower bound of  
14 deformability for the ones that did not fail axially. FSC\_1 with low constant axial load is  
15 cycled up to 21 mm (2.94% drift) without losing its vertical load-bearing capacity. FSC\_2  
16 and FSC\_3 (specimens with increased axial load) fail well before that, reaching a lateral  
17 displacement at the onset of axial failure of 18 mm (2.52% drift) and 15 mm (2.10% drift),  
18 respectively. In this series, increasing the load after the peak is reached led to the axial  
19 capacity being lost sooner than increasing it before the peak. In the SC series, the axial load  
20 in both specimens (SC\_2 and SC\_3) was increased before the peak, due to SC\_3's  
21 unexpected higher displacement at onset of shear failure (compared to all other specimens).

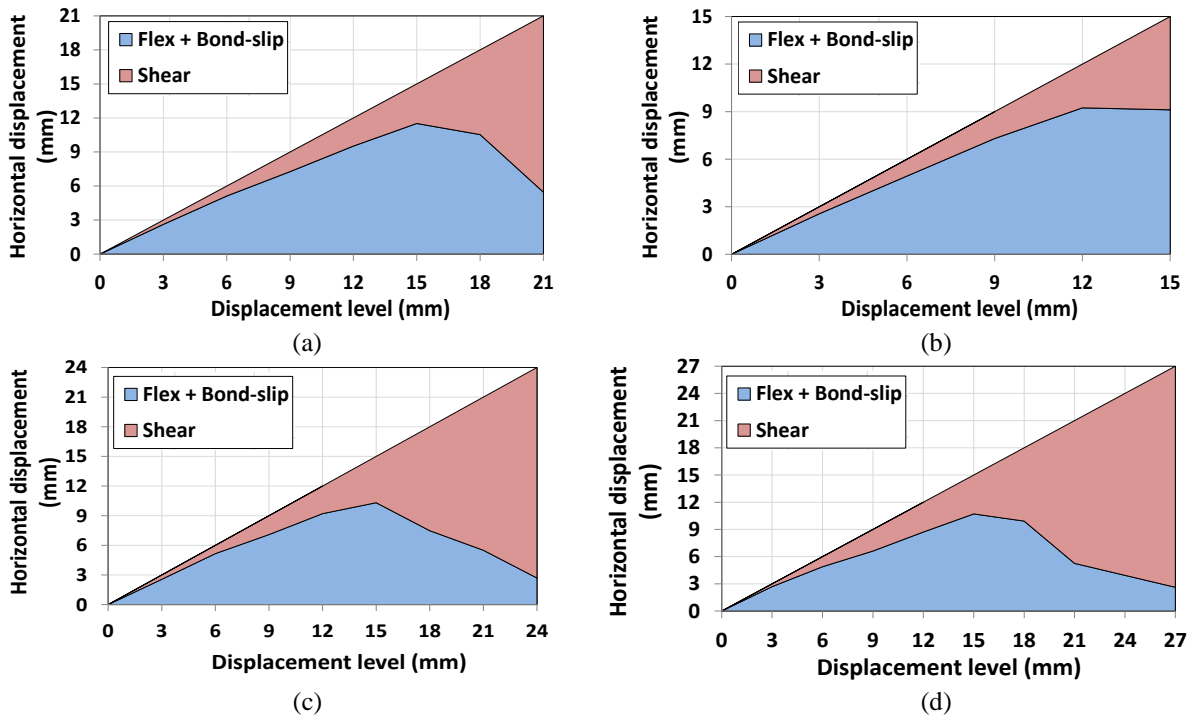
5 Fig. 9: Lateral displacement decomposition: (a) FSC\_1, (b) FSC\_3, (c) SC\_1, and (d) SC\_3.

1 Image Correlation (details in <sup>22</sup>). It is observed (Fig. 9) that shear-induced displacements  
2 always start off low, around 10-15% of the total displacement, at a displacement level of 3  
3 mm (0.42% drift). They increase steadily as damage propagates and much more sharply from  
4 the onset of shear failure onwards. They reach percentages of 40 to 70% at the final  
5 displacement levels. Conversely, the flexural (also including bond-slip) displacements start as  
6 a high proportion of the total, around 85-90%. Although they increase considerably in  
7 subsequent cycles in absolute terms, they decrease as a percentage of the total displacement  
8 up to the onset of shear failure. After the onset of shear failure, flexural and bond-slip  
9 displacements either remain constant or decrease in absolute values leading to significant  
10 further decrease in their relative contributions to the total displacements up to axial failure.

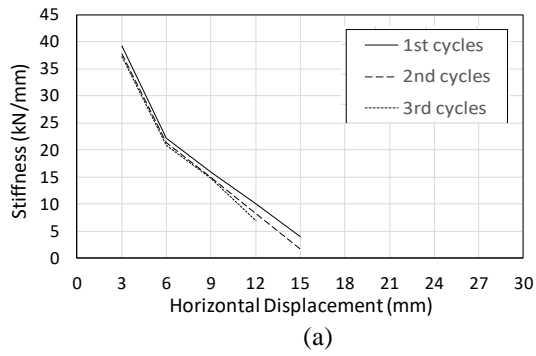
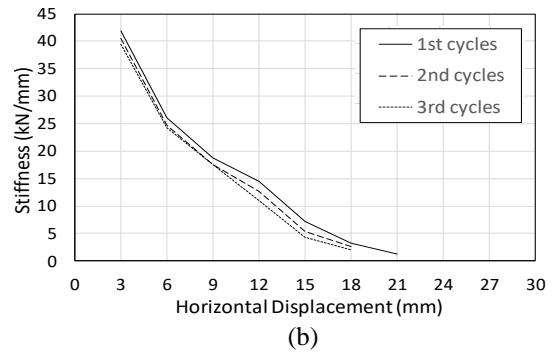
1 *Fig. 10: Lateral displacement secant stiffness against attained lateral displacement for (a)*  
 2 *FSC\_3, and (b) SC\_2.*

16 The secant stiffness at peaks of the hysteretic response is presented in Fig. 10 for  
17 representative specimens of each set, taking into account the average of positive and negative  
18 directions. Overall, stiffness degradation is similar in all specimens with few discrepancies.  
19 There is a very significant decrease in stiffness with increasing ductility, the stiffness  
20 decreasing by about 50% from the 3 to the 6 or 9 mm displacement.; thereafter, it keeps  
21 decreasing, reaching zero stiffness asymptotically after 18 mm (2.52% drift). The second and  
22 third cycles have only slightly lower stiffness than the first cycles at initial displacement  
23 levels. From 9 or 12 mm (1.26% to 1.68% drift), the difference becomes larger, due to higher  
24 cyclic strength and reloading stiffness degradation. The elastic (gross) flexural stiffness,

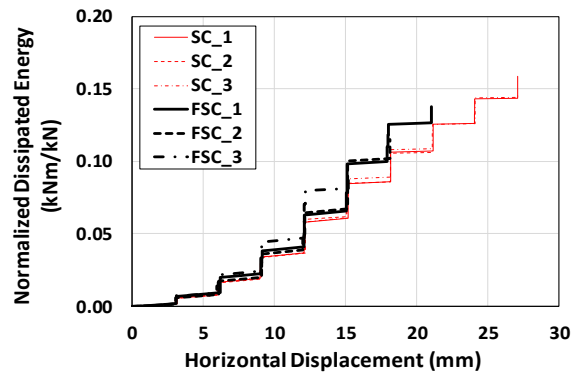
3  
 4 *Fig. 11: Cumulative dissipated energy normalized to recorded strength vs. displacement level*  
 5 *for all specimens.*

14 SC specimens are found to cumulatively dissipate more energy than the FSC ones in absolute  
15 terms, primarily due to the significantly higher strength owing to a higher longitudinal  
16 reinforcement ratio and the difference with regard to the attained ultimate displacement.  
17 Nonetheless, when normalized by their respective strength (Fig. 11), FSC specimens seem to  
18 be dissipating more energy than the SC ones at any given displacement, which is in line with  
19 what would be expected from specimens with a more ductile (FSC) as opposed to a more  
20 brittle (SC) behavior. The rate of energy dissipation is found to increase considerably after 6  
21 mm (0.84% drift), when plastic deformations increase significantly. They tend to slightly  
22 decrease again after 21 mm (2.94% drift), due to the drastic strength and stiffness  
23 degradation, leading to very pinched hysteresis loops.
