Event: Applied Optics and Photonics China (AOPC2019), 2019, Beijing, China

Optical Fiber Sensors for Coal Mine Shaft Integrity and Equipment Condition Monitoring

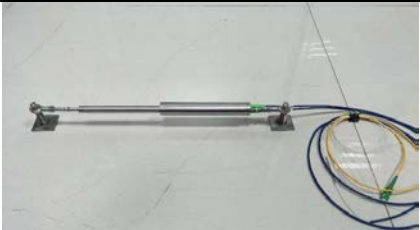
2	Cage guide displacement monitoring	Fiber Bragg Grating Crack Meter	The back of cage guide, the joint and expansion joint of cage guide

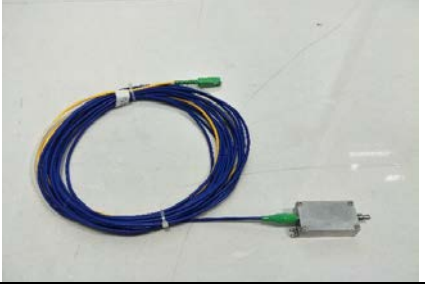
3	Cage guide vibration monitoring	Optical Fiber Vibration Sensor	The back of cage guide
