Application of NDT Thermographic Imaging of Aerospace Structures

Keywords: active infrared thermography, pulsed thermography, vibrothermography, UAV, composite, kissing bond.

Abstract. This work aims to address the effectiveness and challenges of Non-Destructive Testing (NDT) inspection and improve the detection of defects without causing damage to the material or operator. It focuses on two types of NDT methods; pulsed thermography and vibrothermography. The paper also explores the possibility of performing automated aerial inspection using an unmanned aerial vehicle (UAV) provided with a thermographic imaging system. The concept of active thermography is discussed for inspecting aircraft CFRP panels along with the proposal for performing aerial inspection using the UAV for real time inspection. Static NDT results and the further UAV research indicate that the UAV inspection approach could significantly reduce the inspection time, cost, and workload, whilst potentially increasing the probability of detection.

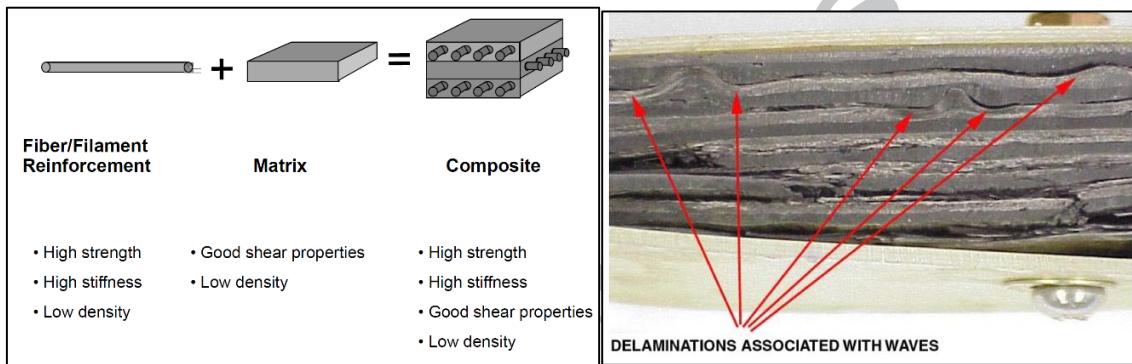
Figure 1: The composition of a composite material [8] [5].

Figure 2: An example of a composite delamination, this is the consequence of misalignments in large aircraft structures [17] [5].

Figure 1 shows the composition of a composite material. The figure demonstrates the material properties. Figure 2 presents a delamination within a composite, this is a consequence of misalignments in large aircraft structures.

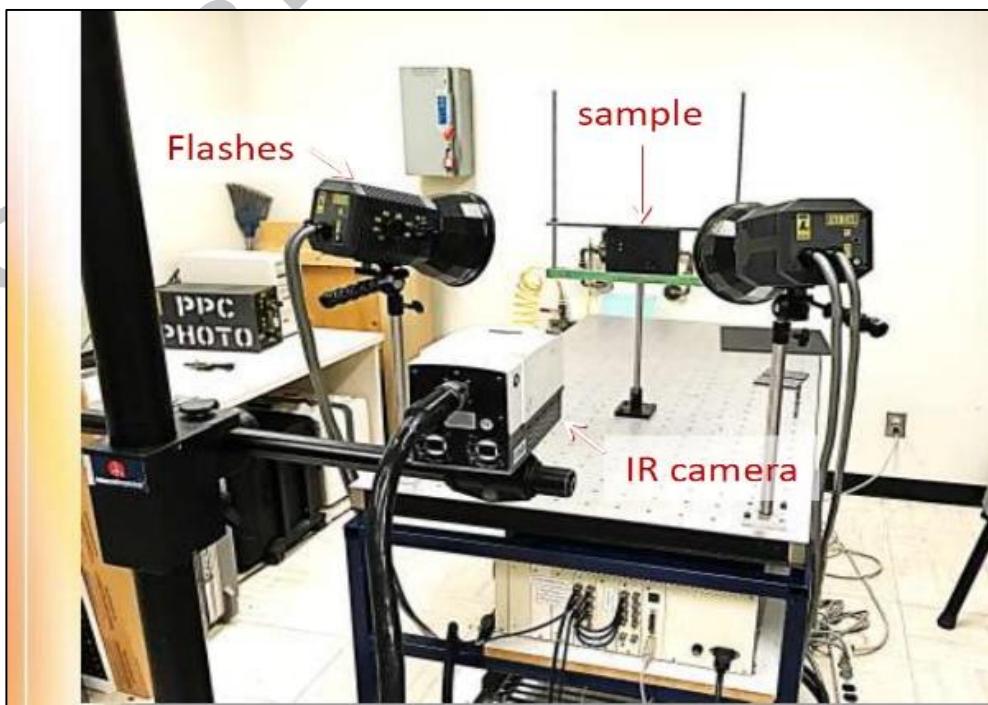
Figure 4: Images showing the PT testing equipment and the experimental set up [5].

There are two main types of thermography, active and passive as depicted in Figure 4. Passive thermography is an inspection without the use of an external excitation source, its commonly used for inspecting materials that have a temperature naturally different than its surrounding [19]. Active thermography uses external heating dissipation to create thermal contrast, once excited the thermal waves propagate through the heated specimen, and when they reach inhomogeneities caused by a medium with different thermal properties, the diffusivity coefficient changes. These inhomogeneities could be defects, such as cracks, surface cracks, air/water/material inclusions, delamination's and debonding damages.

The surface of the specimens were positioned parallel to the camera lens as depicted in Figure 4. The data was acquired for 40 seconds with a 1.5 millisecond integration time, that includes 10 frames before the flashes, plus 1990 frames during cooling a total of 2000 frames were recorded. The software used to acquire the data was RDac from FLIR. For signal processing MATLAB and Ir_view from Visiooimage inc were employed. Two advanced processing techniques were used; PCT (principal component thermography) and PPT (pulsed phase thermography) [5].

The figures below (Figures 5-11) are all the processed results. A reflection test means that the camera and the excitation source are on the same side (as seen in Figure 4). Generally, reflection is more suited to detect defects closer to heated surface. PPT (pulsed phase thermography) was one of the methods used, with the acquired temperature data it varies with time and is transferred to phase data, which varies with frequency, the frequencies which show adequate data are below each image in hertz. PCT (principal component thermography) was the other, method used, the data is re-ordered by variance, this method finds both time series and spatial patterns, most of the variability is contained in the first component: EOF1 (empirical orthogonal function). Usually, EOF1 shows thermal variations related to surface heating. Later EOFs are typically related to surface and subsurface damage. Comparing both techniques, for this specific data set in figure 5 it seems that the PCT technique displays the damage clearer [5].

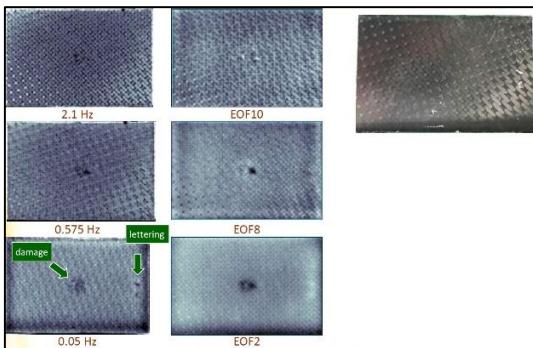
Figure 5: Sample A4 (15 J woven), front face (impacted side), PPT and PCT. The damage is barely visible in the original image of the composite (Far right image), the white marks are lettering from labelling the specimen. The 0.05Hz PPT image, shows clear subsurface damage [5].

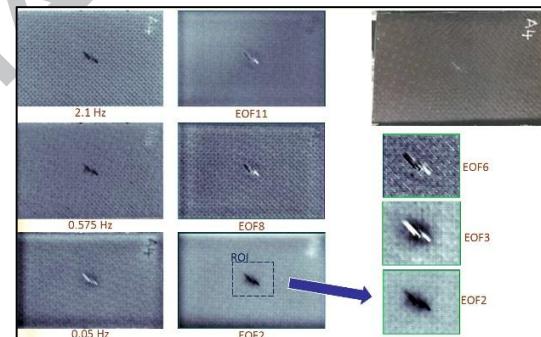
Figure 6: Sample A4 (15 J), Reflection rear face PPT and PCT. The rear surface is cracked, this is interesting because this side is significantly more damaged than the impacted side. This is a prime example of barely visible impact damage [5].

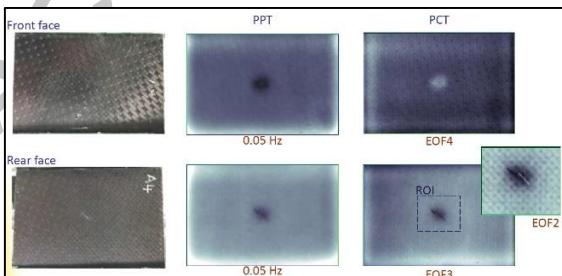
Figure 7: Sample A4 (15 J). Transmission is where the one side of the composite is excited, and the other side is observed by the camera and captures the data [5].

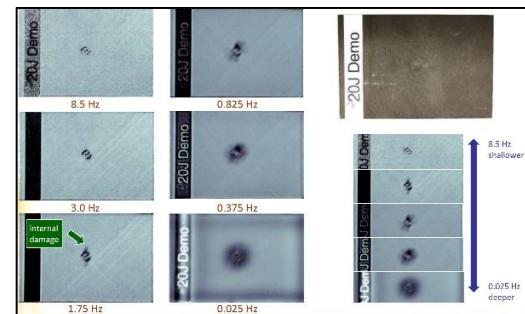
Figure 8: Sample 20 J Demo, Reflection front face, PPT. The damage is visible on the front face, how, it's clear that the damage is much worse subsurface and spreads further than the impacted area [5].

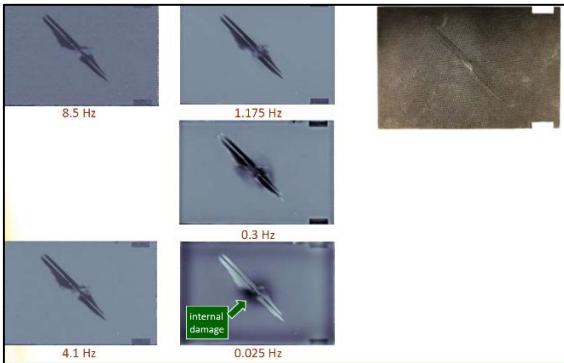
Figure 9: Sample 20 J Demo, Reflection rear face. PPT. The rear face has some substantial damage. The PPT locates the surrounding internal damage [5].

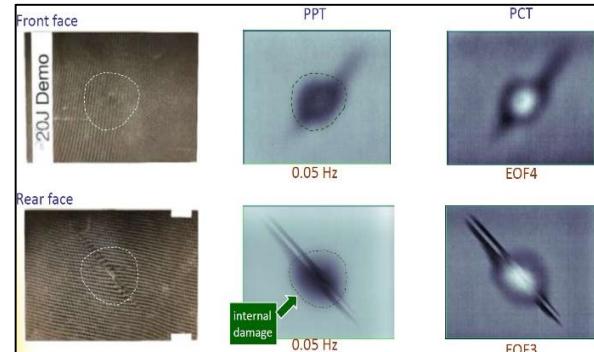
Figure 10: Sample 20 J Demo, Reflection front face, Transmission. The test has adequately located the internal damage [5].

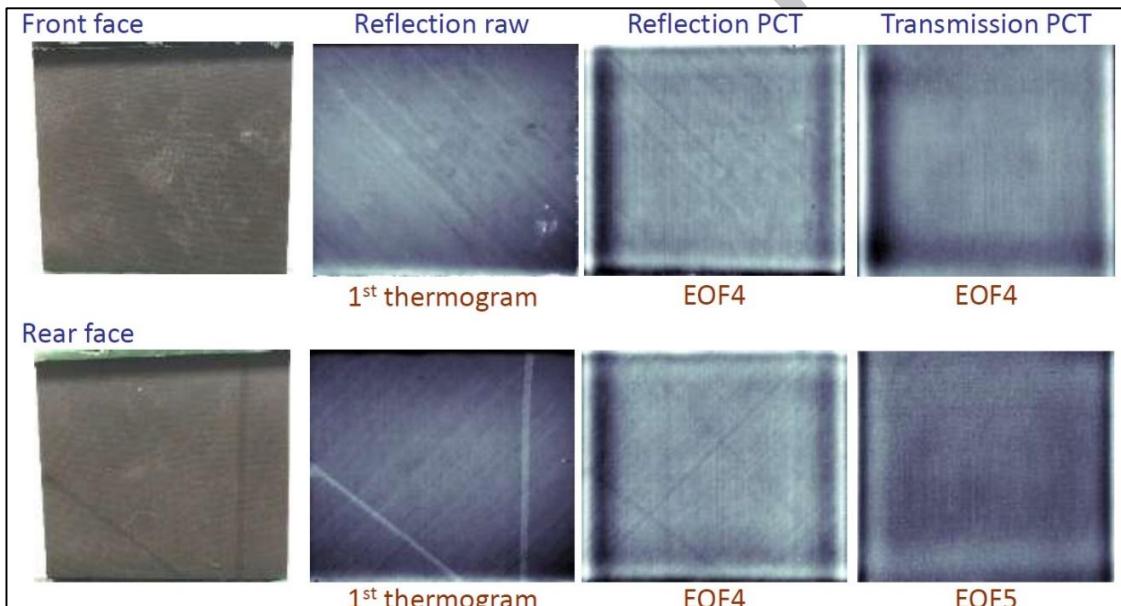
Figure 11: Sample No Name, Reflection front, back, transmission PCT. Undamaged composite sample, which was manufactured the exact same way as the 20J sample, the different NDT test prove that this sample is damage-free [5].

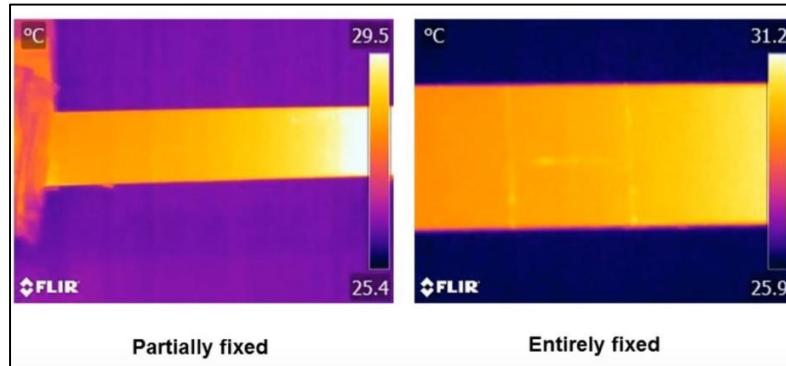
Figure 12: The mechanical wave can be more easily converted into heat when the specimen is entirely fixed [24].

The transducer is made of a stack of piezoelectric elements and concentrated in a titanium horn that acts like a hammer [22]. The specimen must be firmly restraint without damage, the immobilized specimen seeks to avoid cantilever effects, clapping, and sliding of the transducer [22]. For maximum performance the coupling of the ultrasound into the specimen needs to be improved, to do this the transducer horn should be pressed against the specimen. It is recommended to add some sort of material between the transducer and the specimen to avoid damage to the specimen, to improve contact and to eliminate any possible misalignment [22]. In the event of bad coupling it can result in poor ultrasound transmission, the specimen will then be subject to unwanted heat at the injection point, which can ultimately affect the inspection results. Crack detection is extremely sensitive to whether the specimen is fixed or free, in figure 12 the results from the constrained specimen proved the most accurate [23].

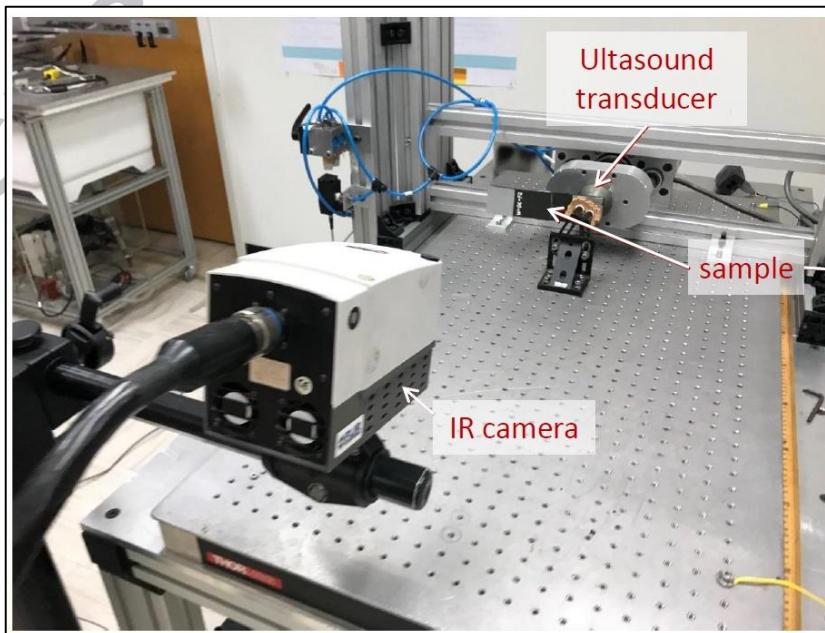
Figure 13: Image displaying the VT testing equipment and the experimental set up.

The data processing is usually easier to manage when using VT, this is since the source of the heat is the damage itself [23]. The IR camera used to capture the data, is the same as used in the PT experiment explained in 2.1. The transducer used is a 20 kHz ultrasound generator (BRANSON 2000), as seen in Figure 13.

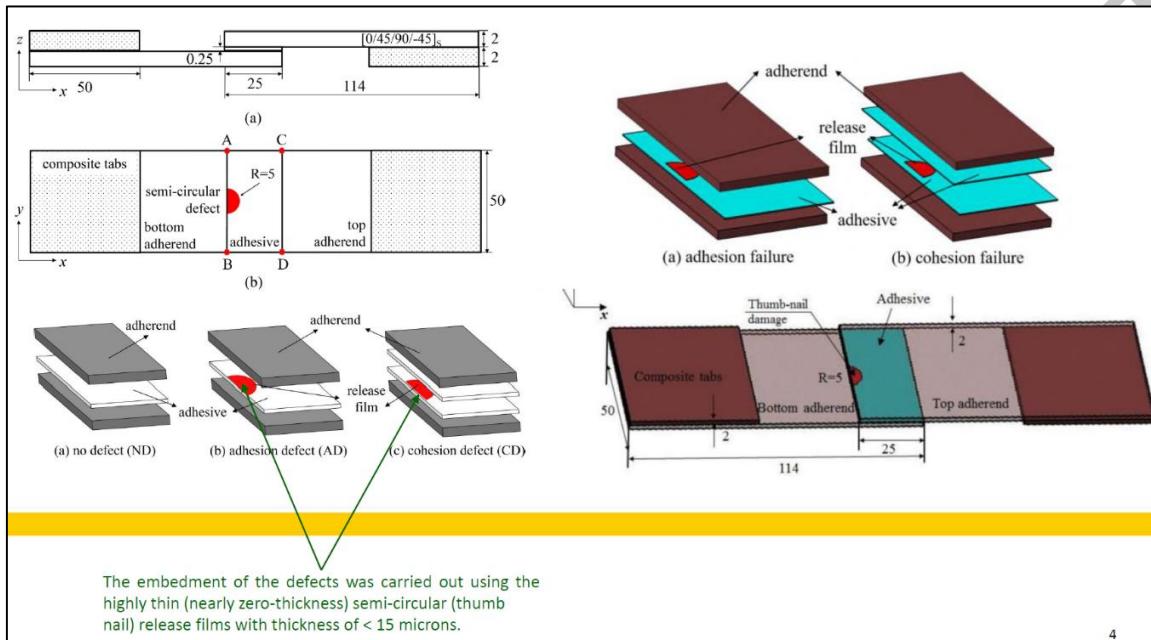
Figure 14: Artificial defects release film kissing bond [25].

The three inspected specimens are all composite material with artificial defects as shown in Figure 14.

- **Specimen N-D-F4P** is composed of one layer of adhesive sandwiched by two layers of adherent (carbon fiber) and contains no defect, it was purposely used for reference only.
- **Specimen W-DA-F4** is similar to N-D-F4P but with a adhesive film release semi-circular ("thumb nail") shape defect, simulating a kissing bond defect.
- **Specimen W-DC-F2** is similar to W-DA-F4 but with an additional adhesive film on top of the one with the simulated defect.

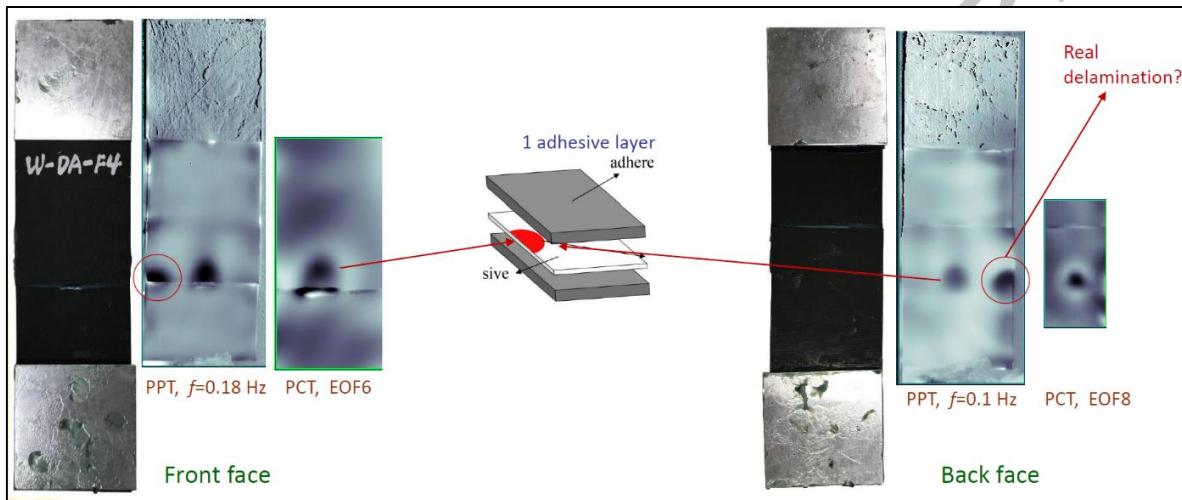
Sample W-DA-F4: Vibrothermography:

Results clearly show the thumb nail shape in all cases, specimens W-DC-F2 and W-DA-F4, from one side and the other (front and back), after processing by PPT and PCT.

Additionally, several indications of real defects seem to be observed. For instance, possible delamination's were found and indicated with red circles.

Figure 15: Image showing the processed results from the vibrothermographic inspection on sample W-DA-F4

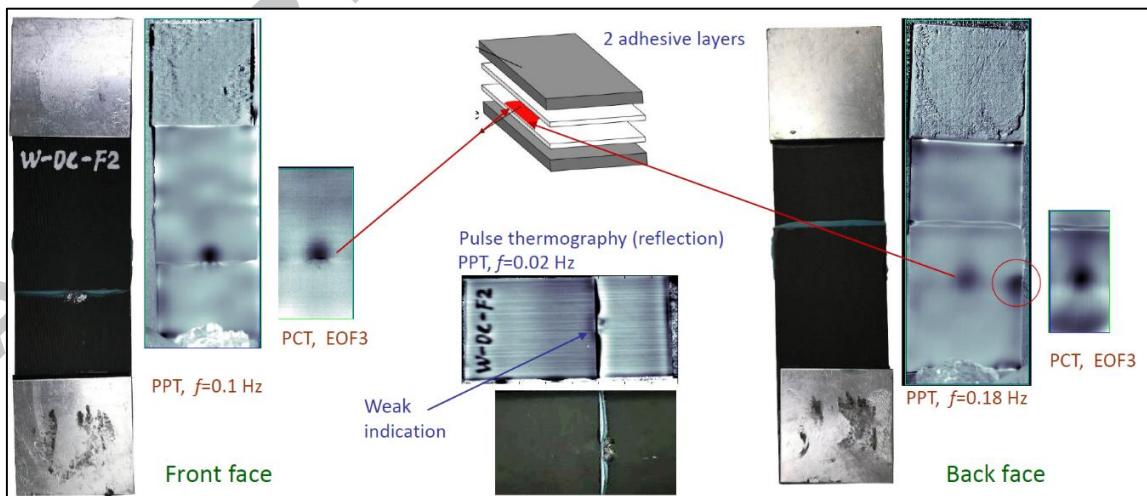
Sample W-DC-F2: Vibrothermography:

Figure 16: Image showing the processed results from the vibrothermographic inspection on sample W-DC-F2

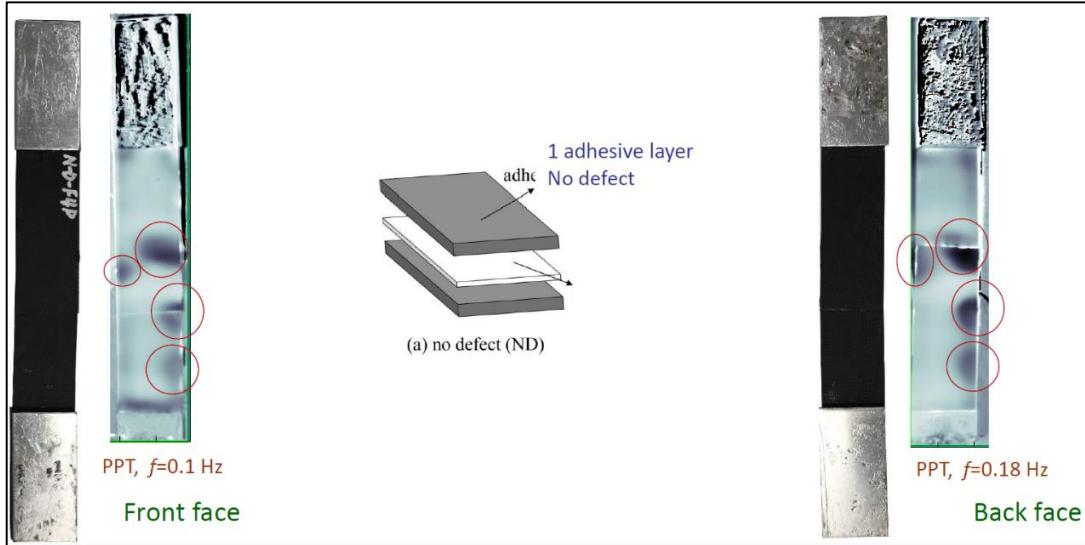
Sample N-D-F4P: Vibrothermography:

There was no kissing bond defect detected in specimen N-D-F4P (as expected) however, delamination-like defects were identified. Further testing using alternative NDT techniques or destructive testing could be used in the future to validate the nature of these indications.

Figure 17: Image showing the postprocessed results from the vibrothermographic inspection on sample N-D-F4P.

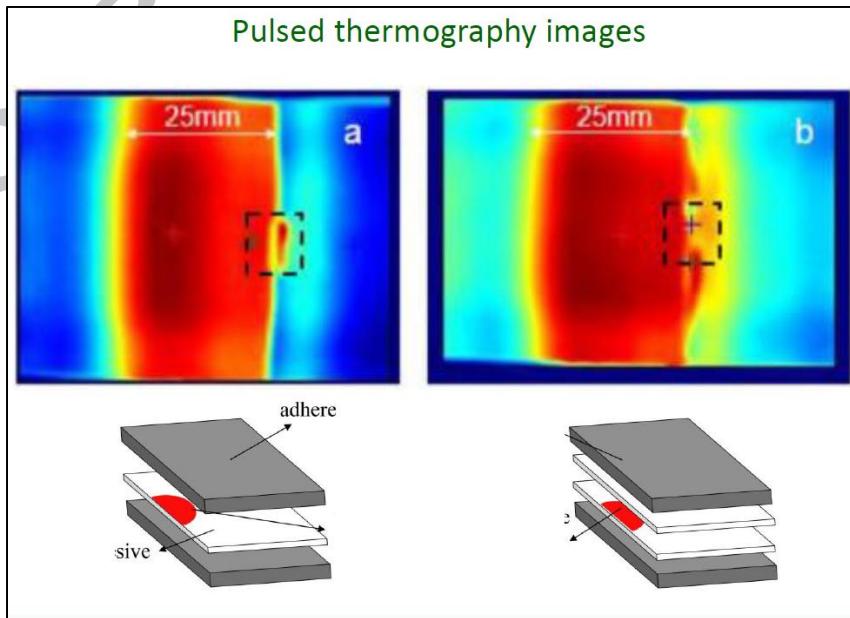
Figures 18 and 19 show some examples of previous IR NDT inspections of similar specimens [26]. Figure 18 is a pulsed thermographic inspection; the defects are located however they are not easily visible in this case.

Figure 18: Past pulsed thermographic inspection from similar specimens as used in the before mentioned VT inspection [25].

Figure 19 is an ultrasound testing inspection. The defects are successfully located and are more visible than the PT results in figure 18. The size of the defect can also be measured during processing, the defect present has a radius of 5mm. The vibrothermography results are promising for the detection of kissing bond defects.

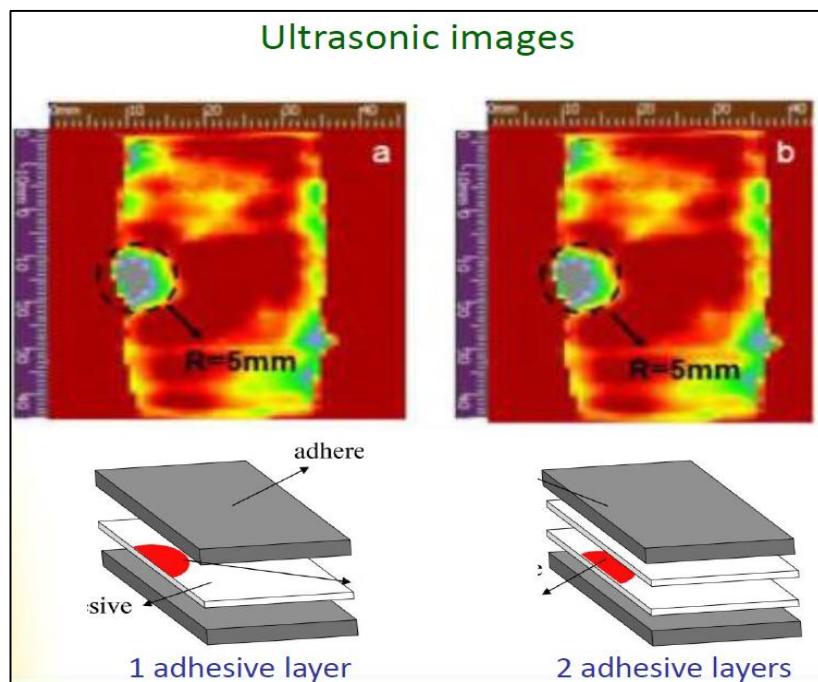
Figure 19: Past ultrasonic thermographic inspection from similar specimens as used in the before mentioned VT inspection [25].

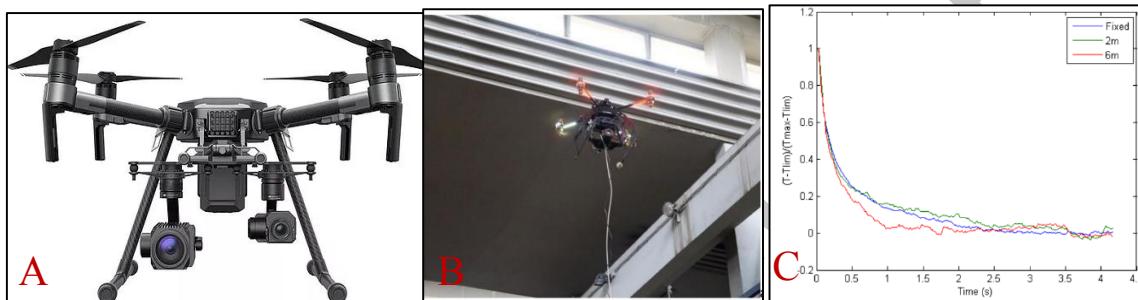
FIGURE 20 A: DJI M210 equipped with thermal camera [27]. **FIGURE 20 B:** UAV equipped with thermal camera [12]. **FIGURE 20 C:** Comparison of front face temperature responses to flash heating in the case of a large uniform irradiation with a fixed camera and a stabilized camera with UAV at two distances (2 m and 6 m) [12] [5].

Along with the liquid penetrant NDT method as mentioned in the introduction, a UAV thermographic inspection was tested for civil engineering applications (see Figure 20B). The UAV is equipped with a FLIR A320, this IR camera is connected to a computer via a cable, one is a power cable and the other provides real time radiometric thermal images, which will reveal heat patterns and thermal anomalies [12]. Transient thermography with flash and step heating where the methods used in this inspection. An inspection took place and gathered data on different distances between the camera and the samples (2, and 6 metres). Along with the UAV equipped with the IR camera, there was a fixed IR camera, therefore two sets of data could be acquired and compared. A thermally uniform area of a sample is delimited, and the IR cameras captured the data [12] [5].
