Collapse Mechanism of Single-Layer Cylindrical Latticed Shell under Severe Earthquake

Abstract: In this paper, the results of finite element analyses of a single-layer cylindrical latticed shell under severe earthquake are presented. A 3D Finite Element model using fiber beam elements is used to investigate the collapse mechanism of this type of shell. The failure criteria of structural members are simulated based on the theory of damage accumulation. Severe earthquakes with peak ground acceleration (PGA) values of 0.5 g are applied to the shell. The stress and deformation of the shell are studied in detail. A three-stage collapse mechanism “double-diagonal -members-failure-belt” of this type of structure is discovered. Based on the analysis results, measures to mitigate the collapse of this type of structure are recommended.

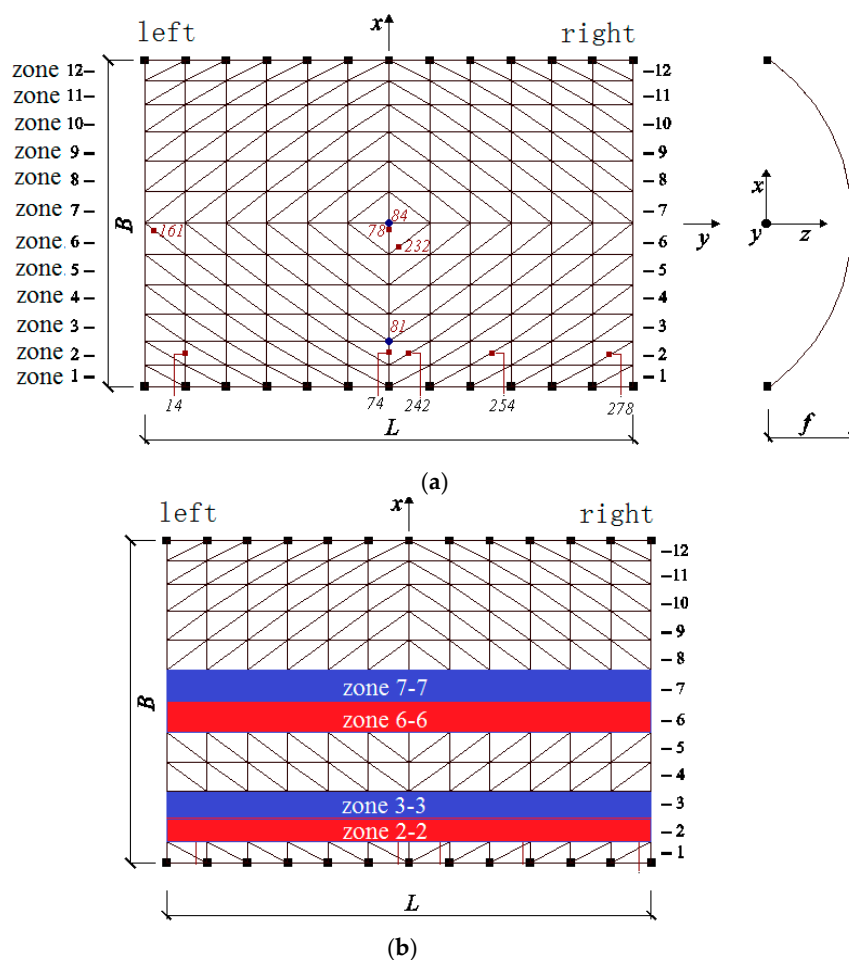
Figure 1. Single-layer cylindrical latticed shell with structural zone denoted: (a) Structural zone in the model; (b) Structural zone in the dome.

The collapse analysis is performed by the general-purpose program ABAQUS 6.12 by Dassault SIMULIA, through the further development of the subroutine VUMAT program in Abaqus. The numerical method introduced in Zhou et al. [36] is used in this research. All the structural members of the reticulated shell are simulated using the beam elements. Each beam element is further discretized into eight longitudinal fibers across their cross-section, with an appropriate constitutive model defined for each fiber, as shown in Figure 1.

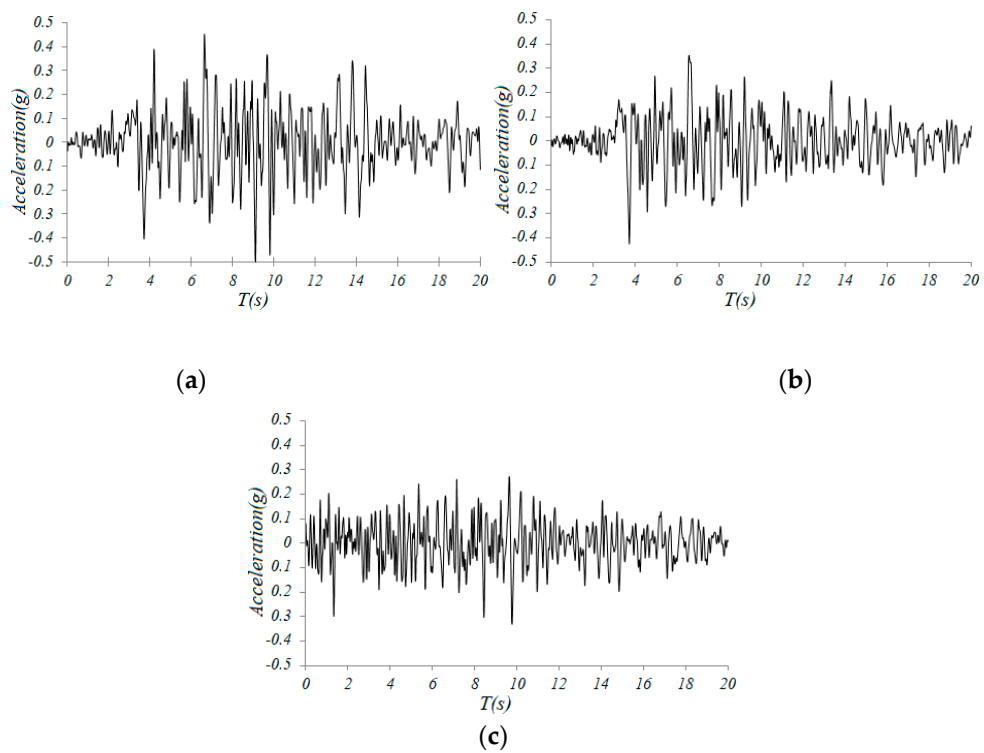
Figure 3. Amplified Taft earthquake wave: (a) X direction, (b) Y direction, (c) Z direction.

The analysis was divided into two steps. The first step was static analysis, where the gravity load was applied to the dome. The second step was dynamic analysis, where the time history of the Taft earthquake (Figure 3) was applied at the support, in X, Y, and Z directions, with the peak ground acceleration (PGA) of 0.5 g in the X direction, $0.85 \times 0.5 \text{ g}$ in the Y direction, and $0.65 \times 0.5 \text{ g}$ in the Z direction, respectively. According to the Chinese earthquake design code [37], the scale factors of 3.211304, 2.370329 and 3.161574 were applied to the original time history in three directions, respectively. The time duration was 20 s, which is greater than 10 times the natural period of the dome. The time step was 0.02 s. The constitutive model of the material uses the hybrid hardening model and the modulus considered the cumulative effect of damage to simulate the performance deterioration of the material, which occurred during plastic tension in the hysteresis process under seismic loading.

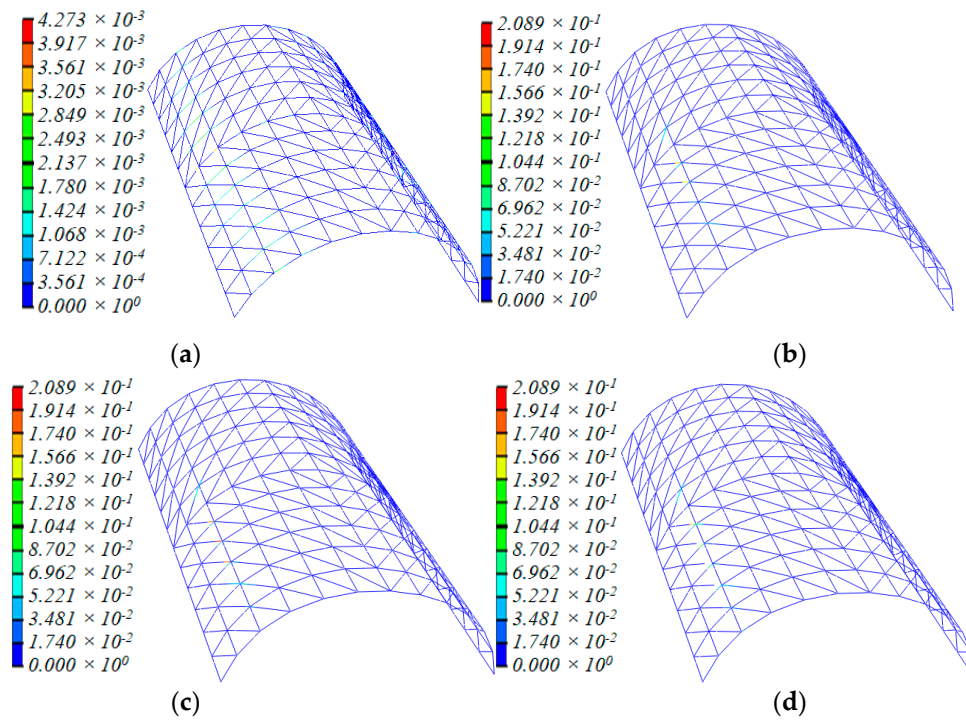
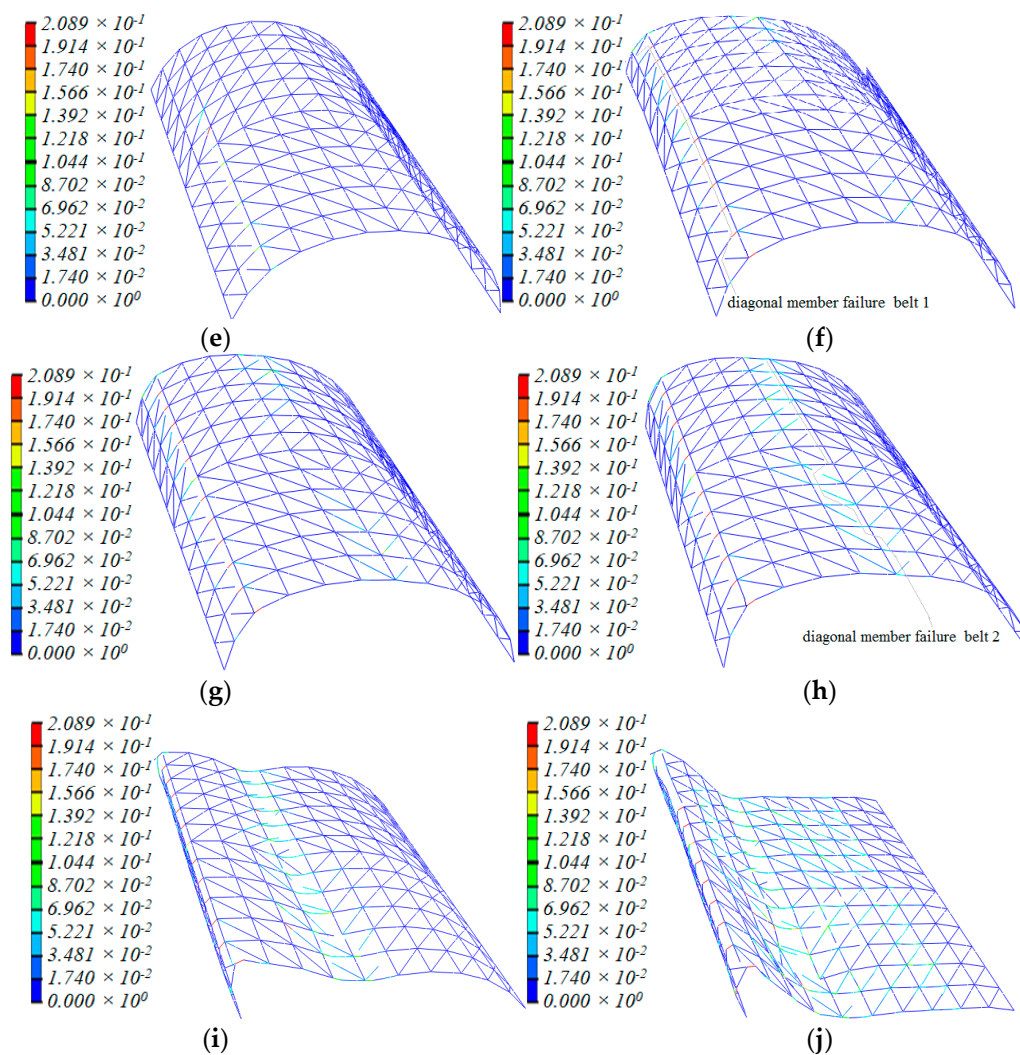
Figure 4. Deformation and D value distribution of structural members during the collapse process: (a) $t = 4.56$ s, (b) $t = 6.16$ s, (c) $t = 11.78$ s, (d) $t = 11.80$ s, (e) $t = 12.03$ s, (f) $t = 14.38$ s, (g) $t = 15.40$ s, (h) $t = 15.83$ s, (i) $t = 16.38$ s, (j) $t = 16.78$ s.

Figure 4 depicts the deformation and damage distribution during the collapse process, where the distribution of the D value can be checked. It demonstrates the process where the D value was zero, which indicates that no damage occurred until the rupture of the member when $D > D_{\text{limt}}$.

According to the analysis results, the dome entered the plastic stage at 1.88 s for the first time. Damage distribution spread to zones 2-2 and 3-3 and the symmetric zone of 6-6/7-7, but the D value was extremely small in this stage. With the ground motion continued, at 6.16 s, the D value of many diagonal and lateral members in zones 2-2 and 3-3, at adjacent ends, had obviously exceeded that of members in other zones (Figure 4b). By 11.78 s, the damage state of the whole dome had furtherly deteriorated. The D value of damaged structural members kept rising and more diagonal and lateral members were damaged. At 11.80 s, three diagonal bars in zone 2-2 failed at the ends of the joints with a threshold value of 0.209.

However, Earthquake loading is asymmetric, so plastic deformation and damage accumulation in the dome are also inevitably asymmetric. This means the D value and the increasing speed of the D value of the bars in this zone are larger than those of bars in other zones. With the continuing ground motion and gradually increasing amplitude, 5.13 s later, the center of gravity of the dome moved towards the X direction (Figure 11). This is because plastic deformation occurred due to vibrations, and the overall geometric configuration shifted towards zone 2-2. This phenomenon conversely caused the internal forces of members in zone 2-2/3-3 to become significantly larger than those in the symmetric zone of 11-11/10-10. Consequently, the speed of damage of bars in zone 2-2 was higher than that of bars in the symmetric zone (Figure 4b,c).

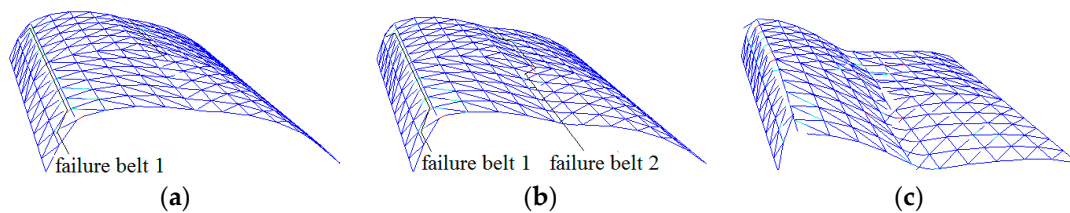
Figure 5. Collapse process of cylindrical reticulated domes of different span/depth ratios at typical times (span/depth = 4:1): (a) belt 1 formed, (b) belt 2 formed, (c) dome collapses.

Figures 5 and 6 depict the deformation and distribution of the damage of the structural member during the collapse process for the other two domes, with span:depth ratios of 4:1 and 2:1, respectively. Their spans are kept at 20 m. Figures 7 and 8, respectively, depict the other two 20-m-span domes, one with a length:width ratio of 1:1, another with a ratio of 2:1. With the increase in the length:width ratio, the position of the “diagonal member failure belt” moved from zones 2-2/6-6 to 3-3/7-7. The decrease in the length:width ratio caused a contrasting trend. With the exception of the above, the basic process of collapse and final collapse forms are similar.

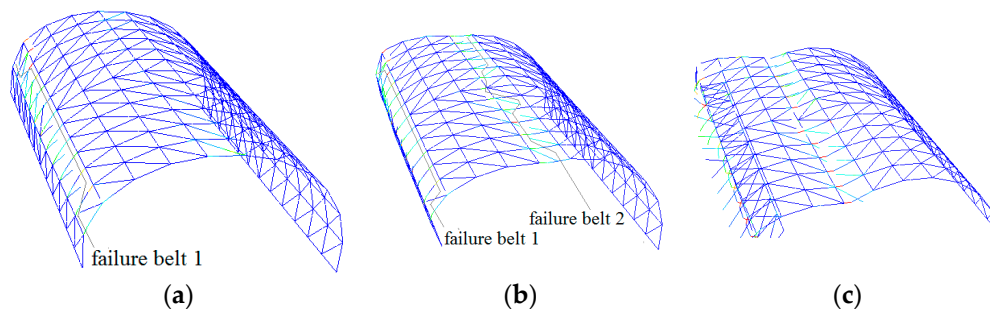
Figure 6. Collapse process of cylindrical reticulated domes of different span/depth ratios at typical times (span/depth = 2:1): (a) belt 1 formed, (b) belt 2 formed, (c) dome collapses.

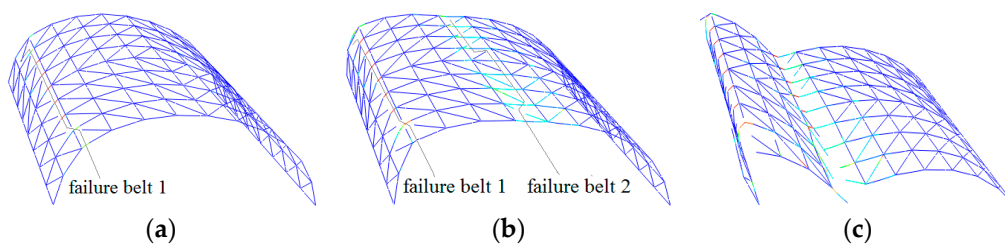
Figure 7. Collapse process of cylindrical reticulated domes of different length/width ratios at typical times (length/width = 1:1): (a) belt 1 formed, (b) belt 2 formed, (c) dome collapses.

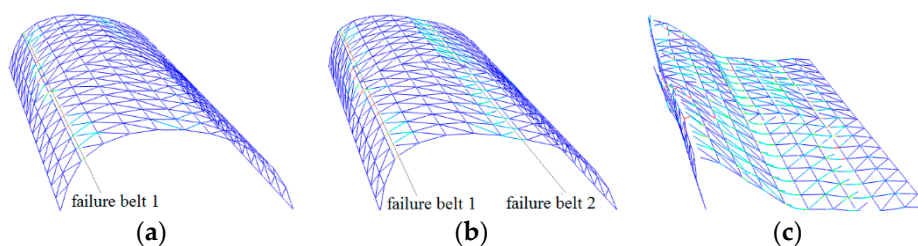
Figure 8. Collapse process of cylindrical reticulated domes of different length/width ratios at typical times (length/width = 2:1): (a) belt 1 formed, (b) belt 2 formed, (c) dome collapses.

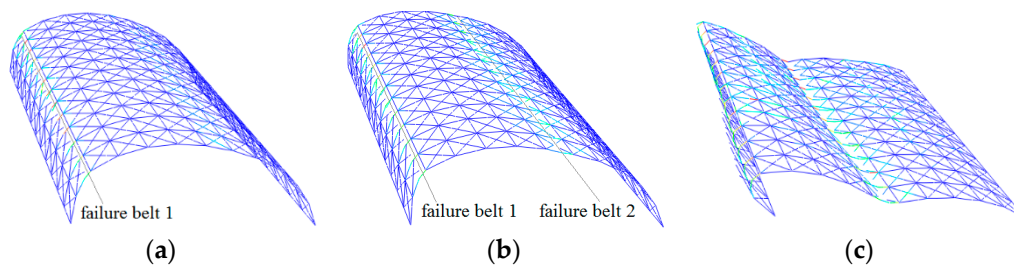
Figure 9. Double diagonal member failure belt: (a) belt 1 formed, (b) belt 2 formed, (c) dome collapses.

Figure 9 depicts the failure mode of double-diagonal member cylindrical reticulated domes, which are similar to single-diagonal member cylindrical reticulated domes.

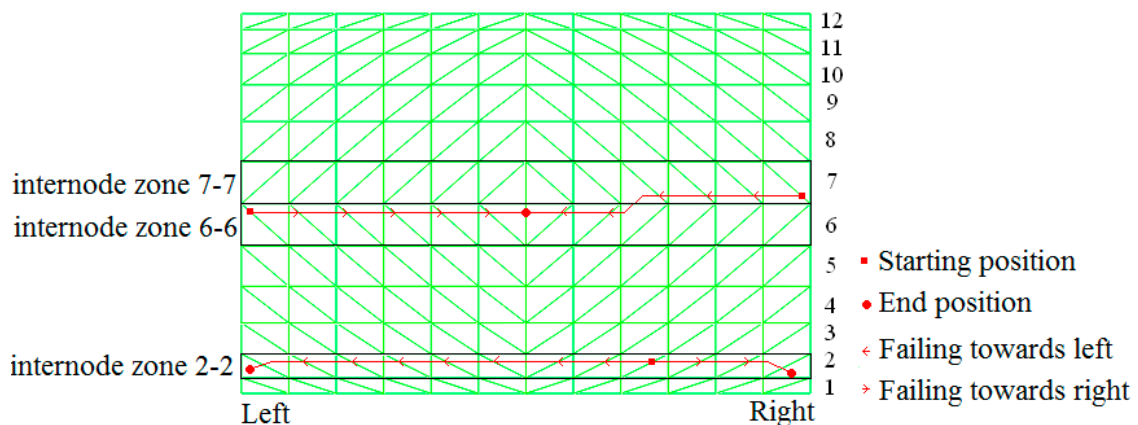
Figure 10. The demonstration of the collapse mechanism of the shell.

Therefore, a consistent failure pattern for the collapse process of single-layer cylindrical reticulated domes can be concluded. Under severe earthquakes, serious damaged first occurs at 1/4 height of the dome. Diagonal members failed continuously from the center to the boundary lengthwise and the first “diagonal member failure belt” came into being (Figure 10). The stiffness of the dome also greatly weakened. Then, another damaged zone appeared at the middle of the dome and, in this zone, diagonal members failed continuously lengthwise from the ends to the center. A second “diagonal member failure belt” was formed. The stiffness of the dome was reduced further. The whole deflection became significant. The position of the “belt” varied slightly with the change in geometry. In the final stage, the dome deflected rapidly at the second “belt”, dropping towards the first “belt”. The dome collapsed. We call this collapse process and phenomenon the “double-diagonal -members-failure-belt” pattern.

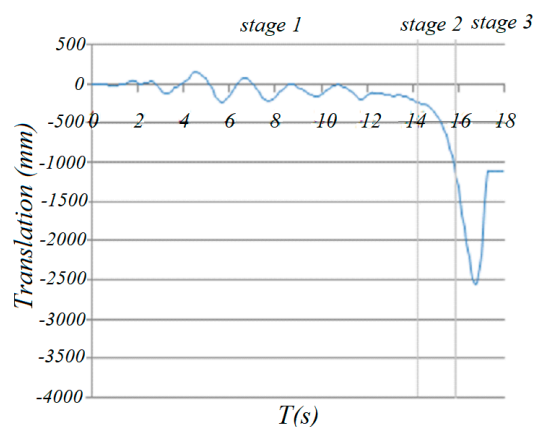
Figure 11. The horizontal translation of gravity center in X direction.

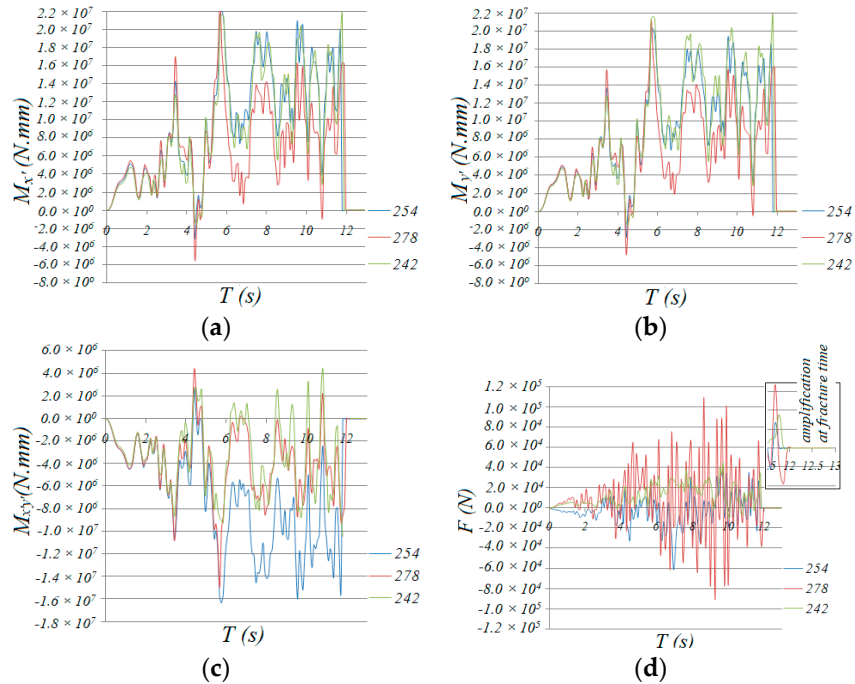
Figure 12. Time history of the internal force of the diagonal members: (a) $M_{x'}$, (b) $M_{y'}$, (c) $M_{x'y'}$, (d) F .

As shown in Figure 12, through a comparison of the time history curves of bending moments $M_{x'}$ and $M_{y'}$, torsion $M_{x'y'}$ and axial force F of members 242/254/278 in zone 2-2, it can be found that, although the axial force F of 254 was less than that of 242, the bending moments $M_{x'}$ and $M_{y'}$ and torsion $M_{x'y'}$ of 254 are obviously larger than those of 242. The axial force and bending moments of 278 are approximate to those of 254, but the torsion of 278 is less than that of 242. So, the D values of the slant bar of 254 and neighboring bars in zone 2-2 are obviously larger than those of other bars (Figure 4b,c).

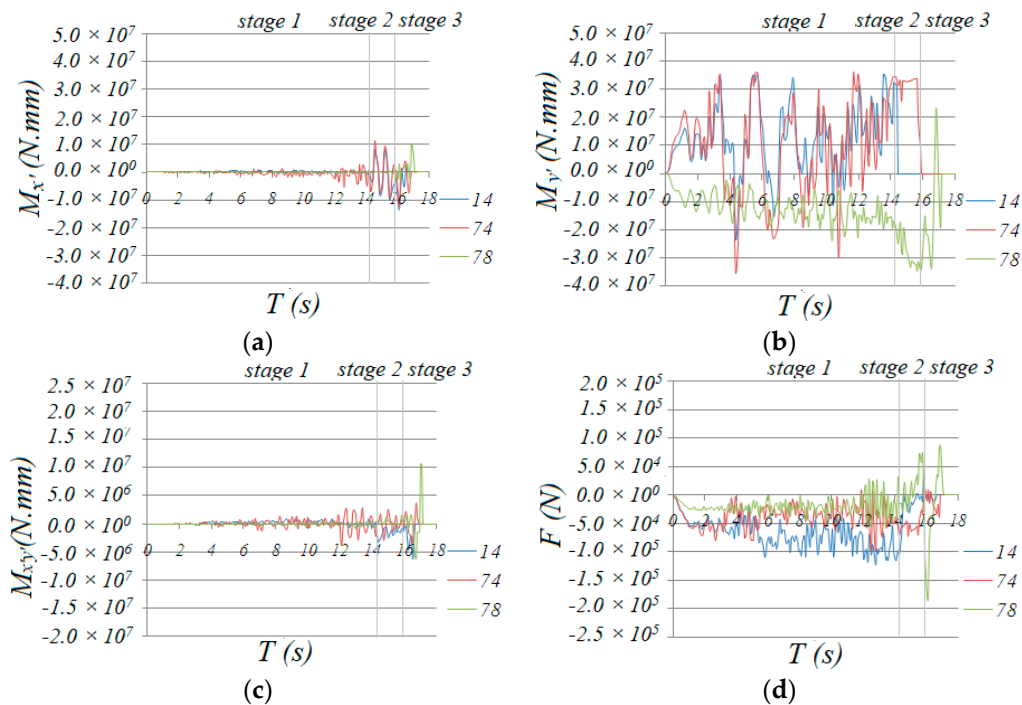
Figure 13. Time history of internal forces of traverse bar 14, 78 and 74: (a) $M_{x'}$, (b) $M_{y'}$, (c) $M_{x'y'}$, (d) F .

According to Figure 13, which shows the variety of internal forces of traverse bars 14, 78 and 74 at the center of zone 2-2, the traverse bars are mainly subjected to bending moment $M_{y'}$, while axial force F , bending moment $M_{x'}$ and torsion $M_{x'y'}$ at this stage are minimal, so $M_{y'}$ contributed mainly to the damage increment. This is why, in Figure 14, the normal stresses of upper section fiber 3 and lower section fiber 7 were much larger than those of middle section fibers 1 and 5, which hardly exceeded the yield point and caused corresponding material damage. Thus, damage development concentrated in fiber 3 and 7 and traverse bars hardly failed. This is the common response observed in all the traverse bars of the monoclinic and double-skew cylindrical reticulated domes under the same ground motion.

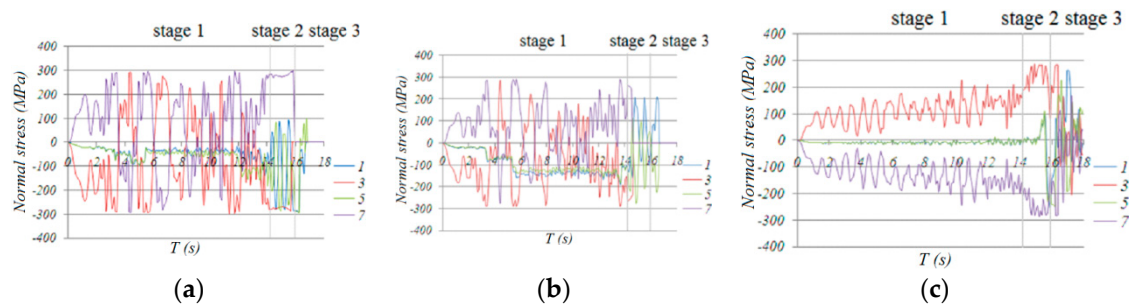
Figure 14. Time history of normal stress in fiber 1,3,5,7 of traverse bar 14, 78 and 74: (a) bar 74, (b) bar 14, (c) bar 78.

In Figure 14a, we can see that the normal stress at upper fiber 3 and lower fiber 7 at the end section of traverse bar 74 was maintained at a value of 280 MPa, which was much greater than the initial yield stress of 235 MPa, while the normal stress of fibers 5 and 1 also increased dramatically, acting as a plastic hinge. Fiber 3 and 7 of traverse bar 14 failed at a short time after entering this stage, but the stress of fibers 1 and 5, whose stress was relatively small, increased rapidly to around 200 MPa. We can conclude that the normal stresses of the remaining fibers of bar 14 were larger than the yield point. This means that the end of bar 14 acted as a plastic hinge as well. Finally, we can conclude that all the traverse bars in zone 2-2 that had not yet failed acted as plastic hinges. The formation of plastic hinges induced significant internal force redistribution effect. As shown in Figure 17, the bending moment M_y' , axial force F , bending moment M_x' and torsion $M_{x'y}'$ of diagonal bars 161 and 232 (Figure 1), one at the end and the other at the mid of zone 6-6, were less than those of bars 242, 254 or 278 (Figure 12) in stage 1. Thus, almost no damage was done to these bars. However, the value of M_y' , M_x' , torsion $M_{x'y}'$, began rapid increasing since the formation of the first “belt”.

The successive failure of diagonal members and damage to traverse bars in zone 6-6 greatly weakened the vertical stiffness of the dome. Thus, under the earthquake loading, the dome deflected downwards significantly. At the same time, angular displacement was observed in the traverse bars in zone 2-2, which made damage in fibers 3 and 7 develop rapidly (Figure 14).

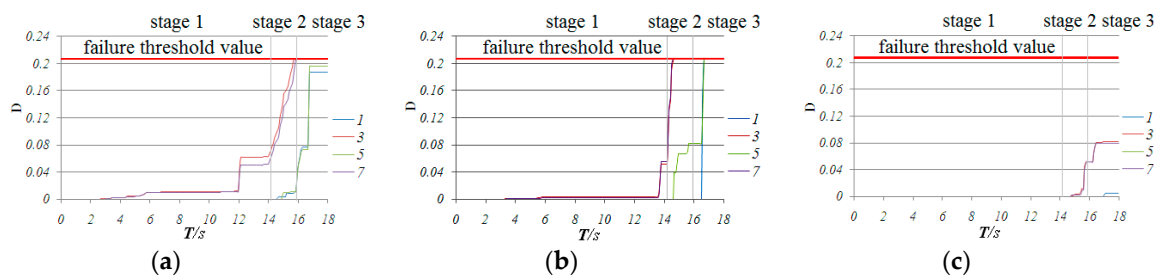
Figure 15. Time history of D value in fiber 1,3,5,7 of bar 14, 78 and 74: (a) bar 74, (b) bar 14, (c) bar 78.

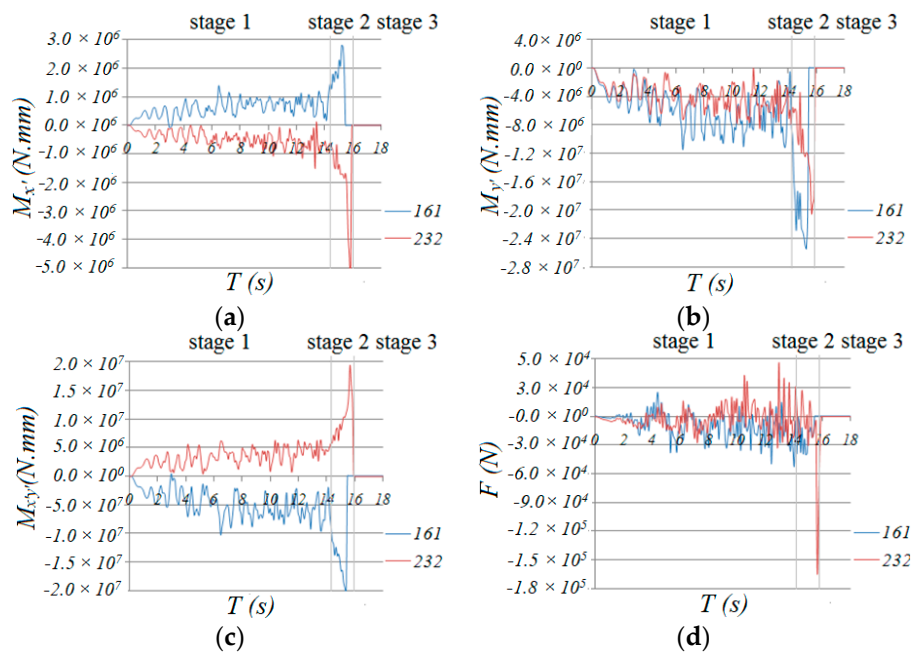
Figure 17. Time history of internal forces of diagonal bar 161 and 232: (a) $M_{x'}$, (b) $M_{y'}$, (c) $M_{x'y'}$, (d) F .

Therefore, continuously increasing the internal force induced by ground motion resulted in severe damage to the diagonal bars 0.8 s later when entering the second stage, because the internal forces of the bars at two ends were larger than that of the bars in the middle; the bars at the ends of the nodes of zone 6-6 failed first (Figure 4g). Then, the other bars failed successively from both ends to the middle in a short time. Finally, at 15.83 s, the second belt was formed.

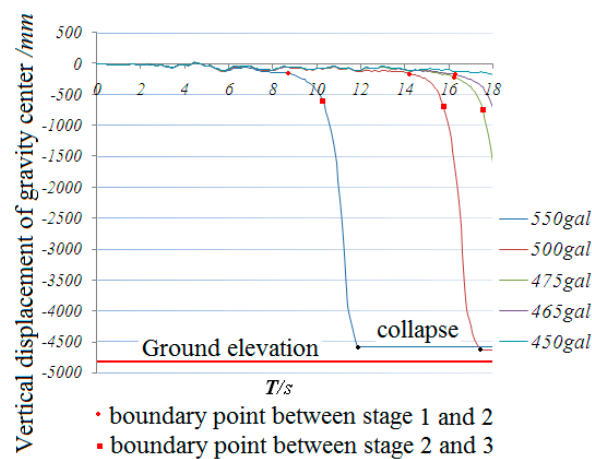
Figure 20. Time history of vertical translation of gravity center.

The deformation of the dome changed throughout the whole collapse process; therefore, the center of the structure changed as well. Figure 20 shows the change in the locations of the center of gravity of the structure during the whole collapse process. Different peak ground acceleration values were selected with the same duration of 18 s. It can be seen that the center of gravity decreased with the different PGA values.

When PGA was 0.45 g, the damage was observed at 1.9 s and the rupture of the first diagonal bar occurred at 16.44 s. However, the failure belt was not formed until 18 s. At 1.9 s, the location of the center of the gravity fluctuated and no significant acceleration in the center of gravity was observed.

It can also be seen that when PGA was 0.475 g, the acceleration distance of the center reached 1286mm; however, for a larger PGA of 0.5 g, when the time was shorter than 16 s, the acceleration distance of the center was smaller than 1286 mm, which indicates the effect of the duration on the time history.

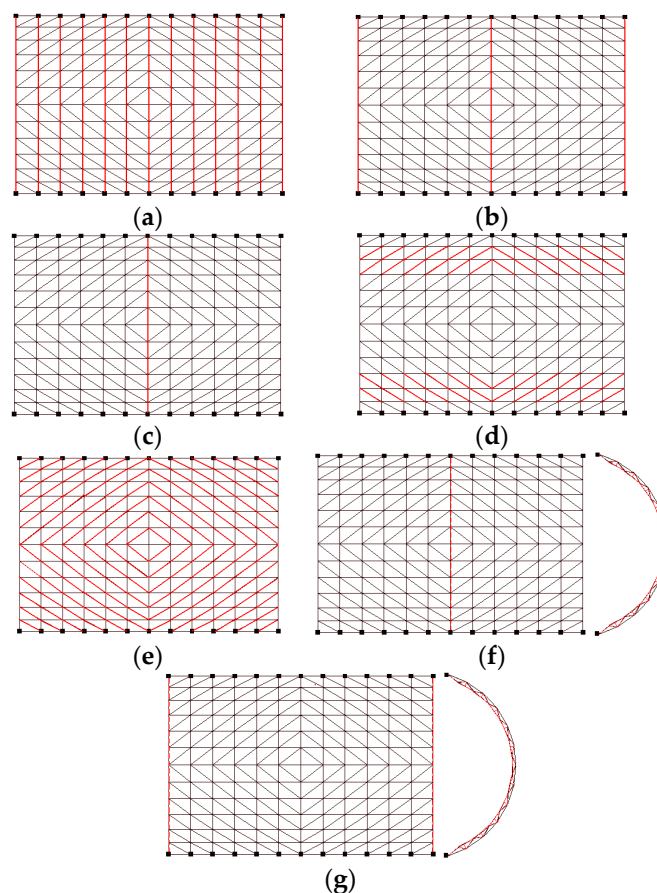
Figure 21. Seven different schemes to enhance the dome: (a) scheme 1, (b)scheme 2, (c) scheme 4, (d) scheme 4, (e) scheme 5, (f) scheme 6, (g) scheme 7.

Note: Red solid line represents the enhanced bars; the red dotted line indicates the plane arch truss. The height of the truss section is 450mm, and the diameter of the truss web members is $\Phi 30 \times 3.5$

Based on the numerical simulation results, seven mitigation schemes were developed to prevent the collapse of the dome: in Figure 21a, the cross section of all top chords in the transverse direction increased. In Figure 21b, the cross section of three top chords in the transverse direction increased. In Figure 21c, the cross section of the top chords at center was increased. In Figure 21d, the cross section of the diagonal members as shown in the Figure increased. In Figure 21e, the cross section of all the diagonal members increased. In Figure 21f, extra diagonal and bottom chords were added to the arch at the center of the shell. In Figure 21g, extra diagonal and bottom chords were added to the two arches at the end of the shell. All the increased section sizes used the ones specified in GBT17395-1998 [38], with a wall thickness of 6 mm.

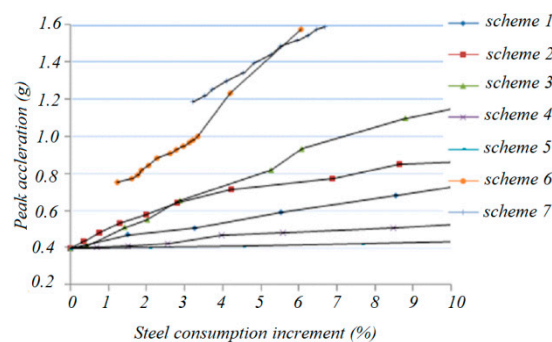
Figure 22. Relation between collapse peak acceleration vs. steel consumption increment.

A time history analysis was performed for all seven enhanced schemes. The results are shown in Figures 22 and 23. Figure 22 shows the relationship between the various earthquake inputs with the increase in the use of the steel material.

It can be seen that, with the increase in the steel consumption, the collapse peak acceleration, which can be taken as the seismic capacity index of schemes 6 and 7, increases most rapidly. On the other hand, for schemes 2 and 3, the capacity index increases less than in schemes 6 and 7, while in schemes 4 and 5, the capacity index increases the least.

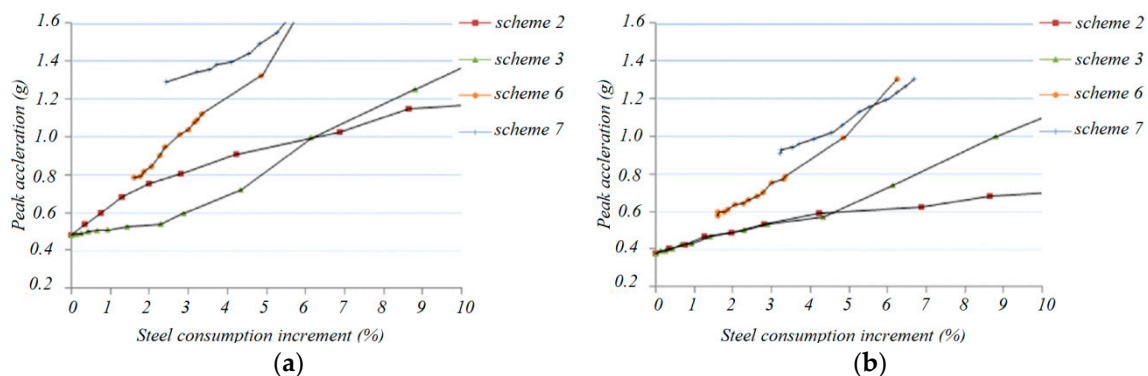
Figure 23. Curve of acceleration vs. steel consumption increment under various live loads: (a) proof live load 1.3 KN/m^2 , (b) proof live load 1.7 KN/m^2 .

Figure 23 shows the relationship between the various live loads (1.3 KN/m^2 and 1.7 KN/m^2) on the roof with the use of the steel material after the analysis. It can be seen that scheme 7 shows a reasonably high earthquake resistance with a small increase in steel usage.
