Autonomous Systems Imaging of Aerospace Structures

Shakeb DEANE ^{1*}, Nicolas AVDELIDIS ^{1,2}, Clemente IBARRA-CASTANEDO ²,
Xavier MALDAGUE², Antonios TSOURDOS ¹, Alex A. WILLIAMSON ³,
Hamed YAZDANI-NEZHAD ¹, Hai ZHANG ²

Abstract. Manufacturers are constantly looking for more cost-efficient means to produce aircraft components. An effective way to do this is to reduce the weight, which results in less fuel required to power the aircraft. This has led to an increased use of composite materials. Carbon fibre reinforced polymer (CFRP) composite is used in industries where high strength and rigidity are required in relation to weight. e.g. in aviation – transport. The fibre-reinforced matrix systems are extremely strong (i.e. have excellent mechanical properties and high resistance to corrosion). However, because of the nature of the CFRP, it does not dent or bend, as aluminium would do when damaged, it makes it difficult to locate structural damage, especially subsurface. Non-Destructive Testing (NDT) is a wide group of analysis techniques used to evaluate the properties of a material, component or system without causing damage to the operator or material. Active Thermography is o

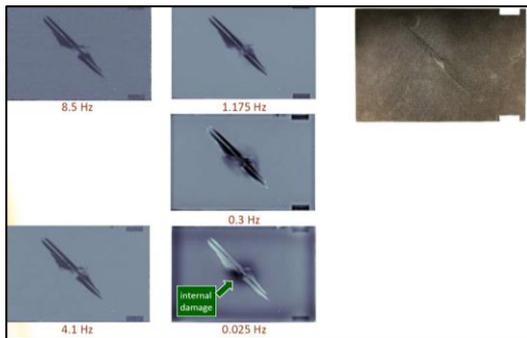
Figure 10: Sample 20J Demo, Reflection rear face, PPT. The rear face has some substantial damage. The PPT locates the surrounding internal damage.

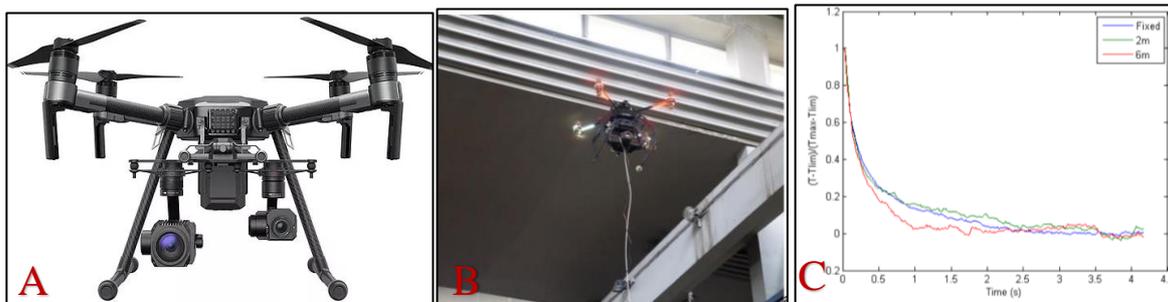
FIGURE 13 A: DJI M210 equipped with thermal camera [8]. FIGURE 13 B: UAV equipped with thermal camera [7]. FIGURE 13 C: Comparison of front face temperature responses to flash heating in the case of a large uniform irradiation with a fixed camera and a stabilized camera with UAV at two distances (2 m and 6 m) [7].

Although a cooling camera was used in the beforementioned NDT test, this type of camera will not be feasible for UAV thermographic inspection. Cooling cameras usually require cryogenic cooling, which is an excess of weight. The equipment we currently have is a DJI M210, which carries an RGB and thermal camera. The thermal camera is 640 x 512 pixels which is the exact same pixels as the FLIR Phoenix that was used. It has a 13mm lens and is radiometric, therefore it uses a set of techniques to measure electromagnetic radiation, including visible light, this means that the acquired data can be extensively analysed after the survey in order to visualise and understand the data such as the temperature variations [8].

UAV dynamic inspection has the potential to provide a complete portrait of the aircraft structure much faster than static inspections. For a UAV inspection an external excitation source will be employed to heat the surface. The thickness of the composite panel may make it difficult to gather adequate results, therefore many excitation sources need to be tested other than flash lamps. For instance, halogen lamps (heating the surface for longer), Heat Blankets or a Laser. Along with the liquid penetrant NDT method, a UAV thermographic inspection was tested for civil engineering applications (see Figure 14). The UAV is equipped with a FLIR A320, this IR camera is connected to a computer via a cable, one is a power cable and the other provides real time radiometric thermal images which will reveal heat patterns and thermal anomalies [7]. Transient thermography with flash and step heating where the methods used in this inspection. An inspection took place and gathered data on difference distances between the camera and the samples (2, and 6 metres). Along with the UAV equipped with the IR camera, there was a fixed IR camera, therefore two sets of data could be acquired and compared. A thermally uniform area of a sample is delimited, and the IR cameras captured the data [7].
