Citation: Su, Q., Cai, G., Hani, M., Si Larbi, A. & Tsavdaridis, K. D. (2023). Damage control of the masonry infills in RC frames under cyclic loads: a full-scale test study and numerical analyses. *Bulletin of Earthquake Engineering*, 21(2), pp. 1017-1045. doi: 10.1007/s10518-022-01565-y

Damage control of the masonry infills in RC frames under cyclic loads: A full-scale test study and numerical analyses

This study investigates the effect of damage control methods on the seismic performance of masonry infilled walls in reinforced concrete (RC) frames, by experimentally investigating three full-scale infilled RC frames with different treatment details and finite element method (FEM) analysis. The control methods included full-length connecting steel rebars, styrene butadiene styrene (SBS) sliding layers, and two gaps between the wall and frame columns. The results indicated that the ductility, wall damage, and residual deformation of the frame with gaps or SBS layers were significantly improved. However, the initial stiffness, energy dissipation capacity, and lateral load-carrying capacity of the frames with SBS sliding layers all were reduced. The fully infilled frames exhibited

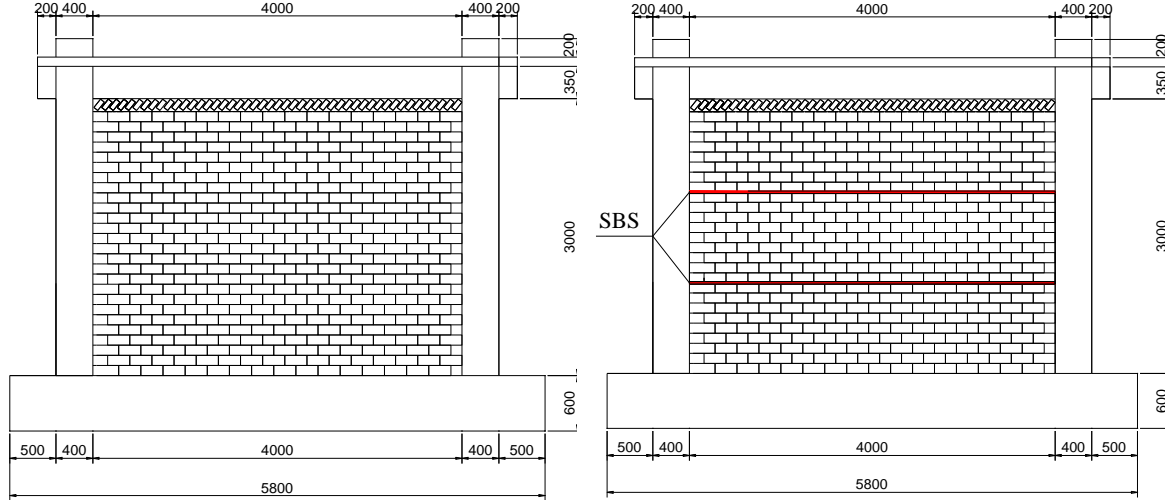
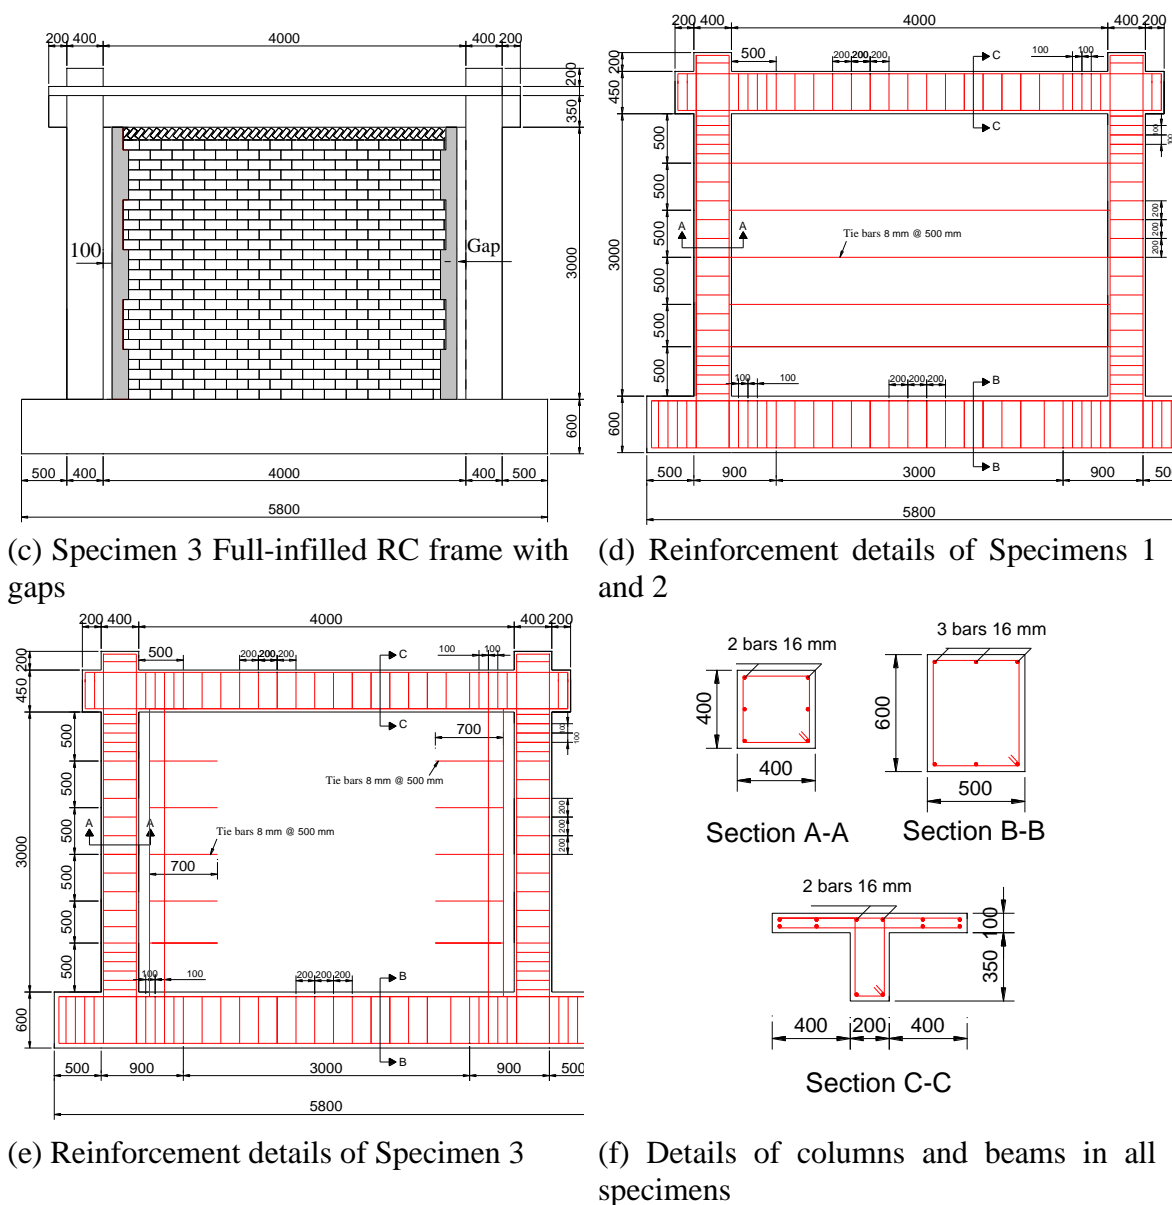
Figure 1 Dimensions and reinforcement of the tested frames

(a) Specimen 1 Full-infilled RC frame

(b) Specimen 2 Full-infilled RC frame with SBS

Specimens 1 and 2 were infilled fully with MHB walls connected with ten full-length horizontal connection rebars at five levels, which include two 8.0 mm diameter plain bars at each level with the same spacing and were fixed in the mortar layer between the bricks. In Specimen 2, two SBS slip layers were arranged inside the infilled wall with the same spacing from the wall bottom. The SBS layers were placed between the bricks without mortar. Specimen 3 applied ten horizontal connection bars, divided into 5 levels (spacing = 700.0 mm), where each level had two plain bars (diameter = 8 mm) with the same spacing from the wall bottom. All rebars were fixed in the mortar layers between the bricks. Two full separation gaps were designed between the filled wall and the frame columns in the direction

of wall height, with a width of 100.0 mm, as shown in Figure 1 (c). In addition, to prevent the wall from collapsing prematurely due to the two gaps during the test, two detailing columns were constructed on both sides, which were staggered by MHBs and their longitudinal reinforcements passed the holes of bricks filled by mortar.

All tested specimens are full-scale one-bay-one-story MHB-filled RC frames designed as per Chinese design codes [30,31]. The details of dimensions and reinforcement of the frames are plotted in Figure 1. The sectional dimensions of the columns were 400 mm \times 400mm ($b \times h$), while that of the beams was T-shape with the dimension of 200mm \times 450mm \times 1000mm \times 100 mm ($b \times h \times b_f \times t_f$). The base beams used a larger section with a dimension of 500mm \times 600 mm ($b \times h$), as shown in Figure 1. Six 16 mm deformed bars, four 16 mm deformed bars, and six 16 mm deformed were used as the longitudinal reinforcements in the frame columns, frame beams, and base beams, respectively. The steel stirrups of the frame beam, columns, and base beam all were 8 mm diameter plain rebars with a spacing of 200.0 mm and 135-degree hooks. The connection rebars were planted into the wall and connected with frame columns, as shown in Figure 1 (b) and (d). The aspect ratio of all walls, l_w/h_w (l_w and h_w are the length and height of the walls), was 1.33.

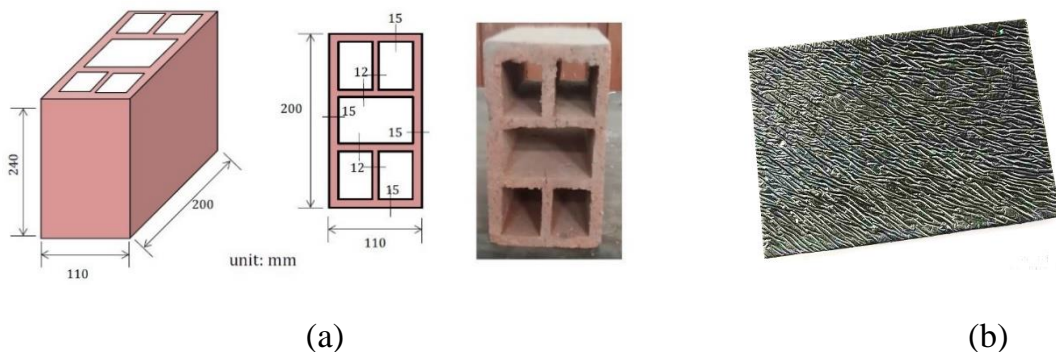
Figure 2 Applied bricks and sliding layers in tested specimens (a) Masonry hollow bricks (b) SBS layer

All frame beams and columns were made of normal compressive strength concrete. The average cube compressive strength of the used concrete (size 100x100x100mm³) was 33.5 N/mm² (prismatic concrete compressive strength, 150x150x300mm³, 14.3N/mm²), whose elastic modulus was 30.0 kN/mm² obtained by standard tests [30,31]. For the longitudinal and transverse reinforcements, the yield strength of the used 8mm and 16 mm diameter plain rebars were 480 N/mm² and 420N/mm²[32], respectively. The frames were infilled with MHBs (240mm×200mm×110 mm, see Figure 2), which are the same as the bricks in the literature [28,29]. The ratio of net area to the gross area of the bricks was 47.85%, and the average weight per unit of the bricks was about 4.96N. The thickness of mortar used for the walls was between 7mm to 10mm. The average compressive and tensile strengths of the mortar used in all frame specimens were 5.62 N/mm² and 0.45 N/mm², respectively, through standard tests [33]. The average compressive strength of the used masonry brick in the direction of its holes was 3.5 N/mm², considering the gross area of the bricks. The SBS layer is made of polyester felt, glass fiber felt, and glass fiber reinforced polyester felt as the base, and asphalt using a modifier of SBS. Its thickness and density were 3.0 mm and 34.3N/m² respectively, and covered with polyethylene film as isolation materials, as shown in Figure 2. The dissoluble composite of the membrane of the SBS layers was 2100g/m² and its elongation at maximum tensile force can be over 35%. The maximum tensile force load along the length direction of the layers (test specimen length 200 mm and width 50 mm) was 3.33N/mm².

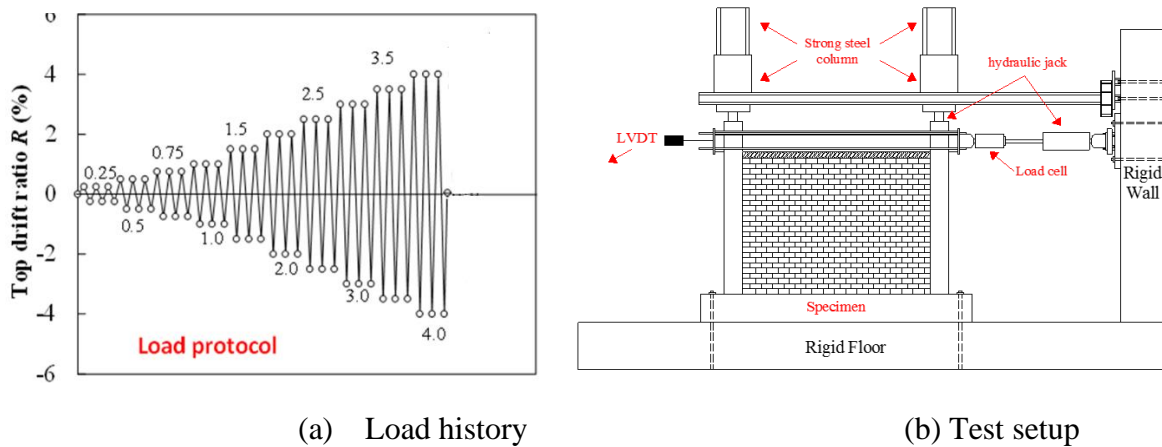
The details of the test setup and instrumentations are presented in Figure 3. The base beams of the specimens were fixed to a strong floor through several high-strength steel bolts.

Figure 3 Load protocol and test setup.

As shown in Figure 3, a reversed cyclic lateral load was conducted at the top frame beam of each specimen, after the designed axial load was applied on the top of the two frame columns. To observe the first crack of the infilled walls, the loading method at the beginning of the test is designed to be force-controlled until the drift rate was 0.25%, in both directions. Afterward, three full cycles of displacement-controlled loading were conducted at the subsequent target loading cycles until the drift ratio was 4.0%. The main test observations included cracking, damage, and collapse of the bricks, all of which were carefully recorded during the tests. The tests were ended when (1) the drift ratio reached 4.0 % to ensure the safety of researchers and test devices, or (2) the frame failed to resist the applied loads making the load-carrying capacity below 50% of the peak load.

Each specimen was tested under a combination load with reversed cyclic lateral load and a constant axial load. The lateral load was applied at the upper frame beams using a hydraulic jack shown in Figure 3, while the axial load was applied at the top of the columns by two hydraulic jacks. The applied axial load in each column was 572.0 kN, about 25% of the axial load capacity of the columns calculated based on concrete prismatic compressive strength. To confirm the possible move of the specimens during the tests, two linear variable differential transducers (LVDTs) were used at the ends of the base beams. One LVDT was applied at the load level to measure the lateral displacement of the specimens to calculate the drift ratio of the specimens (R) to control the lateral loading.

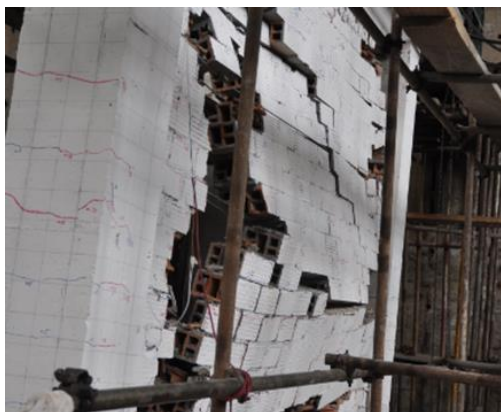
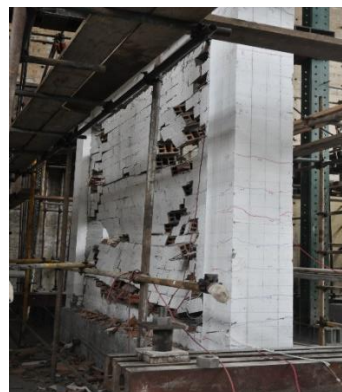
Figure 4 Damage of Specimen 1 at $R=4.0\%$

As shown in Figures 4 to 6, the treatment methods in the walls present a significant influence on the seismic performance of infilled RC frames. For Specimen 1, when the drift ratio was 0.25%, several cracks were observed, including diagonal and horizontal cracks on both sides of the wall, transverse cracks in the middle of the frame columns, and the diagonal zone at the ends of the frame beam (upper beam, same as below). When R reached 0.5%,

new cracks appeared inside the frame columns and were roughly distributed on the infilled wall. The previous cracks at the ends of the beam extended to the beam edges and the beam-column joint zones. While R was 1.0%, several cracks were observed in the mortar in the middle of the wall and the zones of the connection rebars. Some connecting steel bars were exposed and the mortar layer is completely peeled off. The mortar on the wall's middle sides fell off and the upper connection bars were slightly bent outside when R reached 1.5%, and several bricks were crushed and fell off on both sides of the wall at the same time. When R was 2.0%, the cracks in the columns developed significantly, while the connecting rebars were bent seriously and the bricks continually fell off from $R=2.5\%$. After R exceeded 3.0%, the wall top was separated from the upper beam bottom, and more connecting bars were exposed. Before $R=3.50\%$, the wall subsidence occurred in the specimen middle, and more bricks were crushed and more connecting rebars were seriously bent. At $R=4.00\%$, the infilled wall collapsed almost completely, as shown in Figure 4 (a), making the wall exhibit a similar structural behavior to a bare RC frame.

(a) front view of wall collapse

(b) back view of wall collapse

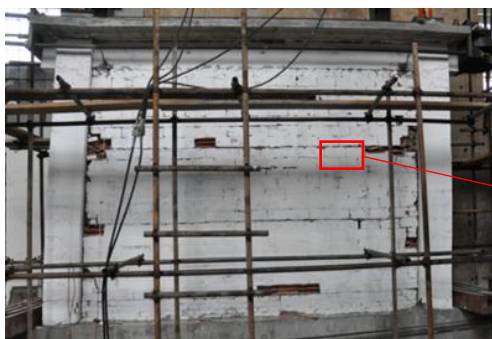
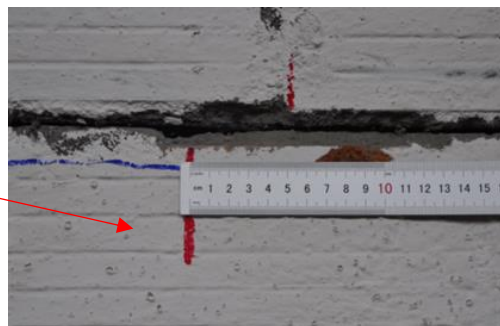
(a) overall damage at $R=4\%$

(b) slippage of SBS layer at $R=2\%$

Figure 5 Overall damage of Specimen 2 and slippage of the SBS layers

Regarding Specimen 2, as shown in Figure 5 (a), the use of SBS layers significantly reduced the damage and collapse of the infilled wall. At $R=0.25\%$, several cracks were observed along the SBS layers, at the bottom corner of the wall, the middle and bottom of

the columns, and the end of the frame beam. When R reached 0.50%, the wall was divided into three parts by the two SBS layers, and the previous cracks were developed slowly until $R=1.0\%$. From $R=1.25\%$, the SBS layers started to slide freely in the wall. In general, the cracks and damage to the wall were much smaller than those of Specimen 1. Major cracks and damage were concentrated on the two bottom edges of the wall. The corner bricks and beam bottom concrete were crushed and the internal longitudinal reinforcements were exposed in the beam. After $R=1.75\%$, several cracks appeared on the columns and the wall sides. When $R=2.00\%$, only the bricks at the corners of the three small walls were crushed. This means that the diagonal resistance struts were formed in each small wall. However, due to slippage of the SBS layer, the diagonal strut was weak and insufficient to form diagonal cracking damage. The three small walls separated by the layers continued to slide along the layers. As shown in Figure 5 (b), the slip displacement reached 50.0mm at $R=2.0\%$. After R exceeded 3.0%, the three small walls continued to slide, as well as the bricks were crushed, fell off, and expanded horizontally until the end of the test. The cracks extended at the beam ends and the bottom of the columns, but the wall was intact with less damage compared with Specimen 1.

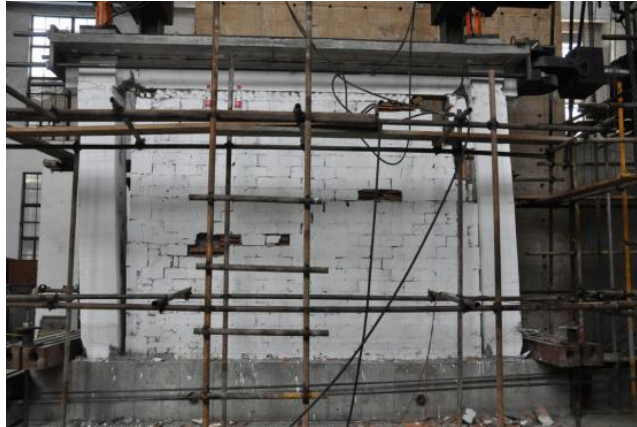
For Specimens 3, several diagonal cracks occurred in the wall and developed rapidly at the beginning. When R reached 0.50%, the bricks at the top of the wall fell off and some cracks were observed between the wall and the columns, at the frame beam ends. When the drift ratio reached 0.75%, more bricks fell off and were crushed at the inside edge of the columns, and the previous cracks were developed quickly. The beam-column joint zones were damaged and local concrete fell off at the same time. When R exceeded 1.0%, all cracks observed previously were developed further and new cracks appeared in the middle of the columns. The collapsed area of the wall was increased and concentrated near the ends of the columns, but the collapse ratio was still small until $R=1.25\%$. At $R=1.50\%$, the large increase in the cracks and collapsing in the middle of the wall was not obvious because the wall was separated from the detailing columns. From that moment on, the frame behaved as a bare RC frame. When $R=1.75\%$, the wall was damaged slightly, the concrete at the beam bottom was crushed, and the steel rebars of the columns were buckled slightly. After that, the rebars of the columns were severely buckled and the concrete at the beam ends was crushed heavily as well. As R reached 2.50%, several steel rebars of the columns were broken, while the rebars of the frame beam were severely buckled. The infilled wall was in close contact with the frame columns on both sides at $R=3.0\%$, and the longitudinal steel rebars at the beam ends were fractured, leading to the final failure of the frame at $R=4.0\%$. In summary, all described cracks and damages were distributed in the infilled wall and several bricks fell off from the frame, however, the wall was intact and the frame was protected well, as shown in Figure 6.

Figure 6 Damage of Specimen 3 at $R = 4\%$

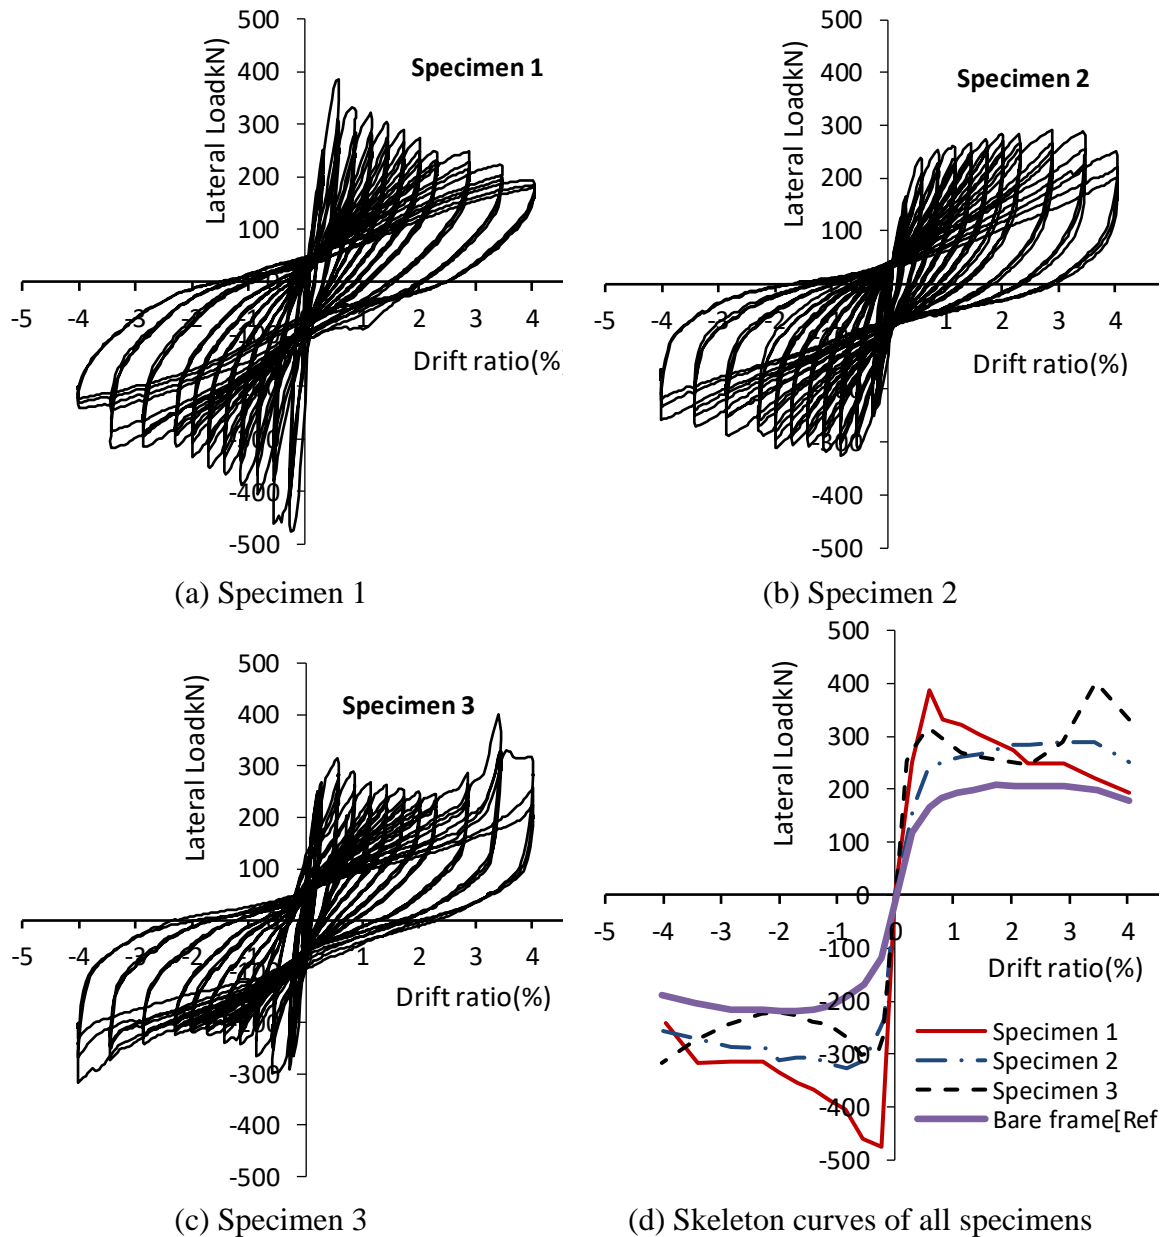
The lateral load-displacement hysteretic curves of all specimens and their skeleton curves are presented in Figure 7, which both are important to assess the seismic behaviors of the specimens. The results show the load-carrying capacity of the specimens is greater than that of the bare frame made with the same bricks in the previous study [28]. Due to the influence of the infills, the skeleton curves of Specimens 1 and 3 present distinct peaks (See Figures 7 (a), (c), (d)). After adding the SBS layers to Specimen 2, the strut effect of the infilled wall was significantly weakened and the skeleton curve did not present an obvious peak (see Figure 7 (b)). As shown in Figure 7 (c), the hysteretic curve of Specimens 3 was firstly a vertical long-narrow shape but rapidly changed to a long-fat shape. Besides, the curve appeared a sudden increase in load-carrying capacity when R reached 2.5%. The closing of the gaps on both sides of the wall was the main reason for the increase in the capacity. The skeleton curves plotted in Figure 7 (d) show that the skeleton curve of Specimen 1 increases to its maximum capacity at $R=0.50\%$ and then decreases sharply until about 2.0%, followed by a short stable stage until $R=3.0\%$. Besides, compared with Specimen 1, the curve of Specimen 2 was more stable in increasing and decreasing phases in both directions. However, both the maximum load-carrying capacity and initial stiffness were smaller than those of Specimens 1 and 3, especially its maximum capacity was only 3/4 times that of Specimen 1. For Specimen 3, the curve reached the first peak load at $R=0.50\%$, then slowly declined with a similar downward trend to that of Specimen 1 and ended at $R=2.0\%$. After that, the load-displacement curve increased to its second peak load when R reached 3.0% to 4.0%, which was larger than the first peak load. As the lateral displacement increased, the lateral load dropped sharply to a similar level to those of the other two specimens. With the lateral load increasing, the bending and damage of the detailing columns increase continuously, and its load-carrying capacity decreases gradually. As the detail columns bent causing the gaps between the wall and detailing columns to be closed, the bearing capacity increased gradually. After that, the bearing capacity decreased again and a second peak occurred as the wall damage intensifies. It was understood that Specimen 3 reached its ultimate load (the first peak) at $R = 0.5\%$, however, the specimen provided a higher load-

carrying capacity because the detailing columns made the wall contact with the frame columns, further increasing the ultimate capacity of the specimen. Compared with Specimen 1, Specimen 3 provided a small early peak capacity because the gaps between the frame and infilled wall reduced the diagonal strut effectiveness of the infills. But after the gaps were closed at the corners, Specimen 3 could provide almost the same level of capacity as Specimen 1 at the same displacement.

Figure 7 Lateral load-displacement curves of tested specimens

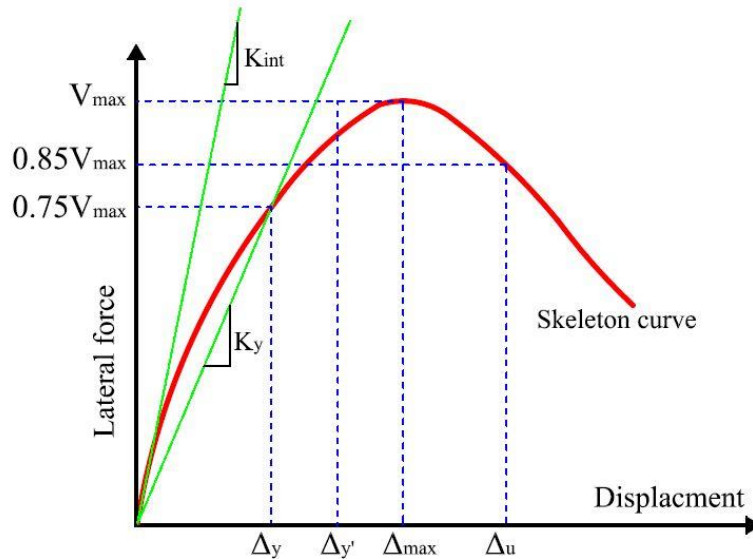
The initial stiffnesses discussed in this study include mainly initial elastic deformation stiffness K_{int} and yielding stiffness K_y , as shown in Figure 8. The stiffnesses were calculated as secant displacement stiffness corresponding to 0.33 and 1.0 times the measured yielding displacement (Δ_y) of the specimens, respectively. The yielding displacement was the measured displacement corresponding to (1) the yielding point of the skeleton curves of the load-displacement curves of the elements or (2) when certain longitudinal rebar in the frame columns reached its yield strength. In the present study, taking the yielding displacement Δ_y of the infilled frames as the measured displacement corresponding to $0.75V_{max}$, and using maximum lateral displacement (Δ_{max}) and ultimate displacement (Δ_u) corresponding to $85\% V_{max}$ [34,35], the maximum and ultimate ductility of the frames (μ_{max} and μ_u) are calculated as Eq. (1). The ultimate drift ratio δ_u was calculated using the ultimate displacement divided by specimen height (H), which is calculated as Eq. (2).

Figure 8 Definition of ductility and stiffness on the skeleton curves

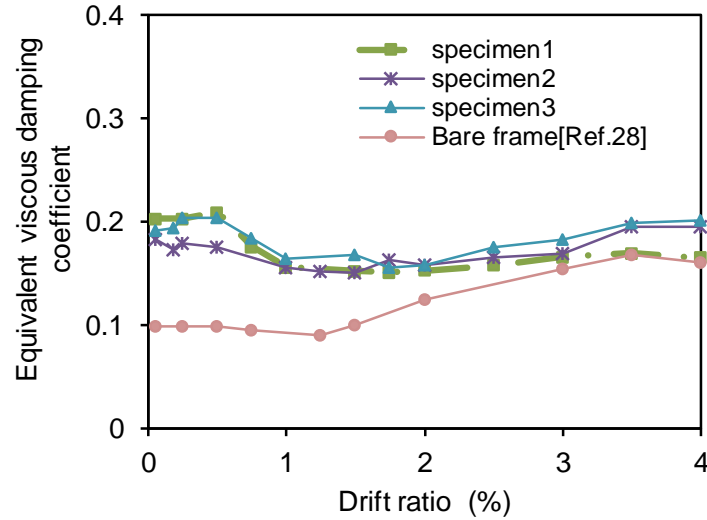
The equivalent viscous damping coefficient (h_{eq}) defined by previous research [36] was applied in this study to discuss the energy dissipation capacity of the specimens. Figure 9 presents the development of the h_{eq} coefficient-drift ratio curve of all specimens. The results indicate that the infill properties, gaps, and the sliding layer all have a significant influence on the energy dissipation capacity of the frames, especially at the early stage of loading. Because the sliding layer reduced the diagonal strut action of the infills, the self-restoring capacity of the infilled RC frame was increased resulting in a significant decrease in the energy dissipation of Specimen 2. Besides, the additional gaps near the frame columns only influenced the energy dissipation capacity of the frame at the large deformation stage, as shown in Figure 9. Compared with the bare RC frame in the literature [28], an obvious decrease in the factor h_{eq} was observed in Specimen 1, in particular before the drift ratio reached 2.0%. The additional SBS layers made the energy dissipation capacity of the RC frame (No.2) higher than that of the bare RC frame [28] before $R=3.0\%$, but a similar energy dissipation capacity was presented at the subsequent loading cycles.

Figure 9 Equivalent viscous damping coefficients versus drift ratios

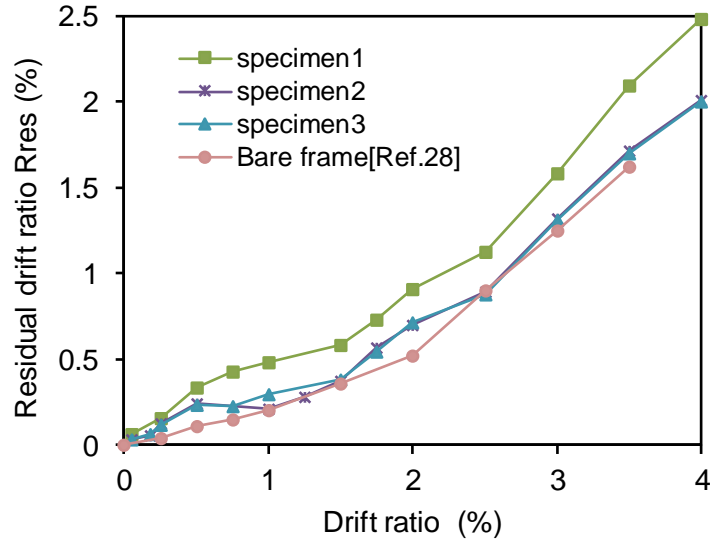
The lateral residual deformation of structural elements represents their self-resilience capacity affecting the repair and strengthening of whole structures. In general, a RC frame is expected to recover for an easy repair after an earthquake, but the damage and plastic deformation accumulated on infilled walls during reverse lateral loads usually prevent RC frames from recovering. In this study, the residual drift ratio (R_{res}) of columns was the drift ratio corresponding to the lateral load equaling zero at the first loading loop with each target drift ratio. The calculated ratios were taken as the mean values obtained in both load directions in the study, which are presented in Figure 10. The results show that the residual drift ratios of all specimens increase stably with the target drift ratios. Specimen 1 presents the highest residual deformation as the wall was damaged significantly caused by the development of cracks and the strongest diagonal strut effectiveness in the fully infilled frame. While both Specimens 2 and 3 show almost the same behavior which means both the SBS layers and the gaps at both sides of the wall reduced the diagonal strut effect of the infills on the surrounding frame columns. This significantly increased the restoring of the frame columns and beams, which is similar to a bare frame, especially at the large deformation stage. The difference in the residual deformation caused by the different lengths of connecting rebars just can be observed before $R=2.0\%$, which may be attributed to the anchorage of the connecting rebars failing at the large deformation stage.

Figure 10 Evolution of residual deformation of the frames

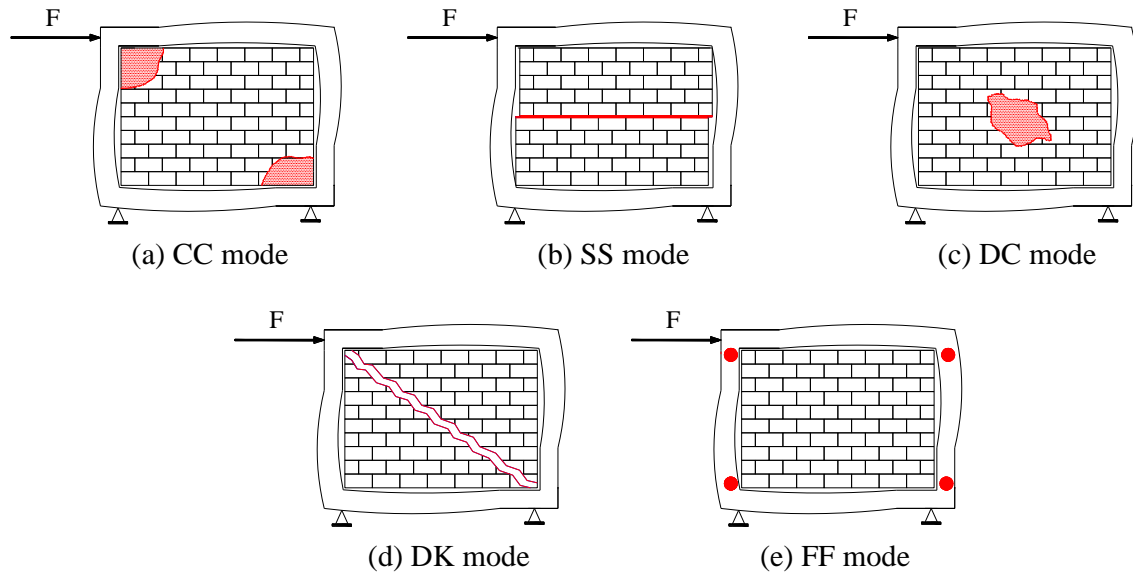
The failure modes of the infill walls used the masonry bricks mainly include corner crushing failure (CC), sliding shear failure (SS), diagonal compression failure (DC), diagonal cracking failure (DK), and frame failure (FF), as same as previous research summarized in Figure 11[37]. Based on the experimental results, the failure modes of Specimens 1 to 3 are CC, SS, and CC modes, respectively.

The CC and DC failure modes are prone to occur in relatively strong RC frames with weak infill walls or RC frames with large aspect ratios. The MHBs or other lightweight blocks are used increasingly recently due to their suitable strength, which can produce the suitable diagonal strut effect of the infill wall in RC frames at the early stage of deformation. The CC and DC are the most common failure modes of infilled walls in China. When thin flexible layers are arranged in the horizontal brick joints of the hollow brick infill wall such as the SBS layer used in the study, the SS failure mode usually occurs in RC frames. Besides, the DK mode usually occurs when the frames or beam-column joints are relatively weak with a quite strong infill. It is worth mentioning that only CC and SS failure modes are of practical importance [38], while the DK mode occurs very rarely because solid bricks with high strength are no longer used in infilled walls in many countries such as China. Generally, the frames with DK failure modes can absorb more earthquake energy, however, their damage is much more serious than other frames. On the contrary, the damage of infilled walls in RC frames with FF failure mode is much smaller, but the frame joints are usually damaged seriously. It can be seen that the walls with SS, DC, and CC failure modes can effectively protect structural frames at the cost of serious damage to the infilled walls (except SS mode). This highlights the superiority of the treatment method in Specimen 2 with SS failure mode.

Figure 11 Different failure modes of masonry-infilled frames

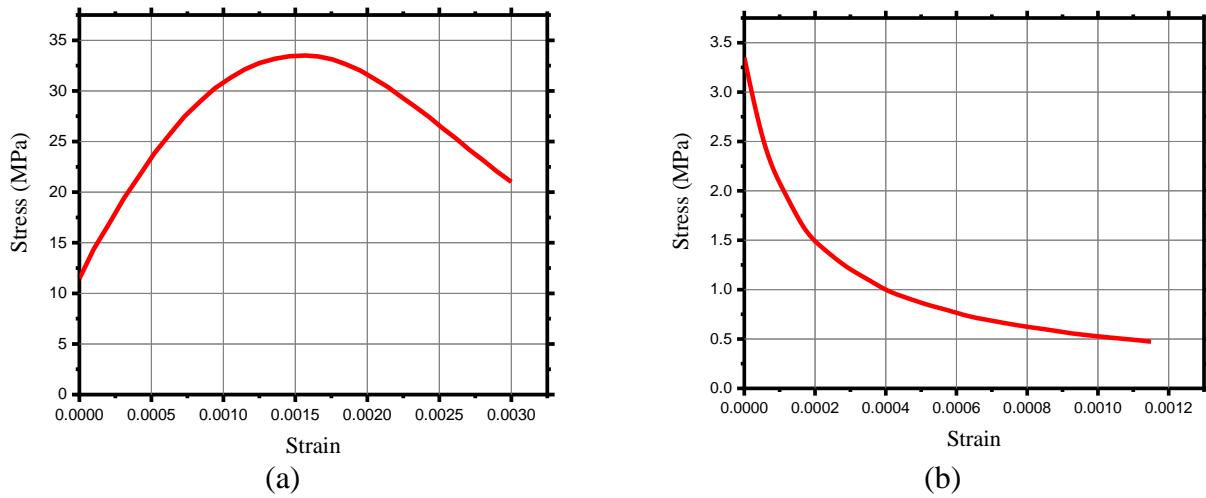
The three-dimensional 8-node solid element, C3D8R, was used to model the concrete frames, masonry units, and sliding layer (i.e. SBS layer, Basalt fiber-reinforced polymer (BFRP) laminate, and steel plate). The beam element (B31) was applied to model the steel reinforcements in RC frames and connection rebars in the infills of RC frames, which presented with an elastic-plastic material response. The Concrete Damaged Plasticity (CDP) model was applied to identify the non-linear behavior of concrete, in which the main failure was assumed as compressive crushing and tensile cracking [39,40]. Figure 12 shows the constitutive model applied in the study for the concrete materials under tension and compression.

Figure 12 Constitutive models of concrete (a) under compression and (b) tension

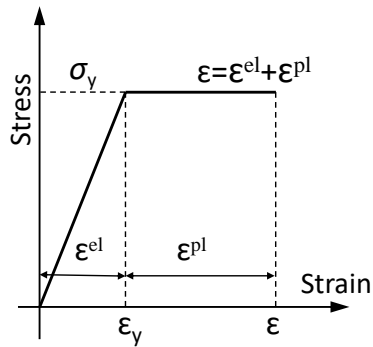
Figure 14 Material model of steel materials

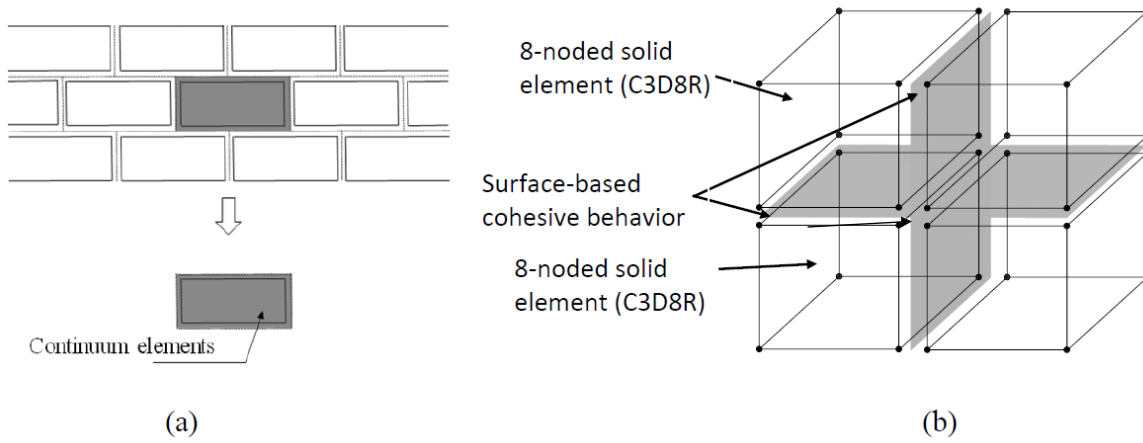
The coherent behavior methodology was used to determine the brick-to-brick and brick-to-frame interaction in this paper. The surface-based cohesive behavior provides a simplified way to model cohesive connections with negligibly small interface thicknesses, which is defined directly in terms of a traction-separation law. It is worth mentioning that cohesive behavior damage on the surface is an interaction property, not a material property [45]. Figure 15 shows that in the masonry portion describing the mesoscale model, the size

of the units has to be expanded by the mortar thickness h_m in both directions. A linear elastic traction separation behavior was assumed in the interaction model followed by the initiation and evolution of the damage. The nominal traction stress vector, $\{t\}$, was determined by three components: a normal stress value (t_n) in the perpendicular direction on the cohesive behavior surface, and two transverse shear stresses (t_s and t_t). The elastic behavior is given as,

Figure 15 Models of masonry units and the interfaces (a) Masonry portion describing mesoscale model (b) masonry units and surface-based cohesive behavior

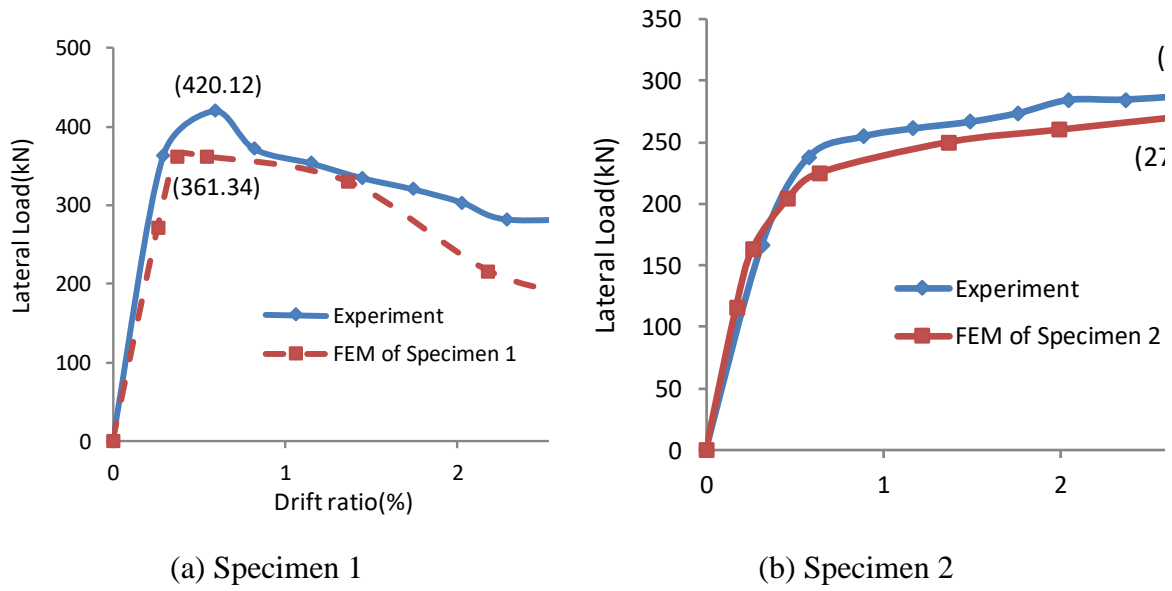
Figure 16 shows the comparison between the experimental curves (average values in both directions) and simulated load-displacement curves of the two control RC frame specimens. The results show that the FEM model evaluates the experimental behavior of the frames with a good agreement. The simulated results of the frame with sliding layers were 15% smaller than the experimental results after the elastic stage in both specimens. Therefore, the simulated load-displacement response of the frame was accepted, as shown in Figure 16. Table 4 lists the comparison details of the curves, including initial stiffness (K_{ini}) determined as the slope of the initial linear portion of the curves, as well as the ultimate load and ultimate displacement (P_{ult} and Δ_{ult}). The results show that the ultimate load and displacement of both frames are evaluated well with a maximum error ratio of 14% and 23%, respectively. The initial stiffness of the frame using the SBS layers was assessed well with an error ratio of 18%.

Figure 16 Comparison between experimental and simulated results

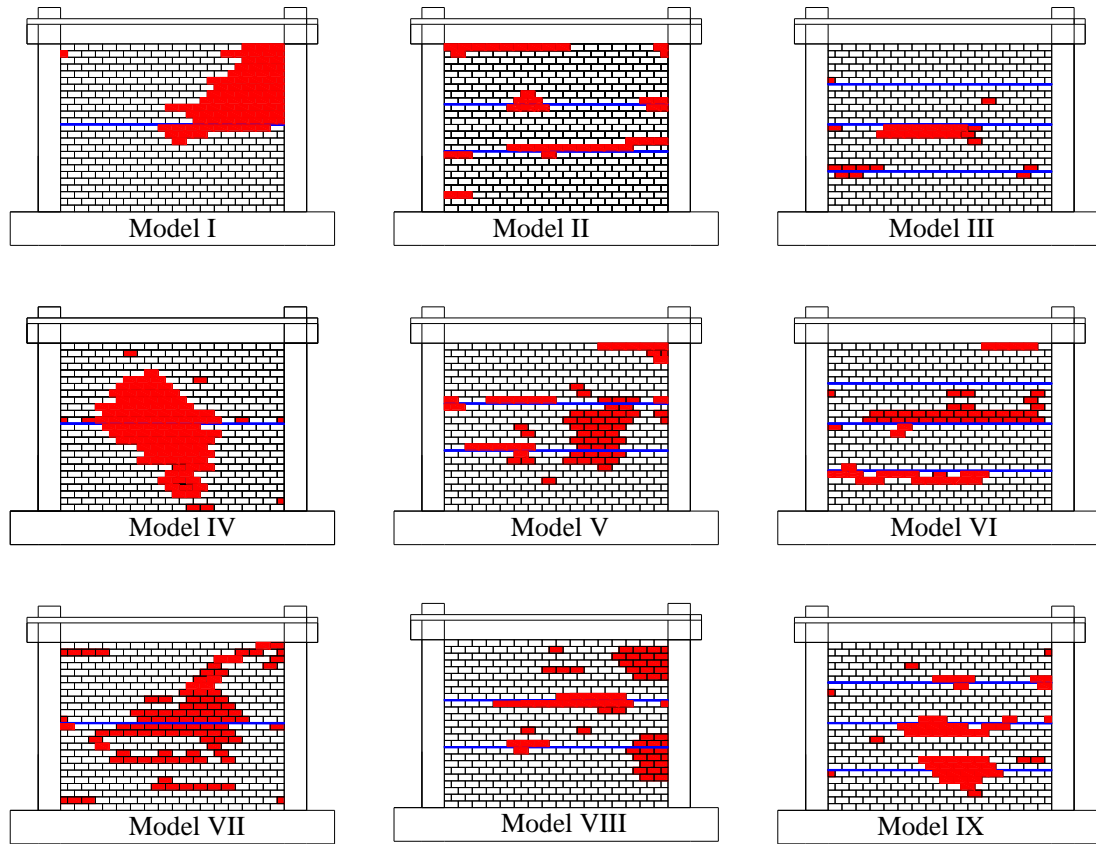
Figure 17 shows damaged areas for all tested and numerical specimens, while Table 6 lists a summary of the main results including the maximum load and corresponding displacement, the initial stiffness, and the failure modes of the frames. The results show that the failure modes of the filled walls change from DC or CC mode to SS mode when the sliding layers are applied inside. This was also verified by the experimental results in the study and the literature [28]. Here, Specimen R1 (RC frame 0% in [28]) in previous research, a fully infilled frame without openings similar to Specimen 1, was applied here for a comparative study. The difference from Specimen 1 was that the connecting rebars were not full length and only had a length of 700mm. The failure mode of Specimen R1 was DC+CC mode, because (1) the length of connecting steel rebars was insufficient and (2) the strength of the filled wall was low. The masonry units in the central zone of the wall were first destroyed under reversed cyclic lateral loads. The damaged area increased and extended to the diagonal zones of the frame finally to form DC+CC failure mode. However, Specimen 2 and other specimens used more than one sliding layer, the filled wall was divided into multiple parts by the layers which then weakened the diagonal strut effect in the whole infilled wall. This led to the frame being damaged with the SS failure mode. The results listed in Table 6 show that the main model of the frames with sliding layers is SS failure mode, especially when the number of layers increases. The DC mode and CC mode disappeared when the number of layers was large. Moreover, the smaller the friction coefficient of sliding layers was, the easier this effect changed.

Figure 17 Damages and collapse of the simulated specimens (Model II= Specimen 2)

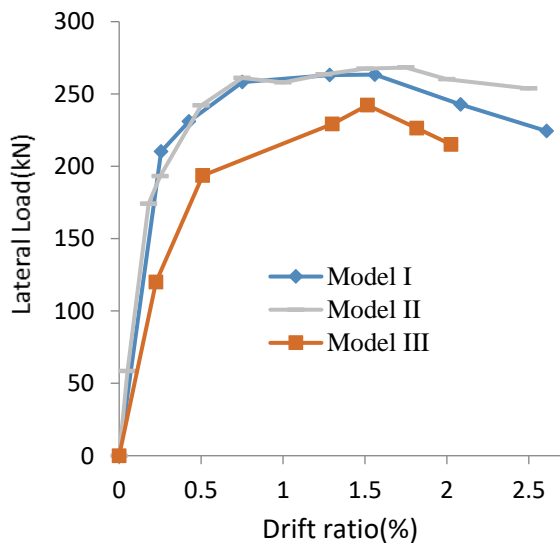
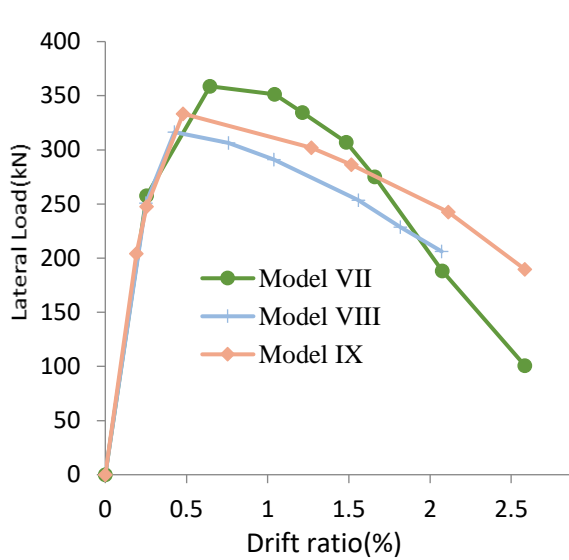
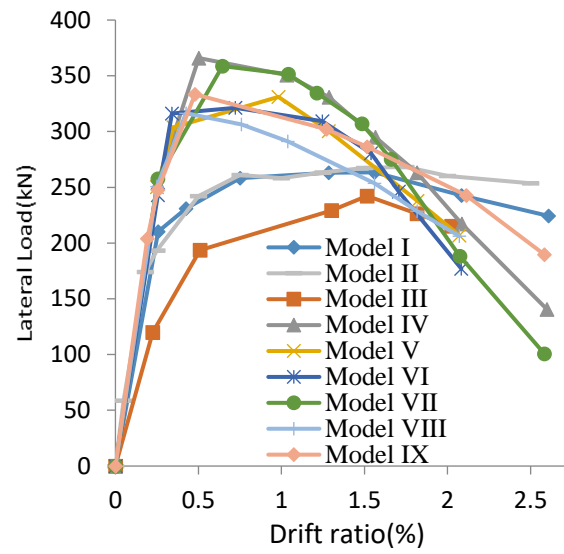
When a SBS layer is paved in the infills (Model I), the diagonal strut effect is interrupted at the sliding layer. When the number of sliding layers increases, the strut effect gradually disappears, and the damage to the infilled wall is concentrated at the sliding layer or the connection between the sliding layer and the column, indicating that SBS sliding layers weaken the strut effect resulting in a significant reduction in the in-plane damage of infilled wall. Figure 18 (a) shows a comparison of the load-displacement curves of the specimens with a different number of SBS layers. The specimens using one and two SBS layers presented a similar behavior until $R=1.5\%$, but the specimen with three layers possessed a much lower capacity than the others. From the point of view of reducing in-plane damage

and improving in-plane bearing capacity for the infills, the preferred spacing of the SBS sliding layer in the infill wall is 1000mm.

On the other hand, all specimens using steel plates possessed the same early linear behavior at the early stage until their ultimate loads, and then the lateral stiffness of the frames began to decrease. This is mainly due to the high coefficient of friction of the sliding layers. The increasing number of layers of steel plate did not lead to a decrease in the capacity of the frames, on the contrary, using more SBS layers can increase the slippage between the layers and wall, which then resulted in a degradation in the peak loads. Therefore, as shown in Figure 18 (b), the number of layers has a negative influence on the peak loads of the frames but made the frames present a similar post-peak behavior to the model specimens. A similar result was confirmed in the specimens with BFRP laminate (see Figure 18 (c)). Because the BFRP layers are non-ductility materials with a large slippage, the load-carrying capacity of the frames with BFRP laminate layers is reduced significantly. The stiffness of the frames significantly decreased after peak load, especially for the frames with fewer laminate layers. However, the stiffness of the BFRP specimens decreased with an increasing number of sliding layers, similar to the cases using steel plates, which also is similar to previous research [49] [50]. Figure 18 (d) presents the load-displacement behavior of all specimens, indicating that the load-carrying capacity of the frames with SBS layers is much smaller than that of the other frames.

(a) Specimens with SBS layers

(b) Specimens with steel plates

(c) Specimens with BFRP laminates

(d) All specimens

Figure 18 Effect of the spacing of layers in the frames

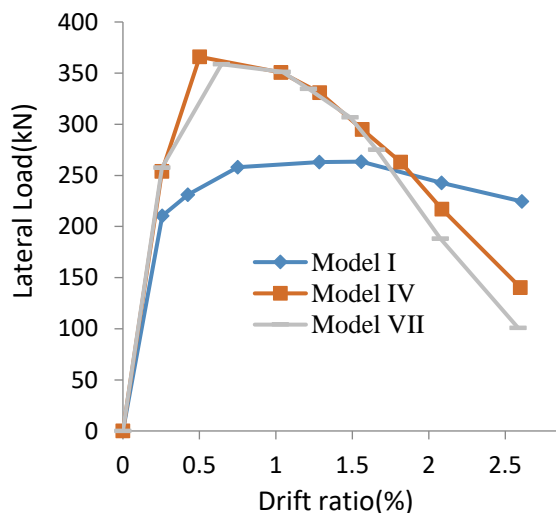
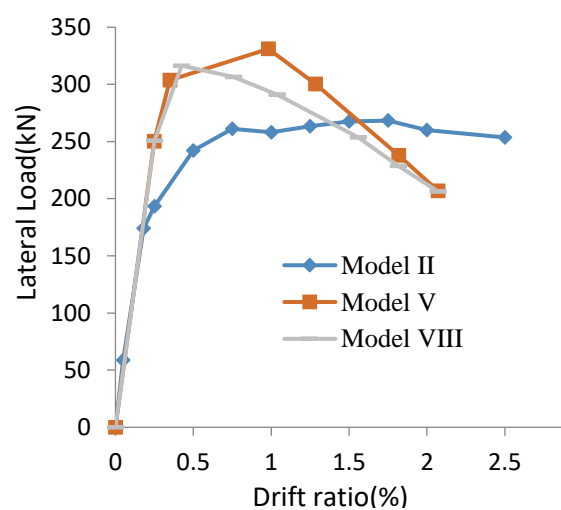
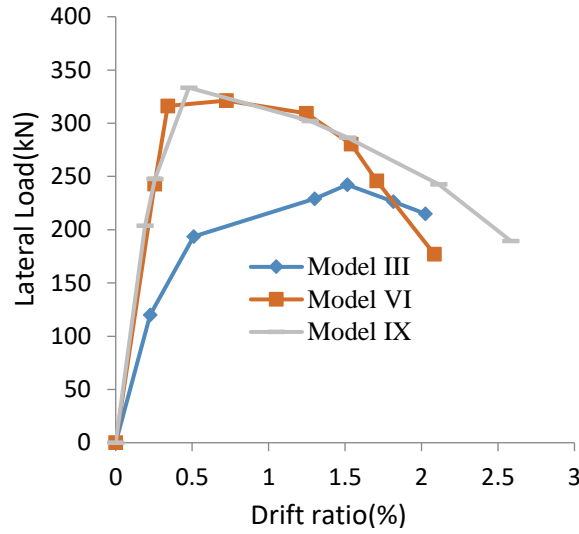
Figures 19 (a) to (c) show the load-displacement skeleton curves of the specimens with the same layer spacing but different sliding layer materials. When using the same layers of steel plate or BFRP laminate, the load-displacement behavior of the frames was the same, including initial elastic behavior, load-carrying capacity, and post-peak behavior. Due to the coefficient of friction of SBS layers, the use of the layers significantly reduced the ultimate load and accelerated the degradation of the load at post-peak. But the specimens using SBS layers can still present similar initial stiffness to the other specimens.

(a) $L_s=1500$ mm, one layer

(b) $L_s=1000$ mm, two layers

(c) $L_s=750$ mm, three layers

Figure 19 Effect of the materials of sliding layers on infilled walls

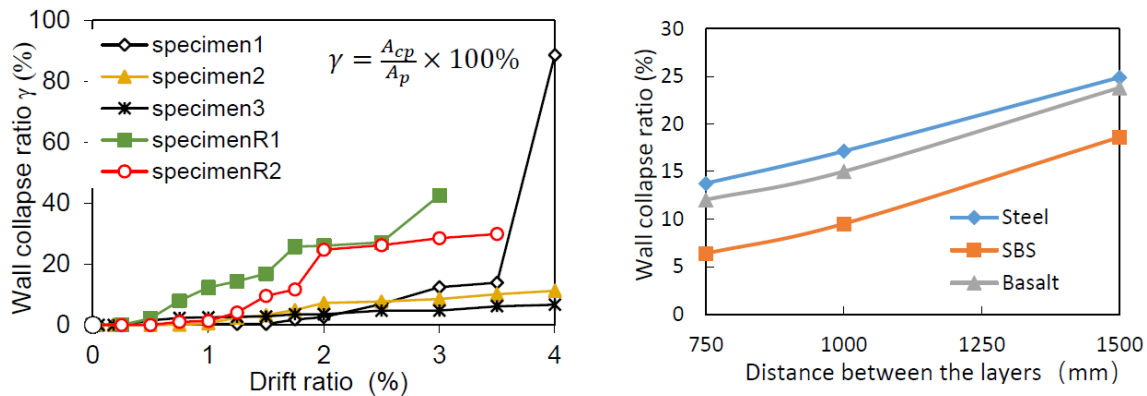
where A_{cp} is the collapsed and crushed area of infilled walls, A_p is the total area of the infilled wall of RC frames. To understand the influence of different measures on the in-plane damage of infilled walls, Specimen R1(RC frame 0% in [28]) and Specimen R2 (RC frame 25.7% in[28]) are applied here for a comparative analysis of the collapse of the MHB-infilled RC frames. The dimensions of frame elements and infilled materials in Specimens R1 and R2 were the same as that of Specimen 1. The connecting rebar length of Specimens R1 and R2 was only 700mm. Specimen R1 was a fully infilled frame (the opening ratio is 0%), and the opening ratio of Specimen R2 was 25.7%. The collapse ratio–drift ratio curves of the tested infills are shown in Figure 20 (a). Specimen 3 presented the lowest collapse ratio as drift ratios, $\gamma=6.63\%$, indicating it has the highest resistance to wall collapse in the frames. That can be attributed to two points: (1) the additional RC detailing columns improves the deformation capacity of the frame, and (2) the gaps relieved the compression of the wall in the corner from the frame columns on both sides. Specimen 1 showed the highest collapse ratio at $R=4\%$, which was 88.64%. The main damage occurred in the wall corners, and the bricks were also severely crushed. The diagonal strut significantly improved the load-carrying capacity at the early stage, but the collapse ratio of the wall was also the highest, and almost all the bricks and mortar were crushed in the state of cyclic compression shearing. Besides, specimen 2 presented a small collapse ratio of the wall, which was 11.2% at $R=4\%$,

in which the damage concentrated only in the sliding layers. The value was higher than that of the specimen with gaps but much smaller than that of the specimen with the fully infilled wall. This is due to the sliding layers improving the restoring of the RC frame compared to the fully infilled frame, but the improvement was slightly less than that of the frame with gaps. It can be found that the longer connecting rebars can reduce the damage to the infilled wall by comparing Specimen R1 and Specimen 1, and the openings are also helpful in reducing the damage to the infilled wall (Specimen R2), as shown in Figure 20(a).

On the other hand, as shown in Figure 20 (b), the collapse ratio of the infilled frames using SBS layers is much smaller than other specimens presenting similar wall collapse ratios. At the same time, the damaged area of the frames using more sliding layers was reduced significantly, regardless of the type of materials. The wall collapse ratios of the specimens decreased linearly with an increasing number of layers. Besides, it can be found that the longer connecting bars can reduce the damage to the infilled wall by comparing with the wall collapse ratio of Specimens R1 and 1 in Figure 20. It is also suggested that the openings are conducive to reducing the damage to infilled walls.

(a) Wall collapse ratio vs. drift ratio

(b) Wall collapse ratio vs. layer spacing

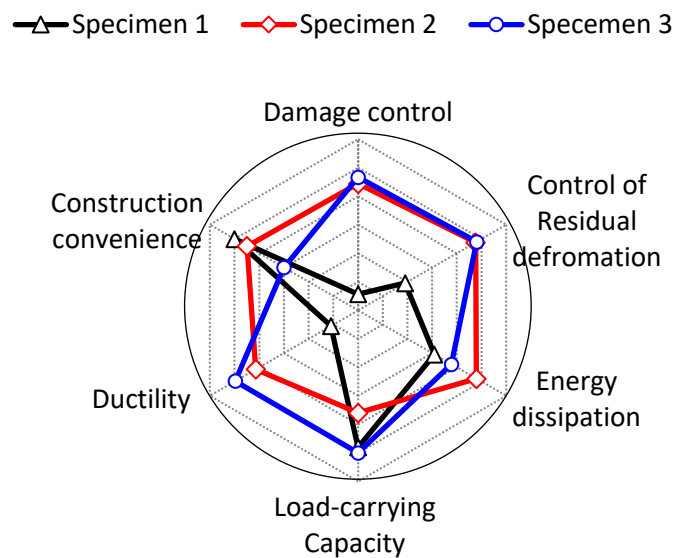
the infill wall. Since the determination of the maximum load carrying capacity of this type of structure was controversial in previous studies [29], it was proposed that the traditional ductility calculation methods were not suitable for MHB infilled frame structures. The observation results show that the deformation performance of this type of structure after the collapse of the wall was close to that of the bare frame structure. When the SBS layers were used, the residual deformation, damage control, and energy dissipation capacity of the infilled frame were improved significantly, but the construction convenience was not improved much and the capacity and ductility of the frame were slightly reduced. Except for the construction convenience and energy dissipation capacity, the use of gaps and detailing columns improved the other performance of the infilled frames, such as Specimen 3 in Figure 21.

Figure 21 Comparison of three control methods of the walls in the frames
