Citation: Cholostiakow, S., McKinley, B., Mergos, P., Hall, C., Kappos, A. & Ayoub, A. (2024). Seismic retrofitting of URM masonry piers with helical steel reinforcement. *Construction and Building Materials*, 431, 136499. doi: 10.1016/j.conbuildmat.2024.136499

Seismic retrofitting of URM masonry piers with helical steel reinforcement

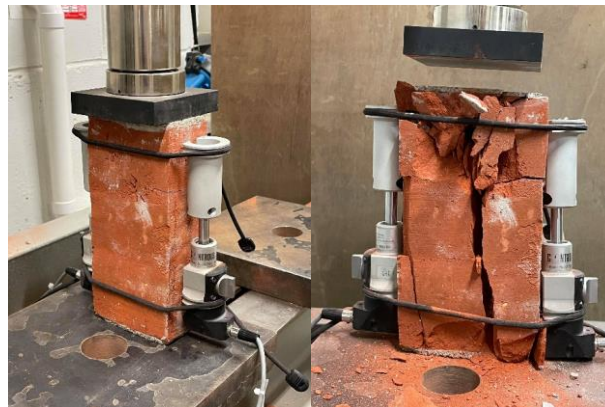
228 **Fig. 3.** Masonry unit tested under compression before and after failure.

220 were tested in an upright (soldier) orientation, based on the readings of two LVDTs attached to
221 the stretchers (Fig. 3). The base length of the gauges was set at 150 mm and a constant
222 displacement rate of 0.2 mm/min was used. The elastic modulus was estimated between the
223 stress levels corresponding to 30-60% of the failure stress as an average across the three
224 specimens. The mean value of the experimental elastic modulus of the bricks was equal to
225 5691.1 MPa (COV 20%) with a maximum mean strain of 0.0039 (COV 6 %).

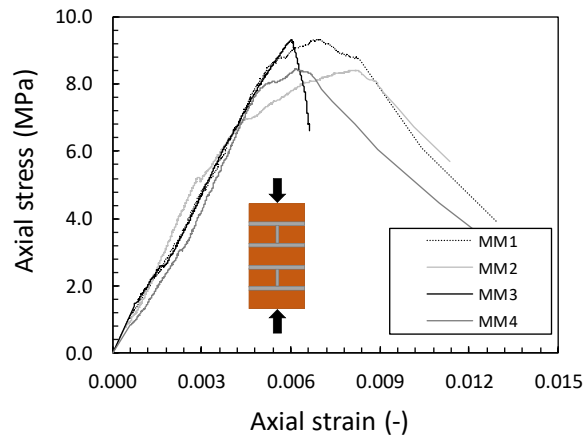
Fig. 5. Compressive characteristics of masonry brick-mortar assemblages.

244 The compressive strength (perpendicular to the bed joints) and elastic modulus of masonry were
 245 estimated according to EN 1052-1 [42] on four identical brick and mortar assemblages tested
 246 at a displacement rate of 0.2 mm/s. The stress-strain responses for all four specimens are shown
 247 in Fig. 5. The tests revealed an average compressive strength of 8.6 MPa (COV 5%) with a
 248 corresponding peak strain of 0.0068 (COV 11%). The average experimental modulus of
 249 elasticity was estimated as 1772.1 MPa (COV 8 %).

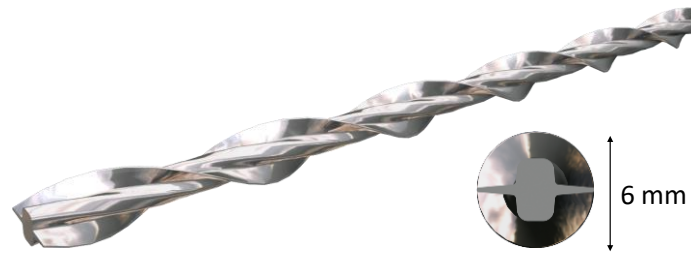
Fig. 7. Geometry of the helical bars

The retrofitting system consisted of helical bar with an overall diameter of 6 mm (Fig. 7) and a cement-based pumpable and thixotropic bonding agent (grout). The shape of the helical bar offers great flexibility, thus allowing for easy bending and installation in masonry joints. The mechanical properties of the helical bars were determined with standard tensile tests on three bar samples using the provisions set out in ISO 6892 [44].

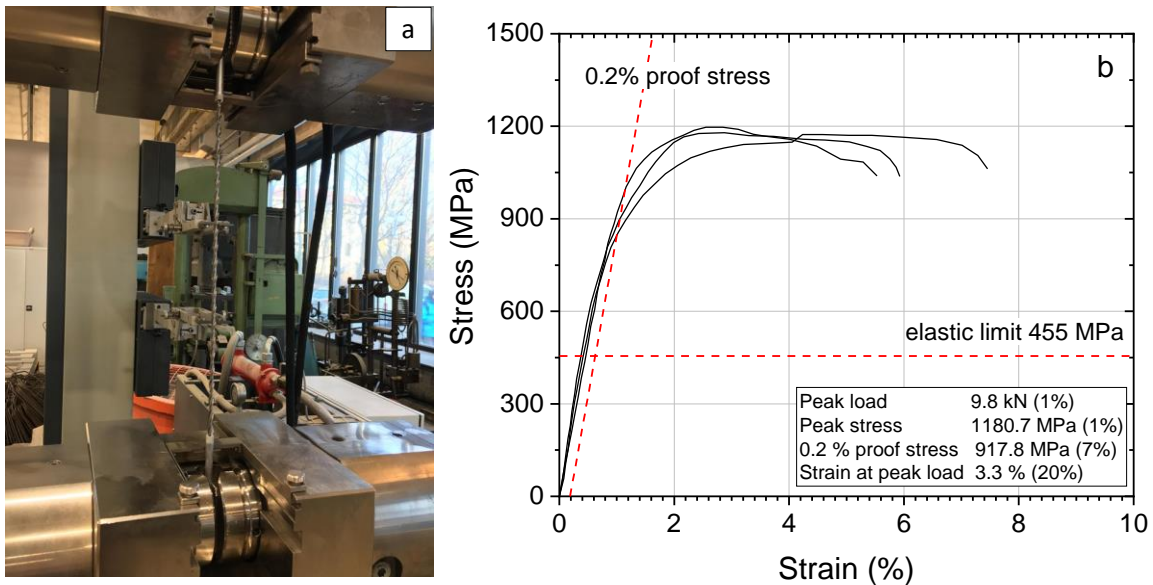
Fig. 8. Tensile testing: a) test setup; b) stress-strain response

266
267
268 Strain was measured using an external extensometer with a base length of 100 mm, spanning
269 the centre of the sample. Due to the specific helical shape of the bars, direct tensile tests could
270 not be performed without risking damage to the helical fins near to the grip jaws of the machine.
271 Therefore, the bar ends were anchored within aluminium tubes of 10 mm internal diameter and
272 filled with resin grout, which enabled a larger surface area of the helix to be gripped. In turn,
273 all tested samples exhibited a rupture within the extensometer's measuring range, which is the
274 intended failure mode for this test. The test setup and the stress-strain response for all three
275 samples is shown in Fig. 8. The average tensile load measured during the test was 9.8 kN (COV
276 1 %); with a cross-sectional area equal to 8.3 mm^2 , such load resulted in an average stress of
277 1180.7 MPa (COV 1%). Based on the test results, it was determined that the response of the

663 Where A_{sh} is the total cross-sectional area of horizontal reinforcement and f_{yh} is the allowable
664 stress in the helical steel reinforcement. A_{sh} was assumed as the area of one helical bar (8.3
665 mm²) multiplied by the number of horizontal bars crossing the diagonal crack. Based on the
666 tensile tests, the allowable stress in the helical bars was as the maximum stress at the elastic
667 range, which was limited to 455 MPa (see Fig. 8).

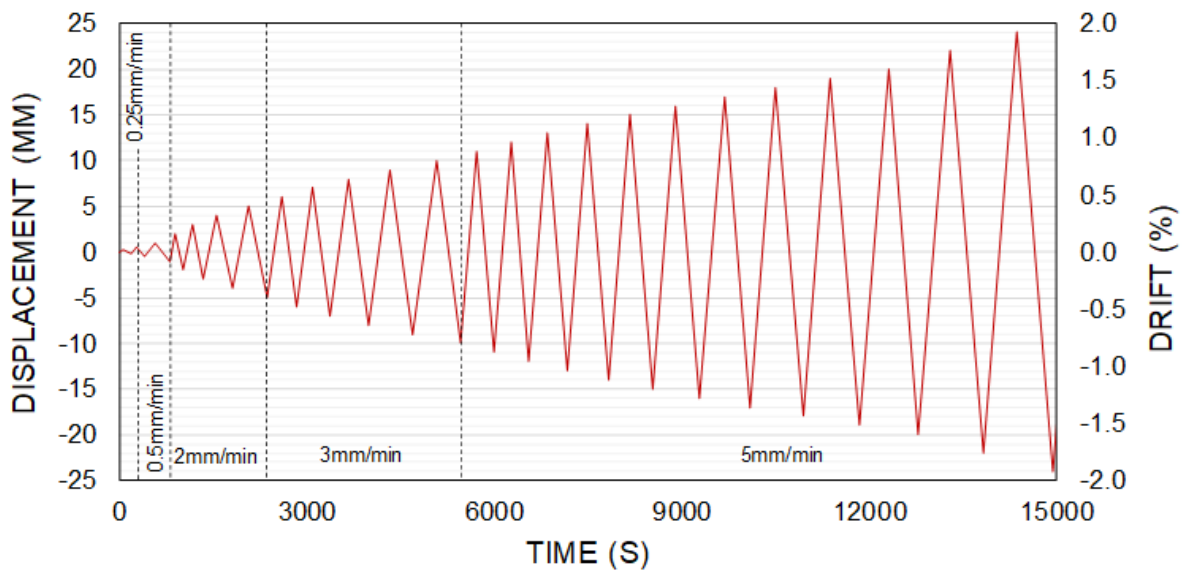
351 **Fig. 12.** Loading protocol adopted for the in-plane cyclic shear testing.

341 The in-plane loading was applied in displacement control under quasi-static conditions to
 342 capture the post-peak softening stage and associated damage accumulation. The vertical stress
 343 was applied with a load-controlled regime. All wall specimens were subjected to the same in-
 344 plane reverse cyclic loading history shown in Fig. 12. The first two cycles were performed at
 345 target displacements of ± 0.25 and ± 0.50 mm to capture the elastic response of the wall
 346 specimen, while the subsequent cycles were performed at increasing target displacement
 347 amplitudes of ± 1 mm. The tests were terminated once a strength degradation of about 25% was
 348 observed, which is close to the level at which the element was considered to have reached its
 349 near-collapse limit state [46].

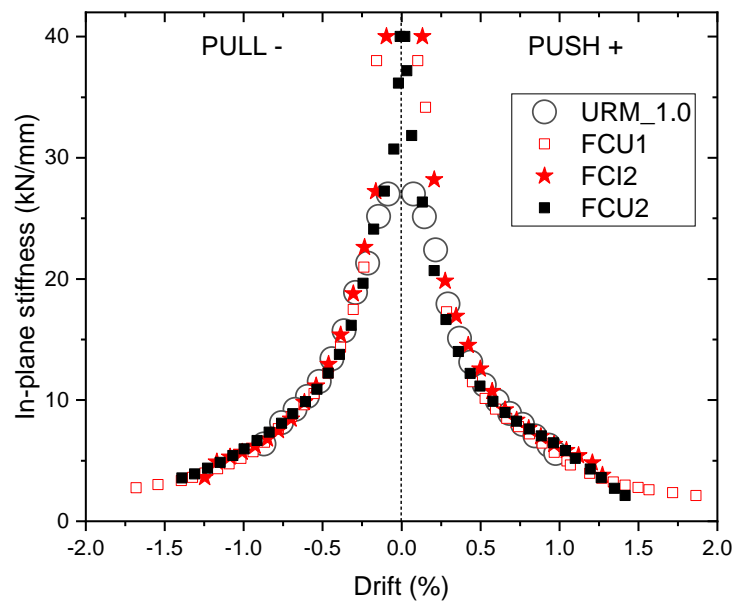
530 **Fig. 15.** Typical degradation of in-plane stiffness.

520 The experimental secant stiffness was estimated as the ratio of the total lateral force per
521 direction to the corresponding displacement amplitude. All retrofitted walls exhibited a similar
522 degradation of lateral stiffness, hence, only four specimens are shown for brevity (URM and
523 three RM specimens, Fig. 15). As can be seen, the addition of helical reinforcement somewhat
524 increased the initial in-plane stiffness; however, it did not substantially change the post-
525 cracking stiffness compared to URM_1.0 wall regardless of the retrofitting pattern, and both
526 the “wiggled” and the straight flexural bars yielded a similar response. Although stiffness did

527 not increase, the helical bars allowed for extending the stiffness degradation path and enabled
 528 larger drift levels to be achieved.

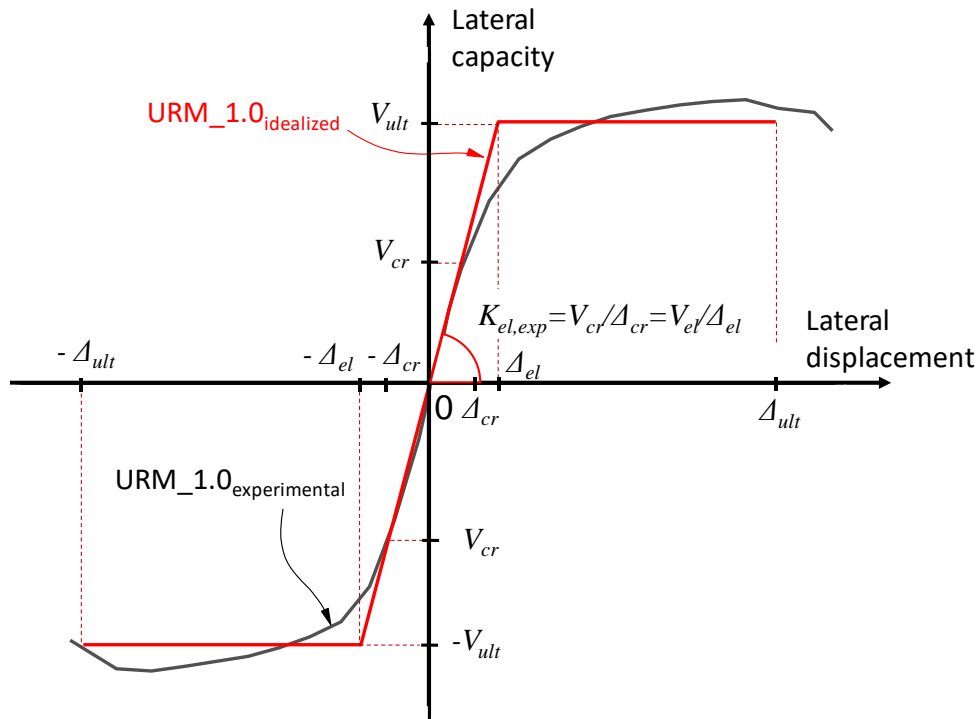
575 **Fig. 16.** Typical bilinear idealisation of force-displacement response.

545 The elastic stiffness K_e was determined based on experimental data and was taken as a ratio
 546 between the measured experimental lateral load at onset of cracking, V_{cr} , and the corresponding
 547 displacement at cracking, Δ_{cr} . The value A_{env} is the average area under the experimental
 548 envelope curves and represents the total energy dissipated during the test per direction. The
 549 shape of the idealised bilinear response (red curve in Fig. 16) was determined by imposing that
 550 the total energy of the experimental response is equal to the total energy of the bilinear response.
 551 The experimental and idealised characteristics of the in-plane responses are listed in Table 3.
 552 The values obtained from this analysis seem to be consistent with the literature and close to
 553 current design recommendations. The average experimental crack limit was $0.69V_{max}$ (COV 12
 554 %), which is in very good agreement with the limit proposed by Tomažević [6] ($0.70V_{max}$) and

555 is less conservative than the 40% to 60 % crack limit provisions proposed in key design codes
 556 (EC8 [47], FEMA [48], ASTM [49]). The ratio between the idealised and experimental
 557 maximum shear resistance V_{ult}/V_{max} oscillated around 0.9 (0.89, COV 6 %), which is in line
 558 with the findings of previous studies ([5-6], [12],[50]) and thus attests the validity of the
 559 analysis.

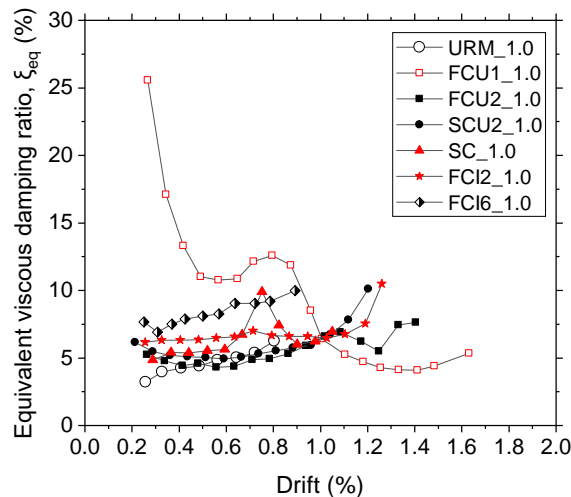
605 **Fig. 18.** Equivalent viscous damping ratio for walls specimens with an axial stress level of 1.0

597 MPa and dissipated more energy than the walls loaded to 0.6 MPa. The equivalent viscous
598 damping ratio for the retrofitted walls was up to 10% (Fig. 18). As the figure shows, the
599 hysteretic energy dissipation was higher in the case of specimens characterised by higher
600 ductility, i.e., FCU1_1.0, FCI2_1.0, and FCI6_1.0.

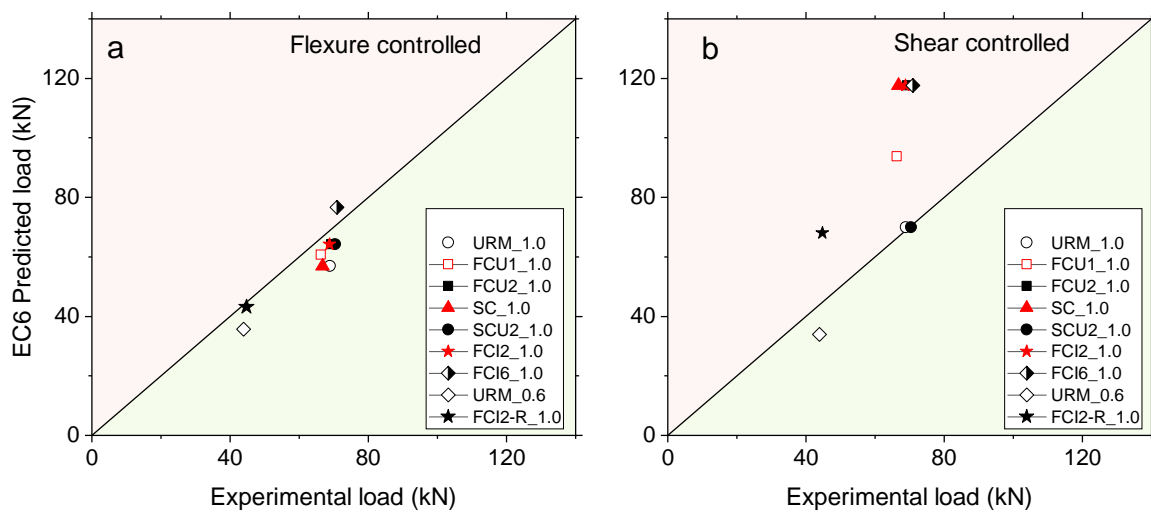
694 **Fig. 19.** Predictions of lateral load capacity: a – Predictions associated with flexural failure; b

676 Results of the predictions are illustrated in Fig. 19, with the experimental-to-theoretical ratios
677 listed in Table 4. Given that mixed failure modes were observed during testing, the contribution
678 of bare masonry was verified against the models for flexural capacities and the two shear
679 capacities (sliding/diagonal cracking) separately. The capacities of the wall specimens

680 retrofitted with helical reinforcement were estimated as the sum of the contributions of
 681 unreinforced masonry and contribution of helical reinforcement. As such, for the flexure-
 682 controlled estimate, the total lateral in-plane capacity consisted of the flexural contribution of
 683 the bare masonry wall (Eq. 9) and the contribution of the vertical helical bars (Eq. 12). The
 684 shear controlled-estimate comprised the component associated with shear resistance of bare
 685 masonry (either Eq. 5 or Eq. 7, depending on the failure mode observed during the experiment)
 686 and the contribution of the horizontal helical bars (Eq. 10).

707 walls, and thus, both checks (flexural and shear) should be carried out. As can be seen, flexural
708 and shear predictions can give reasonable estimates of the in-plane lateral load capacity and
709 confirm the experimental observations. For the failure modes corresponding to experimental
710 observations, the predictions of shear resistance yielded ratios equal to 0.99 for diagonal
711 cracking (URM_1.0) and 1.29 for shear sliding (URM_0.6). The prediction of flexural
712 resistance yielded experimental-to-theoretical ratios equal to 1.21 and 1.23 for URM_1.0 and
713 URM_0.6, respectively. Based on the predictions, it can be concluded that the theoretical shear
714 capacities of the unreinforced cantilever walls were estimated reasonably well using Eurocode
715 6 provisions and the predictions are in a good agreement with the experimental behaviour.
