# CFD simulations of blade damage effect on the performance of a transonic axial compressor near stall

Yan-Ling Li<sup>a,\*</sup>, Abdalnaser Sayma<sup>b</sup>

## Abstract

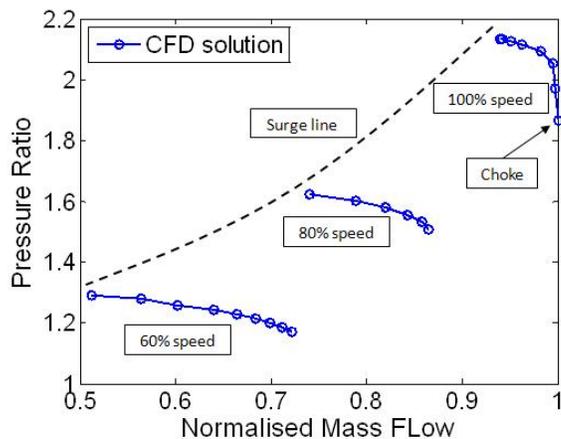
Figure 1: Part of characteristic map of NASA Rotor 37

Compressor performance plays an important role in gas turbine engines. It is normally characterised by pressure rise versus mass flow function as shown in Figure 1. The operating range of the compressor is bounded by the choke and surge boundaries at a given rotational speed. The surge margin indicates how close the operating condition of a compressor is to the surge line. Flow under most of the operating conditions on the map is normally steady in the rotor's frame of reference and axisymmetric. When compressors operate near the surge boundary, mass flow is reduced due to high positive incidence. When the incidence is beyond the critical value, instability may be encountered in the form of flow separation. If the situation gets worse,

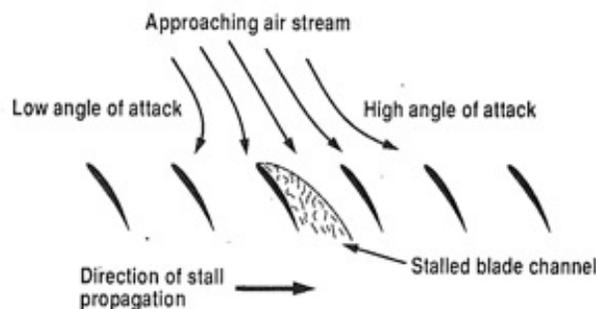
Figure 2: Typical stall cells propagation in an axial compressor [3]

shaft speed. The number of stall cells and the propagation speed may vary at different operating conditions in different compressors, but typically, the propagation speed is around half of the shaft speed. Rotating stall initiation mechanisms and characteristics are still the subject of continuous scientific debate. However, it generally starts with a localised flow perturbation which causes flow separation on one or more blades due to excessive positive incidence as shown in Figure 2 Iura et al. [3]. The flow separation on the suction side resulting in the formation of a stall cell which reduces the flow passing into the passage. Then the blockage diverts flow around the blade so that the incidence increases on the blade on the right hand side and decreases on the blade on the left hand side, in the rotating frame of reference. This leads to the stall cell moving to the passage to the right. This is the start of propagation of stall cells around the annulus.

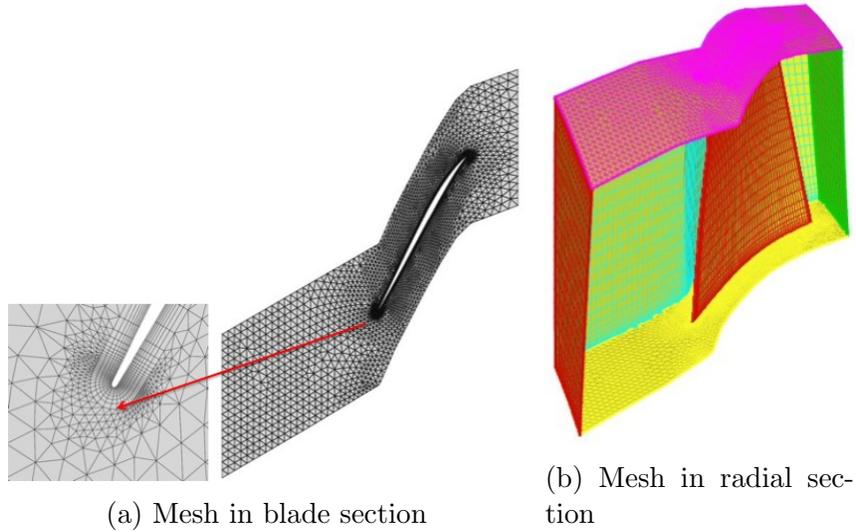
Figure 3: Typical mesh used for Rotor 37

the casing, which is meshed allowing the flow to pass over the tip. The tip clearance used in this paper is the same as the one obtained from the experiment at 60% of design speed [15]. Because the flow equations are solved in a rotating frame of reference, the grid points on the casing are given zero rotational speed. Hence, it is inherently assumed that a given blade sees the same mesh points on the casing all the time.

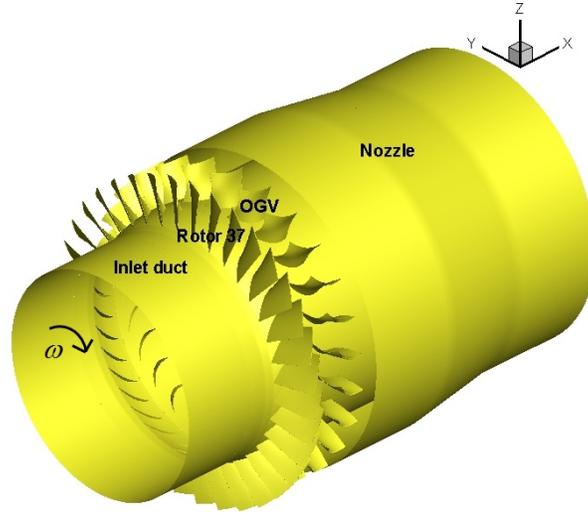
Figure 5: Representing model for unsteady time accurate simulations

A major difficulty in rotating stall simulations is to specify the downstream boundary conditions when there are fluctuations in mass flow and pressure rise. In this investigation, a methodology reported by Vahdati et al. [16] using a choked nozzle to control downstream flow boundary conditions was used. The inlet boundary is located at about three chord lengths upstream of the rotor blade. At the inlet, ambient conditions were assumed and uniform total pressure and temperature were applied. **The nozzle has a length of approximately eight chord lengths of the rotor blade, as shown in**

Figure 4. Different performance points on the compressor characteristic map can be achieved by adjusting the size of the downstream nozzle with a constant back pressure. If fixed static pressure profile is provided downstream of the compressor, the flow is stable under most of the operating conditions. However, numerical difficulties could be encountered when the compressor is approaching stall where the downstream boundary conditions are neither known nor fixed. Therefore, this approach could provide better boundary condition for rotating stall studies than prescribed pressure profiles. More details can be found in Wu et al. [17].

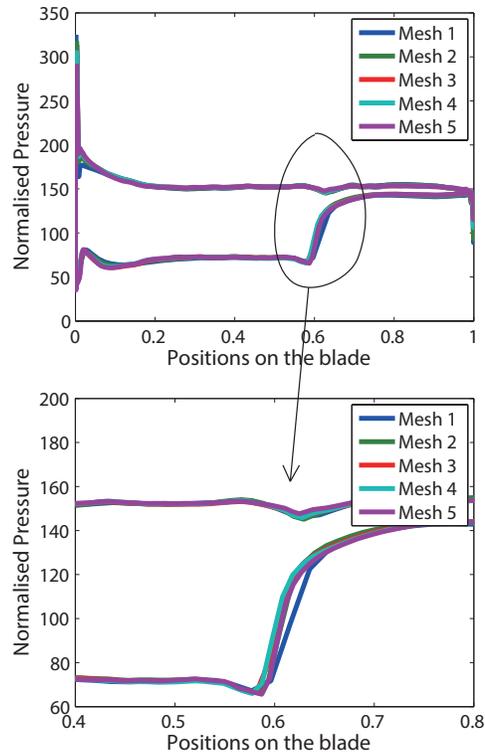
Figure 6: Pressure profile comparison at 95% span

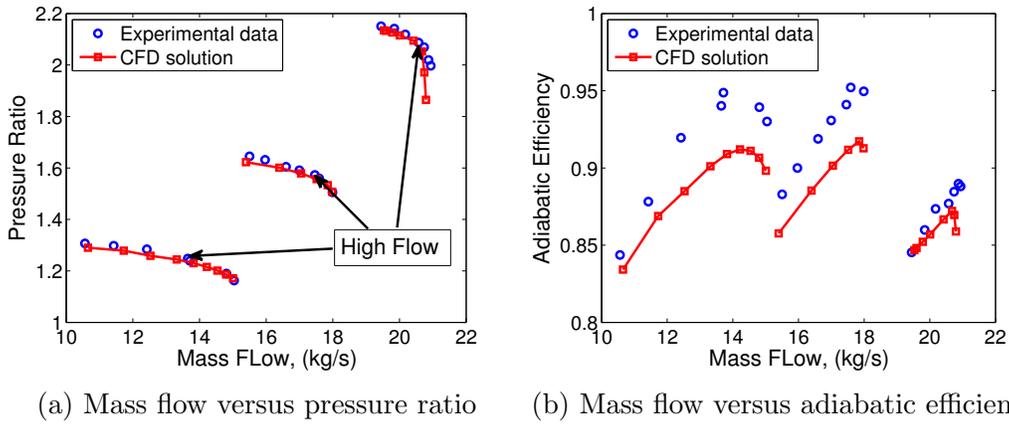
Figure 8: Compressor map comparisons (Right to left: design speed, 80% speed and 60% speed)

This subsection presents comparisons between experimental data [15] and CFD simulations. Comparisons of compressor characteristic map at three different rotational speeds are shown in Figure 8. It can be seen that CFD solutions have a good agreement with the experimental data for the pressure ratio. Efficiencies at all three speeds are under predicted. This may be ex-

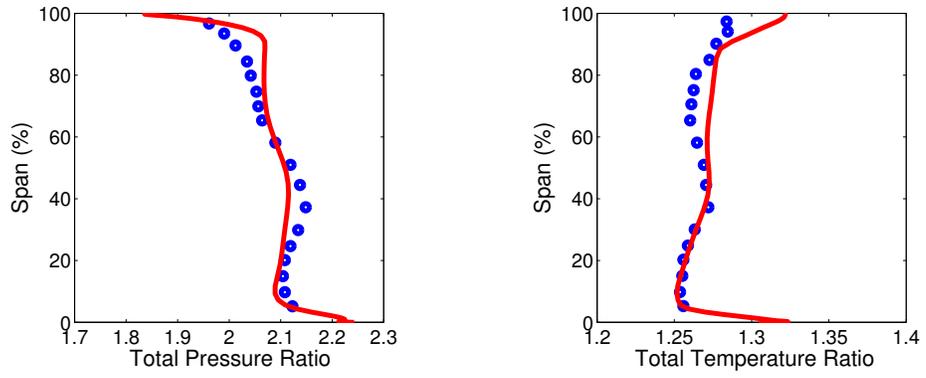
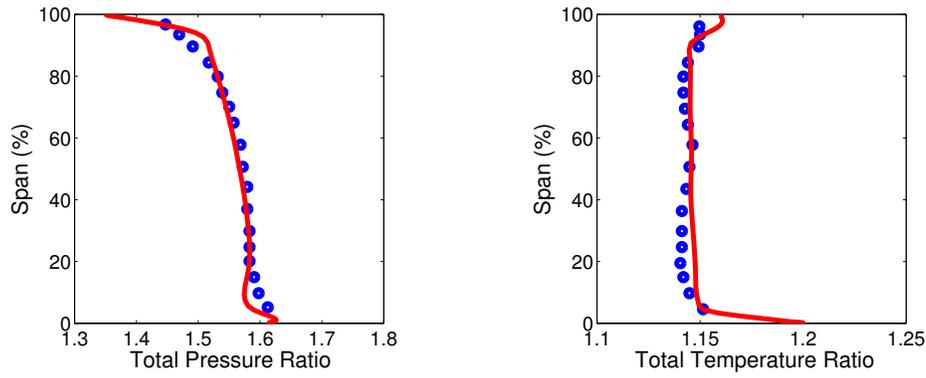
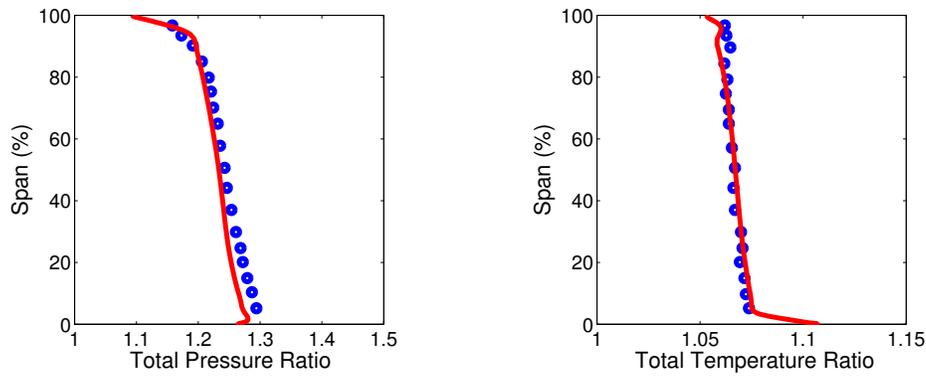
Figure 9: Total pressure ratio and temperature ratio distributions downstream of rotor, at high flow conditions (Blue: experimental data; Red: CFD solutions)

Total pressure ratio and temperature ratio distributions in the spanwise direction for the three speeds are shown in Figure 9. The solutions from CFD were circumferentially averaged. Those distributions were obtained at high flow operating conditions, which were marked in the pressure ratio map in Figure 8. The CFD results agree fairly well with the measured quantities.

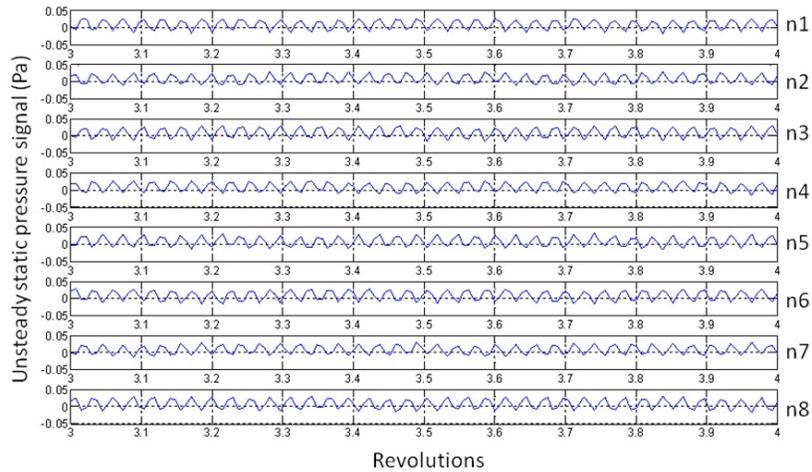
Figure 10: Unsteady static pressure time history at the inlet of rotor without rotating stall

As seen in Figure 10, the pressure fluctuation caused by blade-passing

was the only fluctuation observed which shows the periodicity in one rotor rotation. There are 36 spikes which indicate 36 rotor blades passing the same sensor in one rotor revolution. In Figure 11, the dominant frequency is the blade-passing frequency (BPF). The time averaged values of the main flow parameters from the solution of this case were also compared with the steady state results. The maximum difference was less than 0.2%. This also provided confidence to perform the unsteady simulation at near stall condition.

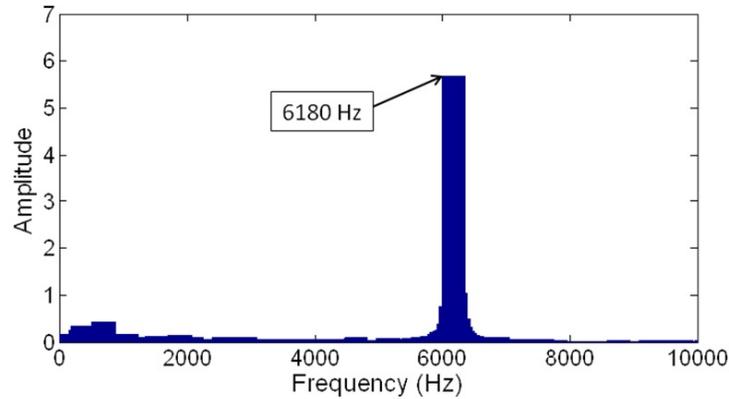
Figure 11: Fourier transform components from one of the numerical sensors on the casing and flow behaviour when the compressor was operating near stall boundary. Two different degrees of damaged blades were used as shown in Figure 12. Each damage starts at the leading edge to 20% of chord on the tip and from 70% span increasing its spanwise extent linearly up to the tip forming a typical tip curl damage.

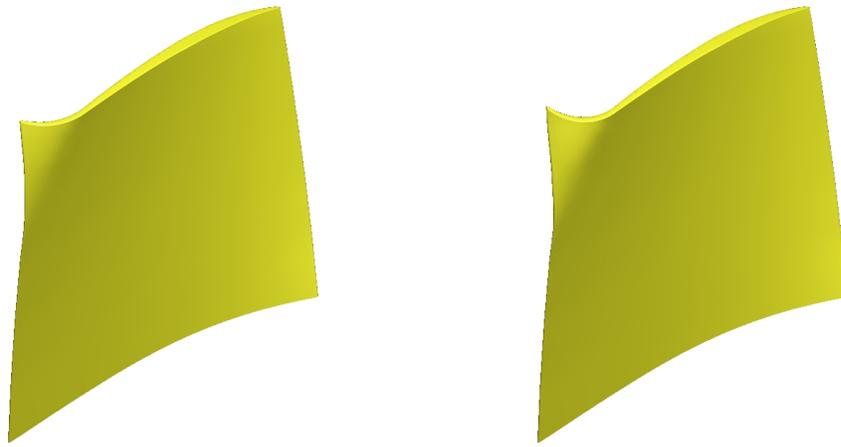
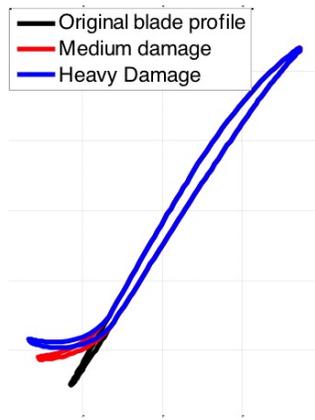
(a) Medium damage

(b) Heavy damage

(c) 2D blade profile comparison near the tip

Figure 12: Curl damage at leading edge

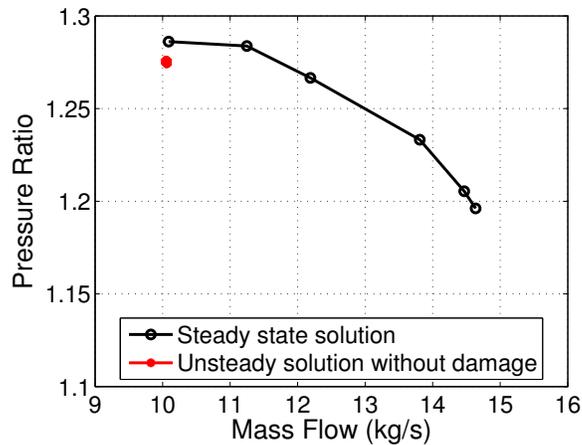
Figure 13: Compressor performance during rotating stall with steady state solutions

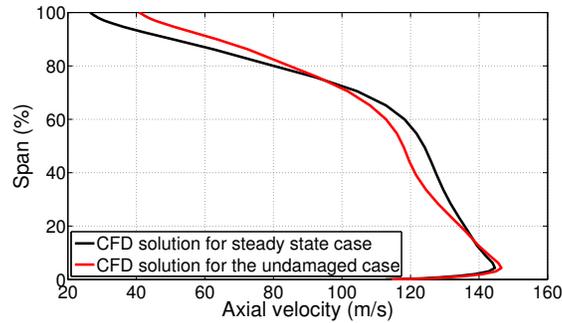
Figure 14: Circumferentially averaged axial velocity profile comparison downstream the rotor

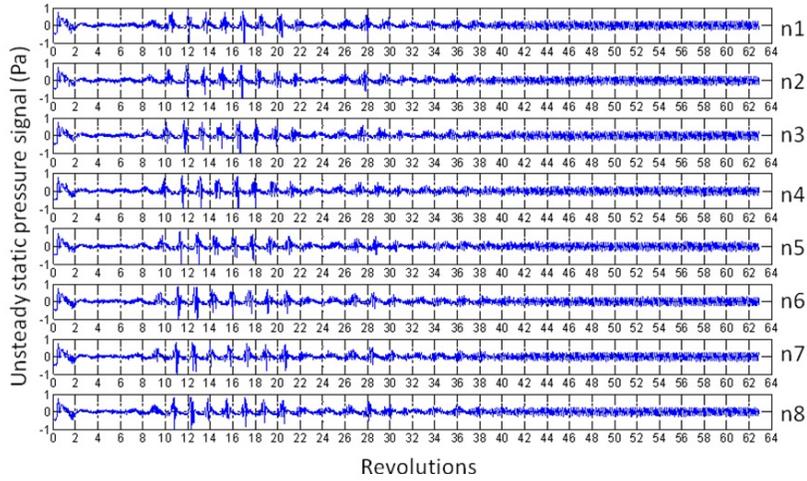
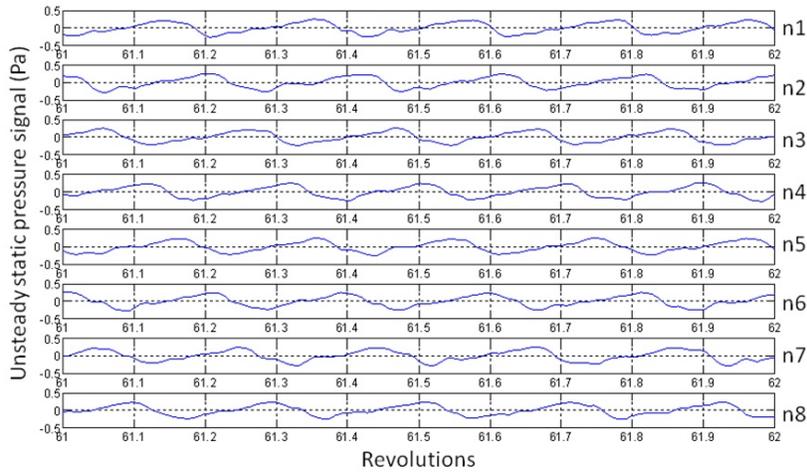
Figure 16: Unsteady static pressure time history from numerical sensors on the casing for the undamaged assembly

As seen in the full time history from numerical sensors in Figure 16a, after the initial numerical transient, three different types of spikes can be observed which indicate three different patterns of stall cells. Rotating stall started approximately after the 8th revolution. After a long transition period, a

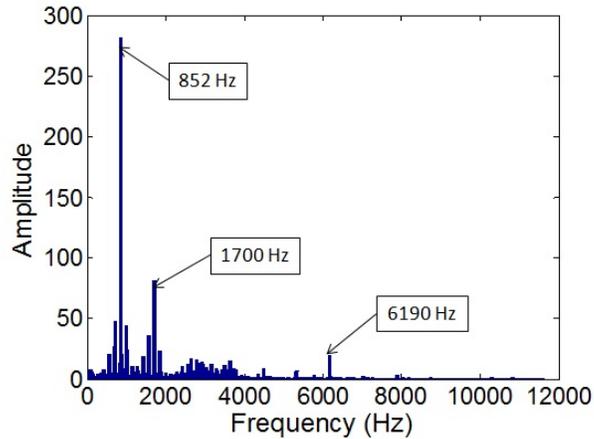
Figure 17: Fourier transform components of numerical sensor 7 on the casing

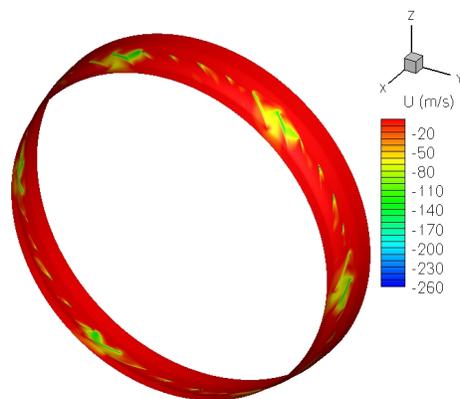
Figure 18: Instantaneous negative axial velocity near the tip of the rotor

For the flow behaviour during rotating stall, the instantaneous negative axial velocity near the tip of the rotor is shown in Figure 18. It was obtained after a regular rotating stall pattern was formed. Six stall cells were found

with similar size and approximately equally spaced. Each of them covered about 60% of the axial domain in the rotor. Rotating stall for this rotor at design speed was investigated using multi-passage model [20]. For that case, rotating stall predicted also has 6 stall cells with a propagation speed of 80% of the rotor speed based on the available data. Stall cells covered about 40% span of rotor blades and about 4 passages in the circumferential direction. The spanwise extent of rotating stall is larger than the present study and could be caused by the interaction between shock waves, boundary layer and tip clearance flow at design speed while present predictions are performed at 60% of the design speed. In addition, their simulations were performed over two engine revolutions only and the solution could have developed to a different pattern if the simulations were continued beyond that. Figure 19 shows the negative axial velocity on an axial cut in the rotor at the same time instant as in Figure 18. The axial cut plane is at 40% of chord

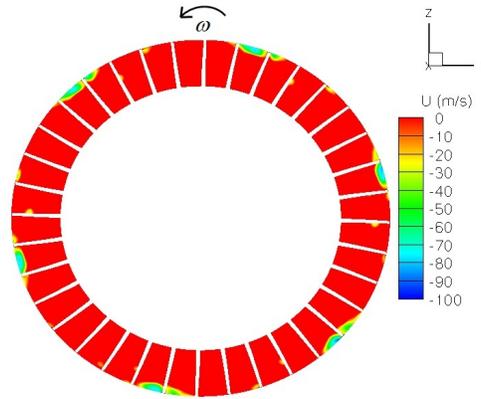
Figure 19: Instantaneous negative axial velocity on an axial cut plane

length downstream from the leading edge at the hub. It also shows stall cells equally spaced in the circumferential direction and covered about 17% in radial span. This shows that stall cells are found only near the tip region. That is a typical behaviour of spike type rotating stall as reported by Day [21] which shows that stall cells tend to be confined to the tip region of the rotor suggesting that tip clearance flow is mostly responsible for its inception. Spike type disturbances have also been experimentally measured to have a circumferential extent of two to three blade passages ([21], [22], [23]).

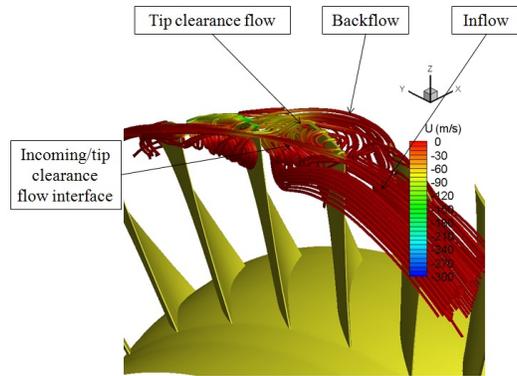
Figure 20: 3D stream trace inside the stall cell

Figure 20 shows 3D streamlines contoured by the negative axial velocity. The inflow comes from the leading edge of one blade, and the back flow was reversed at the trailing edge of the neighbouring blade and going into the passage. It meets the tip clearance flow and the vortex of the stall cell. The interface between the streamwise inflow and with tip clearance flow is aligned with the leading edge plane. This is consistent with the explanation

of the flow features for the spike initiated rotating stall proposed by Vo et al [3]. Inside the stall cell the blocked flow diverts the oncoming flow to the neighbouring area. Outside the stall cell, flow is passing the passages smoothly without blockage. Stall cell also formed a radial vortex attached to the blade and the casing. The concept of radial vortex was proposed by Inoue et al. [24] and also recently confirmed by Weichert et al. [25] and Pullan et al. [26]. The similarity predicted in this study is due to the design of this rotor, some blades encounter higher incidence beyond the critical value near the tip region which leads to separations from the suction side. The stalled region constitutes a radial vortex attached to the suction side and the casing. As shown in Figure 20 in the rotor reference frame, when the cell is propagating in the anti-clockwise direction, the vortex leaves the suction side of one blade and moves towards the pressure side of the next blade, which will divert the flow to the surrounding region. Also the stall cell indicates a

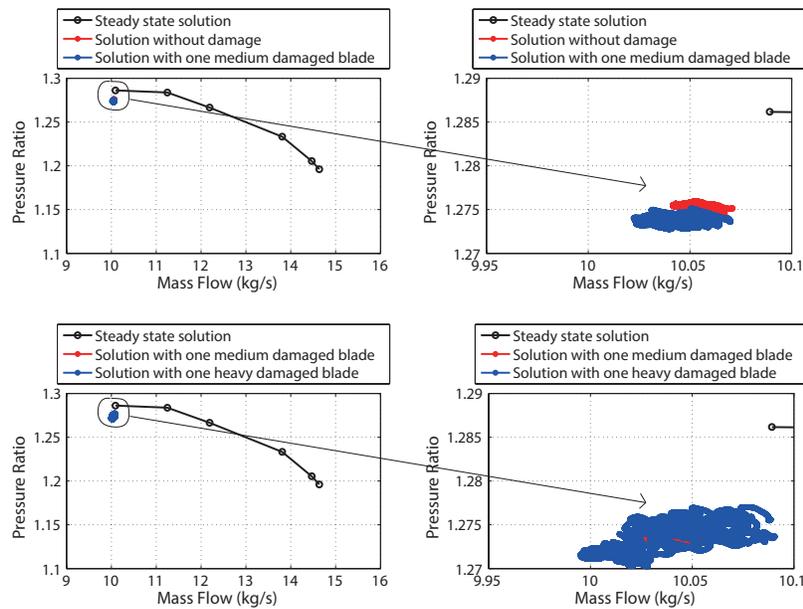
Figure 21: Compressor performance during rotating stall with one damaged blade

In this subsection the comparison of one damaged blade with different degrees of damage is discussed. The case with one medium damaged blade and one heavy damaged blade will be noted as Damaged Case 1 and Damaged Case 2 respectively. A comparison of compressor performance is shown in Figure 21. For Damaged Case 1, the overall compressor performance was very similar for the mass flow but the pressure ratio decreased slightly compared to the undamaged case, which could be caused by rotating stall with the damaged blade. Compressor performance for Damaged Case 2 has

slightly larger variation for mass flow and pressure ratio than Damaged Case 1. However, both cases do not have significant influence on the overall compressor performance. The reason for that is the same as for the undamaged case, the results are similar as shown in Figures 14 and 15. Therefore, they are not shown here to avoid repetition.

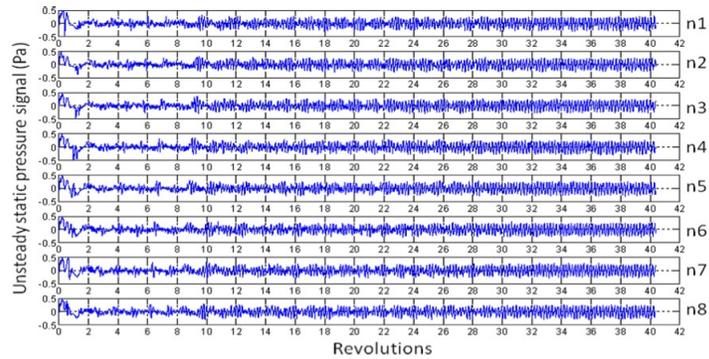
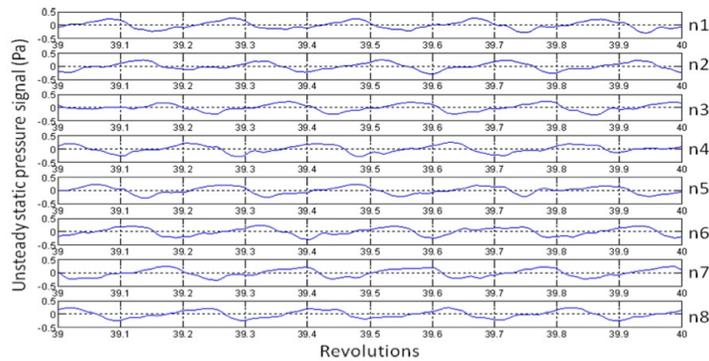
Figure 22: Unsteady static pressure signal time history from numerical sensors on the casing for Damaged Case 1

It was observed that stall cells started from the damaged blade and rotated in the opposite direction to rotor rotation seen in the relative frame. For Damaged Case 1 in Figure 22a, after the initial numerical transit, rotating stall started after 2 revolutions. Then the transition process of 28 revolutions took place until a clear pattern was established after the 30th revolution. Compared to the undamaged case, it takes less time to achieve a clear form

of rotating stall. It can be seen from Figure 23a that when increasing the damage, it takes longer for the flow to settle. In Figures 22b and 23b, it can be seen that 5 and 6 cells passed the same sensors in that time period for Damaged Case 1 and Damaged Case 2 respectively. There are small kinks at the beginning of some of the spikes for both cases with damage, circled on the plot. That could be the effect that the cell just passed the damaged blade. Compared to the undamaged case, the rotating stall characteristic is the same for Damaged Case 1. For the Damaged Case 2, there are 7 rotating stall cells instead. The propagation speed of rotating cells is very similar to the other two unsteady cases.

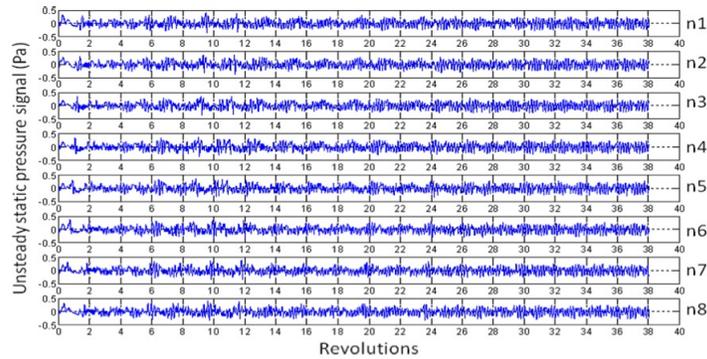
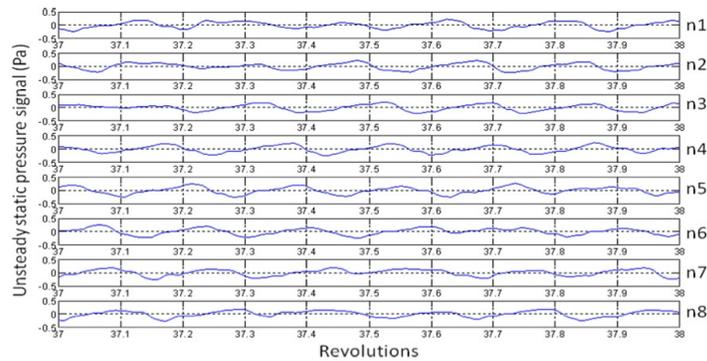
Figure 23: Unsteady static pressure signal time history from numerical sensors on the casing for Damaged Case 2

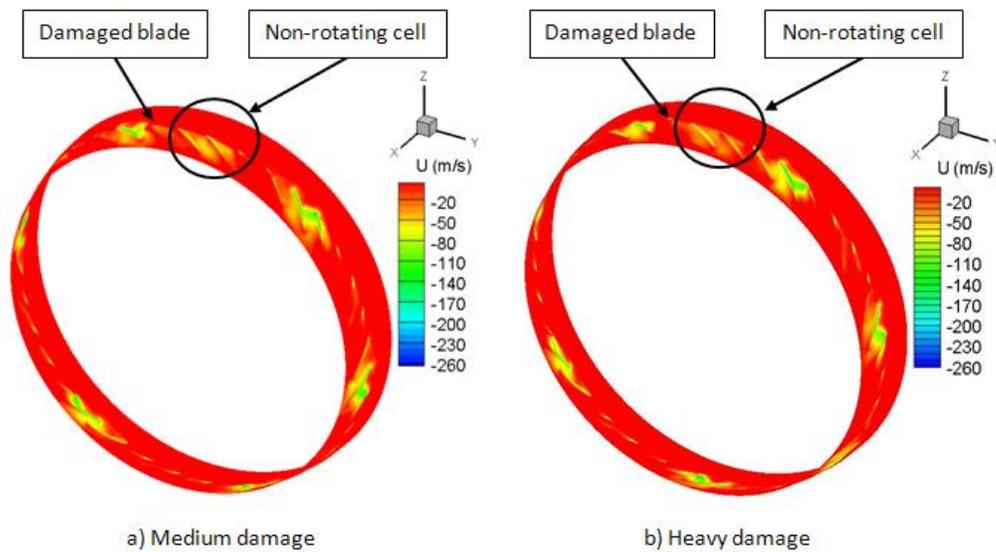
Figure 24: Instantaneous negative velocity near the tip of the rotor

Figure 24 shows the instantaneous negative velocity near the tip. For both cases with damage, 6 and 7 rotating cells could be observed respectively at the same time with similar size, shape and approximately equally spaced. Compared with the undamaged case, the difference is that a non-rotating stall cell covered the neighbouring region around the damaged blade all the time after rotating stall started. It is caused by the presence of the damage, which always diverts the flow. When a rotating stall cell passes through the damaged blade passage, it merges with the non-rotating cell. After it passes by, the non-rotating cell recovers to its original state. That could be seen clearly in the animation. The extent of stall cells in the radial direction can be seen in Figure 25, which shows the negative axial velocity on an axial cut plane at 40% chord downstream from the leading edge at the hub. For Damaged Case 1, each stall cell covered the same extent as the undamaged

case. The non-rotating stall cell is smaller in the radial direction covering about 11% of the blade span. For Damaged Case 2, the rotating cells covered from about 10% to 18% of the span and non-rotating cell covered about 12%.

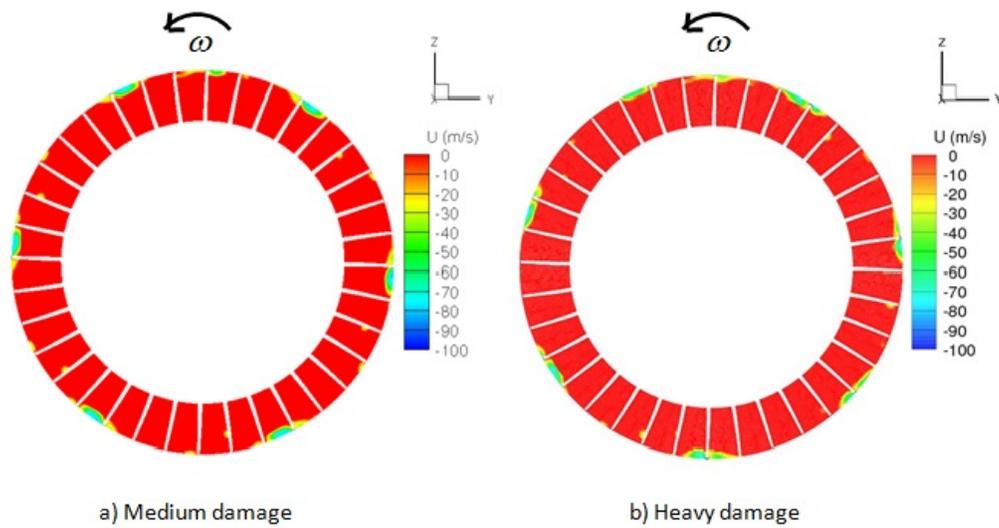
Figure 25: Instantaneous negative velocity on an axial cut plane

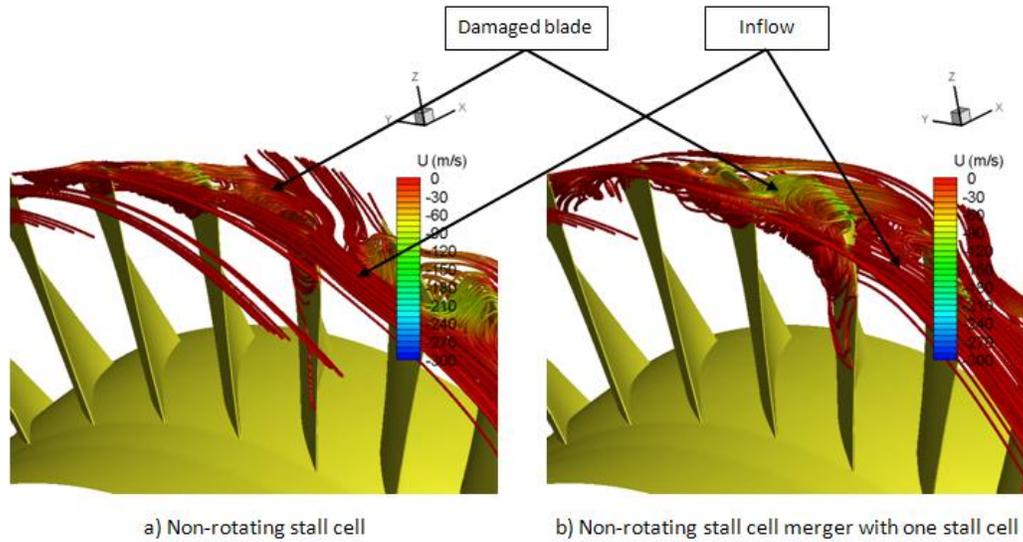
Figure 26: Stall cell structure for Damaged Case 1

Figure 26 shows 3D structure of stall cells after a clear rotating stall pattern obtained for Damaged Case 1. Figure 26a shows the non-rotating stalled region including the damaged blade. Figure 26b which is obtained at a consequent time to Figure 26a shows one stall cell was merging with the non-rotating stall cell. The size of the stalled region enlarged in both

radial and circumferential directions. When rotating cells passed the non-rotating stall region, the structure of the non-rotating stall region recovers after rotating cell passes by as mentioned earlier. The structures of other cells at other locations seem to be very similar as in the undamaged case. Again, it showed that the non-rotating stall cell was caused by the damaged blade because the flow was always diverted by the damage feature at the leading edge. For Damaged Case 2, the difference is that the non-rotating stall cell is

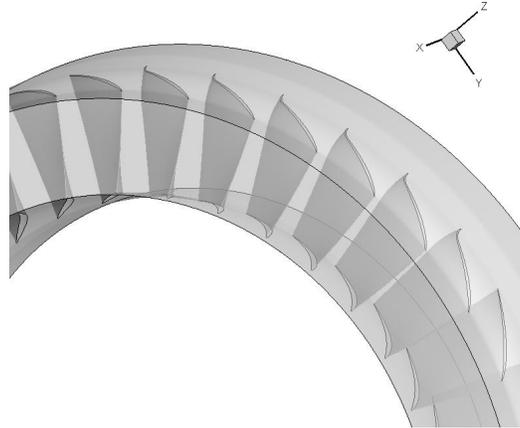
Figure 27: Part of the rotor assembly for Damaged Case 3

The last case investigated was a rotor assembly with six damaged blades of medium degree of damage. This case will be labelled as Damaged Case 3. The rotor assembly used is partially shown in Figure 27. The six damaged blades were allocated next to each other for the reason that it was believed that it was likely to provide the most negative effect on compressor performance with this arrangement.

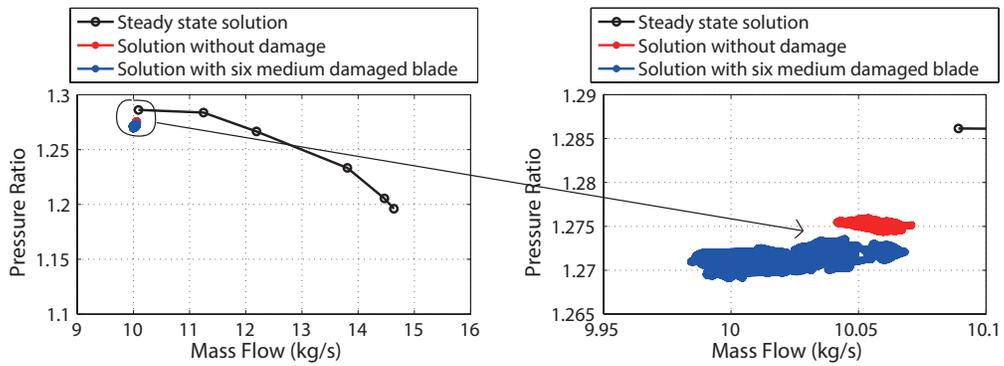
Figure 28: Compressor performance for Damaged Case 3

Figure 28 shows a comparison of overall compressor performance with steady state simulation during the last 10 revolutions of the simulation. Compared to the steady state solution, the mass flow was very similar and on the other hand the pressure ratio had a slightly larger reduction, which was

about 1.2%. Compared to other unsteady cases, mass flow has large variation. However, it could also be seen that there was no significant change on the compressor overall performance. This case does not have a clear pattern of rotating stall and it is believed that it will not have one. Due to the limited time scale for this study, it is not possible to prove at this stage.

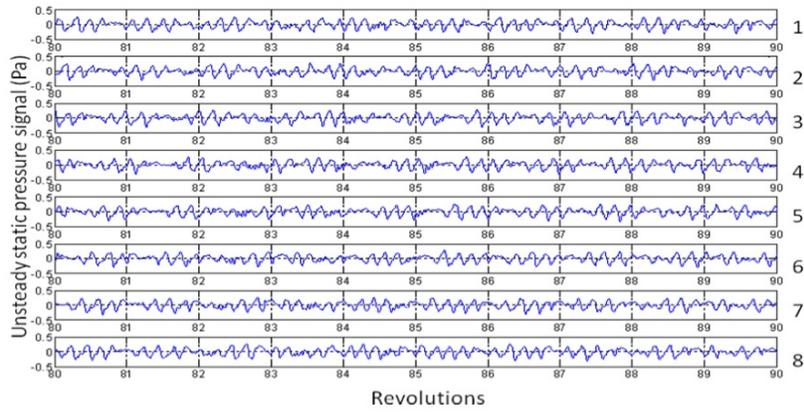
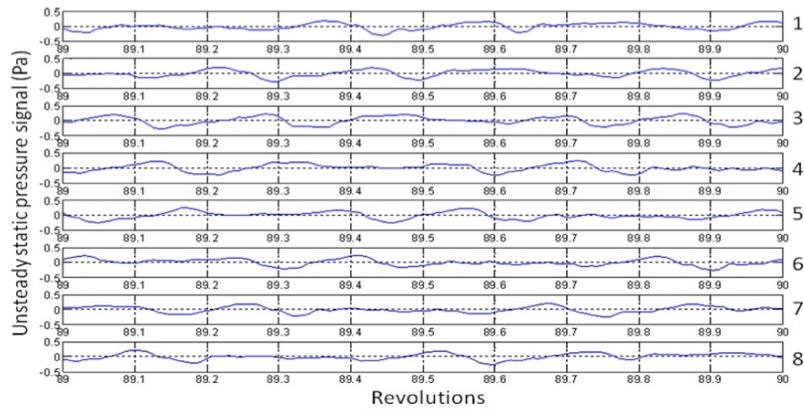
Figure 29: Unsteady static pressure signal time history from numerical sensors on the casing

Figure 29 shows the unsteady static pressure signal time history from

numerical sensors. The case was simulated more than 90 revolutions with the mass flow still changing. That indicates that with six damaged blades in the rotor assembly, it could take a much longer time for the flow to settle. In Figure 29b, the rotating stall pattern was very different from other cases. There was rotating stall cell passing the large non-rotating stall region, which was circled in the plot.

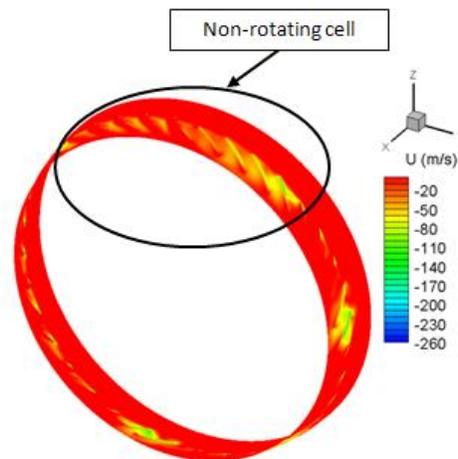
Figure 30: Instantaneous negative axial velocity near the tip of the rotor

Figure 30 shows the instantaneous negative axial velocity near the tip of the rotor and the contour plot was captured after **the 91st revolution**, which was close to the end of the simulation. There was a very large non-rotating stalled region covering the damaged blades and some of the neighbouring area, from the animation. In the meantime, there were three other cells in much smaller size which were propagating around the annulus. Another negative axial velocity contour plot was obtained on an axial cutting plane, which was 40% of chord length downstream, the leading edge of the rotor on the hub in Figure 31. As clearly seen from the plot, the large non-rotating stalled region covered about 9 blade passages **and** three smaller cells covered about two passages each and up to 17% of the radial span. Since the flow is still changing, it was difficult to determine the propagation speed of stall cells.

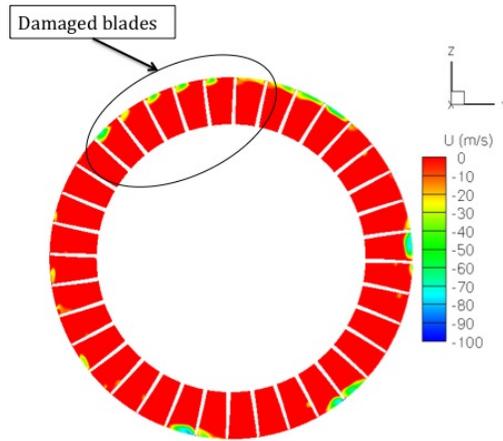
Figure 31: Instantaneous negative velocity on an axial cutting plane through the rotor blade
