Citation: Maraveas, C. & Tsavdaridis, K. D. (2019). Assessment and retrofitting of an existing steel structure subjected to wind-induced failure analysis. *Journal of Building Engineering*, 23, pp. 53-67. doi: 10.1016/j.jobe.2019.01.005

Assessment and Retrofitting of an Existing Steel Structure subjected to Wind-Induced Failure Analysis

C. Maraveas^{1,2*} and K.D. Tsavdaridis³

¹C. MARAVEAS & ASSOCIATES P.C. - Consulting Engineers, Greece

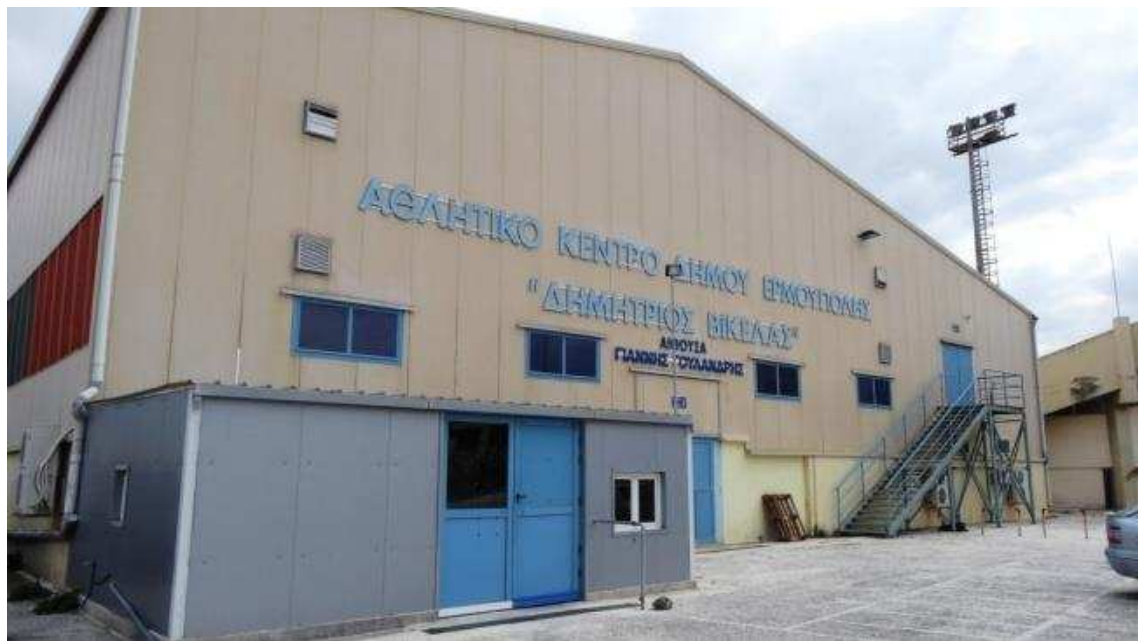
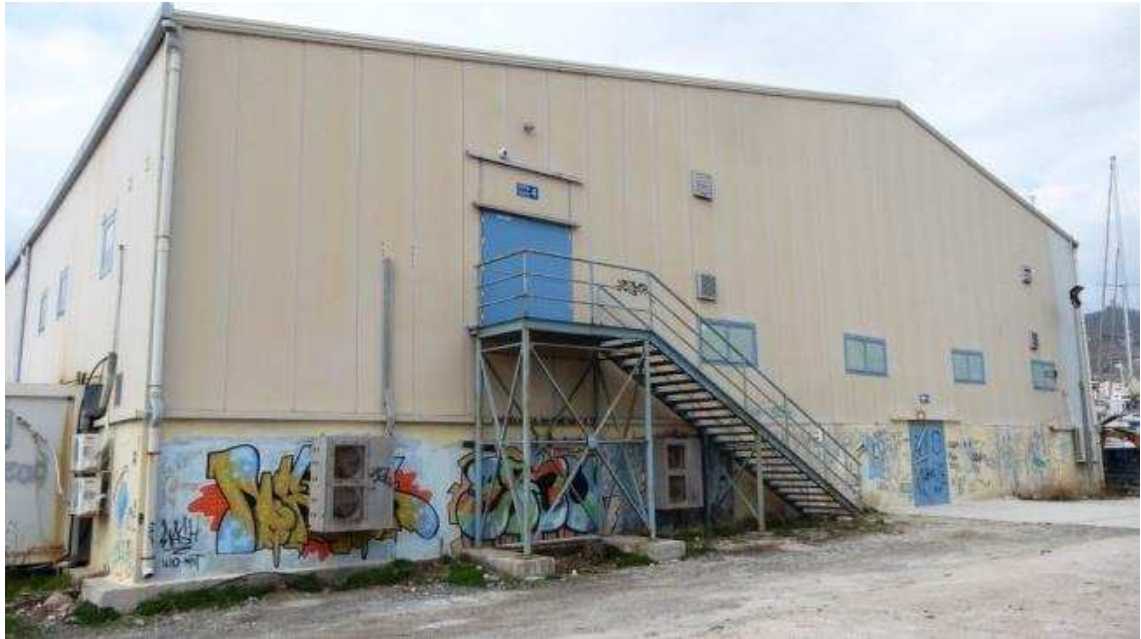
Fig. 1. Views of the a) west and b) east sides of the building.

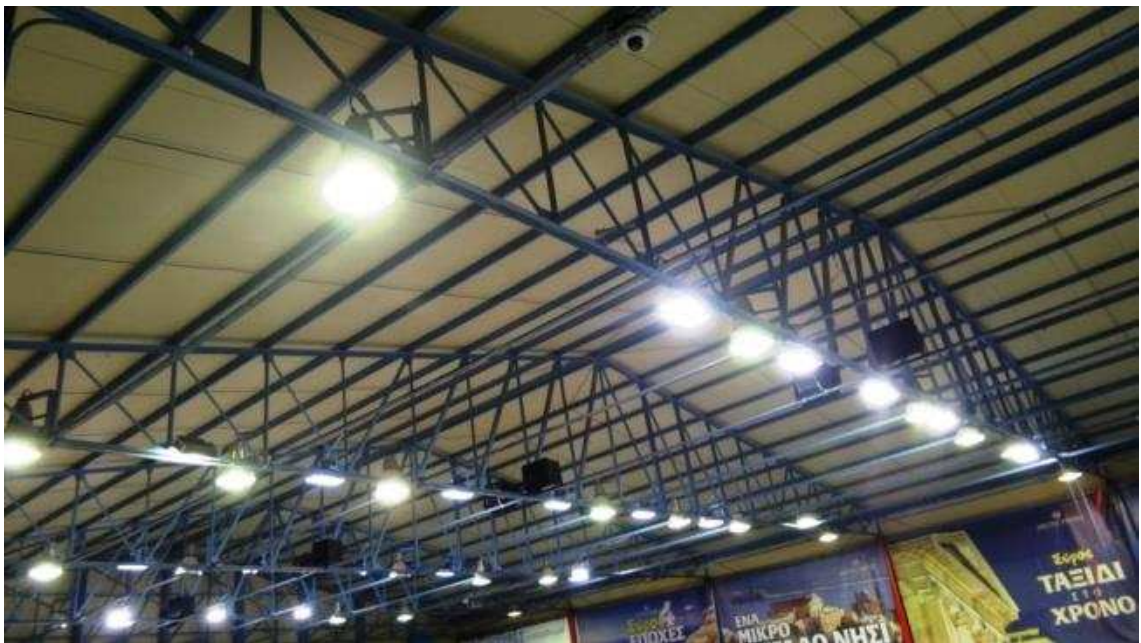
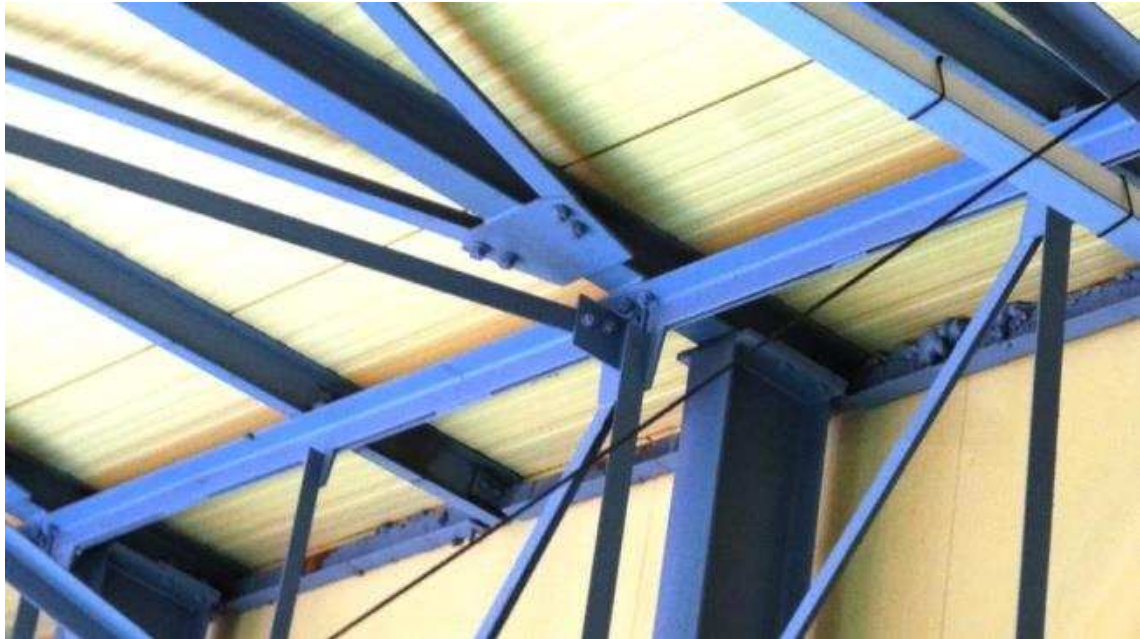
Fig. 2. a) Overall view and b) structural details of the steel lattice roof.

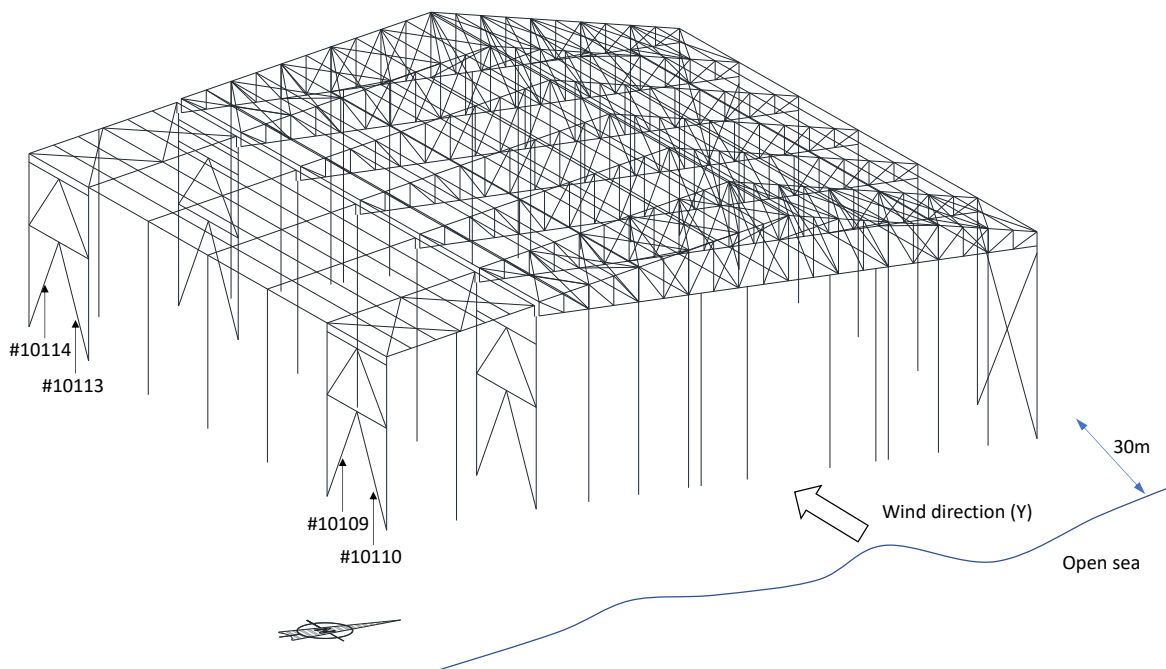
The wind load in the longitudinal direction is simulated only for the Y-axis since major building damage has been observed in this direction in particular. The vertical component of the wind load is not considered in the present study. In Fig. 11, the 3D view of the existing simulated structure is shown as well as the element numbering for 4 selected bracings.

Fig. 11. The overall configuration of the existing structure.

An interesting clue appears to significantly affect the structural response with regard to excessive second-order deformation of the south-west lower bracing [member no. 10114 presented in Fig. 4(a)]. The stiffness and vertical load capacity of the damaged member are obtained from FE buckling analyses using Abaqus [20]. The results are presented in section 2.3.2.

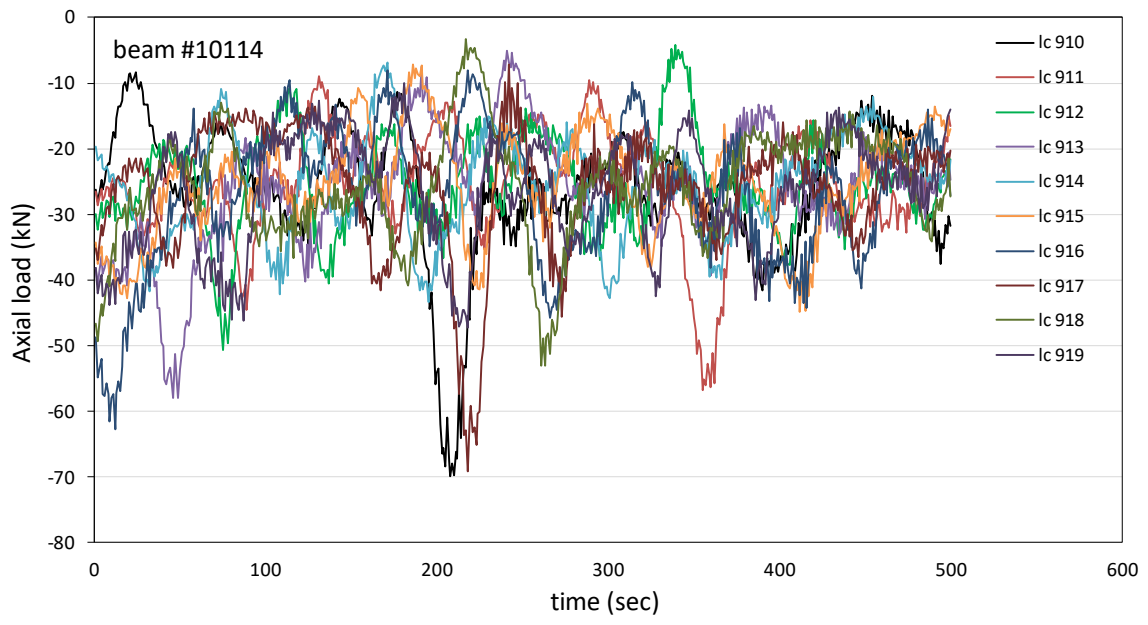
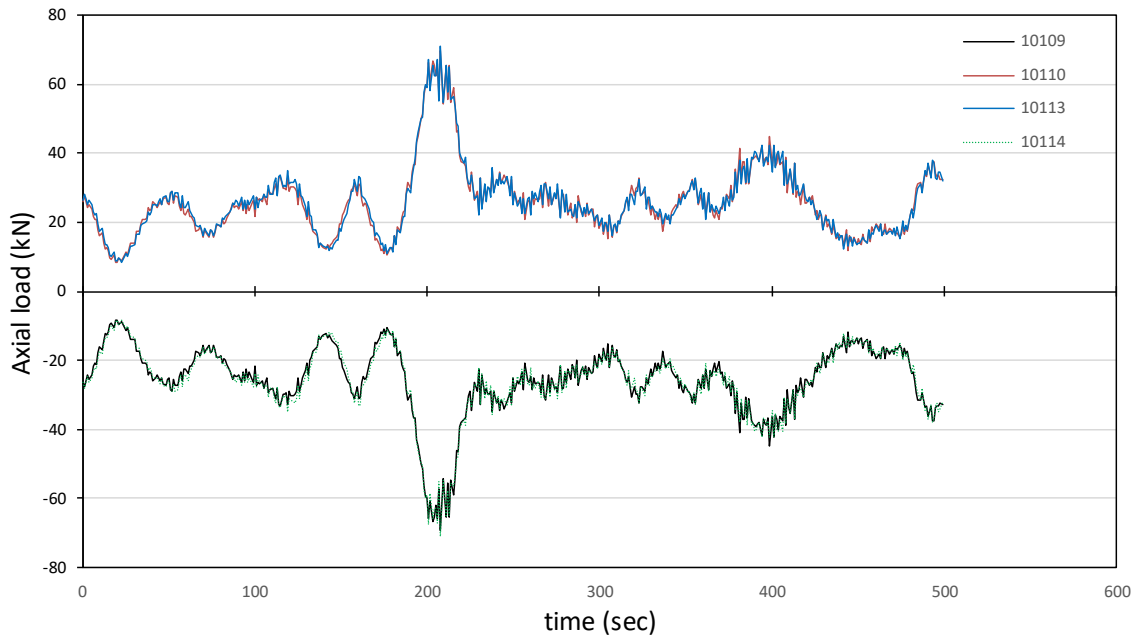
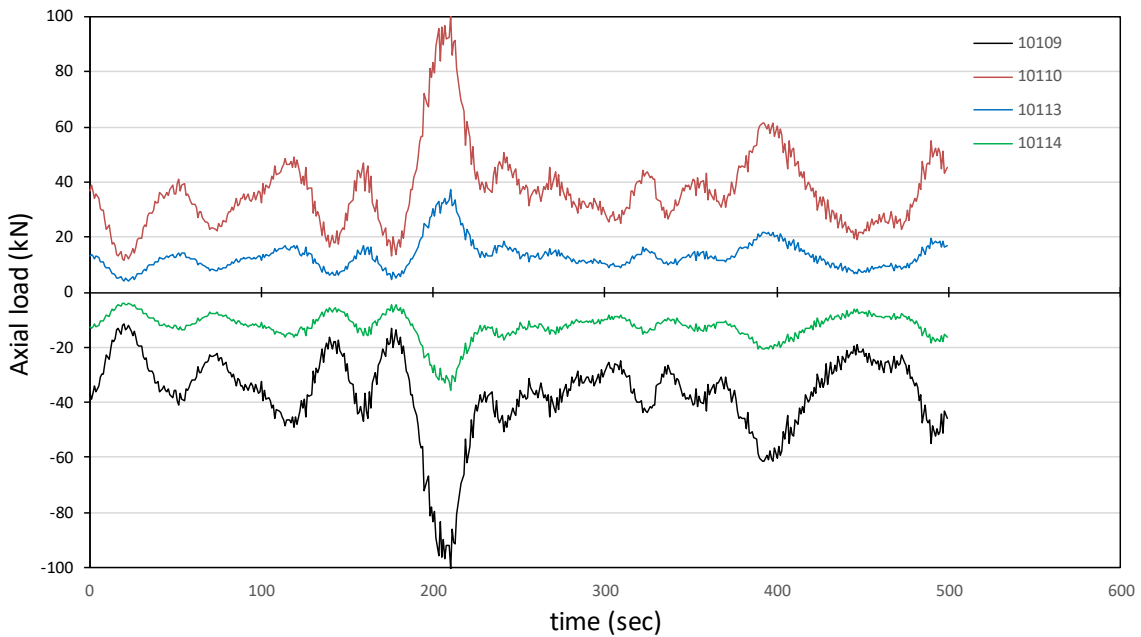
The results of the time-history dynamic analyses for the selected beam elements in terms of axial force are presented in Figs. 12(b) and 12(c). Figure 12(a) shows the axial forces developed on element 10114 (failed element) during the time history analyses performed for the 10 different wind spectras. The two figures (12(b) and 12(c)) respectively address conditions that exclude and include geometrical imperfection from the buckled L-section. The latter case can be referred to as the "imperfect" one. A thickness reduction of 1.0 mm due to corrosion is also included in this case. One can clearly observe relief of the damaged and tensile (member no. 10113) members. In contrast, the east pair of bracings displays additional axial force, which reveals a more unfavourable design status (member nos. 10109, 10110). The axial forces are differentiated by approximately $\pm 45\%$.

Fig. 12. Axial load histories for Λ -type vertical bracings with a) axial force developed on element 10114 for 10 different wind spectras and b) perfect structure axial loads of bracing elements 10109, 10110, 10113 and 10114 for the most unfavourable time history and c) imperfect structure axial loads of bracing elements 10109, 10110, 10113 and 10114 for the most unfavourable time history.

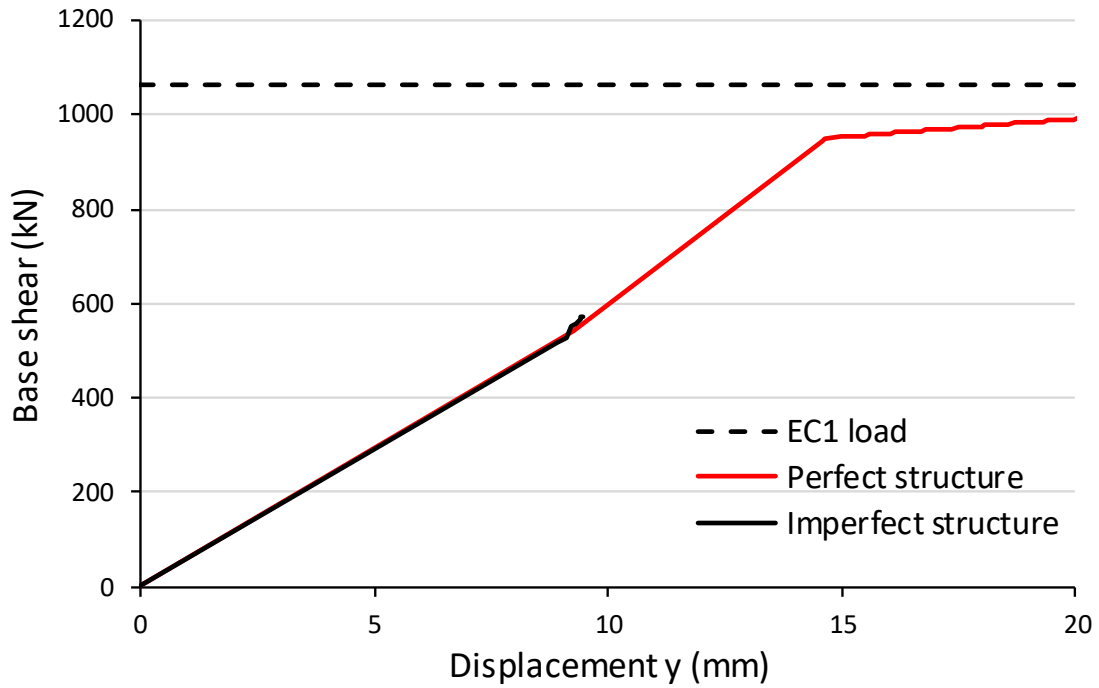
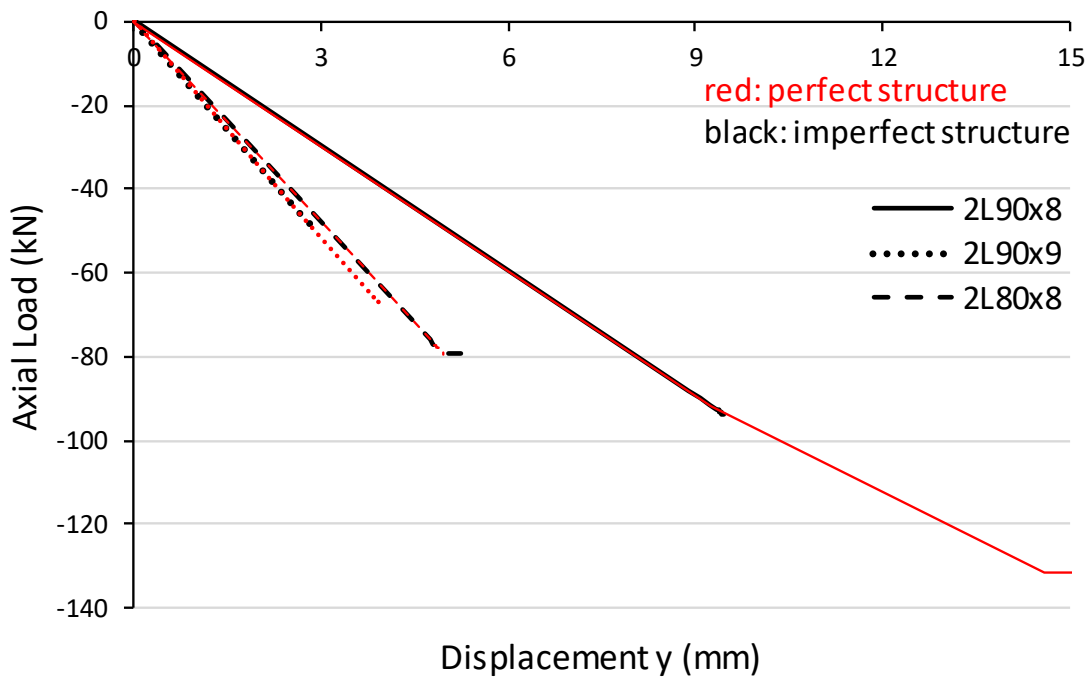
The vertical load capacity curves are shown in Fig. 15(a) capture the total response of the structure, while the dashed line defines the minimum requirement that the structure should have met. After considering imperfections, i.e., excessive deformation of the damaged bracing, the bearing capacity is only 58% of the perfect sample. Nevertheless, the latter vertical load capacity does not satisfy the Eurocode requirement in terms of the total base shear force. Furthermore, the axial load-displacement curves of the major vertical bracings are compared in Fig. 15(b), while the selected imperfection is neglected during pushover analysis. The double equal angle cross-sections L90x8, L80x8, and L90x9 correspond to the existing bracings of the north, south, and Section 1-1 views, respectively.

Fig. 15. Comparison of the a) vertical load capacity curves and b) axial load-displacement paths of vertical bracings within perfect and imperfect structures.

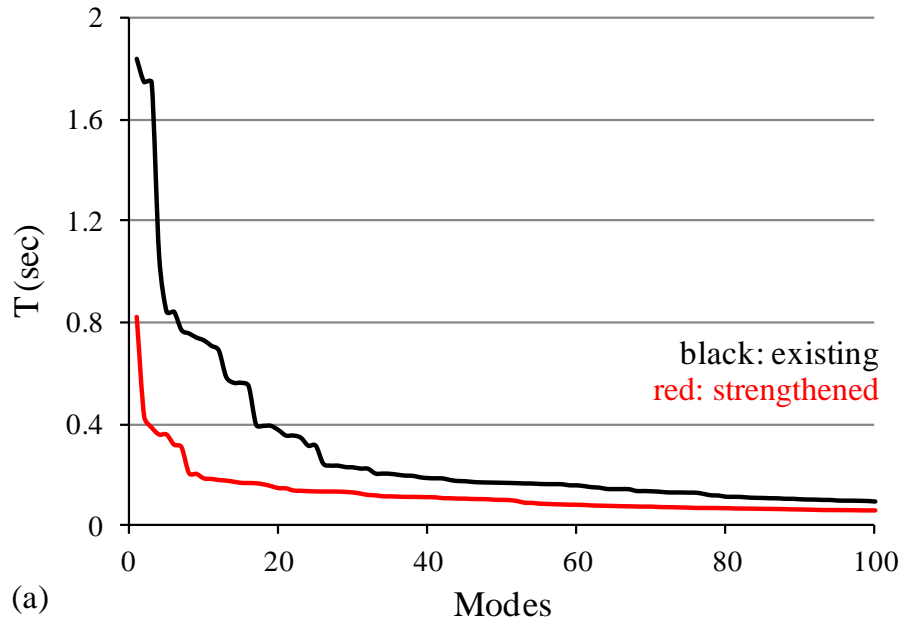
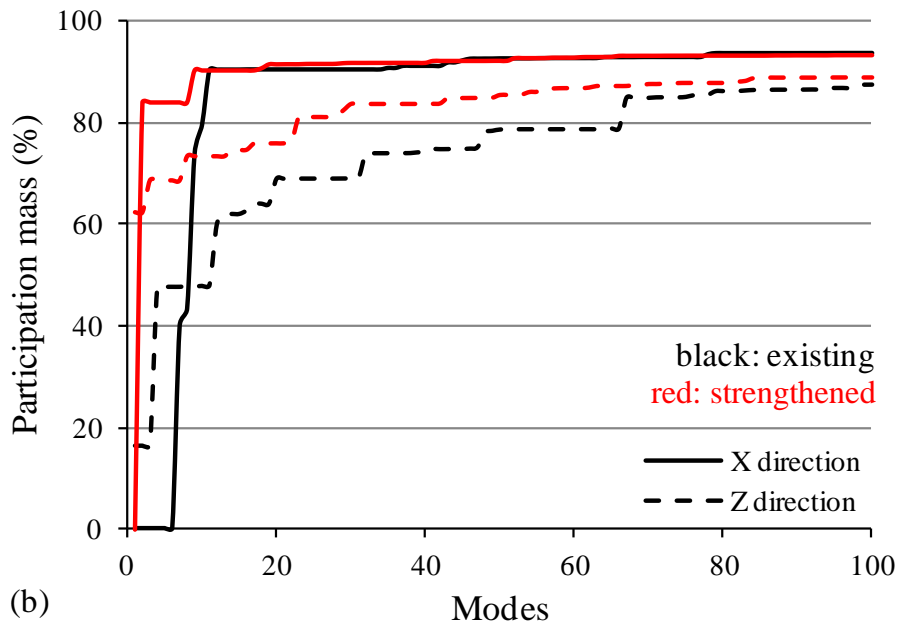
Fig. 19. Comparison of the dynamic characteristics of the existing (black) and strengthened (red) structure (solid and dashed lines for the X- and Z-directions respectively).

Modal analyses [23] have been performed to compare the existing and strengthened structures. The results are shown in Fig. 19 demonstrate clear improvement to the dynamic characteristics of the structure. In particular, mass participation is increased to 62% and 84% in the long and transverse directions (along Z- and X-axis, respectively), compared to 31% in the unstiffened structure. The corresponding periods decrease from 1.07 s to 0.82 s and from 0.74 s to 0.43 s along Z- and X- directions, respectively, after the proposed retrofit. The aforementioned mode shapes for the long and transverse directions are compared in Figs.

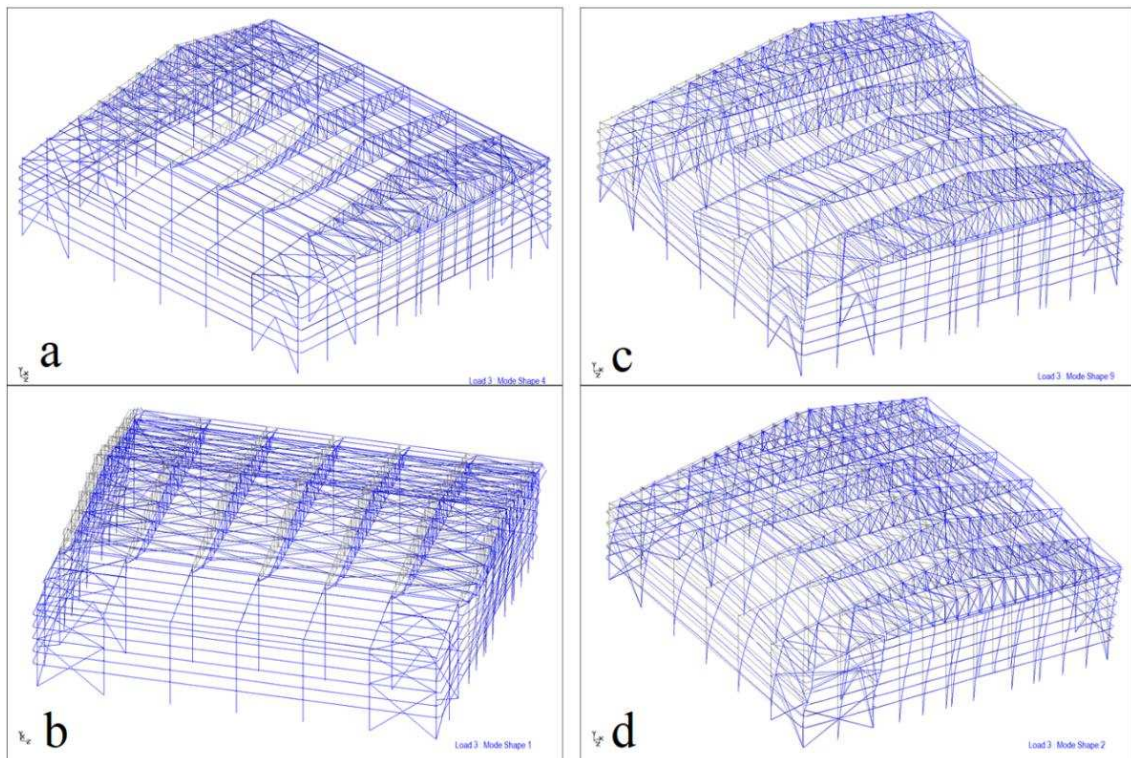
Fig. 20. Schematic view of some characteristic mode shapes of the existing (upper) and strengthened (lower) structures.

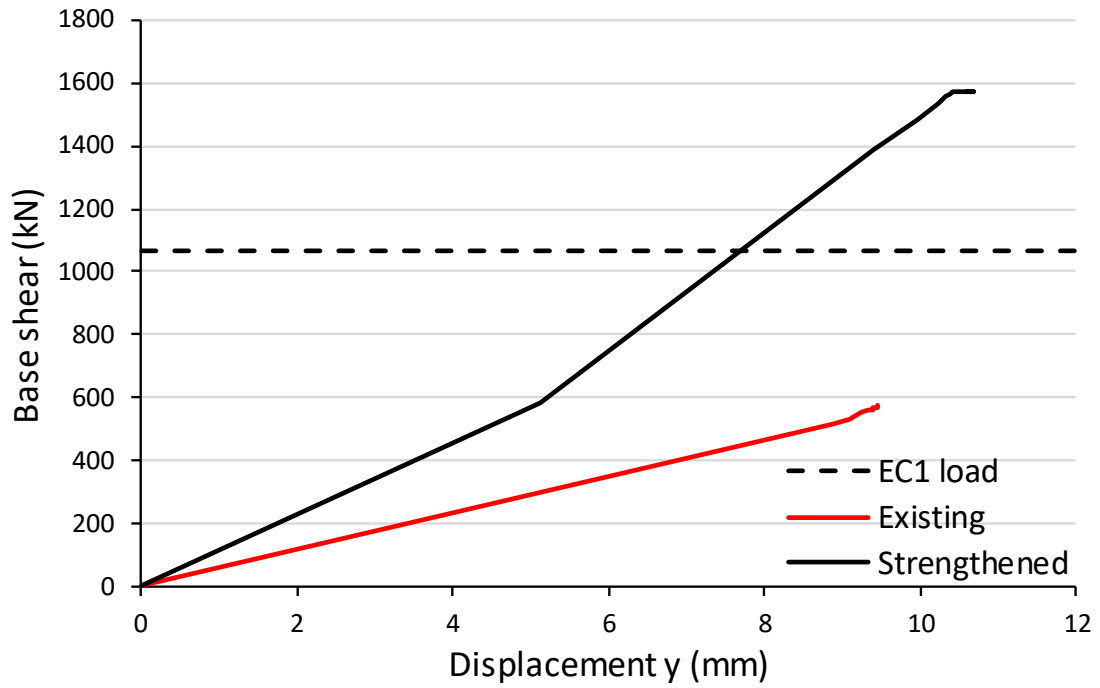
For the sake of completeness, the vertical load capacity curve of the proposed modified structure was established and compared to that of the existing structure. The procedure presented in Section 2.3.1, is repeated in Sofistik using the enhanced properties of the new and strengthened members. Fig. 21 depicts the new curve that indicates a total base shear force enlargement from 571 kN to 1571 kN.

Fig. 21. Comparison of the vertical load capacity curves of the existing and strengthened structures.

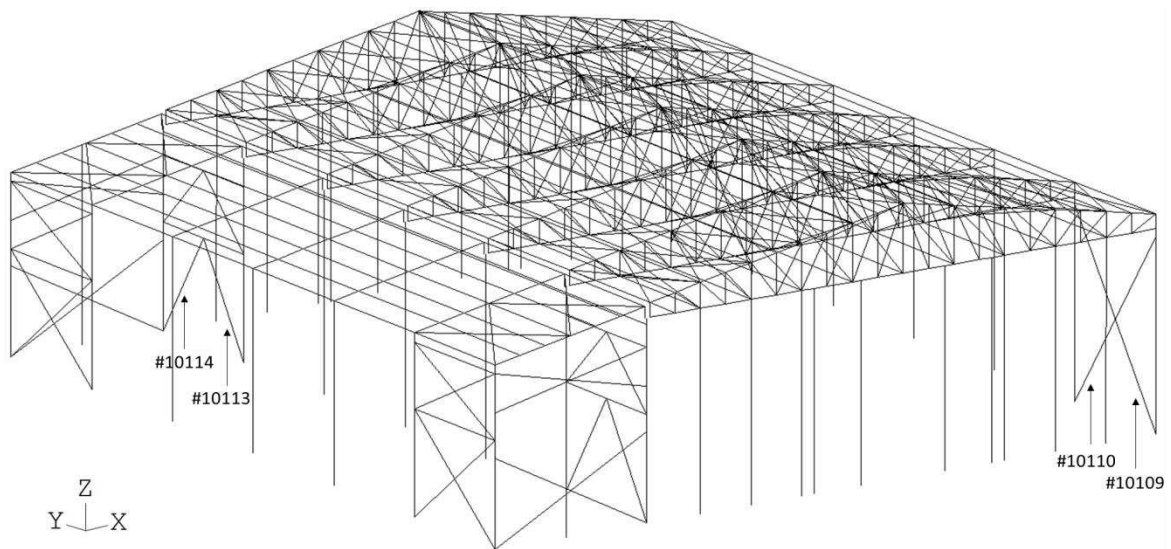
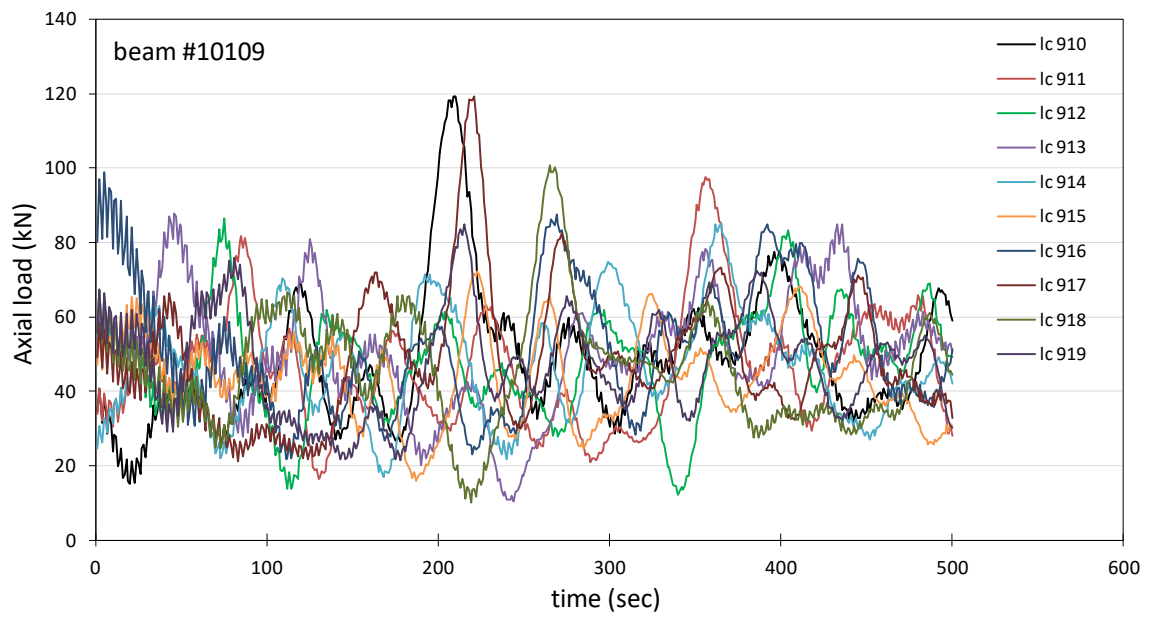
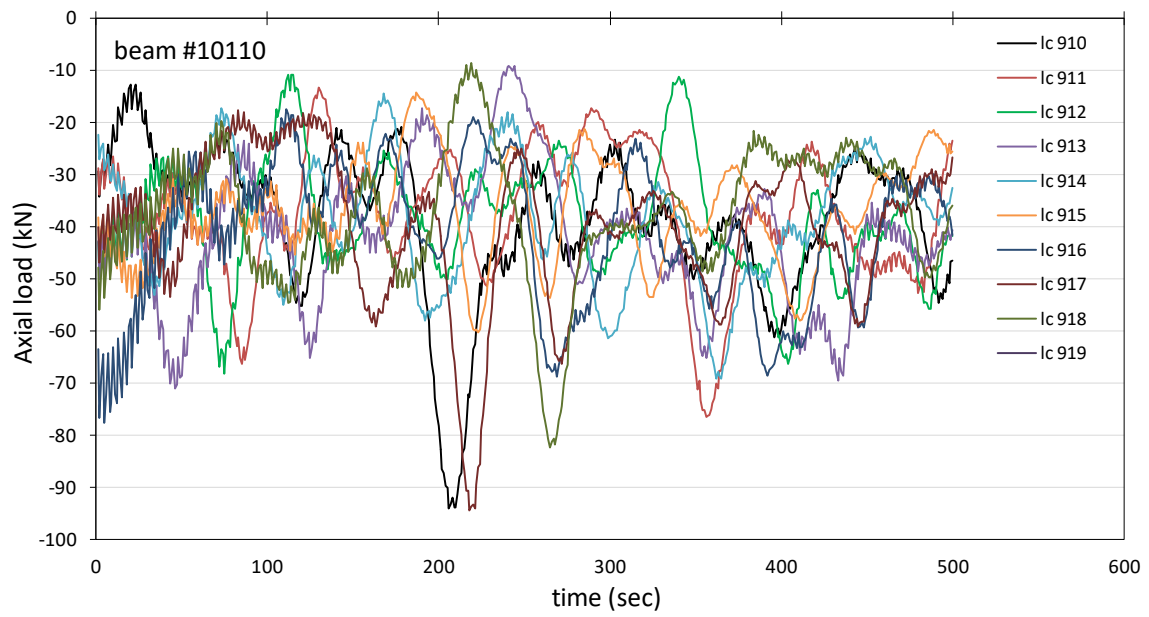
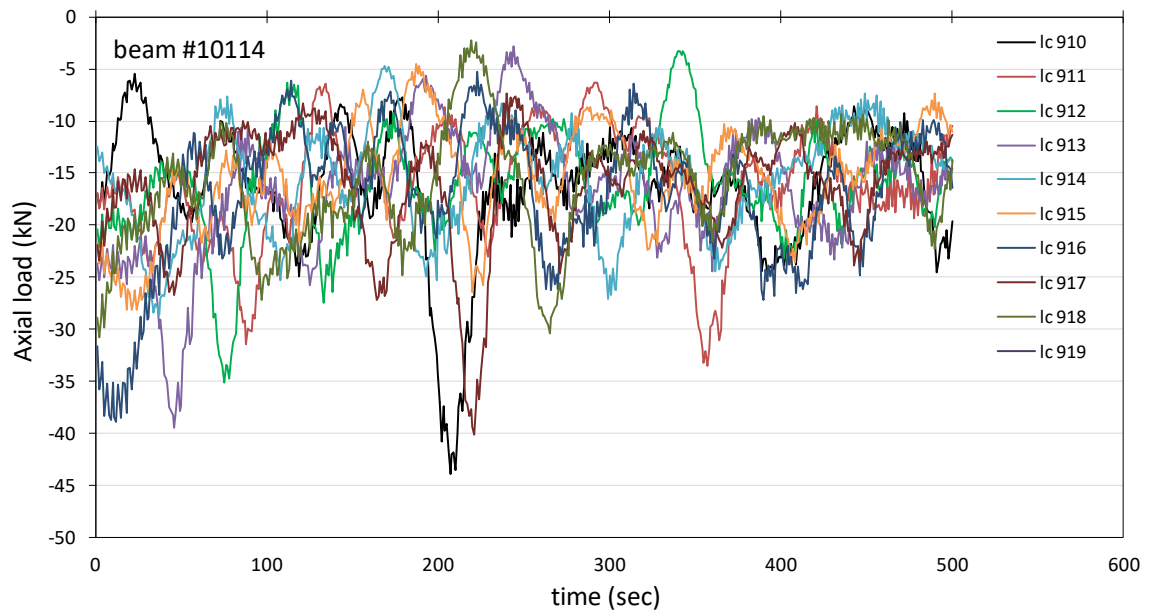
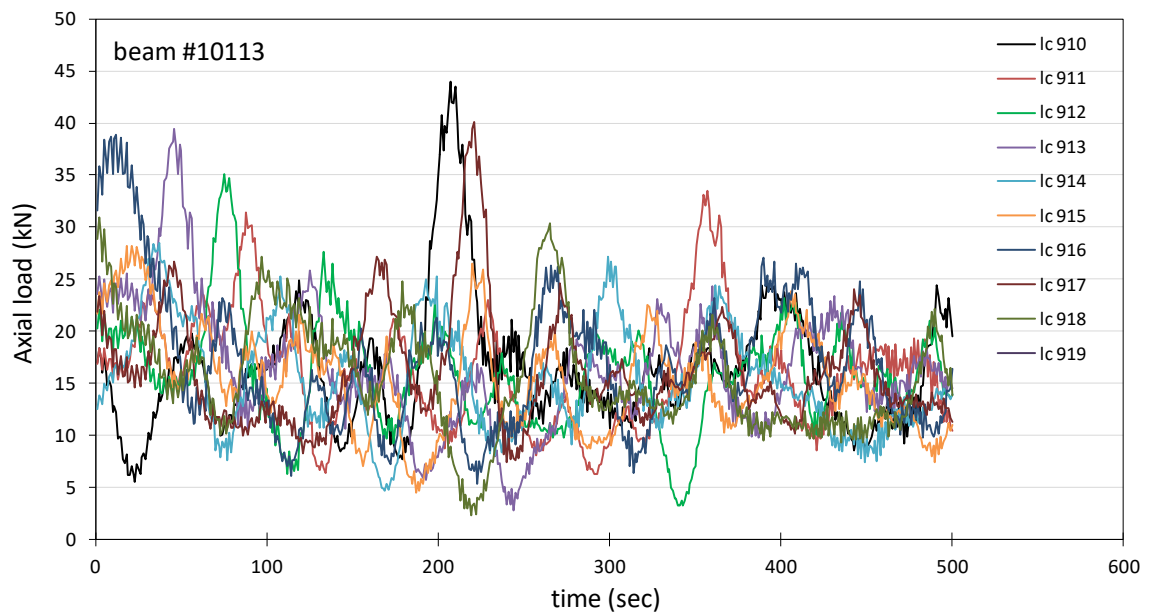
Furthermore, Fig. 22 shows the axial force histories of bracing elements for the 10 different wind histories. In order to ensure that the analysis parameters are providing safe results, a sensitivity analysis for the coherence factor was performed and showed that the used coherence factor was appropriate (Fig. 23).

Fig. 22. (a) Strengthened structure numerical model with a number of bracing elements analysed, (b) axial force history of element 10109 for 10 wind time history analyses, (c) same for element 10110 (d) same for element 10114 and (e) for element 10113.

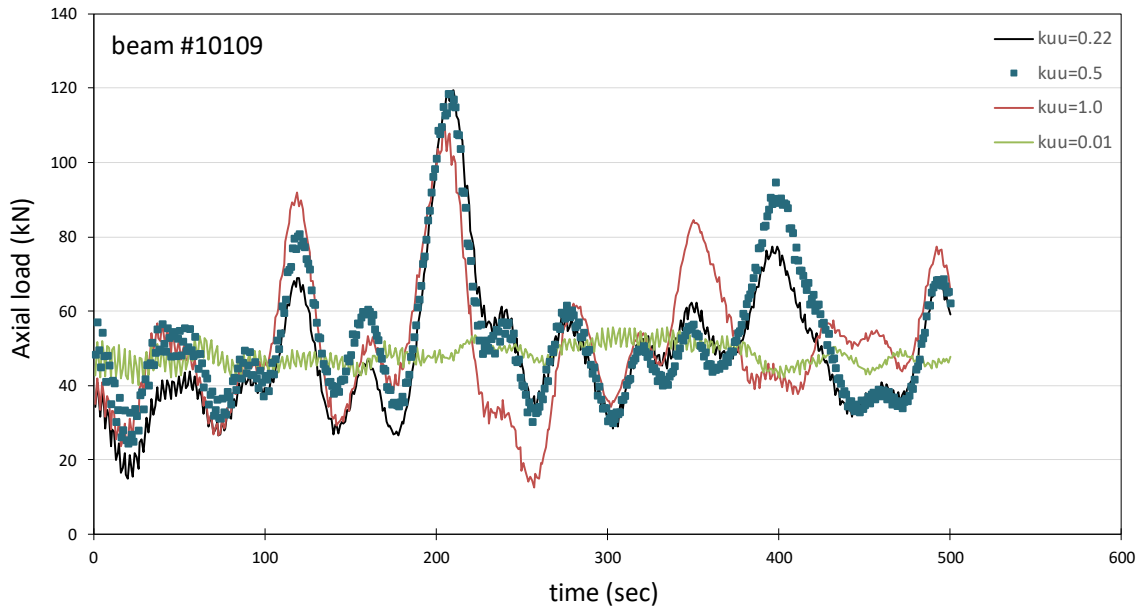
Fig. 23. Axial force history of element 10109 for different coherence factors.
