Citation: Addepalli, S., Zhao, Y., Roy, R., Galhenegge, W., Colle, M., Yu, J. & Ucur, A. (2019). Non-destructive evaluation of localised heat damage occurring in carbon composites using thermography and thermal diffusivity measurement. *Measurement*, 131, pp. 706-713. doi: 10.1016/j.measurement.2018.09.040

Non-destructive evaluation of localised heat damage occurring in carbon composites using thermography and thermal diffusivity measurement

Sri Addepalli ^{*}, Yifan Zhao, Rajkumar Roy, Wathsala Galhenege, Marine Colle, Jingjing Yu, Aziz Ucur

Through-life Engineering Services Centre, Cranfield Manufacturing, Cranfield University, Cranfield MK43 0AL, United Kingdom

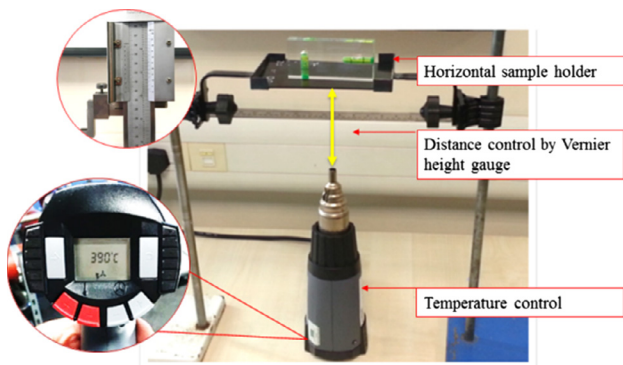
In order to maintain repeated presentation of the part, the rig was setup as seen in Fig. 1. The setup consisted of a heat gun with electronic temperature controller; two custom made holders set on the stand, the height of which was set using a Vernier height gauge with an accuracy of ± 0.02 mm. The holder was designed to match the precise location of the sample and maintain repeatability. For the selection of a suitable heat source a range of heat sources were explored during the research and included systems that used laser, infrared and resistive heating methods. With an approach to represent an in-field scenario, a hot air gun was finalised as the heat source.

Fig. 1. Heat exposure test rig.

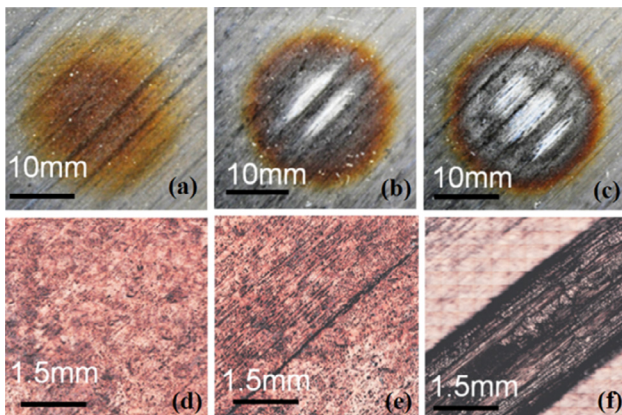
As the heat gun exhaust was circular, the damage formed in this case was circular and were measured at 24 mm, 26 mm and 26 mm diameter respectively. It was observed that a 5-minute exposure caused the initial crack and a 30 min exposure produced extended cracks and blisters. As heating the laminate to the initial crack was characterised by discolouration first, a 2-minute exposure was set to capture initial discolouration to represent incipient damage. The microscopic evaluation confirmed the observed features as seen in Fig. 2, where (d) showed no significant difference; (e) the initial crack and (f) showing the full-grown damage.

Fig. 2. Visual inspection results for laminates exposed to medium heat exposure; Digital and microscopic images: (a) (d) M2, (b) (e) M5, and (c) (f) M30.

As describe previously, the samples were exposed to two different sets of experiments. The set one had a set medium temperature of 386.2 °C with exposure durations set to 2, 5 and 30 min and set two was exposed to low and high heat conditions. The visual and microscopic indications obtained from set one are presented in Fig. 2.

Fig. 4 clearly picked up the damage caused due to heat exposure, which is also visible from a normalised line profile plot. However, it did not reveal the circular pattern as seen in the digital image (Fig. 2(c)). Also, the sample M2 showed discolouration visually and did not show any thermal response to the discolouration as presented by Fig. 5.

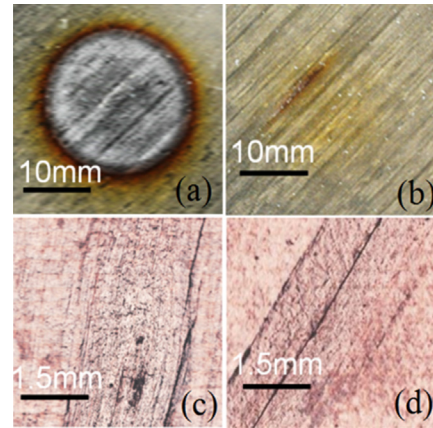
It can be observed from Fig. 3 that the sample with low heat exposure (L220) showed the strongest discolouration around the periphery of the damage, whereas the laminate with high heat exposure (H1) showed only limited signs of discolouration evidenced by Fig. 3, suggesting that the discolouration is time dependant. Further, it was observed that the high heat exposure did not allow much discolouration to occur as the damage formation was instantaneous, in this case at 0.25 min due to the high exposure

Fig. 3. Visual inspection results for laminates exposed to varying heat exposure; Digital and microscopic images: (a) (c) L220, (b) (d) H1.

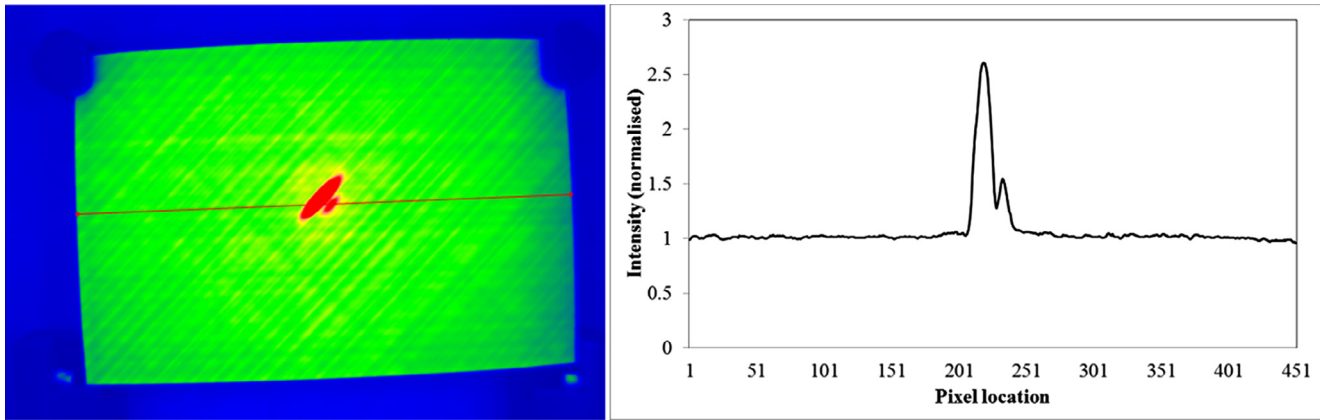
Fig. 4. RAW thermal image of the laminate M30 sampled at 0.28 s (left) and the normalised thermal line profile plot (right).

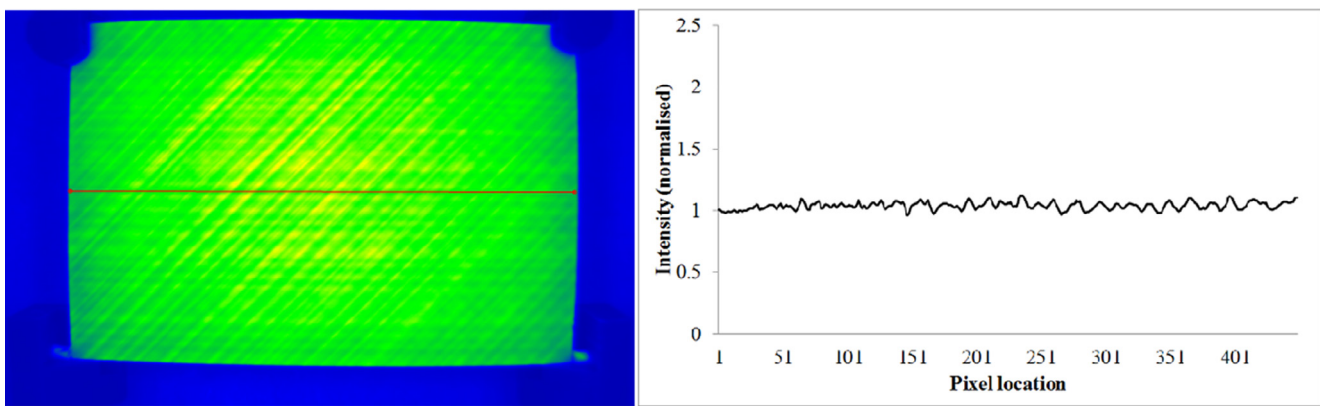
Fig. 5. RAW thermal image of the laminate exposed to medium heat for 2 min; and sampled at 0.28 s (left) and the normalised line profile plot (right).

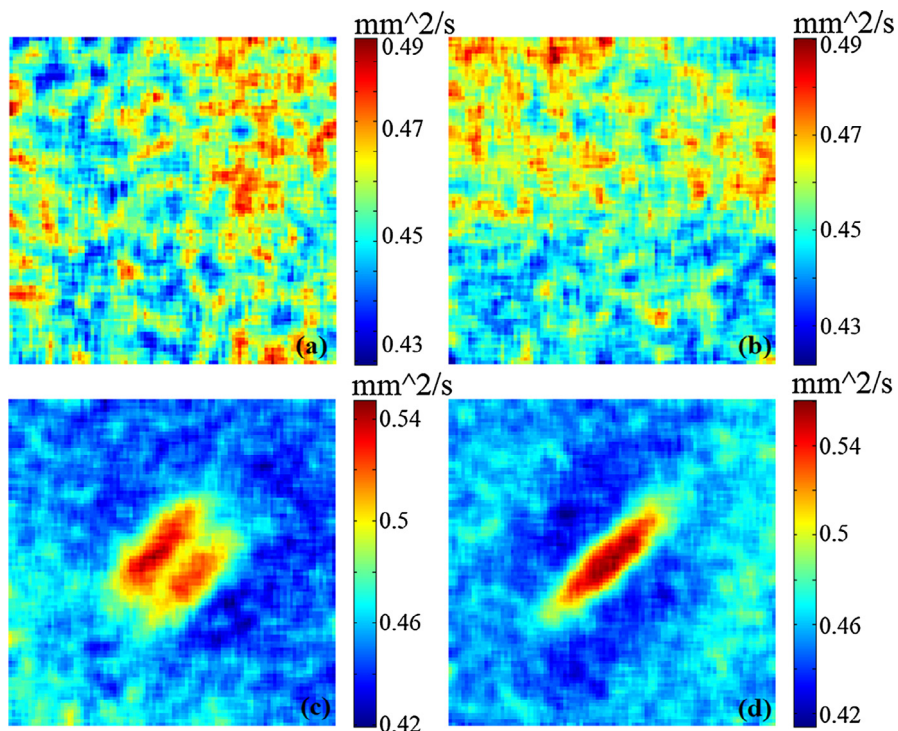
Fig. 6. Surface diffusivity maps reconstructed for an area of 100×100 pixels using the LSD method for the laminate exposed to medium heat for (a) S1, (b) M2, (c) M5 and (d) M30.

Fig. 6 shows the results of estimated surface diffusivity maps of the considered samples.

It can be inferred from Fig. 6 that the medium heat exposed laminates clearly picked up damage caused for the initial crack (at 5 min) and extended char (30 min), but did not show major change in terms of detecting the incipient damage characterised by visible discolouration. Hence a statistical approach was adopted where histograms were plotted from multiple trials. Fig. 7 shows the results obtained from statistical analysis, where the histogram of estimated thermal diffusivity values is plotted. The ‘as-is’ laminate with no damage achieved an approximate Gaussian distribution confirming the thermal diffusivity of the laminate. As expected, this distribution changed owing to the presence of damage, with changes occurring even for the discolouration damage. This is evidenced by higher sigma values ($>0.0081 \text{ mm}^2/\text{s}$) corresponding to the laminate heat exposure conditions. It was also observed that the sigma value increases with increase in exposure time (0.0101, 0.0112 and $0.0117 \text{ mm}^2/\text{s}$), indicating a larger damage area evidenced by the deviation in the thermal diffusivity of the laminate.

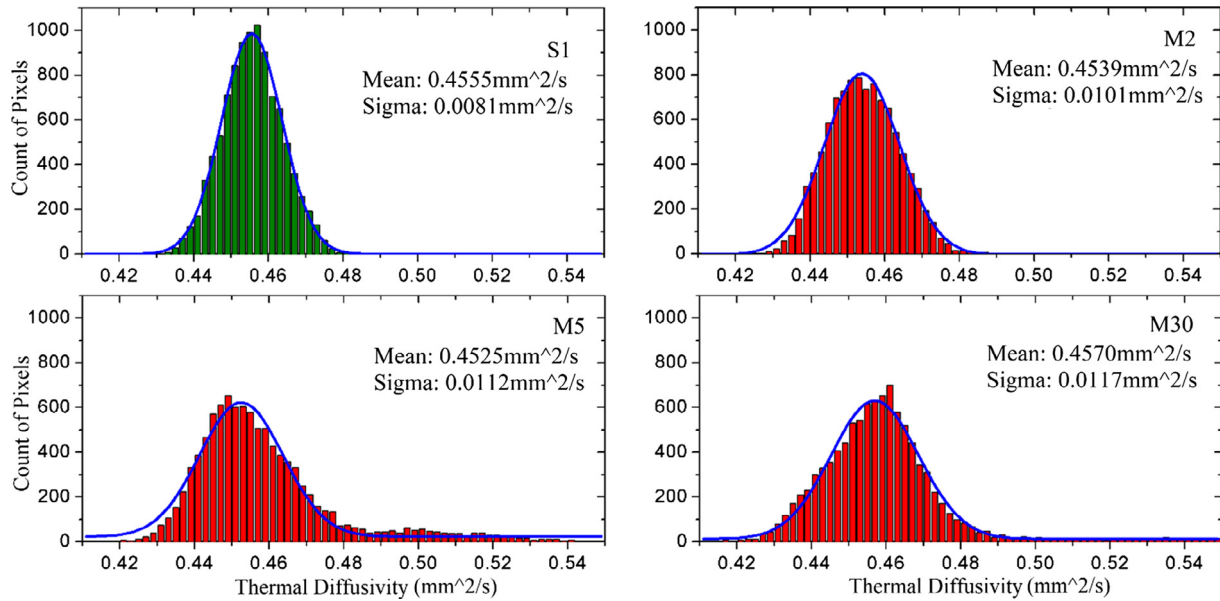
Fig. 7. Histograms plotted for laminate with no exposure and those with medium heat exposure.

were detected with additional tailing for higher diffusivity values exceeding that of $0.48 \text{ mm}^2/\text{s}$ as indicated by the virgin plate. It can be established from Fig. 7 that the laminates exposed at a medium heat for a 2 min exposure shifted the peak and the coverage area (also evidenced by the increase in sigma value to $0.0101 \text{ mm}^2/\text{s}$) and thus it does not follow the Gaussian distribution any more. Thus, pulsed thermography clearly picked up discolouration through statistical analysis.

Though neither the thermograms nor the diffusivity maps presented any change associated with discolouration, the histogram plot readily confirmed the presence of surface anomaly. Assuming that non-exposed or virgin laminates exhibited a normal Gaussian distribution when plotted for thermal diffusivity, the distribution completely changed for the 5 min and the 30 min exposure conditions where significant change in both the peak and coverage area

The statistical analysis assumed a Gaussian distribution as a reference to understand the ideal behaviour of the 'as-is' laminate. The change in distributions as seen in Figs. 7 and 9 show that the distribution has changed which can be evidenced not just by the fitting but also the sigma values of the histograms.

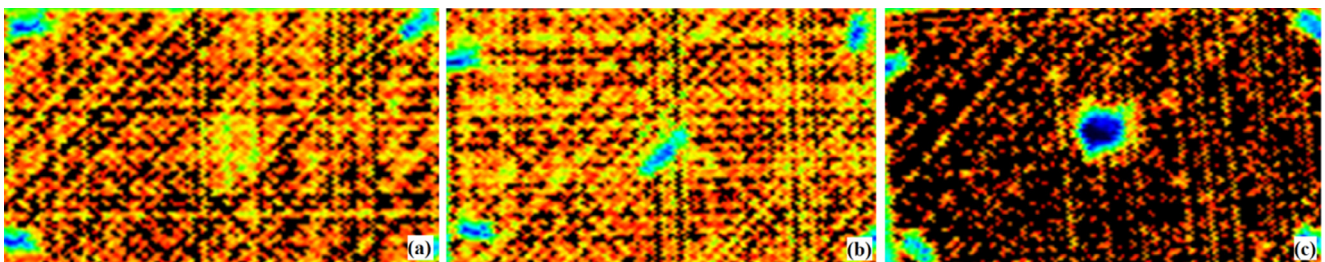
Fig. 8. Immersion UT amplitude image for laminate exposed to medium heat for (a) M2; (b) M5; (c) M30.

Again, the immersion UT results confirmed the presence of both the initial and extended cracks but failed to detect the discolouration damage other than presenting a very minor amplitude change near the exposed area as seen from Fig. 8(a) above.
