Citation: Addepalli, S., Zhao, Y., Roy, R., Galhenege, W., Colle, M., Yu, J. & Ucur, A. (2019). Non-destructive evaluation of localised heat damage occurring in carbon composites using thermography and thermal diffusivity measurement. *Measurement*, 131, pp. 706-713. doi: 10.1016/j.measurement.2018.09.040

Non-destructive evaluation of localised heat damage occurring in carbon composites using thermography and thermal diffusivity measurement

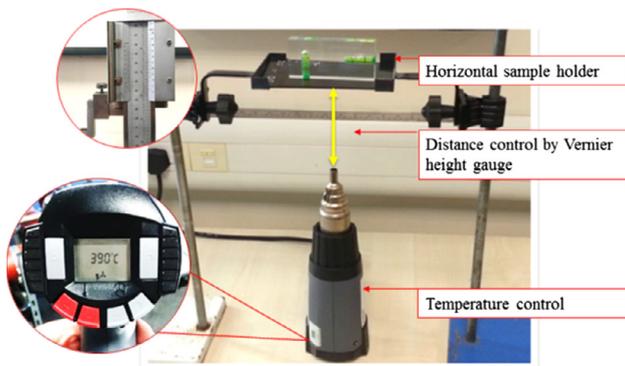
Fig. 1. Heat exposure test rig.

In order to maintain repeated presentation of the part, the rig was setup as seen in Fig. 1. The setup consisted of a heat gun with electronic temperature controller; two custom made holders set on the stand, the height of which was set using a Vernier height gauge with an accuracy of ± 0.02 mm. The holder was designed to match the precise location of the sample and maintain repeatability. For the selection of a suitable heat source a range of heat sources were explored during the research and included systems that used laser, infrared and resistive heating methods. With an approach to represent an in-field scenario, a hot air gun was finalised as the heat source.

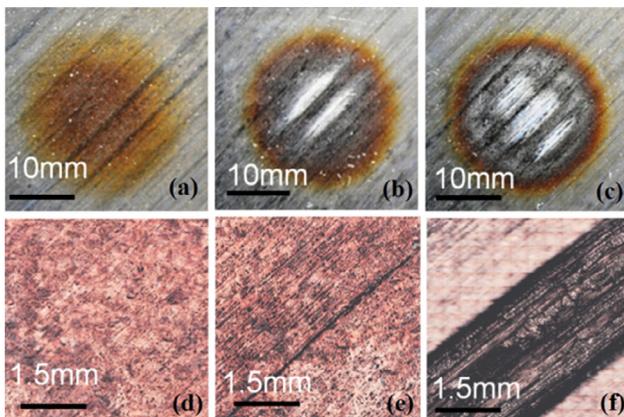
Fig. 2. Visual inspection results for laminates exposed to medium heat exposure; Digital and microscopic images: (a) (d) M2, (b) (e) M5, and (c) (f) M30.

As describe previously, the samples were exposed to two different sets of experiments. The set one had a set medium temperature of 386.2 °C with exposure durations set to 2, 5 and 30 min and set two was exposed to low and high heat conditions. The visual and microscopic indications obtained from set one are presented in Fig. 2.

As the heat gun exhaust was circular, the damage formed in this case was circular and were measured at 24 mm, 26 mm and 26 mm diameter respectively. It was observed that a 5-minute exposure caused the initial crack and a 30 min exposure produced extended cracks and blisters. As heating the laminate to the initial crack was characterised by discolouration first, a 2-minute exposure was set to capture initial discolouration to represent incipient damage. The microscopic evaluation confirmed the observed features as seen in Fig. 2, where (d) showed no significant difference; (e) the initial crack and (f) showing the full-grown damage.

Fig. 4 clearly picked up the damage caused due to heat exposure, which is also visible from a normalised line profile plot. However, it did not reveal the circular pattern as seen in the digital image (Fig. 2(c)). Also, the sample M2 showed discolouration visually and did not show any thermal response to the discolouration as presented by Fig. 5.

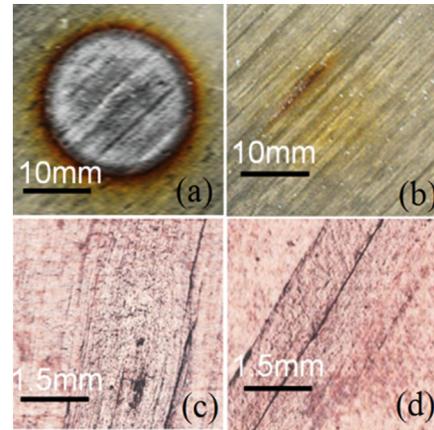
Fig. 3. Visual inspection results for laminates exposed to varying heat exposure; Digital and microscopic images: (a) (c) L220, (b) (d) H1.

It can be observed from Fig. 3 that the sample with low heat exposure (L220) showed the strongest discolouration around the periphery of the damage, whereas the laminate with high heat exposure (H1) showed only limited signs of discolouration evidenced by Fig. 3, suggesting that the discolouration is time dependant. Further, it was observed that the high heat exposure did not allow much discolouration to occur as the damage formation was instantaneous, in this case at 0.25 min due to the high exposure

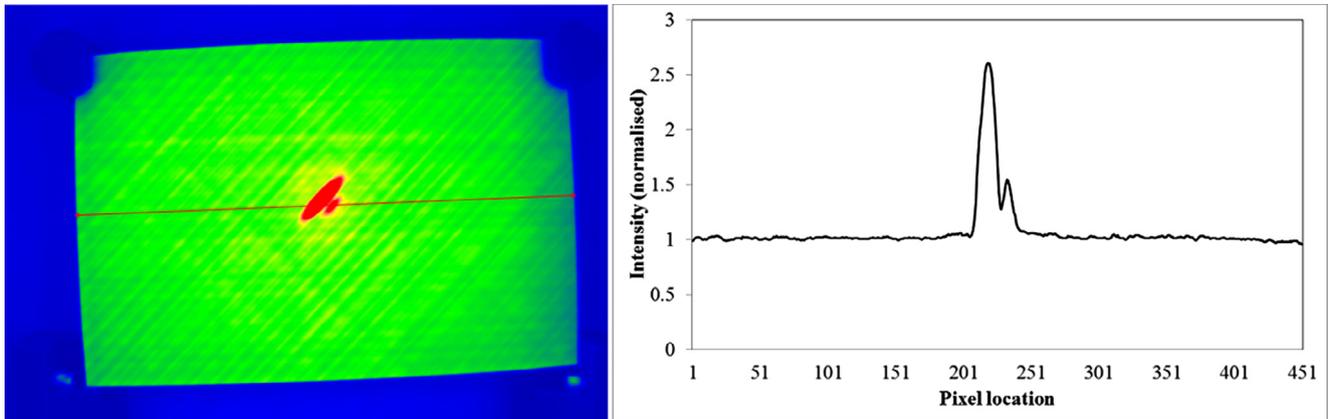
Fig. 4. RAW thermal image of the laminate M30 sampled at 0.28 s (left) and the normalised thermal line profile plot (right).

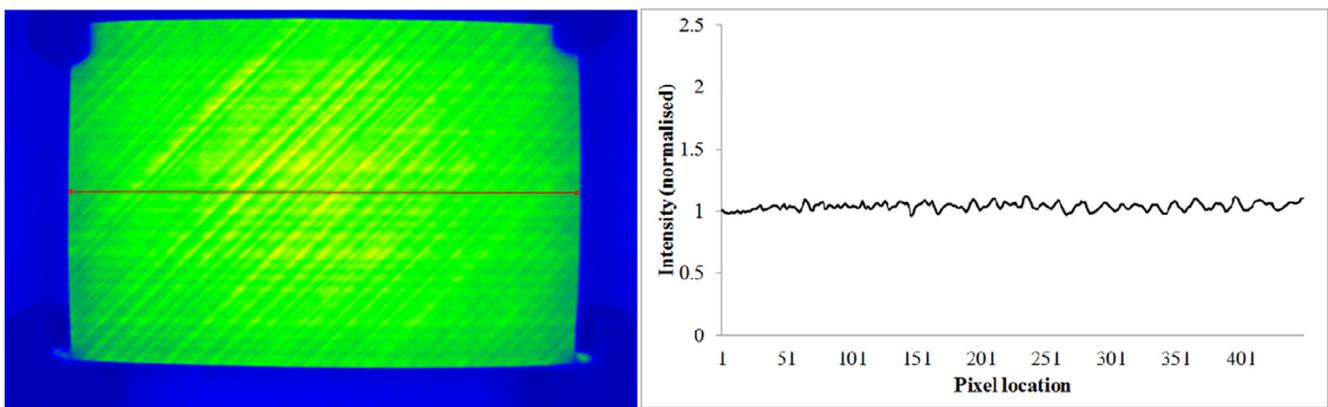
Fig. 5. RAW thermal image of the laminate exposed to medium heat for 2 min; and sampled at 0.28 s (left) and the normalised line profile plot (right).

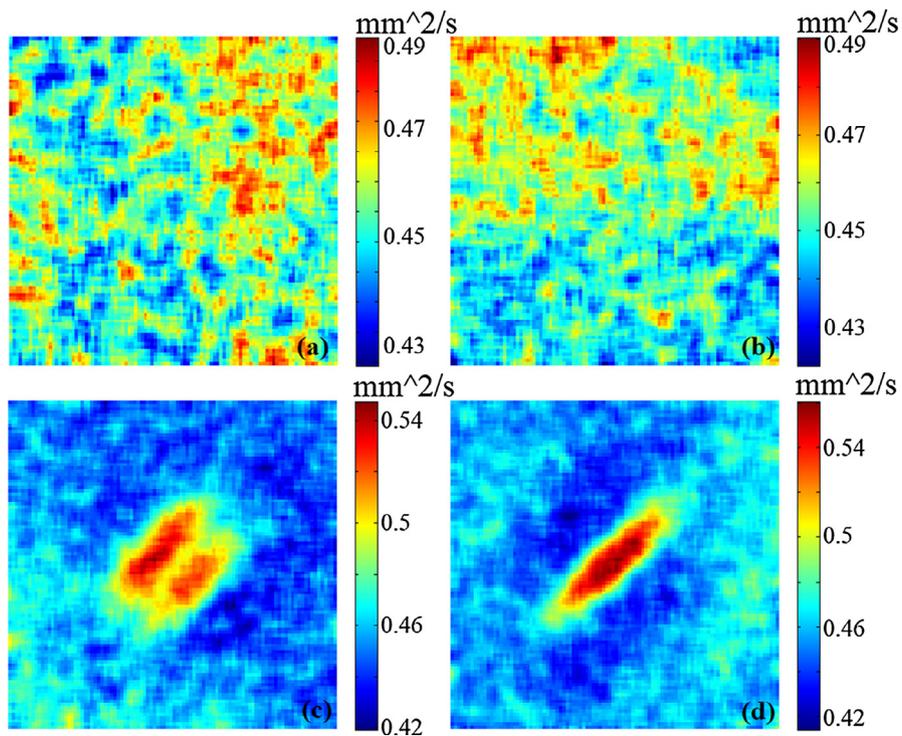
Fig. 6. Surface diffusivity maps reconstructed for an area of 100×100 pixels using the LSD method for the laminate exposed to medium heat for (a) S1, (b) M2, (c) M5 and (d) M30.

Fig. 6 shows the results of estimated surface diffusivity maps of the considered samples.

It can be inferred from Fig. 6 that the medium heat exposed laminates clearly picked up damage caused for the initial crack (at 5 min) and extended char (30 min), but did not show major change in terms of detecting the incipient damage characterised by visible discolouration. Hence a statistical approach was adopted where histograms were plotted from multiple trials. Fig. 7 shows the results obtained from statistical analysis, where the histogram of estimated thermal diffusivity values is plotted. The ‘as-is’ laminate with no damage achieved an approximate Gaussian distribution confirming the thermal diffusivity of the laminate. As expected, this distribution changed owing to the presence of damage, with changes occurring even for the discolouration damage. This is evidenced by higher sigma values ($>0.0081 \text{ mm}^2/\text{s}$) corresponding to the laminate heat exposure conditions. It was also observed that the sigma value increases with increase in exposure time (0.0101, 0.0112 and $0.0117 \text{ mm}^2/\text{s}$), indicating a larger damage area evidenced by the deviation in the thermal diffusivity of the laminate.

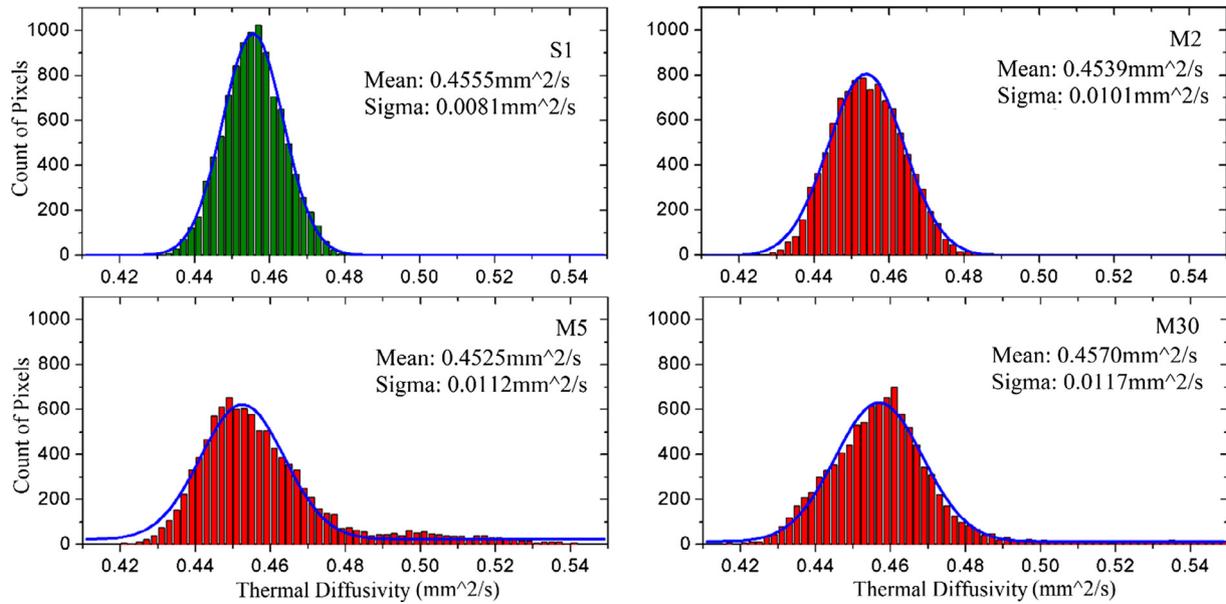
Fig. 7. Histograms plotted for laminate with no exposure and those with medium heat exposure.

Though neither the thermograms nor the diffusivity maps presented any change associated with discolouration, the histogram plot readily confirmed the presence of surface anomaly. Assuming that non-exposed or virgin laminates exhibited a normal Gaussian distribution when plotted for thermal diffusivity, the distribution completely changed for the 5 min and the 30 min exposure conditions where significant change in both the peak and coverage area

were detected with additional tailing for higher diffusivity values exceeding that of $0.48 \text{ mm}^2/\text{s}$ as indicated by the virgin plate. It can be established from Fig. 7 that the laminates exposed at a medium heat for a 2 min exposure shifted the peak and the coverage area (also evidenced by the increase in sigma value to $0.0101 \text{ mm}^2/\text{s}$) and thus it does not follow the Gaussian distribution any more. Thus, pulsed thermography clearly picked up discolouration through statistical analysis.

The statistical analysis assumed a Gaussian distribution as a reference to understand the ideal behaviour of the 'as-is' laminate. The change in distributions as seen in Figs. 7 and 9 show that the distribution has changed which can be evidenced not just by the fitting but also the sigma values of the histograms.

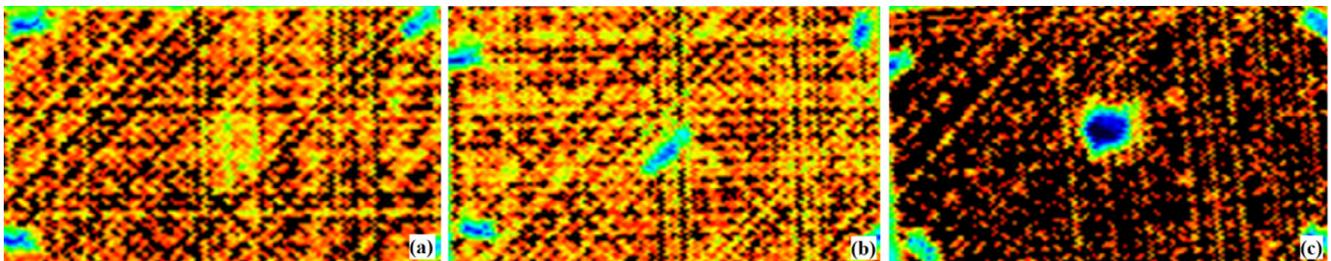
Fig. 8. Immersion UT amplitude image for laminate exposed to medium heat for (a) M2; (b) M5; (c) M30.

Again, the immersion UT results confirmed the presence of both the initial and extended cracks but failed to detect the discolouration damage other than presenting a very minor amplitude change near the exposed area as seen from Fig. 8(a) above.

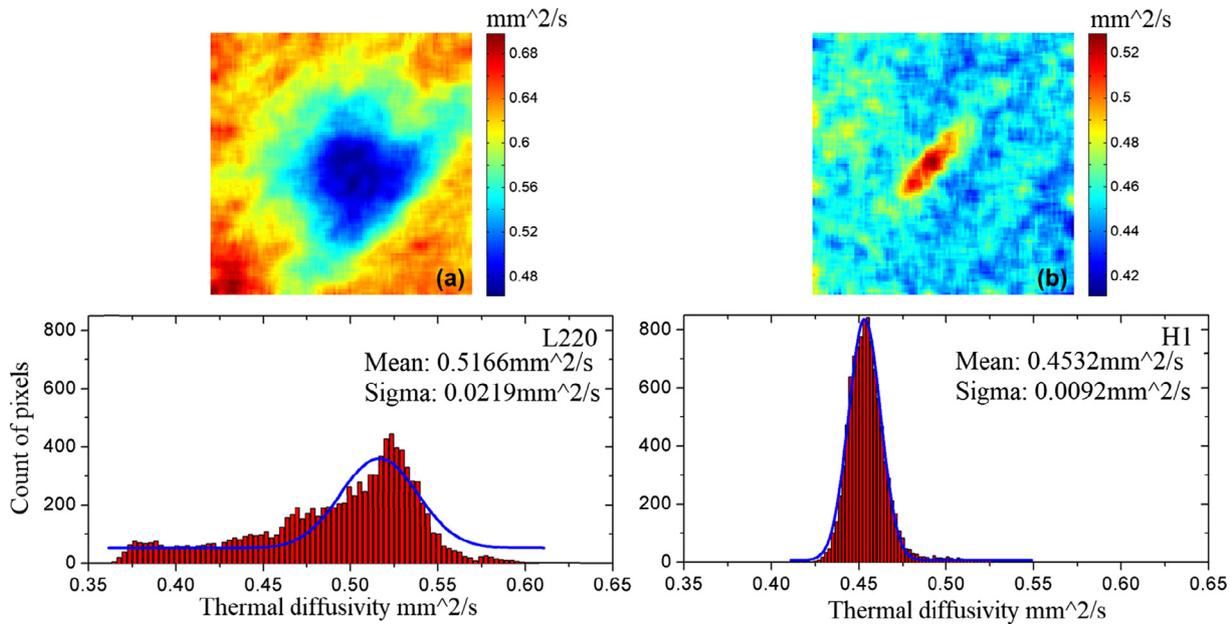
Fig. 9. Thermal diffusivity maps (above) and histograms (below) for (a) L220 (b) H1.

A similar analysis of the laminates exposed to low and high temperature exposure conditions clearly picked up damage on the laminates (Fig. 9). The diffusion map for the high heat sample represented data similar to the medium heat exposure laminates. This is due to the fact that the crack formed instantaneously within the first minute (0.25 min) indicating that the high stress to the resin fibre matrix caused the crack to appear straightaway, leaving limited or no time to undergo the extended degradation process of discolouration and charring. However, the low heat 220 min exposure caused severe localised damage as confirmed by low extended peak from the histograms. This result was found to be in line with the digital image obtained and presented in Fig. 3(a) above. It can be concluded that the sample endured an extended degradation process where there was continuous growth in the area of discolouration which extended to the back surface of the laminate. This feature was only noticed in the low temperature long expo-
