2015 IOP Conf. Ser.: Mater. Sci. Eng. 90 012003

Rotor clearance design and evaluation for an oil injected twin screw compressor

D Buckney¹, A Kovacevic^{1,2}, N Stosic²

¹Howden Compressors Ltd., Research and Development, Glasgow, UK

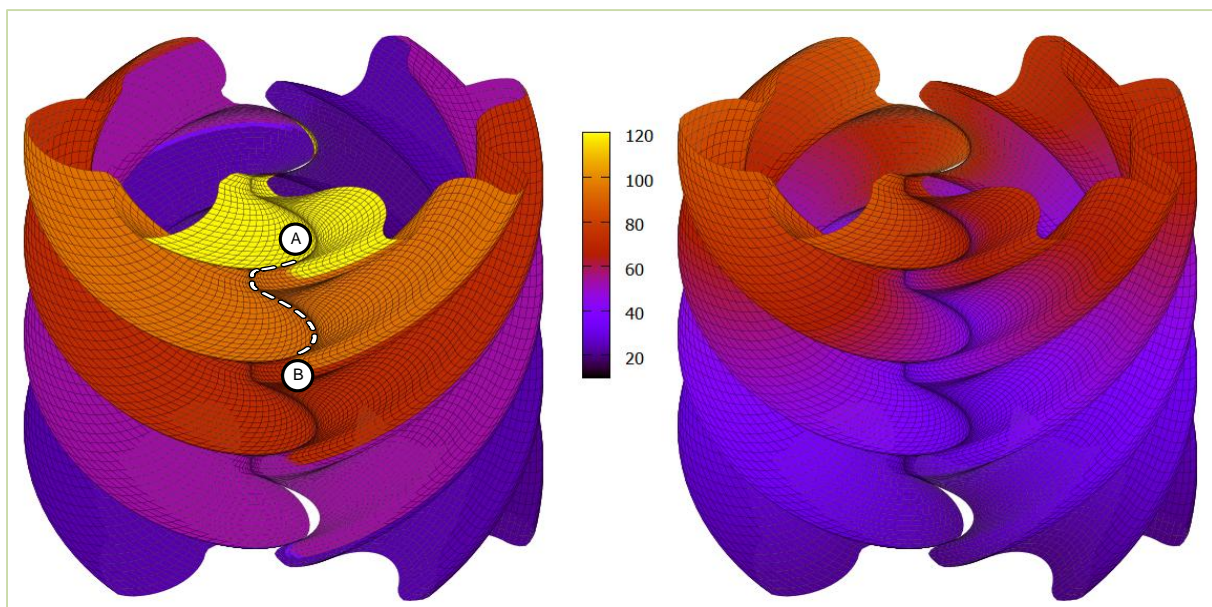
Figure 2. Instantaneous (left hand side) and averaged (right hand side) fluid boundary temperature mapped onto the surfaces of the main and gate rotors. Line AB highlights the interlobe sealing line for a single compression chamber.

Using a procedure developed by the authors [2], the fluid temperature from the compression cycle was mapped onto the surfaces of the rotors and the casing bores. These fluid boundary conditions at the surface of the compressor components can be used for further thermal analysis to determine the temperature distributions within the metal components of the compressor. Figure 2 shows the temperature of the fluid boundary on the main and gate rotor surfaces. The left image shows the instantaneous fluid temperature for a particular rotor position – this highlights how different compression chambers are exposed to different points in the compression cycle which are at different temperatures. In the right hand image these instantaneous temperatures has been averaged over one full rotation for each respective rotor in order to show the local average boundary temperature. In addition the temperature has also been averaged over each transverse plane of the rotors as this allows potential thermal distortions to be approximated analytically.

It is interesting to note that the average boundary temperature is higher on the main rotor than on the gate rotor, this is related to the number of lobes on each rotor. Consider the 4 compression chambers at the outlet end of the main rotor shown in the left hand figure. The gate rotor is also exposed to these 4 chambers but only over an angle of 240 degrees. For the other 120 degrees the gate rotor is exposed to 2 additional compression chambers at a lower temperature.

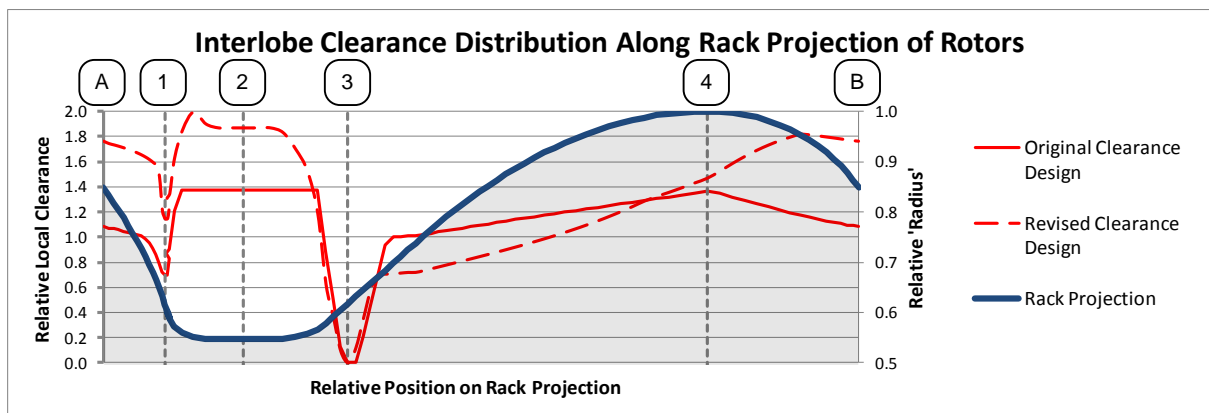
Figure 4. Interlobe clearance distribution along rack projection of rotors comparing original and revised clearance designs. Key clearance locations are highlighted along the common horizontal axis. The secondary axis shows the radius for the corresponding main rotor to give a better indication of where local clearances are located.

The compromise that has been taken is to plot the local clearances on the axis of a rack projection along which the rack would translate. Thus, the magnitude of the local clearances can be simply graphed and superimposed against the somewhat familiar shape of the rack as presented in Figure 4.

Rather than put a numerical value on the horizontal axis vertical lines have been added to identify key points along the length of this sealing line projection, details of which are provided in Table 2.

The original and revised clearance distributions are both presented in Figure 4. In all cases the relative rotation between the rotors is adjusted in order to provide zero clearance at location 3: the pitch radius on the round side of the rotors. This is where the driving force is transferred from the main to the gate rotor. In the revised clearance design the main difference is that the clearance in the main rotor root has been increased and to a lesser extent also at the main rotor tip. Notice that the clearance on the round flank of the rotors (between locations 3 and 4) has actually been decreased on the revised clearance design – this clearance will not significantly reduce during operation because the gap is maintained due to the nearby contact at the pitch point (location 3), therefore this clearance was deemed to be unnecessarily large. Conversely, on the straight flank (from 4 to B, and from A to 1) the gap is adversely affected by thermal distortions at location 3 which are transferred over to the straight flank. Therefore it was necessary to increase the clearances on the straight flank.

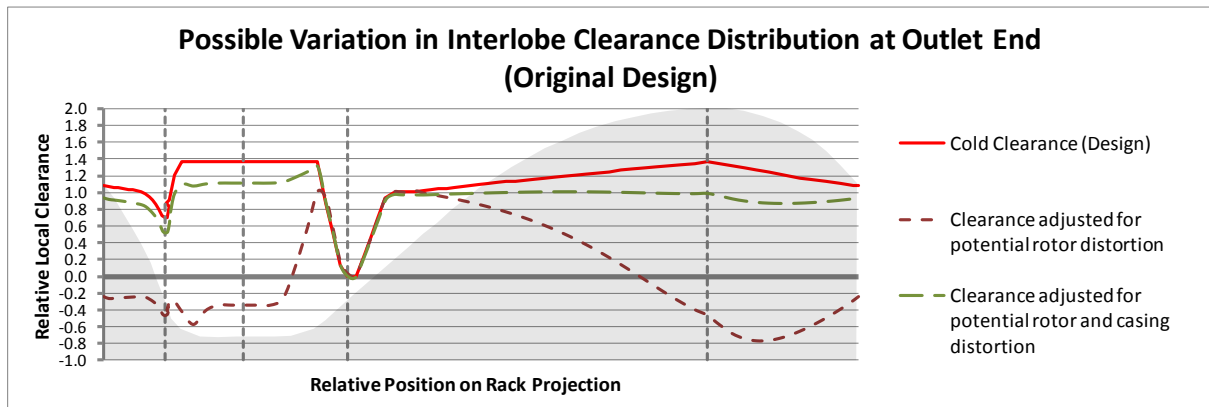
Figure 5. Possible variation in interlobe clearance distribution at outlet end (original design).

The following results show the predicted operational clearance distributions for the original and revised designs respectively. As previously discussed, a similar temperature increase in both the rotors and casing results in little net change in the operational clearances, this case has been presented with the longer dashed lines on each figure, the trend is not far off the original clearance.

A second case has also been presented where the rotors do not move apart due to casing thermal expansion. This case is quite possible in the event that sudden temperature changes cause the rotors to heat up faster than the casing or alternatively the outlet end bearings might be situated remotely from the rotor outlet plane in a location where the casing temperature is much lower than estimated in Table 1. Unfortunately the distance between the two dashed curves for the different operational scenarios results in a large band of uncertainty but it does serve to highlight 1) where rotor contact is most likely to occur for a given clearance design, and 2) where clearances can be further reduced without compromising reliability.

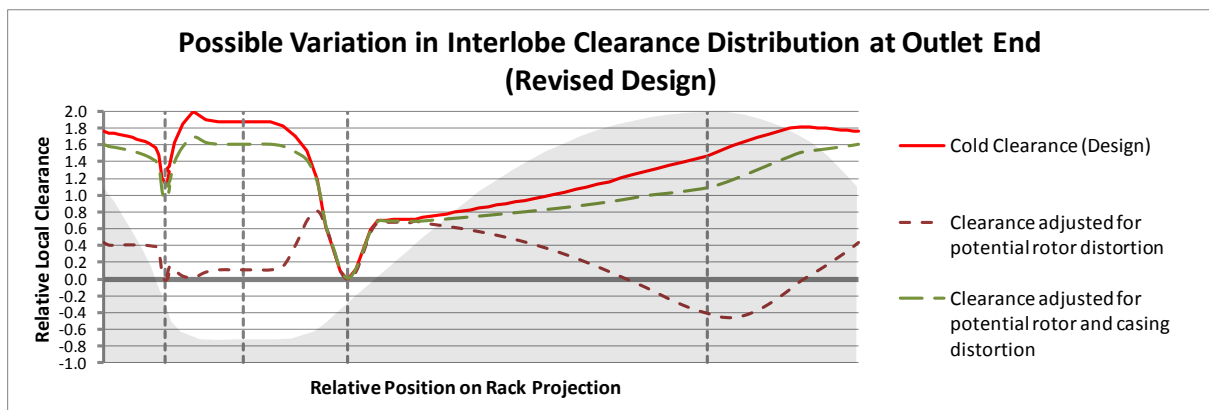
Figure 6. Possible variation in interlobe clearance distribution at outlet end (revised design).

This analysis supports the revised clearance in the root of the main rotor which shows contact cannot now occur there due to thermal distortion alone. The chance of contact at the tip of the main rotor has been significantly improved however the analysis suggests contact is still possible under extreme circumstances.

The most problematic clearance area is on the straight (undercutting) flank of the rotors – since distortions are transferred from the round contacting flank these clearances vary more than in other areas. What the figures do not show is that this represents a long part of the sealing line path due to the effect of undercutting, so this has a large effect on the overall leakage area. This area also experiences faster relative sliding motions between the rotor surfaces so contact should certainly be avoided. With these considerations in mind, there is probably still some scope to slightly reduce the clearances on both flanks just above the pitch locations.
