Impact of Accidents on Organizational Aspects of Nuclear Utilities

Anthony J. Spurgin^{*1}, David W. Stupples^{**2}

Abstract. This paper applies the Beer Viable Systems Model (VSM) approach to the study of nuclear accidents. It relates how organizational structures and rules are affected by accidents in the attempt to improve safety and reduce risk. The paper illustrates this process with reference to a number of accidents. The dynamic cybernetic aspect of the VSM approach to organizations yields a better understanding of the need for good decision-making to minimize risk and how organizations really operate.

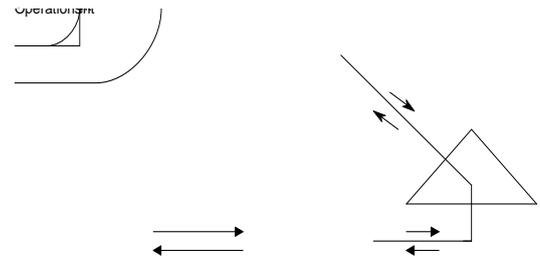
Figure 1 Basic VSM Figure depicting Key Elements within the Approach

VSM is now discussed. Figure 1 depicts a simple version of a VSM model of a system, in which there is a central management body that determines policy and gives top-level guidance. In this representation, a regulatory/control body controls various activities at the working level (supervisors). Then there are operational activities, from running a Nuclear Power Plant (NPP) to shoe-making, tire production, etc. The environment represents the public, the physical environment or even the Government. Feedback occurs and information or society actions can result from the activities of the plant or the organization. For example in the case of shoes, the public may change its taste from black shoes to red shoes and this would lead to a change in production rates for black and red shoes.

The regulator in Figure 1 operates in a similar manner to normal equipment controller. The set point could be related to say the number of shoes to be produced per month as set by top management of the manufacturer. The regulator has a number of rules, which correspond to the algorithm of the controller and can be quite complex. These rules could cover such things as the colour ranges of the shoes, the sizes and selection of materials. The rules may also determine the use of machines, targeted hours per shoe for manufacturing and the length of run producing the shoes. The VSM model depicted here is a simplified model of a shoe manufacturing business. Feedback occurs from the operations function as to the construction and assembly of the shoes and such things as the utility of certain machines to produce different kinds of shoe and of the downtime requirements due to the need to maintain the machines, and the impact of shift changes of operating personnel. The VSM model structures can be expanded to include sub-units with a similar structure to that of Figure 1. The expansion of VSM depends on the needs of the user.

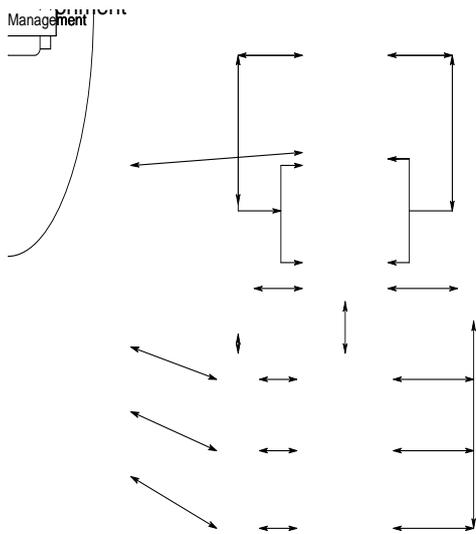
Figure 2 More Complex Version of VSM

In practice a more detailed form of VSM is used to illustrate some managerial and supervisory aspects of organizations. Figure 2 shows a complex version of VSM that will be used in relation to utility management and associated personnel when considering the impact of accidents on management. It is as well to select a compact model in order to show the dynamic relationships between the various levels of an organization.

One can see here that the management function is now represented by S5, S4 and S3, the communications are represented by S2 and S3* and operations by the S1 groups (both supervisors and operators). The environment is made up of local and global effects. The environment covers public and the regulators. S3, S4 and S5 represent the top management functions of planning, economics and plant management. The S3* and S2 functions represent co-ordination and auditing functions.

Earlier a VSM was depicted in figure 2 (‘More Complex Version of VSM’), which is a version of Beer's original VSM. He referred to a number of parts of the organization and denoted them as sets of System's from S1 to S5. The upper management functions were S3 to S5 and the lower level functions were S1 to S2 and also included S3* which was an audit function. Here that VSM model structure has been modified to conform to a US

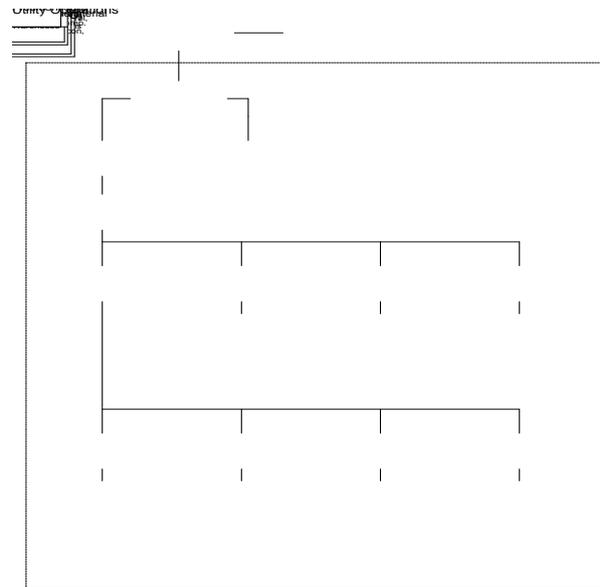
Figure 3 Typical Nuclear Power Plant Organization

This section is concerned with a more detailed examination of the various management levels within a utility covering maintenance and plant operations. Figure 3 shows a typical nuclear power plant organization. A number of utility organization structures were examined during the early phases of the project, but the one given in the IAEA report [10] captures the management structure in an idealized form.

The figure reflects some of the various functions carried out at single station NPP. The share holders and the Board are not part of the operating plant but are important in terms of holding the President, CEO and CFO accountable to the public and of course to the interests of the share holders and the other stake holders, the employees. Utilities with multiple stations (or Fleet organization) would have a corporate structure covering each station within a Fleet organization.

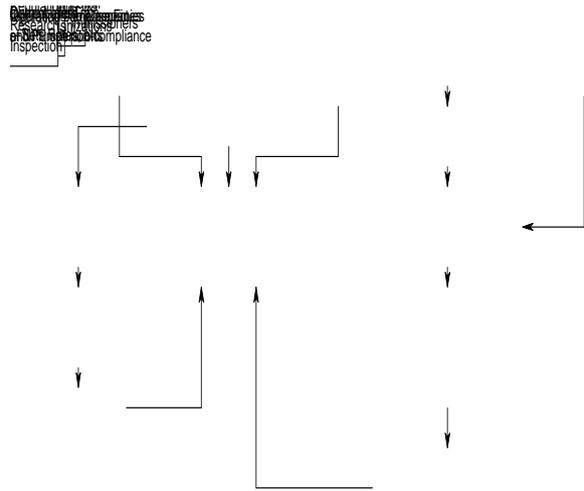
Figure 4 Diagram showing the Interrelationships within the US Nuclear Industry

The main organizations that interface with the nuclear utilities are the United States Nuclear Regulatory Commission (NRC) and the Institute of Nuclear Operations (INPO). Also the President and Congress have their part to play in this process.

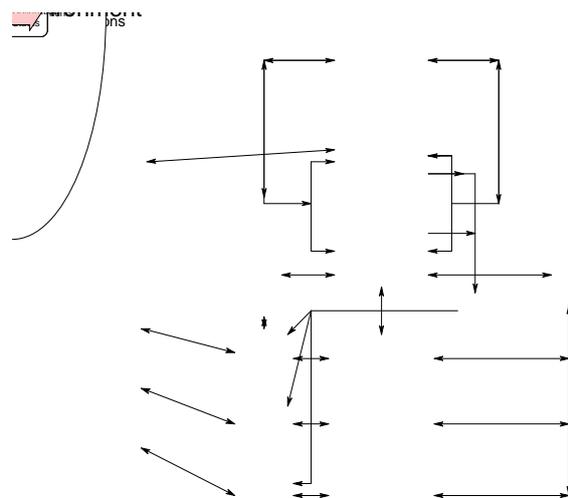
Figure 5 VSM model of a US Nuclear Utility

nuclear utility organization. This modified VSM is shown in Figure 5.

The figure models a current single US NPP type of organization, which involve the lessons learned over the years from the impact of accidents upon the structure of the utilities and the rest of the industry. The structure of both the industry and each utility was less complex at the beginning of the nuclear utility age. The Three Mile Island, (TMI) accident has had a deep influence on the US industry and led to the formation of INPO. The impact of the accident led to the need to enhance the importance of the reactor operator in performing key safety functions in the operation of NPPs. This has led in turn to modifications and changes in a number of support organizations. Modifications to Beer's VSM figure have been made to reflect these changes in that INPO and a training feature have been added. Operator training was included from the beginning, but the degree, complexity of training and importance has been increased since TMI. So the general structure of control of the organizations has remained much the same, but a number functions added to reflect the need to factor safety within the VSM representation.

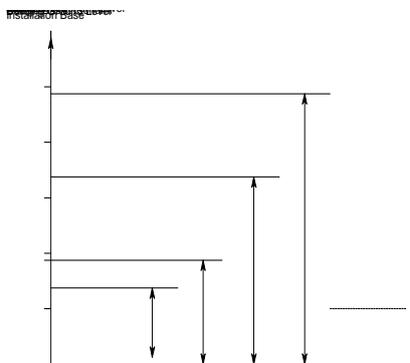
Figure 6 Diagram showing various key water levels related to the Accident

later than the Braun report [12] and is much more detailed, but still does address questions related to why certain actions were and were not taken. The Tsunami caused devastation of the area around the region where the NPPs were located. Thousands were killed and their property destroyed, roads swept away and rail transport ceased along with a loss of communications. The INPO report indicates that there were multiple tsunamis, seven altogether. It also states that several after-shocks of lower magnitude occurred before the tsunamis arrived. At least one of the waves was approximately 46 to 49 feet (14 to 15 meters) based on water level indications on the buildings. The design basis tsunami was 18.7 feet (5.7 meters), so the actual largest tsunami was well above the design basis and the ground level. Figure 5-5 shows the various measurements related to the building, and water levels achieved during the tsunami. In addition to the above mentioned earthquake damage, the tsunamis were of such a size that they overflowed the NPP seawall protection, which was supposed to be bigger than the design basis for the NPPs.

The sizes of both the earthquake and Tsunami magnitudes exceeded the design bases for the NPPs. It has been reported that seismic experts had informed TEPCO about two years earlier that this same area was devastated in 875 AD one of a similar size to this Tsunami and that information should have been included in the data base from which the design basis Tsunami was selected. [11].

The earthquake and the tsunami were unexpectedly high relative to what the TEPCO management expected. The earthquake was 9.0 on the Richter scale and the level of the tsunami reached 48ft, which was well above the design basis level of 18.75feet. The nuclear accident seen by itself was very bad, both economically, radiation release wise and from the death of a number of people. However, seen in the context of the effects of the tsunami on the surrounding land this seems small. The direct result of the tsunami about 20,000 people died and 110,000 houses damaged.

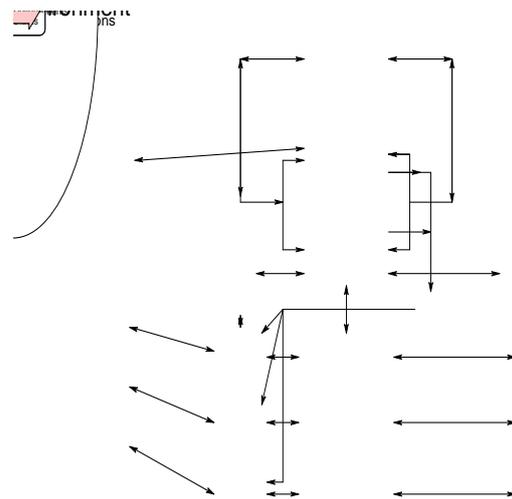
Figure 7 Depiction of a VSM model of a US Nuclear Utility

Figure 7 shows the VSM model of a US Utility with interactions between the NRC and INPO. The internal communications within the utility shows the central role of the CNO, interfacing with the NRC and INPO. The plant manager is in communication with the maintenance and operation staff and there are monitoring and audit staff ensuring operations are being carried out per instructions and procedures.

A VSM model of a utility in the early days of nuclear power would not have these features. There would be no INPO, no CNO and controls and procedures would be much less. Training of the operators would most likely not use a training simulator on a regular basis since the utility was likely not own and operate one. Emergency operating procedures are now symptom-based as opposed to event-based. Other accidents have also had an impact on the utilities, maybe not quite as significant as TMI, up to this time.

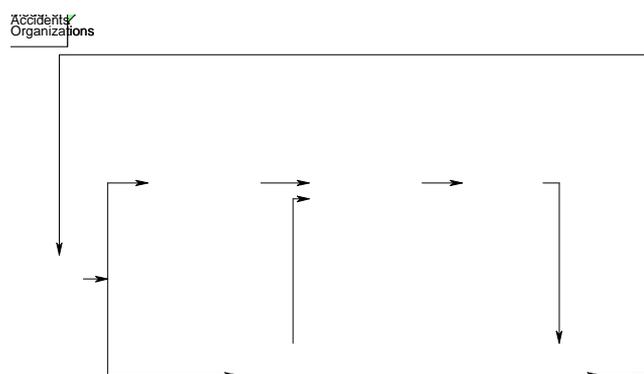
Figure 8 Depiction of the Improvement Pathway

One can think of the NPP business as a business than needs to learn and in fact INPO calls itself a learning organization. However, it is observed that the industry is less likely to learn from deep understanding of the issues than from the direct effects of an accident. Opinions can be argued around, but it is difficult to withstand the fact that an accident has occurred! The model for improvement is captured in figure 8.

The figure shows how the improvement process works seen as changes in the VSM structure and rules.

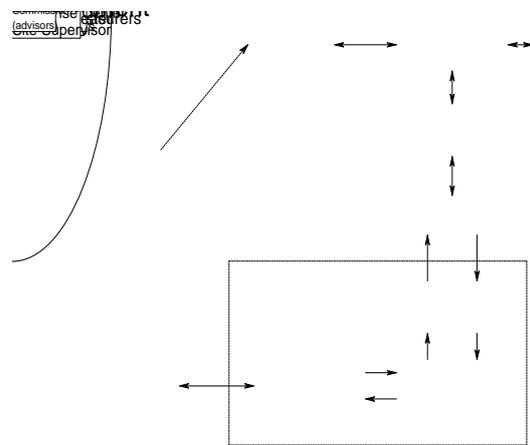
Figure 8 Emergency Daiichi Organization

These persons had to evaluate and plan to do operations, ab initio, under the direction of the station manager. Consequently, the accident progressed faster than the personnel could effect change. One of things that the local personnel did was to form a tight group trying to effect a credible response to the accident, so the normal NPP organization morphed to a smaller organization, see figure 8.

The figure shows the presence of the Japanese Prime minister, who was involved, and others. However, the principal burden was on the skills and tenacity of the site personnel.

The emergency organizational model is in fact a VSM model, which evolves in emergency conditions from the normal VSM organizational model. The decision-making, communications and control dynamics are features of a cybernetic process. In order to be effective, the organizations needs to be trained, practiced, and have both procedures and ancillary equipment to support the timely actions of the operators.
