Dielectric Spectroscopy of Epoxy/Glass Composite Materials

M. N.Ajour¹, L.A.Dissado¹, J.C.Fothergill¹, P.N.Norman²

Abstract: *Glass fibre reinforced epoxy (GFRE) material is used in pressboard transformers for optical telecommunication systems, typically at voltages between 1 to 2kV. A programme has been set up to follow the electrical ageing of the GFRE through dielectric and space charge (PEA) measurements. Here we report on the characterisation of the GFRE prior to ageing made by means of linear dielectric spectroscopy. Preliminary results for the aged samples show differences in dielectric response that could be related to de-bonding at the epoxy-fibre interfaces observed in some failed samples.*

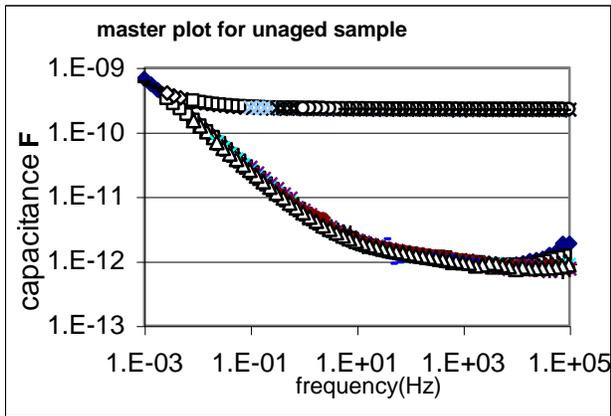
Figure (1). Master plot of the dielectric response of composite, for real (upper) and imaginary (lower) parts of capacitance, for 8 temperatures from 20-90 C

The measurements were performed on disc samples of 54 mm diameter ranging in thickness from 200 to 400 μ m. The dielectric experiments were carried out using a Solartron FRA system with a custom built temperature control accurate to ± 0.1 C. Capacitive and loss components were measured over a frequency range from 1 mHz to 100 kHz and from $T = 20$ C to 100 °C. The results for the composite are shown in Fig 1 in the form of a master plot constructed by translating the data along the $\log \{ \text{frequency} \}$ axis to bring them into coincidence. A broad loss peak was found at high frequencies that were assigned to the β -process of the glassy epoxy. The activation energy of ~0.3 eV found for the characteristic frequency is typical of such processes. A low frequency process was also found that possessed a constant phase angle (CPA) behaviour (i.e. $C'' \propto C' \propto f^{-p}$ with $p \approx 0.8$). This type of process has been termed a quasi-dc transport [2]. A characteristic activation energy of ~ 1.1 eV was found, but it is not possible to separate this into independent carrier concentration and mobility components. The dielectric response of a glass fibre mat showed a dc conductance at very low frequencies ($f < 1.3 \cdot 10^{-2}$ Hz), which transformed into a quasi-dc conductance (CPA) at higher frequencies, Fig 2. Both processes have the same activation energy of 0.46eV implying that the barriers to charge transport are the same in both cases. Measurements were made with two fibre mats as well as one. The results showed that the q-dc process varied with an inverse power of the thickness rather than inversely with the thickness. This result shows that the response observed is truly a bulk response and is what would be expected of a q-dc response originating with a percolation system. [2]. Although the activation energy is much lower than in the q-dc response of the

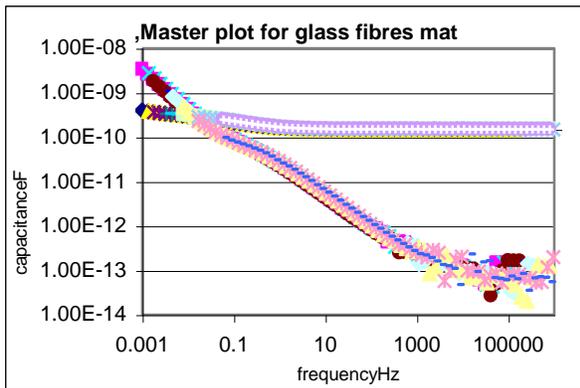
Figure 2. Master plot of the dielectric response of the glass fibre mat, Cr and Cim are real and imaginary parts of the capacitance respectively for the temperatures noted..

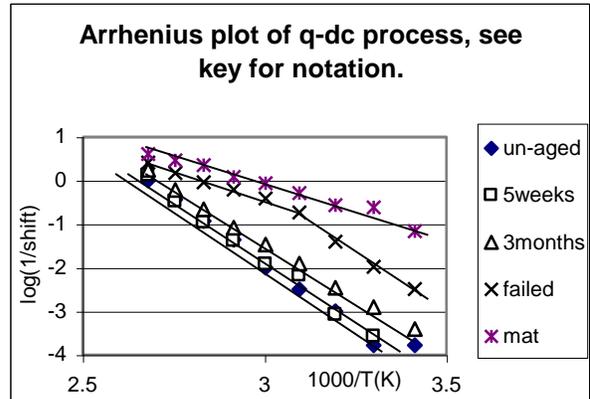
Figure 3. Activation energy of dielectric q-dc response in a range of samples as shown.

Dielectric measurements made on samples removed temporarily from ageing at 5 weeks, and 3months (at $E=62.5\text{kV/mm DC}$, $T=15\pm 5^\circ\text{C}$) and on the sample that failed show the same form of response as for the unaged composite. However, the q-dc process had moved to higher frequencies. Arrhenius plots for the set of samples measured are shown in Fig 3. It can be seen from this plot that except for the high temperature region of the failed sample, the activation energy has not changed with ageing. There is, however, a displacement towards higher frequencies, i.e. the process moves towards the behaviour observed on the fibre mat alone. This is even more marked in the failed sample where the activation energy changes at high temperatures to a value (0.53eV) close to that of the mat.

The dielectric response of the aged sample showed other features in addition to the q-dc behaviour. In part this may be due to the presence of the bored-out breakdown channel. The activation energy plot shows two regions of behaviour: one at low temperatures that paralleled that of the composite and one at higher temperatures that followed the fibre mat behaviour. A possible explanation is that the response is contributed by two systems in series. In this case the one with largest impedance will dominate. Thus the one with the smallest activation energy will dominate at high temperatures, and vice-versa the one with the largest activation energy will dominate at low temperatures. The values of the activation energies obtained indicate that the two systems correspond to regions where the fibre mate has become substantially de-bonded and regions where the fibre mat is still mainly bonded to the epoxy.

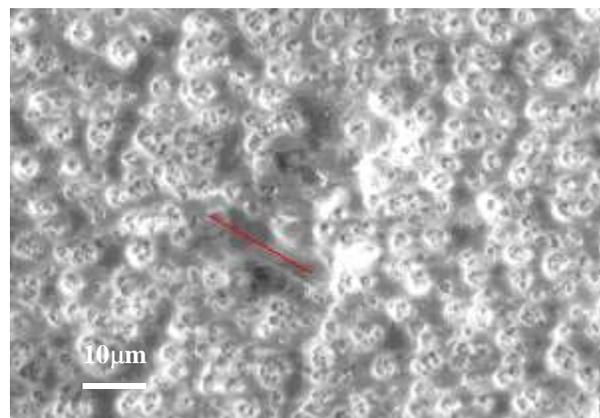
Figure 4. Shows the area near a black line that is indicated by the bar.

The failed sample was noted to have many ‘black lines’ in the plane of the sample (i.e. perpendicular to the field direction) and well away from the breakdown site. It proved impossible to resolve these under the optical microscope, so an SEM analysis was attempted. Figure 4 shows a view of a black line from above and there is little to see. Figure 5 shows the view of such a line in a region where the surface has been removed to expose it to view. The line can be seen to be a $2.5\mu\text{m}$ void running alongside the glass fibre for millimetres. Figure 6 shows an elemental analysis obtained on a sample prior to ageing using an SEM. The carbon peak is quite strong, as are peaks associated with the elemental content of the glass fibres (e.g Si, Ca, Al). The same analysis taken around the ‘black line’ in the failed sample, Figure (7), showed a strong reduction of the carbon peak with respect to the aluminium peak. This indicates that the black lines are not carbonised tracks such as may be produced by partial discharges.

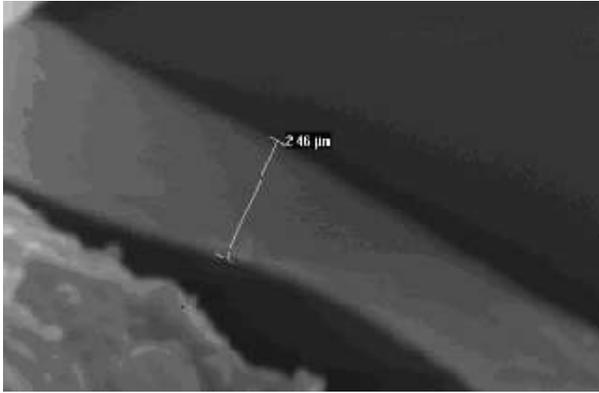
Figure 5 shows the voids (black lines) between the fibres and epoxy. The white line is 2.46 μm long

The generation of the interface voids is likely to be the cause of dielectric breakdown [6] as long as they are aligned with their long axis in the direction of the electric field [7]. Because of the weave of the mat most such voids will be aligned perpendicular to the field direction with a width of around 2-3 μ m, which is insufficient to support discharges at the fields applied [7]. At some stage, however, such voids can be expected to join together to provide a gap in the field direction long enough to support discharges. Once discharges can occur failure will follow rapidly. We believe that this is what happened in the sample that broke down.

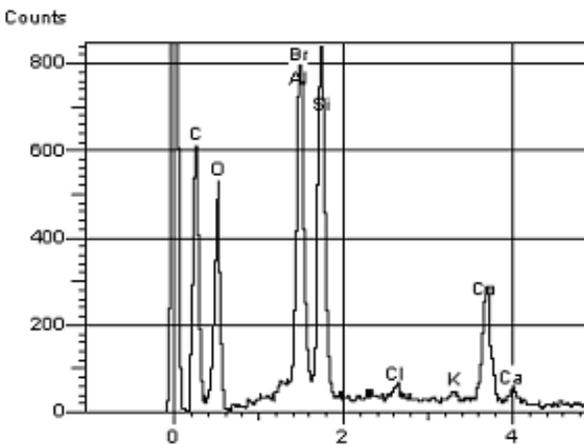
Figure 6 Elemental analysis of un-aged sample (cps vs. keV)

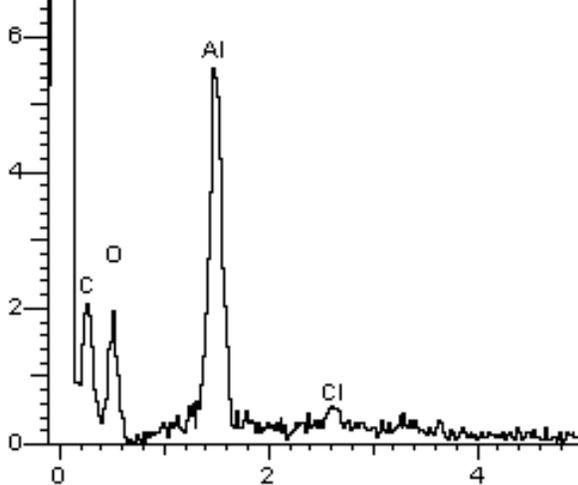
Figure 7. Shows elemental analysis of black line region (cps vs keV).
