## Remoulding of the Mercia Mudstone Group around CFA pile shafts

Observations of the remoulded zone around continuous flight auger piles constructed in the Mercia Mudstone Group

L J Seward<sup>1\*</sup>, S E Stallebrass<sup>2</sup>, J Skipper<sup>3</sup>

**Abstract:** A field test has been undertaken to investigate changes to *in situ* Mercia Mudstone at the pile soil interface after installation of four 5.5 m long 350 mm diameter CFA piles. The test investigated whether a remoulded zone exists, the extent of the zone, changes caused by remoulding and the effect of the installation method. The piles and surrounding soil were excavated after installation to a depth of just under 2 m. The sections of pile and surrounding soil were returned to the laboratory where a variety of detailed observations at both micro and macroscopic scales were undertaken, together with chemical and mineralogical analysis. It was found that a remoulded zone existed in all piles but that this varied in thickness both laterally and vertically around a pile. Across all piles the maximum thickness observed was 55 mm. The average thickness, fabric and texture were all affected by installation method. A dist

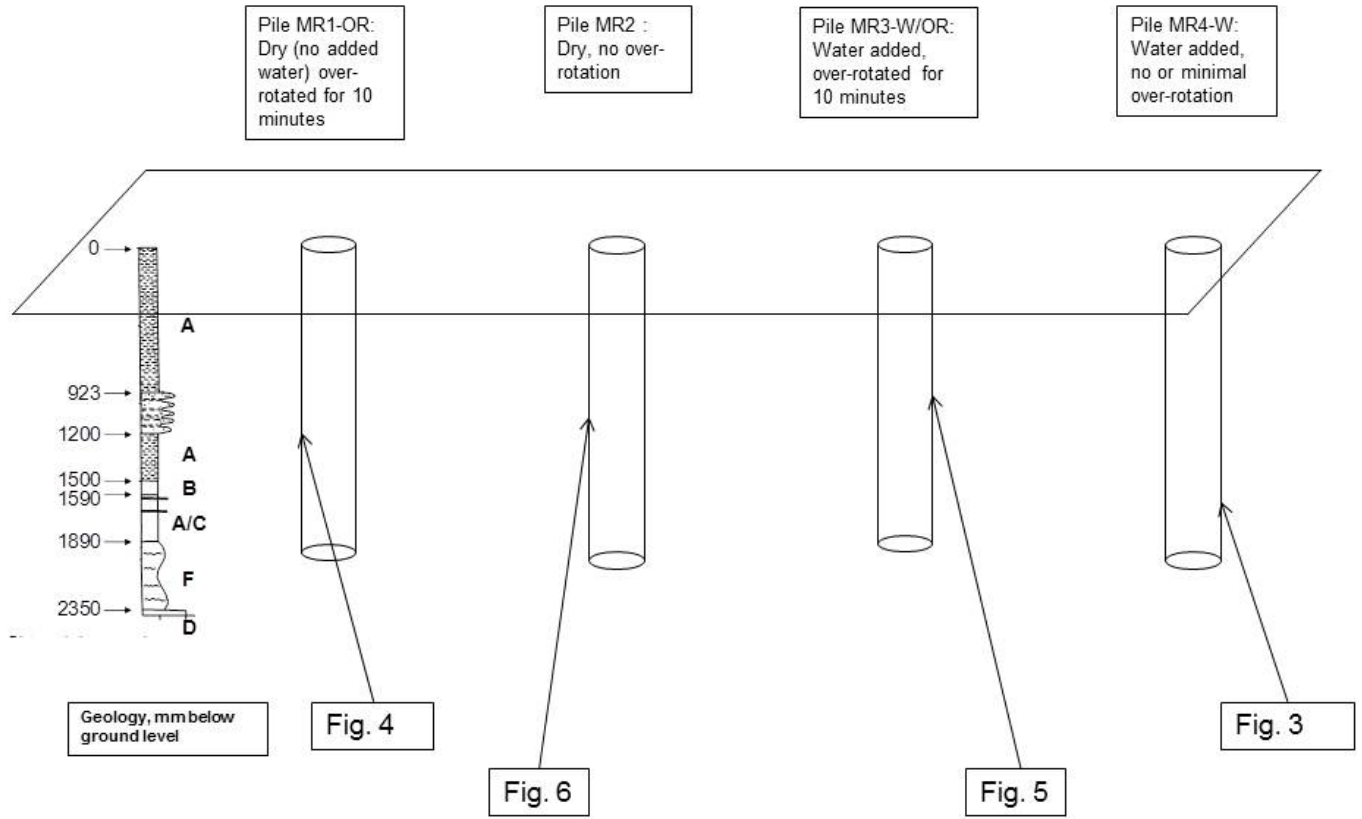
Figure 2a Schematic figure showing placement of piles in the ground, relative lengths of piles, approximate locations of figures 3-6 and stratigraphy (see figure 2 for stratigraphy).

The field test required the construction of a line of continuous flight auger piles, which would be left to cure and then excavated so that the pile-soil interface and any zone of remoulded soil could be examined. The method used to install each of the piles was varied to investigate the effect that this might have on the pile soil interface and remoulded soil zone. None of the piles were loaded.

The piles were all installed on 26<sup>th</sup> June 2007 between 13:00 and 16:00. There were four test piles 5500 mm deep and 350 mm in diameter and one practice pile 2000 mm deep and 350 mm in diameter. They were all installed using a Casagrande B125 rig in Continuous Flight Auger (CFA) mode. The concrete used was a C28/35 strength structural concrete with a pumpable mix.

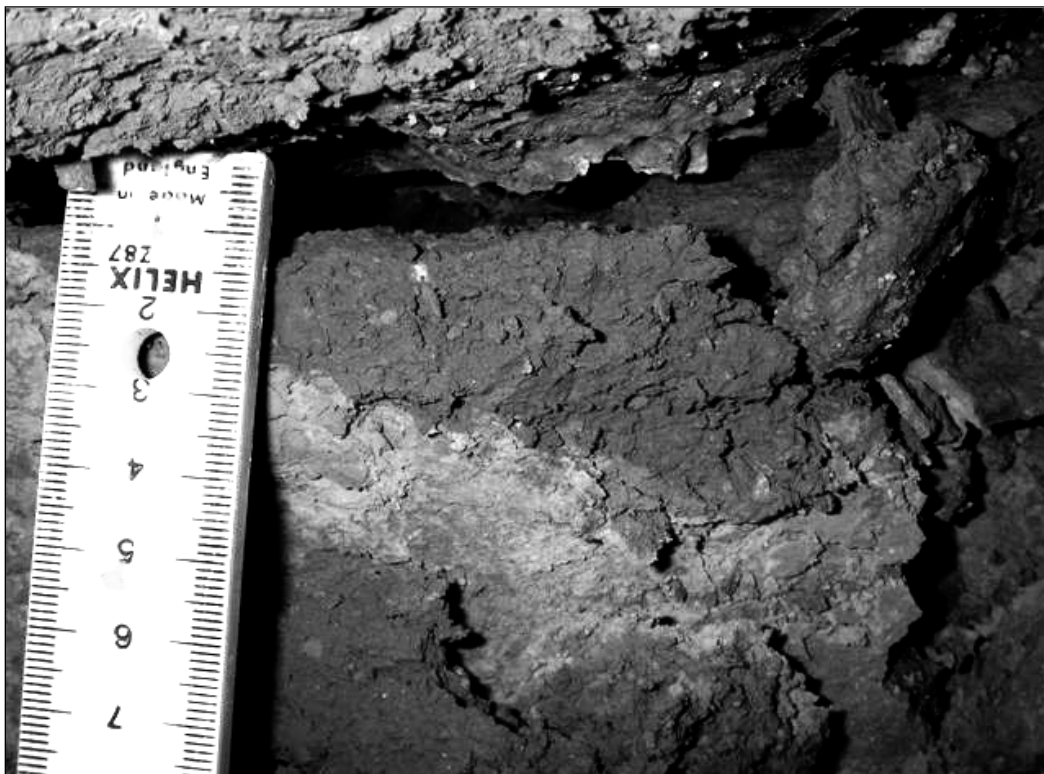
Figure 4 The boundary between the host soil and remoulded soil around pile MR1-D/OR, 819-1277mm bgl as viewed from above. The lateral variation in remoulded zone thickness can be seen.

The observations reported above can be explained by considering the continuous flight augering process. The often uneven boundary between the remoulded and undisturbed soil indicates that because of the layered nature of the *in situ* soil the auger breaks rather than cuts through some layers with the cutting teeth at the end of the auger. The size of remoulded zone, as much as 55 mm that is equivalent to an approximately 30% increase in radius, also indicates that material is being broken away. It is unlikely that the auger would move laterally by that amount whilst creating the cavity and if it did so the sides of the cavity would not change in dimension so dramatically over such a short distance, see Figure 4.

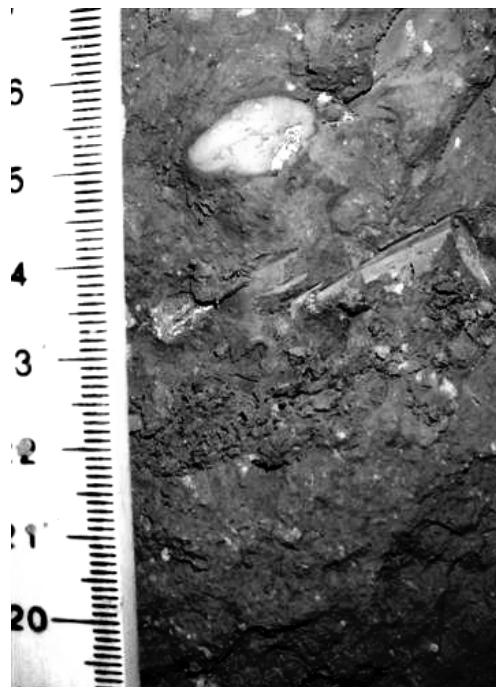
Figure 6 The vertical elevation of the remoulded surface of pile MR2 showing free aggregates within the remoulded layers. 1000-1457mm bgl.

Around all piles, pieces of aggregate were found within the remoulded zone, which were unlike anything occurring naturally in the geology on site (Figure 6). These aggregates have therefore been assumed to

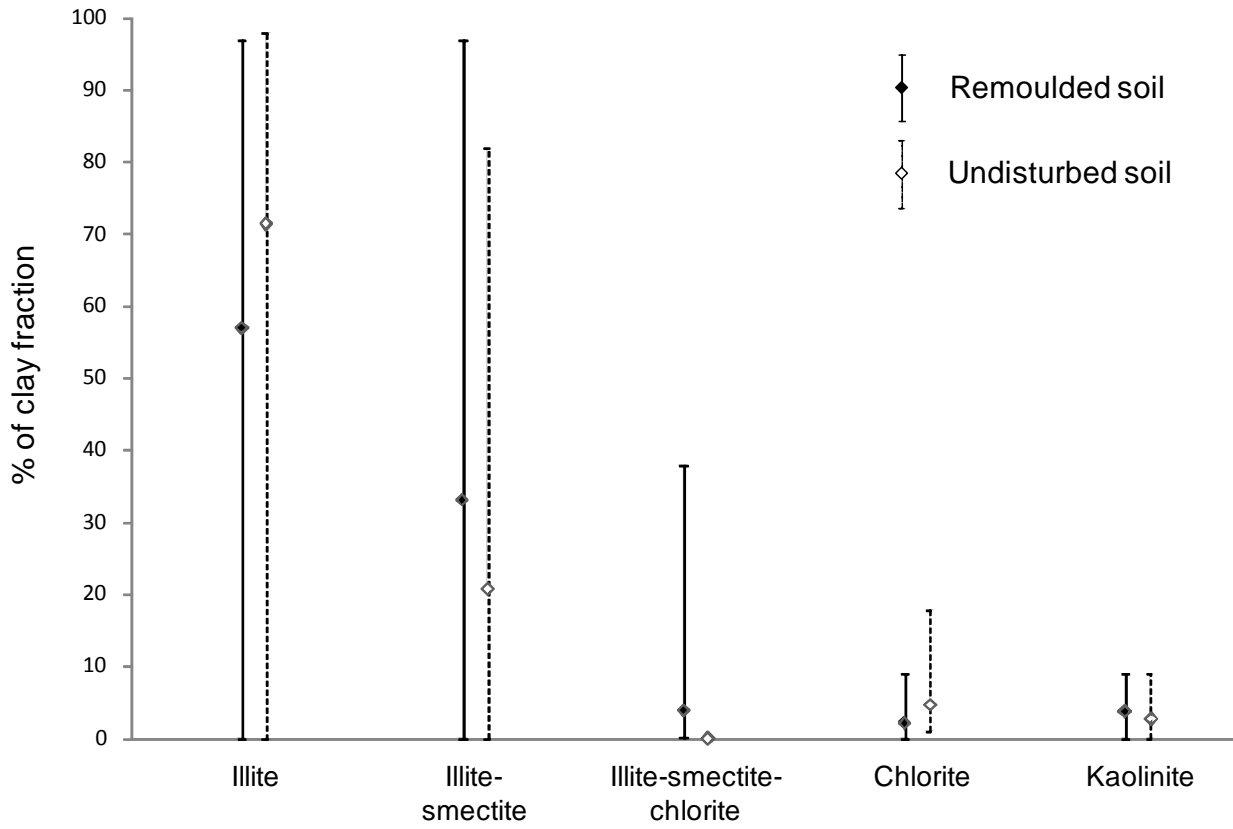
Figure 10 Abundances of minerals within the clay fraction of undisturbed soil outside remoulded zone and remoulded soil adjacent to the piles. Data is from samples from all piles. Error bars give maximum and minimum values measured.

chlorite. However in these samples, illite and smectite were combining rather than the chlorite-smectite combinations found by Chandler et al (2001) and there is also approximately the same average % of kaolinite as chlorite.

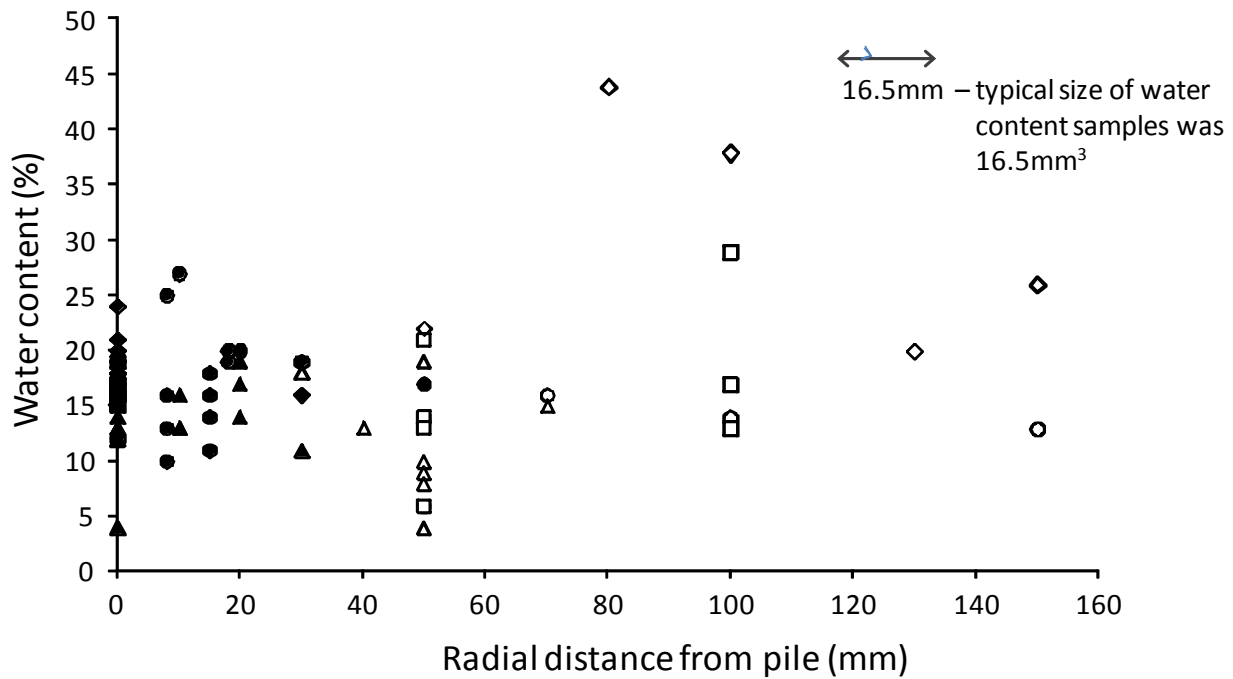
Figure 12 Variation in water content with (a) depth and (b) radial distance from the pile. Data from all piles, remoulded and undisturbed soil

As stated earlier because of the permeability of the mudstone and the length of time before the piles were exhumed, it is unlikely that changes in water content represent a transient response caused by the installation of the piles, but they should be a measure of the difference in the packing of the remoulded and undisturbed soil. If the mudstone had a significant clay content the remoulding should have created a more loosely packed soil, even if no swelling took place. The small average variation in water content in the remoulded zone is consistent with most remoulding and disaggregation of clay particles aggregates taking place near the pile as was observed and a mudstone which on average has a low clay content with low swelling potential. However, the variability in water content makes it difficult to draw any firm conclusions.

zones in all 4 piles soon become very relatively similar as evidenced by the water content data presented in Figure 12. Fissures also had a clockwise pattern which would be consistent with the movement of the auger in a clockwise direction implying that they were created by the auger.
