The 5th International Conference on Through-life Engineering Services (TESConf 2016)

## Tensile Response of Adhesively Bonded Composite-to-composite Single-lap Joints in the Presence of Bond Deficiency

Rachana Bhanushali, David Ayre and Hamed Yazdani Nezhad\*

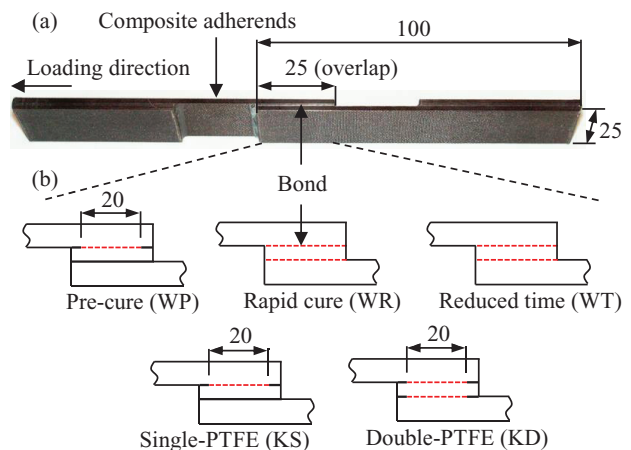
Figure 1. (a) Bonded joint geometry (all dimensions are given in mm); (b) schematic of weak bond categories (dashed lines represent regions where bond was weakened)

A 2mm-thickness carbon fibre-reinforced composite panel was manufactured from aerospace grade unidirectional Hexply® M21/T800S pre-preg using manual laying-up and autoclave cure, having the stacking sequence of  $[0^\circ 90^\circ 45^\circ - 45^\circ]_s$ . The joint laps were then extracted from the laminate using abrasive water jet technology (dimensions are given in Figure 1(a)).

Figure 1(b) schematically shows five modified categories with the dashed line representing the weak bonds. The PTFE films (categories KS and KD) were embedded at centre not the bond run-outs, to avoid pre-cracking. The WP category was then introduced to the centre to provide comparisons with the KS and KD cases.

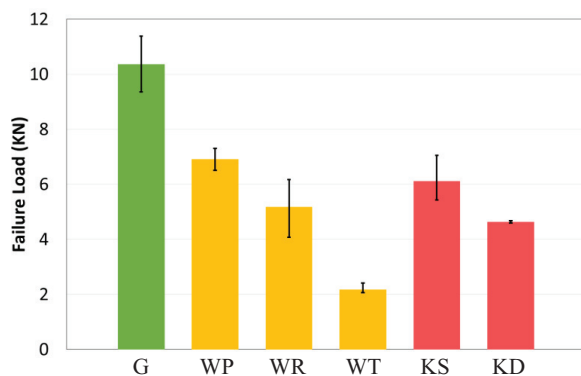
Figure 2. Comparison of failure loads in joints with different bond quality

Consistent data were obtained for each bond category, Figure 2. The KD (double-side PTFE) bond provided the most reproducible data, and WR (rapid cure) bond provided the largest spread in failure loads. The weak joint with the pre-cured bond (WP) represents an incomplete or partial curing scenario in actual bonded repair applications and is of greatest interest. The results in Figure 2 show that despite curing the centre prior to bonding the composite adherends, the joint has been able to sustain 67% of the failure load of the good bond (no defects). Whilst rapid curing using the temperature rate of 4°C/min, twice the specified rate, produced a bond which only reached 50% of the standard joint's failure load. This is approximately the same response as the joint with a double-side PTFE. Among all joint categories, the bonded joint with the reduced cure time exhibited with the greatest reduction (79%) in the failure load.

The images, figure 3, are consistent with the failure load results, figure 2. The pre-cured bond (WP) and the kissing bonds with PTFE films (KS) failed approximately at a same load and their failure mechanism appears to be similar, Figure 3. It should be noted that due to the unsymmetric bond area in the WP and KS categories, unsymmetric secondary bending is introduced, i.e. the composite adherend at the weak bond side undergoes higher bending strain.

Also of interest is the bond cured by rapid heating (WR). As seen, the morphology of the failure surface is different from the others. It has been observed that higher ramp rate could cause increased voids and increased variation in degree of cure due to temperature gradients throughout the bonded joint [14]. This significantly affects the bond and structural integrity. This category with the one with reduced curing time (WT) has both shown the lowest failure loads in Figure 2.

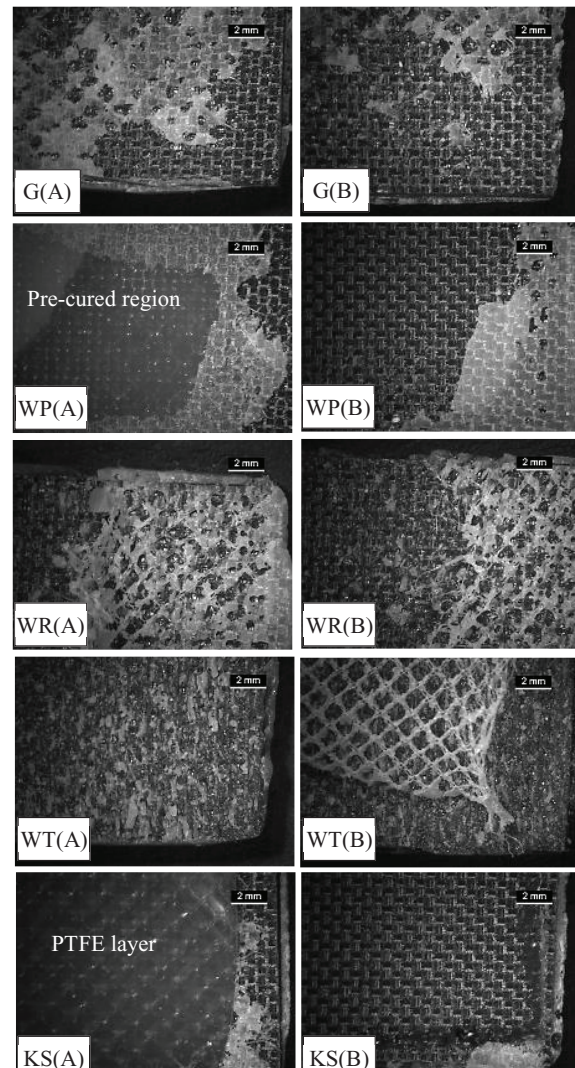
Figure 3. Microscopic images of the bonded joints after failure

All joints were observed to fail at the bond interface. The images from each adherend contact faces (A and B) of the bond of one representative joint from each category (except KD) are shown in Figure 3. Bright and dark regions represent the adhesive and the surface of the composite respectively. The images for the bonds incorporating PTFE film (KS and KD) were very similar and only images for the KS joint are presented. Any cohesive failure behavior of the adhesive was minor, with most joints exhibiting adhesive failure at the adherend/film adhesive interface. This was evident from the microscopic images in Figure 3 where the adhesive has been

observed bonded on one adherend only and peeled from the other. The only exception was the bonded joint cured in a time shorter than the others (WT), where a combination of interface and cohesive failure was observed. This is expected as in a

The adhesive films contain carrier cloth which, based on our observations, did not fail (see e.g. WT(B) in Figure 3), and thus is believed to be directing damage toward the interface. The bond thickness was relatively low (0.25mm) compared to the Standard [10] recommendation (0.76mm). This difference should reduce the joint eccentricity but the reduced thickness is expected to experience higher peel strain from geometry effects.

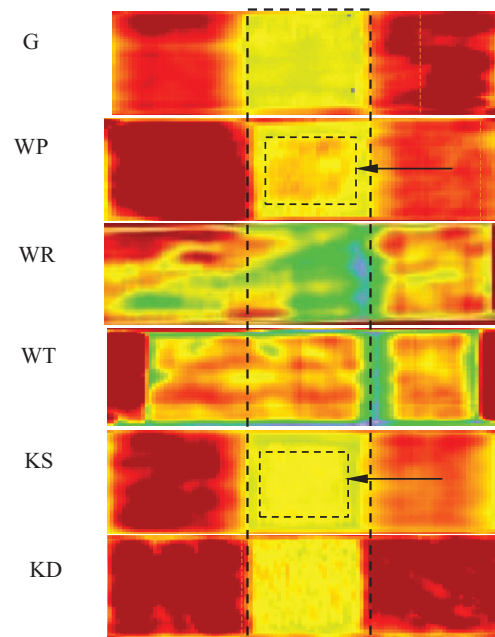
Figure 4. C-scan images of the bonded joints before test (outer dashed line represents the overlap bonded region of the joints (25mm×25mm) while inner dashed lines with arrows represents 20mm×20mm disbond at the centre of the overlap for WP and KS joints)

The C-scanned images of the joints' overlap region is shown in Figure 4, carried out using the parameters given in section 2.3 (the outer dashed line represents the overlap bonded region for all joints). Note that the C-scan images represents attenuation of a probe signal through the two composite adherends and the adhesive (bond). However as the significant difference is expected to arise from the adhesive (bond), and not in the adherends, the difference seen in the colour contours is referred to as defects. Taking the good bond with green/yellow contours as the reference for a bond with no defect, apparent differences observed for the rest of the joints are a sign of bond deficiencies. The WR and WT joints have also shown a clear mismatch and difference in the whole overlap region of the bond, compared to the image of the good bonded joint. This is in agreement with the results in Figure 2 where WR and WT had the most significant drop in failure load compared to the good bond. Clearly for the joint with reduced cure time, the C-scan is able to qualitatively capture the significant mismatch in the adhesion and bulk properties of the pre-maturely cured bond. Moreover, the main outcome from the figure is that the ultrasound technique clearly highlights the bond deterioration at the centre of the overlap region for WP (pre-cured bond) and KS (single-PTFE bond). This central region captured by NDI, shown by the arrows in the figure, represents the 20mm×20mm disband intentionally introduced at the centre of the overlap for WP and KS joints. Surprisingly, the disbond region is not observed for the KD joint which has

two PTFEs at either side of the bond. Understanding this requires further investigation.
