Post-fire assessment and reinstatement of steel structures

C. Maraveas^{1,2,*}, Z. Fasoulakis², K.D. Tsavdaridis³

Abstract

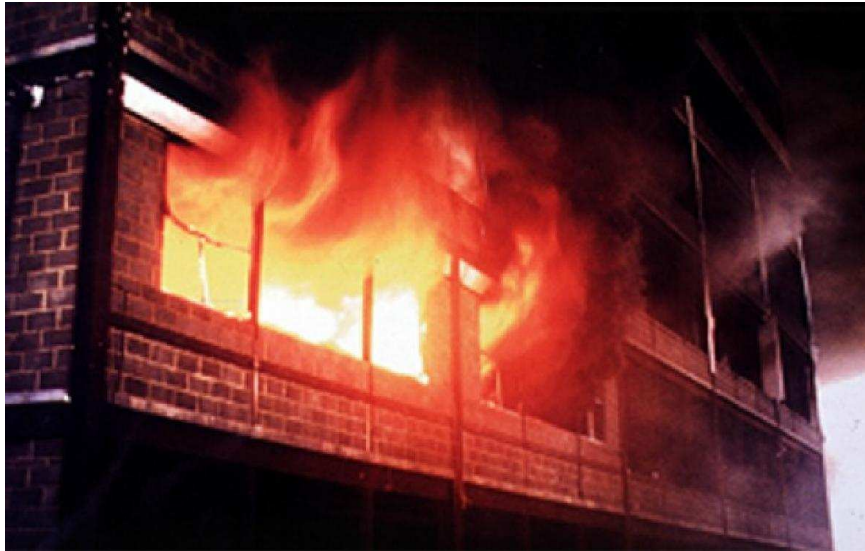
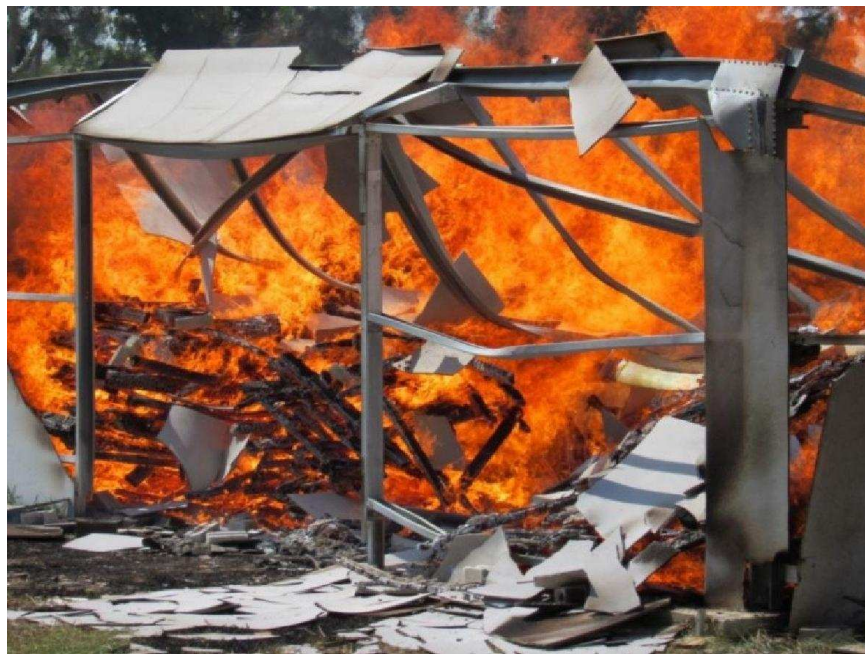
Figure 1. Fire tests in progress, conducted by a) Kirby et al. [21] and b) Johnston et al. [22].

valuable results were observed via experimental fire development on full-scale steel structures. The Swinden Technology Centre conducted a major research project [21], which applies to an eight storey steel framed building, while a cold-formed steel portal frame was tested by Johnston et al. [22]. Both of the studies above, which can be observed in **Fig. 1**, adequately represent the true behavior under fire conditions, aiming to the rational guidance establishment.

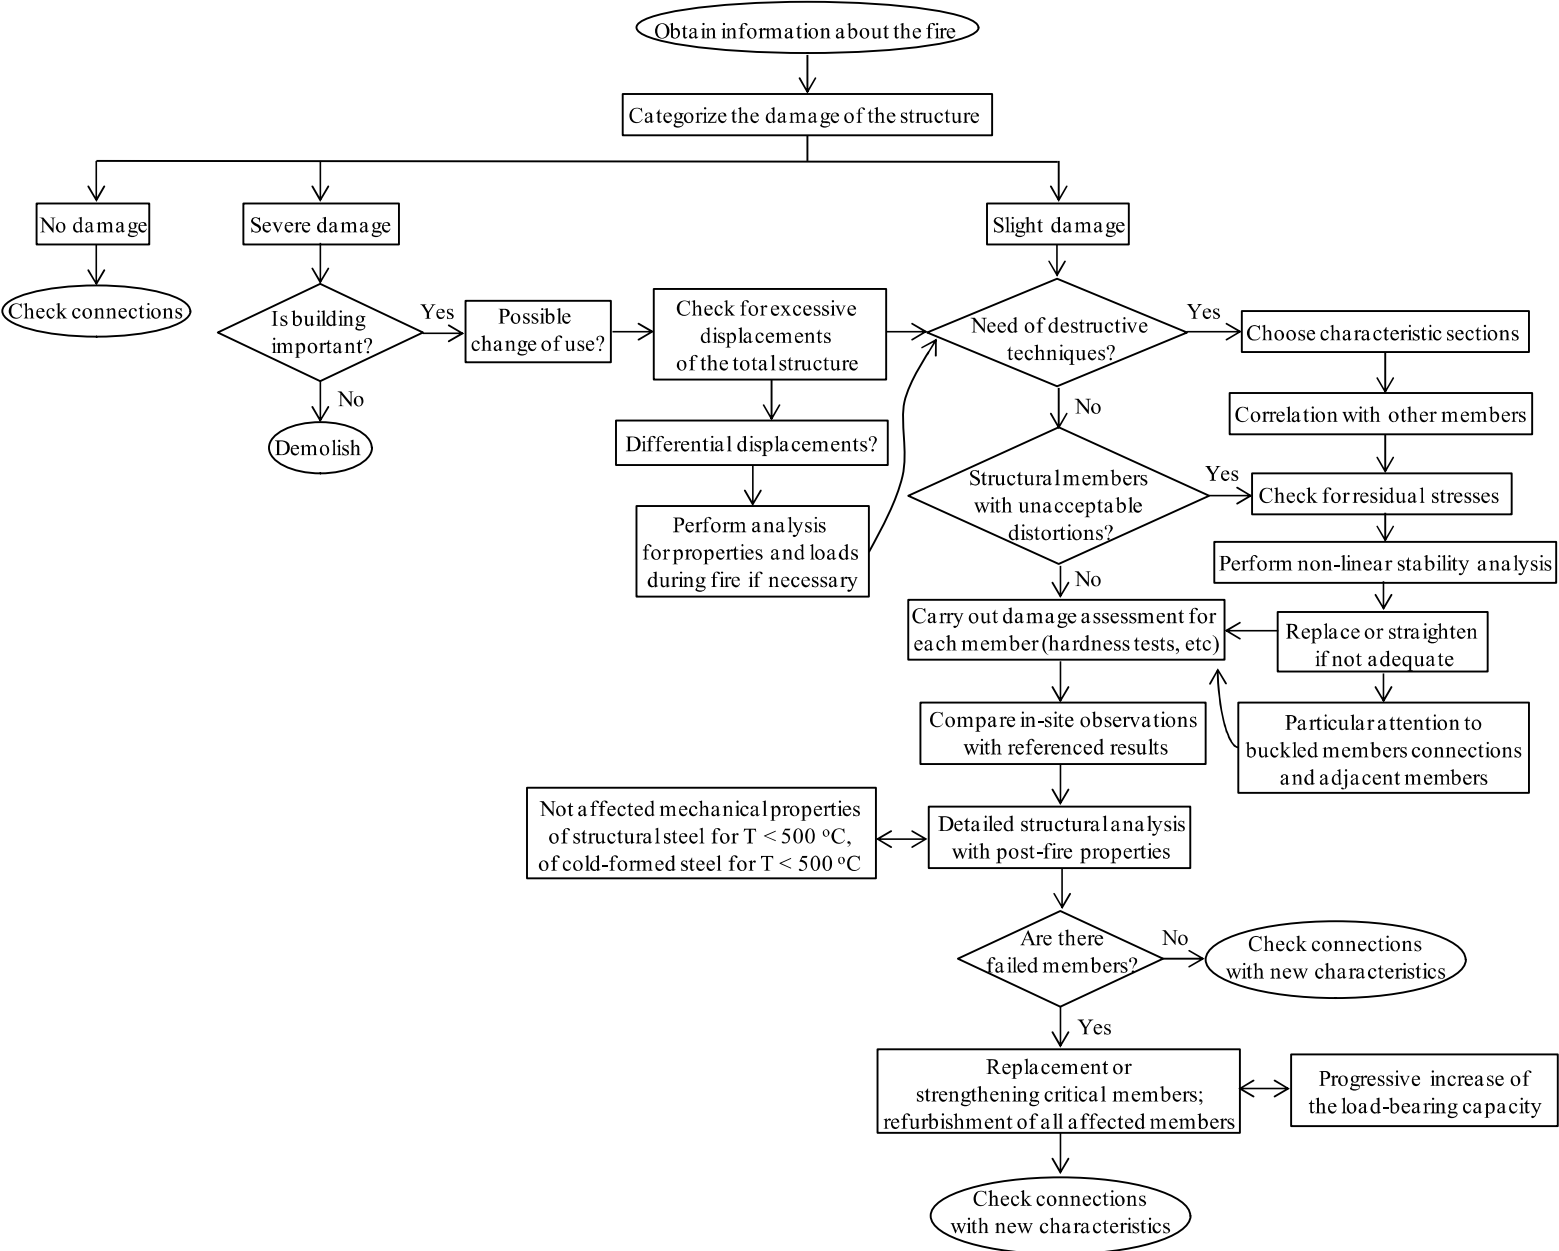
Figure 2. Reinstatement survey flow chart for fire damaged steel structures.

The step-by-step process of the fire damage appraisal is dissimilar to the fire resistant design of structures, which can be followed by prescriptive approaches. **Fig. 2** depicts the reinstatement survey flow chart of steel structures which illustrates the basic steps.

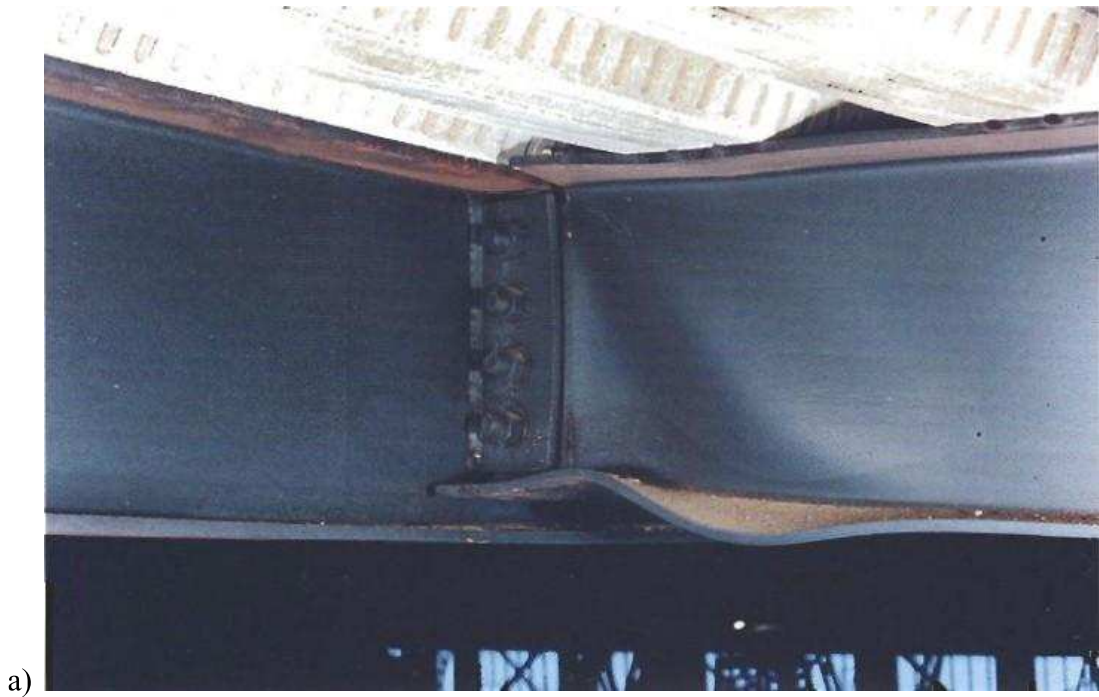
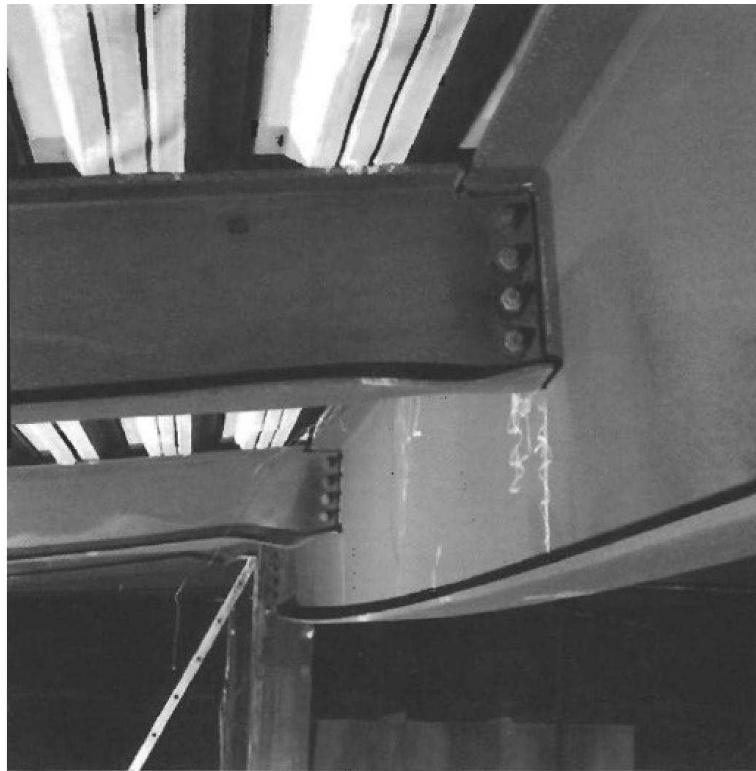
Figure 3. Fin-plate connections of secondary beams showing local buckling [21].

The observation of fire damaged elements provides to the engineers great insight into the ability of structures to withstand in the fire. For this reason, structural deformations of special interest, created during or after fire events are attached in **Figs. 3-4**. In particular, local buckling of the bottom flange and web folding occurred at a secondary beam (**Fig. 3a**) during the heating and cooling phases of the Cardington multi-storey steel frame test, respectively [21]. Such failure is attributed to the axial rigidity of the adjacent connection, the bolts of which do not seem to be affected. In this case, it is highly recommended for the inspector to check for any possible twisting of the primary beam, as it is observed for the corresponding one in **Fig. 3b**. Another failure that highlights the stress development during the cooling phase is attributed to the shear fracture of the bolts at the fin-plate joints. These facts reinforce the statement that localized damages of key elements may be more critical for the overall stability. Another type of distortion, regarding cold-formed steel frames, is observed in **Fig. 4** [12]. The column under investigation is regarded

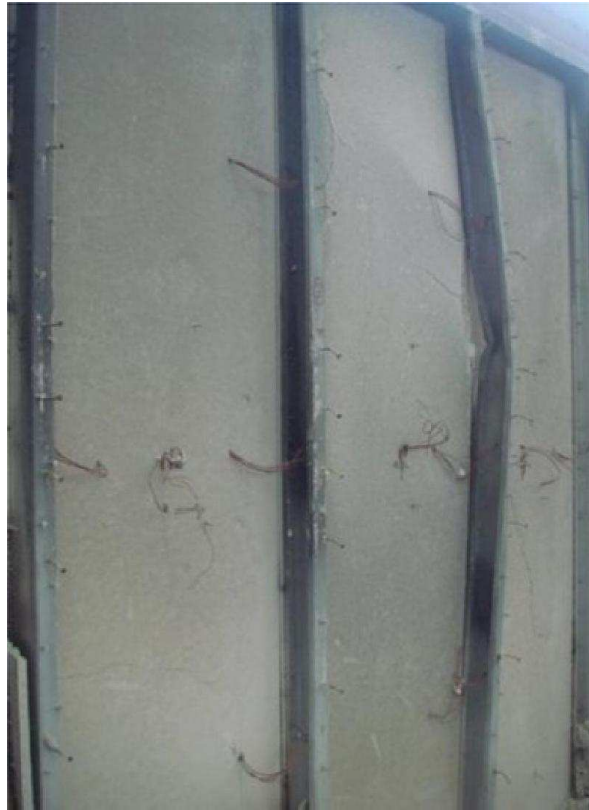
Figure 4. Cold-formed steel frame after fire [12].

noticeably deformed (category b); the restoration through heat-straightening works is preferable as opposed to its replacement.

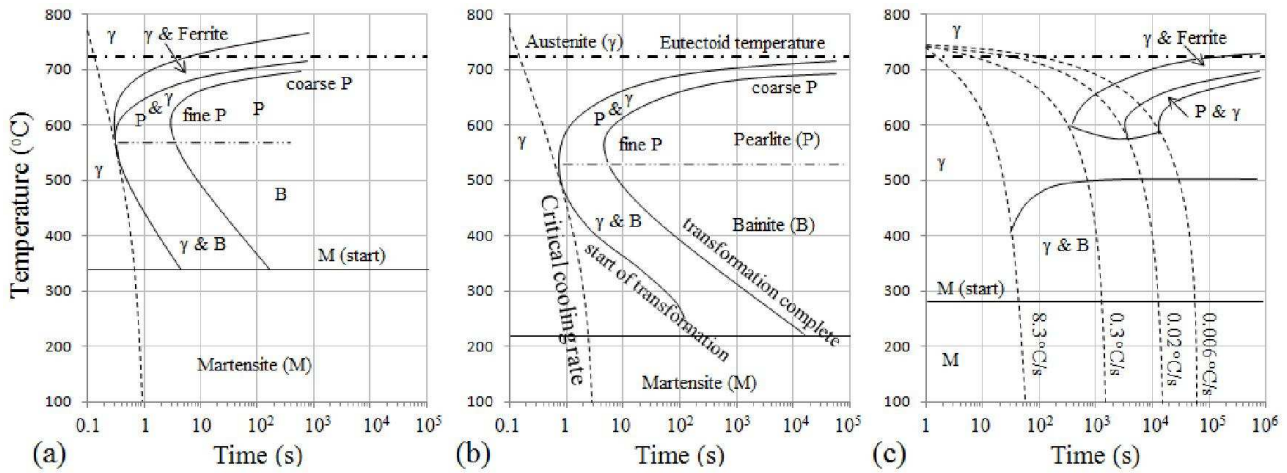
Figure 5. Schematic diagrams illustrating isothermal curves (IT), critical cooling curves and resulting microstructures for a) hypoeutectoid, b) eutectoid and c) alloy steel [26].

Fig. 5 demonstrates the isothermal time-temperature-transformation (TTT) diagrams for three different types of steel: a) hypoeutectoid steel (less than 0.8% of carbon), b) eutectoid steel (0.8% of carbon) and c) alloy steel. Firstly, the steel is held at elevated temperatures, greater than the eutectoid temperature ($A_1=727^\circ\text{C}$), where the transformation to austenite begins. The temperature A_3 is associated with the completion of the transformation of ferrite to austenite. It must be noted that for hypoeutectoid steel, A_3 varies linearly, inversely related to the carbon composition ($A_{3,\text{max}}=910^\circ\text{C}$).

The course of transformation can be completed in either an isothermal or a continuously cooling way. If the austenite is cooled unchanged to a relatively low temperature (M_s), partial transformation takes place instantaneously, producing martensite. This formation attributes to the maximum hardness that can be obtained while the transformation can take place by cooling in water (CIW) or in ice. The critical cooling rate for each steel type is illustrated in **Fig. 5**.

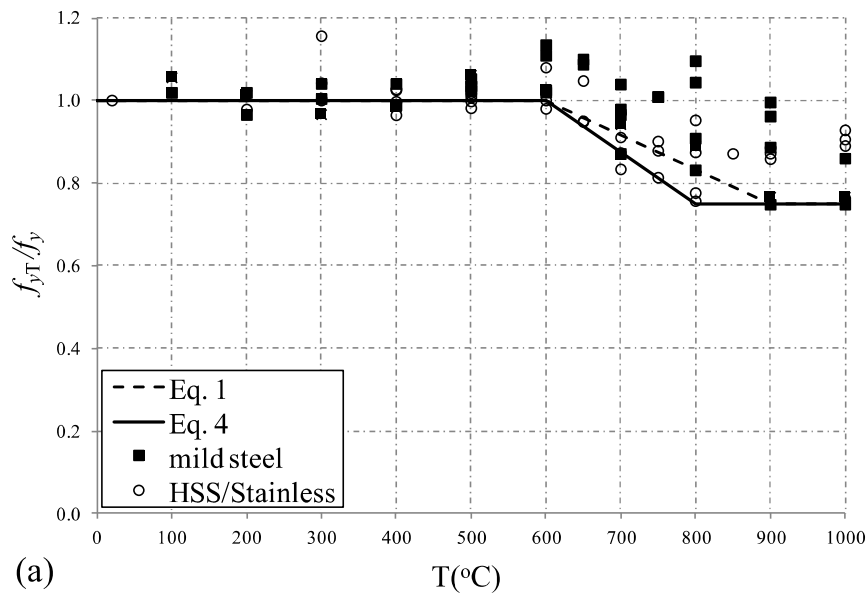
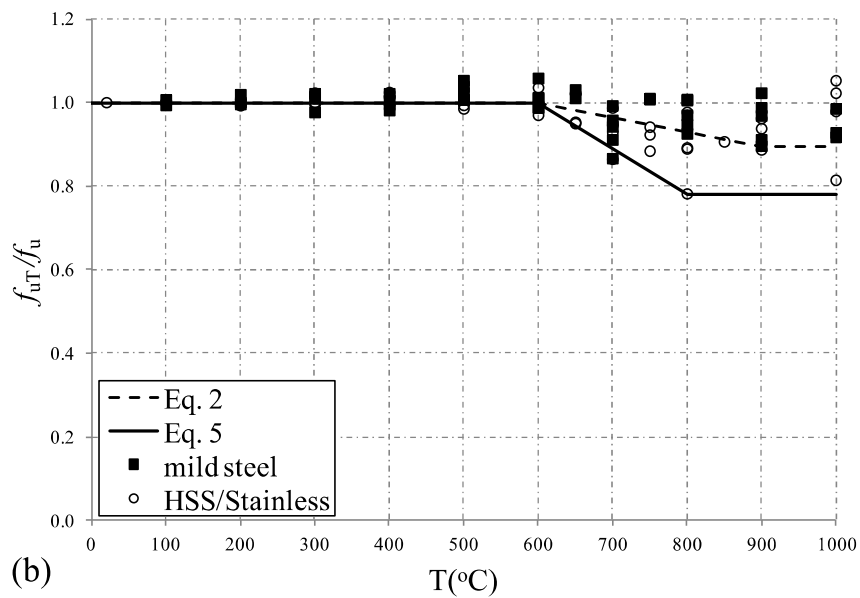
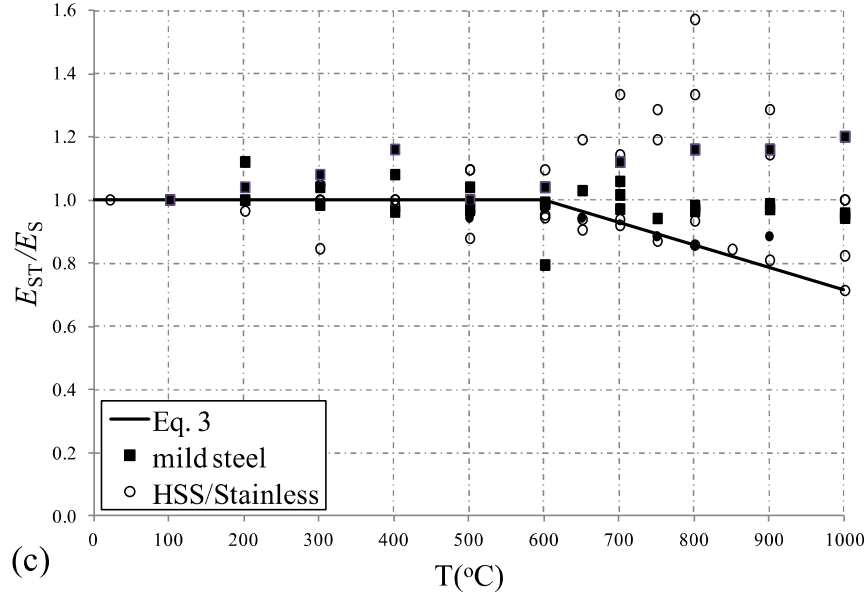
Figure 6. The ratio of a) f_{yT}/f_y , b) f_{uT}/f_u and c) E_{sT}/E_s as a function of temperature for hot-rolled steel.

The experimental ratios of f_{yT}/f_y , f_{uT}/f_u and E_{sT}/E_s for hot-rolled steel are plotted in **Fig. 6**, where f_y , f_u and E_s are the reference yield strength, ultimate strength and elastic modulus (i.e. before the fire exposure), while those with the subscript T are the corresponding temperature dependent values.

Eqs. (1)-(5) define the potential predictions and are compared with the test data. Eqs. (1)-(2) are the most accurate ones according to all test data with mild steel, but sometimes overestimate the strength of high strength steel. Eqs. (4)-(5) are recommended for practical use to determine the residual yield and ultimate strength of high strength, alloy and stainless steel after cooling down from fire temperatures up to 1000°C.

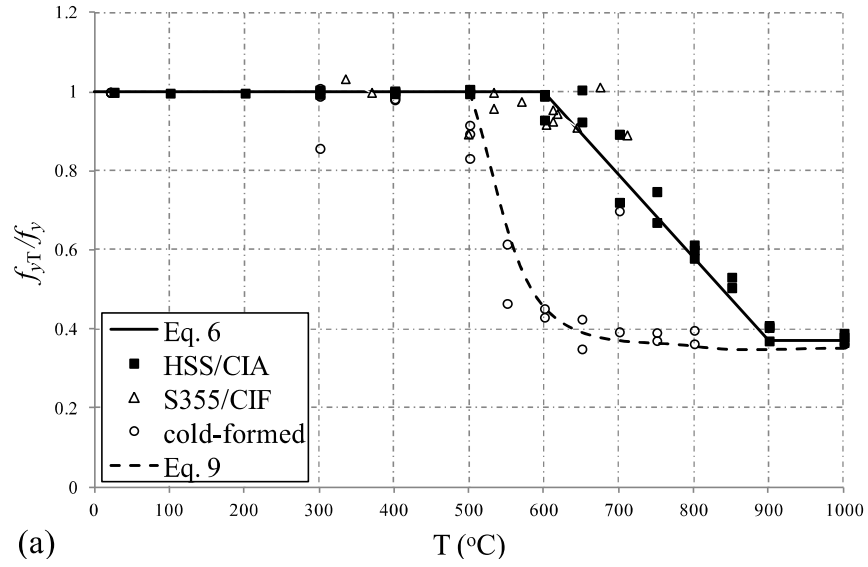
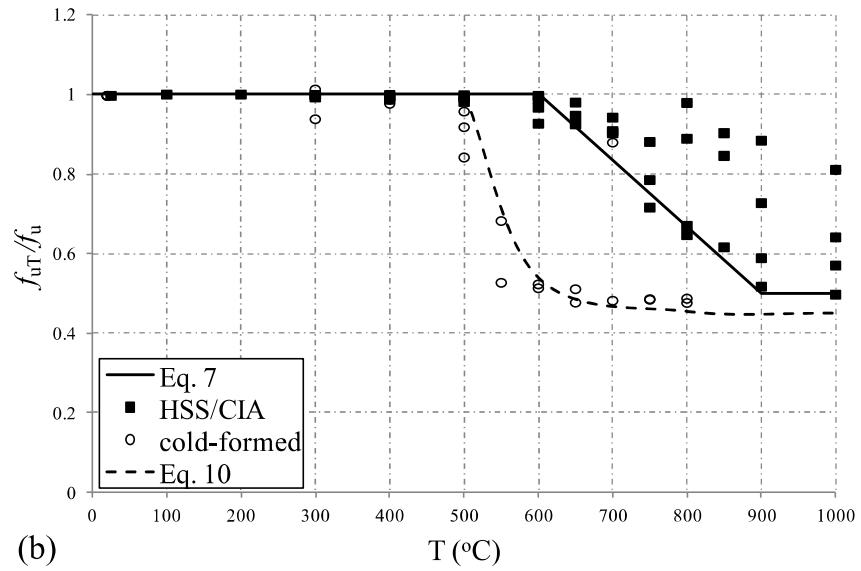
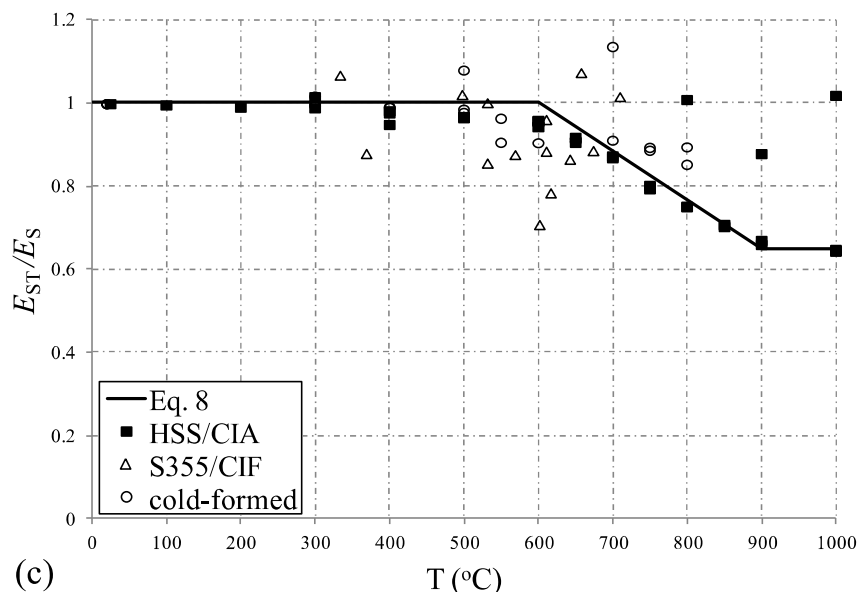
Figure 7. Comparison of predicted residual factors a) f_{yT}/f_y , b) f_{uT}/f_u and c) E_{sT}/E_s for heat-treated and cold-formed steel.

Post-fire mechanical properties for heat-treated steel are defined by Eqs. (6)-(8). An obvious difference between cold-formed and heat-treated steel is apparent in terms of yield and ultimate strength [6,12,13]. Therefore, the residual capacities for cold-worked steel and the sudden decrease of which is clearly illustrated in **Fig. 7**, are established by Eqs. (9)-(10), respectively. The comparison of the corresponding equations with the test data is also presented.

It is concluded that the post-fire behavior of structural steel is hardly influenced after exposure to temperatures up to 500°C. In addition, the residual ultimate strength of mild steel is found greater than 90% of the initial one, whereas none of the properties of hot-rolled steel is reduced more than 25%. The distinction between mild steel and HSS is also stated in Appendix B of British Standards 5950-8 [23], which recommends the reuse of steel grade S235 and S275, following a 10% reduction in the initial strength. On the other hand, for steel grade S355, at least 75% of the strength is regained on cooling from temperatures above 600°C, which is in agreement with the experimental results [5,7,8] (**Fig. 6**). On the other hand it is worth to note that these suggestions are considered as non-conservative for heat-treated [8,9] and cold-worked steel, as the deterioration of the capacity is more significant (**Fig. 7**; residual factors over 35%).

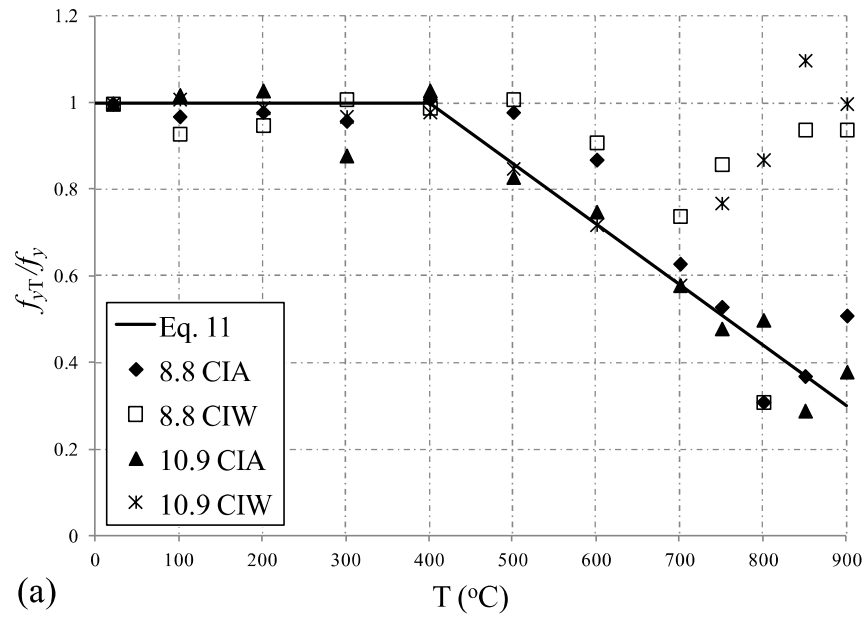
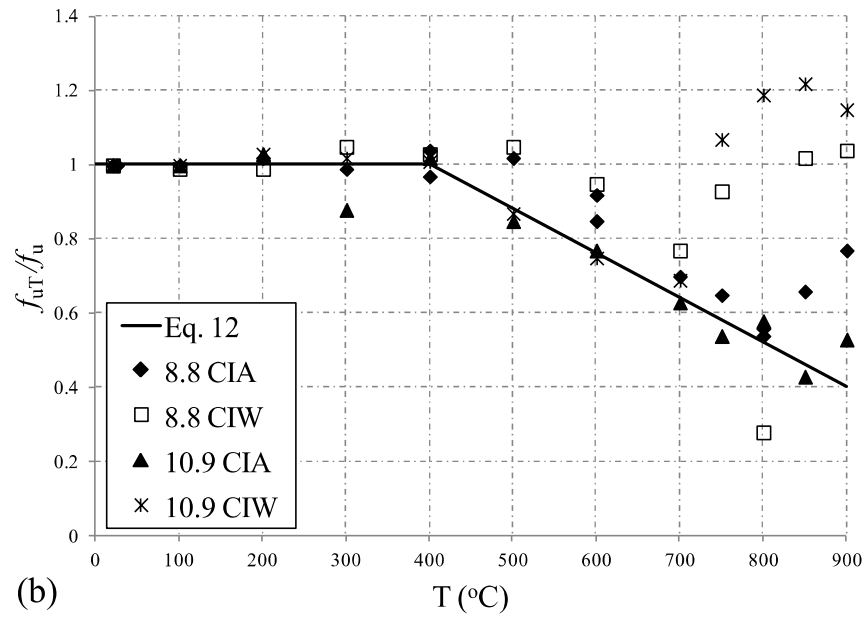
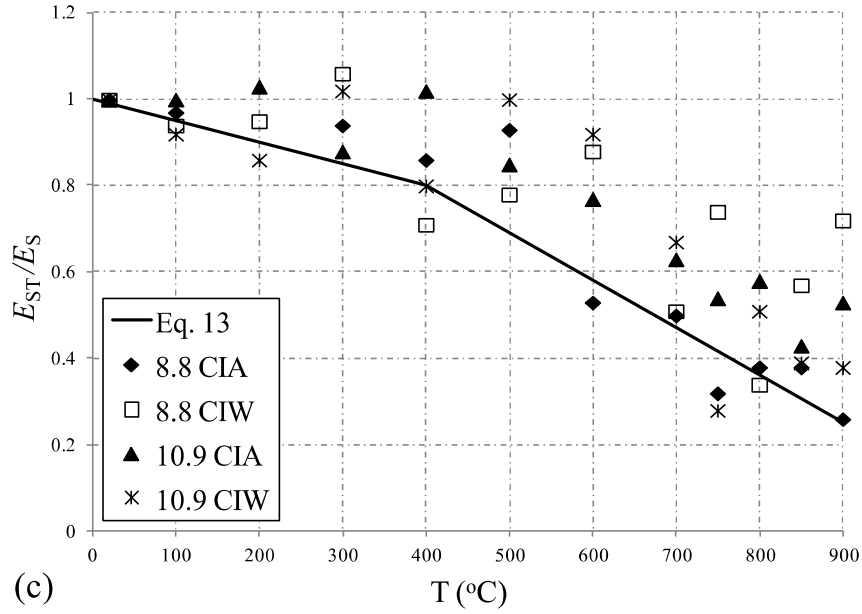
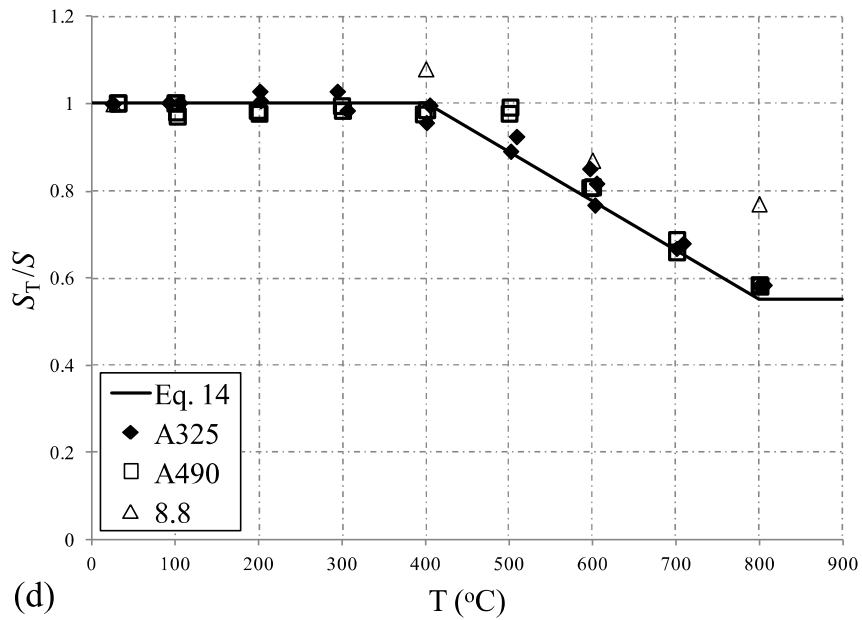
Figure 8. Comparison of predicted residual factors a) f_{yT}/f_y , b) f_{uT}/f_u , c) E_{sT}/E_s and d) S_T/S for high-strength bolts.

properties remain unaffected for temperatures up to 400°C, whereas the mechanical properties deteriorate from 25-55% of the initial ones for temperatures up to 900°C.

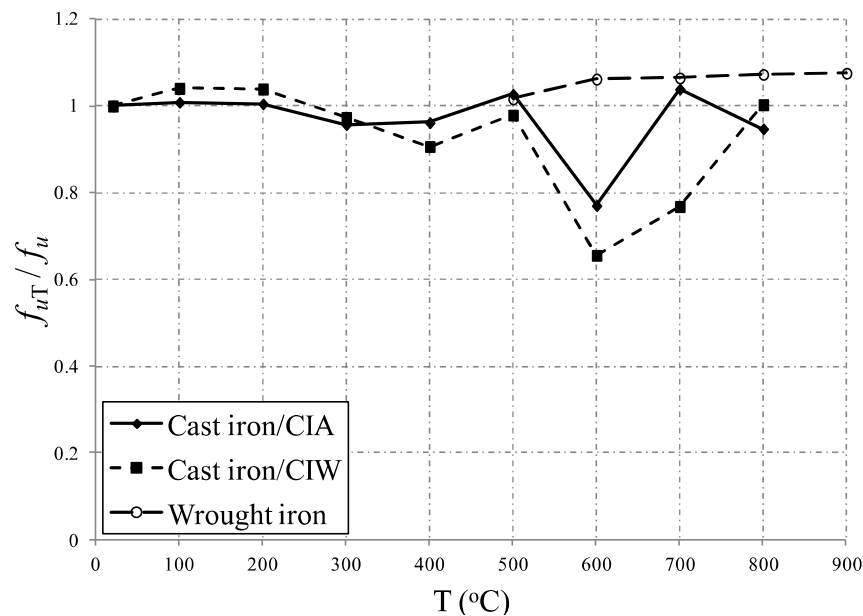
Figure 9. Residual factors f_{uT}/f_u for a) cast iron [14] and b) wrought iron [4].

Wrought and cast iron materials have been widely used in historical structures [14], the preservation of which should be taken into account after fire events. Their post-fire behavior was observed by Kirby et al. [4]. Nevertheless no experimental data is available nowadays, except the recent results conducted by Maraveas et al. [14]. The work conducted in this paper demonstrates the mechanical behavior of cast iron under high temperatures as well as after cooling to ambient temperature. The results indicate deterioration in capacity only for temperatures between 600°C and 700°C. Oppositely, wrought iron demonstrates the same mechanical behavior after cooling from elevated temperatures [4]. The observations above are graphically displayed in **Fig. 9**.
